SUBURB: Rockingham

Code No. F1R

Connects Chalwell Street (head of cul-de-sac) to Esplanade

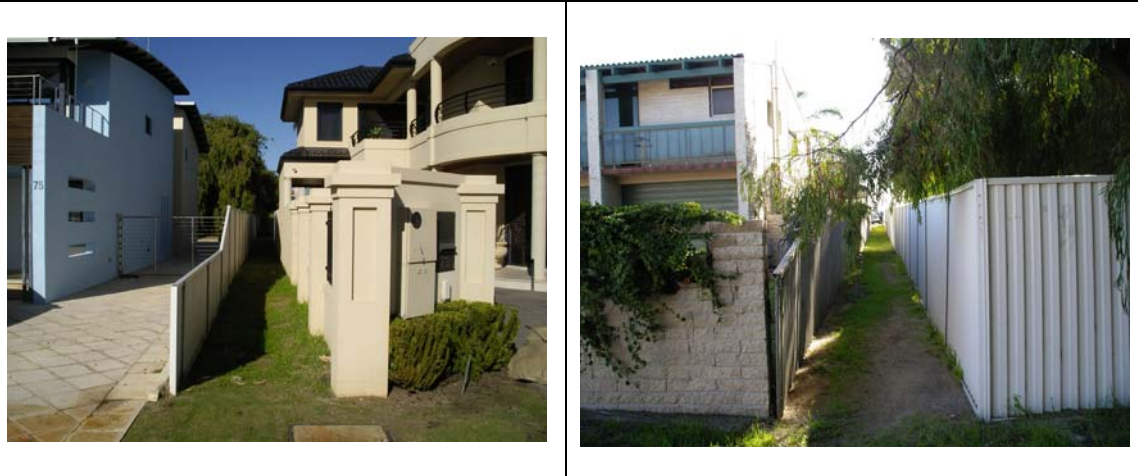
Accessway approx. 1.5m wide (very narrow) and 64m long. Straight, slightly undulating. No bollards.

Poor. Graffiti, weeds, rubbish, unpaved.

This very narrow accessway probably provides convenient access to and from the beach for a very small number of nearby residents. However, it lies parallel to, and near to, PAW R262. The real purpose of this accessway, and its ownership, is not known.

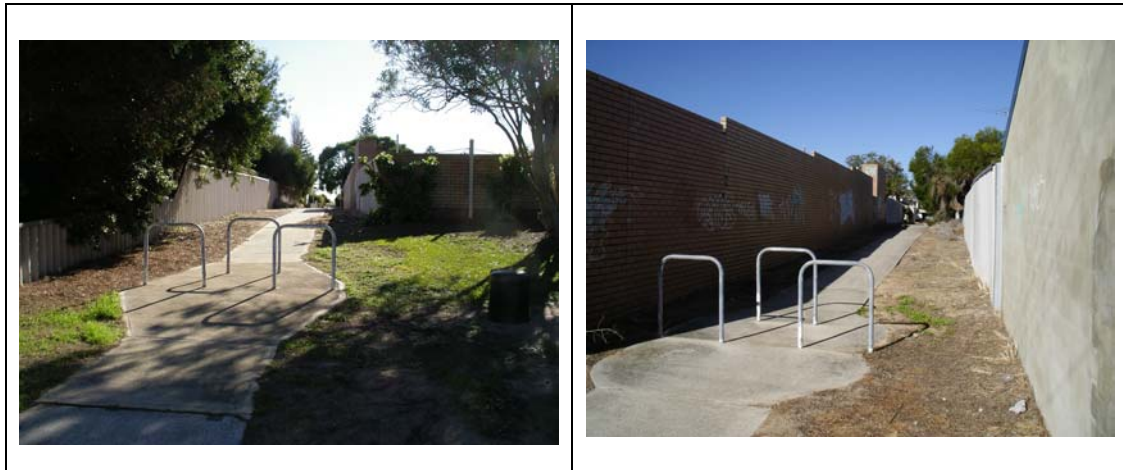
Code No. F2R

Accessway approx. 5m wide and 64m long. Straight, undulating, bollards at both ends.

Poor to fair. Lots of graffiti, some rubbish & sand over path.

This accessway has all the appearance of a genuine PAW. It connects directly with PAW R262.

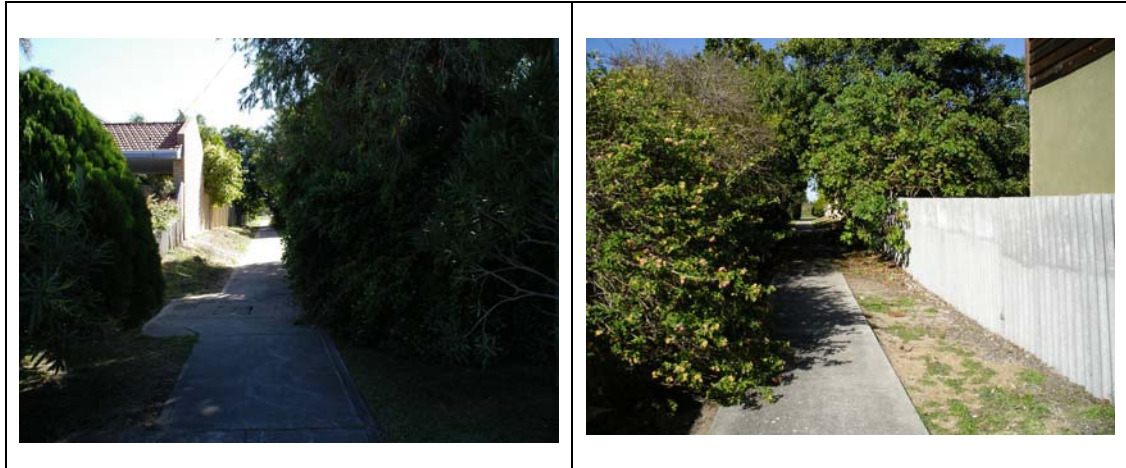
Code No. F3SB

Accessway approx. 5m wide and 83m long. Straight, long, slightly undulating. Bollards at north end only.

Poor to fair. Some graffiti, leaves, rubbish, grass clippings, high sand margins.

Lots of vegetation overhanging the accessway and over the path.

The overhanging vegetation needs to be severely pruned.

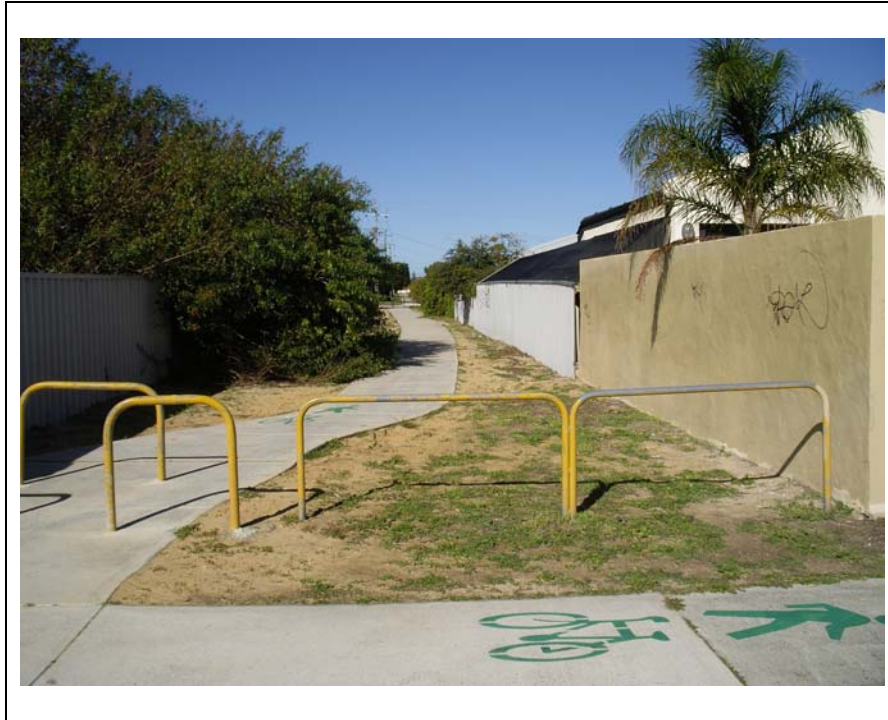
Code No. F4SB Map C4

Poor to fair. Some graffiti, broken glass & rubbish.

Ivy and large tree overhanging.

This accessway has all the appearances of a genuine PAW. It also has a dual-use path symbol stenciled on the concrete path. It connects to Rae Road, which is a bus route and has a dual-use path. It also connects directly at its southern end to Fawdon Street, providing good north-south access in this locality. Despite this accessway not being a genuine PAW, it needs to be retained as an important part of the local pedestrian/cycle network. It also appears to have some major underground services within it.

The overhanging foliage needs to be cut back.

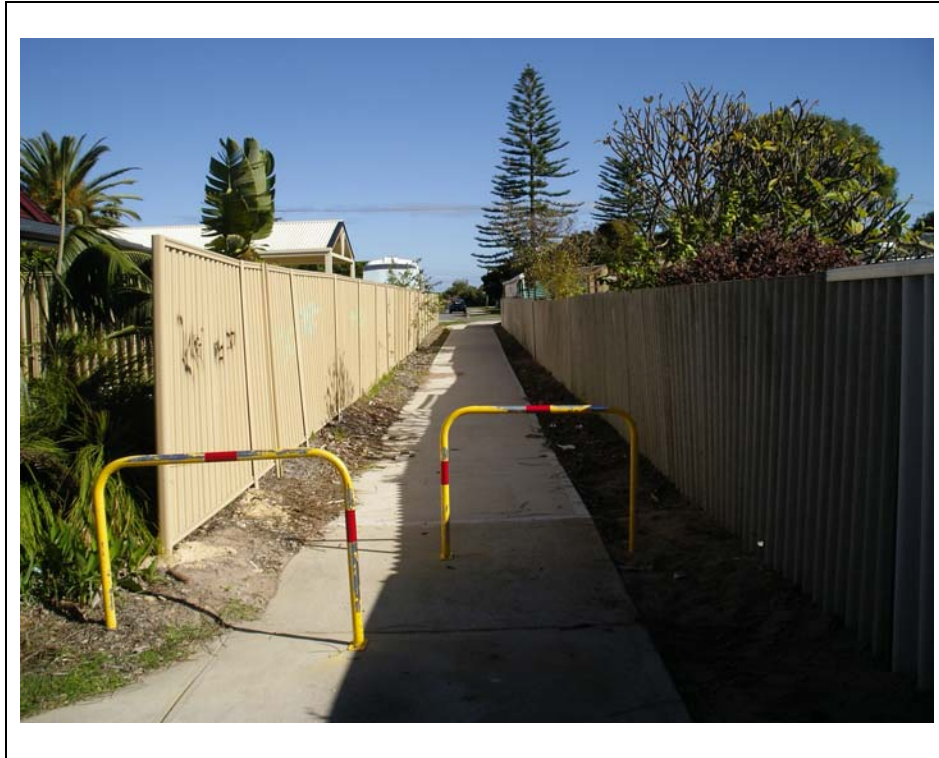
Code No. F5R **Map** D4

Accessway approx. 3.7m wide and 70m long. Slightly sloping. Right-angled bend two-thirds the way along. Bollards placed at bend.

Poor. Some graffiti, broken glass & rubbish, weeds, sand over path, high sand margins.

This accessway has all the appearances of a genuine PAW. The path appears to have been recently replaced. The holes in the concrete for bollards at each end have been provided, but as yet no bollards are in place (July 2009). The accessway has a blind corner, and no lights.

This accessway, due to the convoluted street pattern in the area, provides some convenience of access, but only to a small number of residents living in close proximity to it. Whilst it may be preferable to retain the accessway, the safety of its users needs to be given greater consideration. For example, bollard lights should be provided, and the end bollards installed.

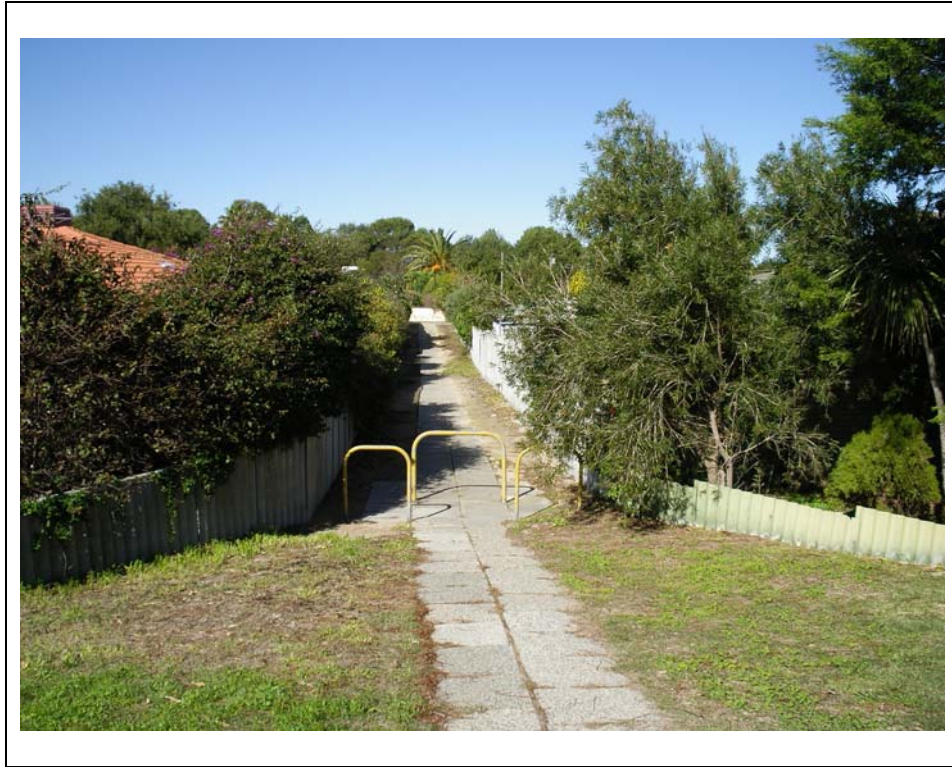
Code No. F6R **Map** D4

Poor. Some graffiti, weeds, leaves, sand over path and high sand margins.

Old concrete slabs, two x wide. Cracked, uneven.

The path needs to be replaced with a minimum 2m wide concrete path.

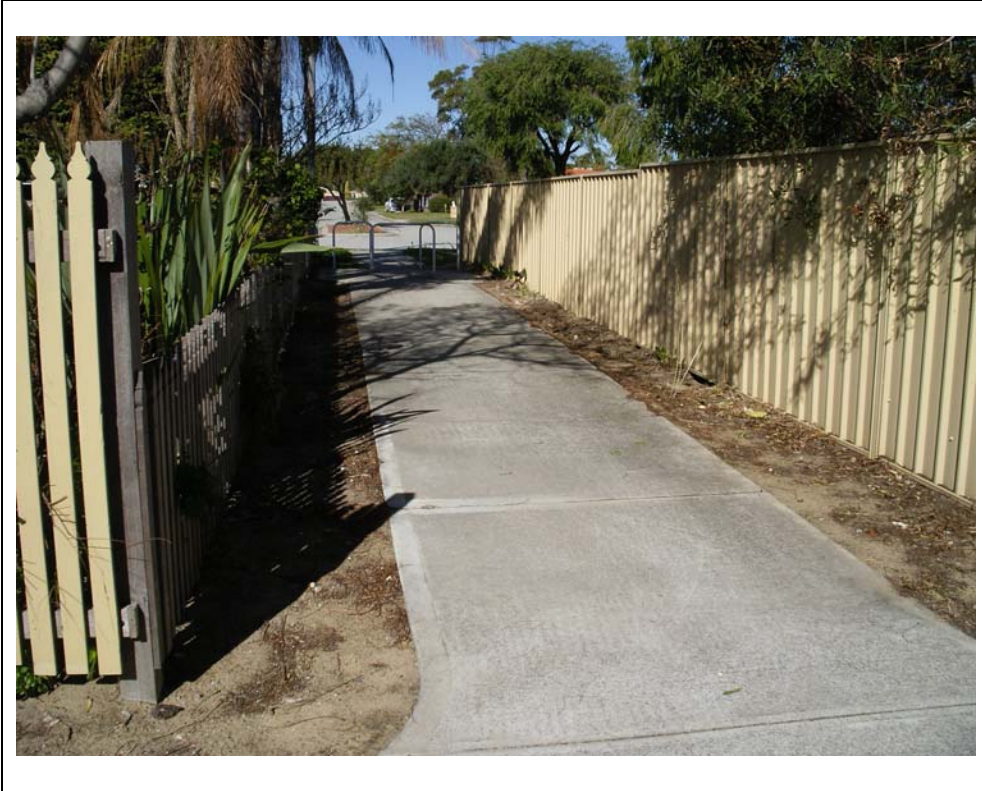
Code No. F7R **Map** D4

Fair. Some leaves, rubbish.

This accessway has all the appearances of a genuine PAW. It connects directly to PAW R232.

This accessway is an integral part of a comprehensive, inter-connected pedestrian/cycle network, and must be retained.

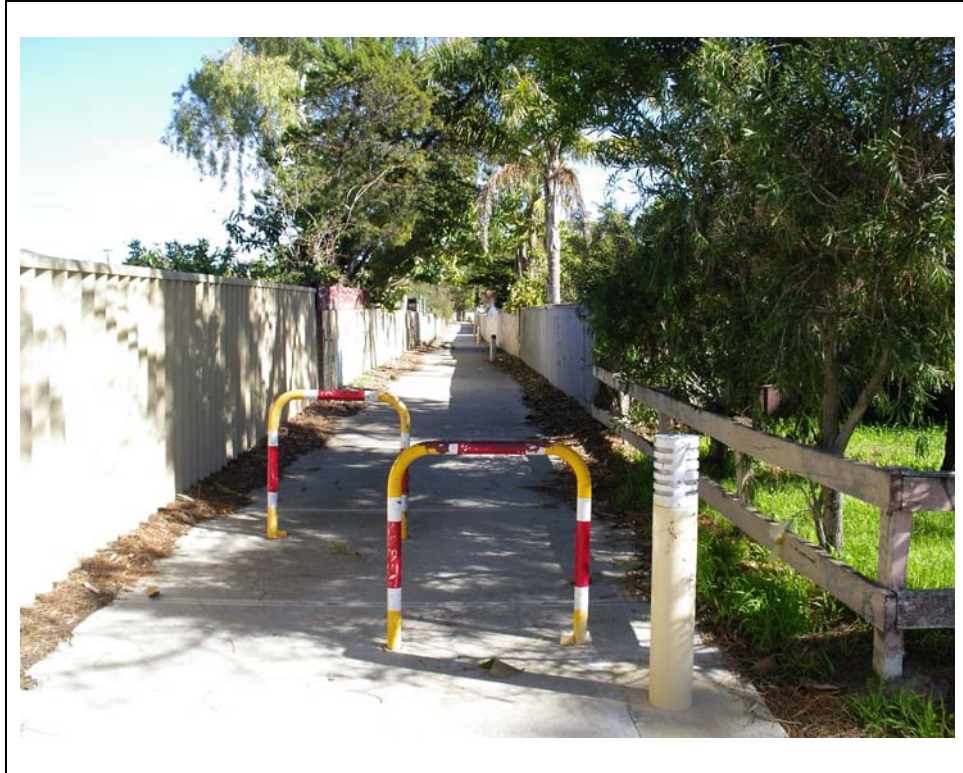
Code No. F8R **Map** D4

Accessway approx. 3.7m wide and 180m long in total. Main section is long and straight, with three “legs” coming off it at right-angles. Slightly undulating, with bollards at various locations.

Poor. Lots of graffiti, weeds, leaves, rubbish, tree branches and sand over path. Abandoned shopping trolley.

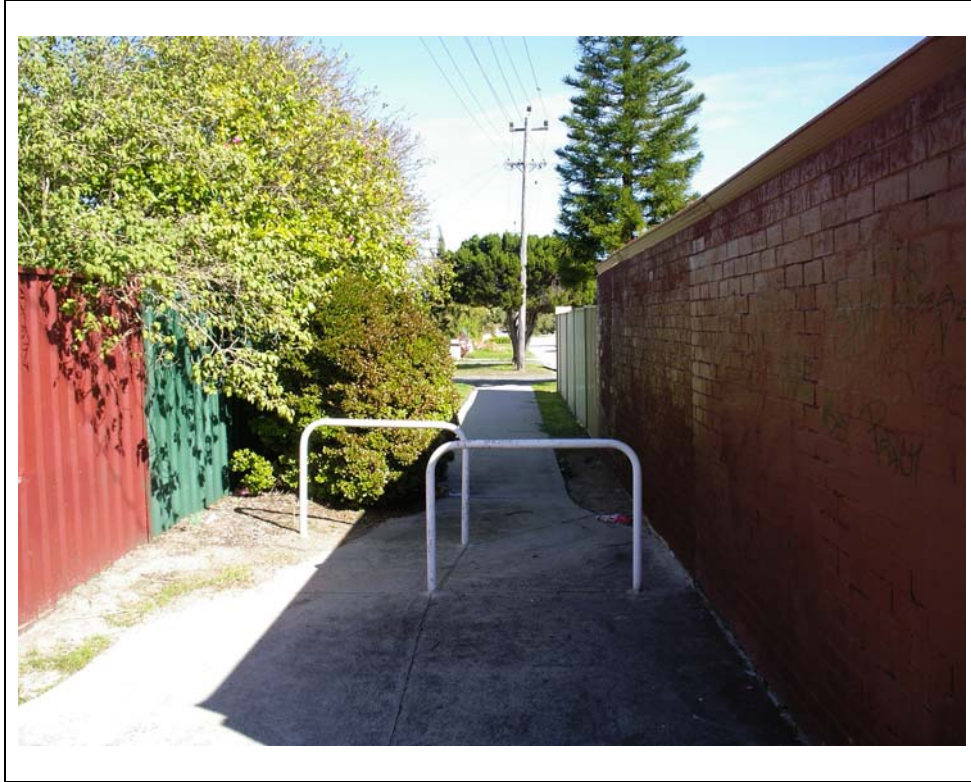
Code No. F9R **Map** D4

Accessway approx. 3.7m wide and 20m long. Flat, with bollards at park end.

Fair. Some graffiti, weeds, rubbish, broken glass.

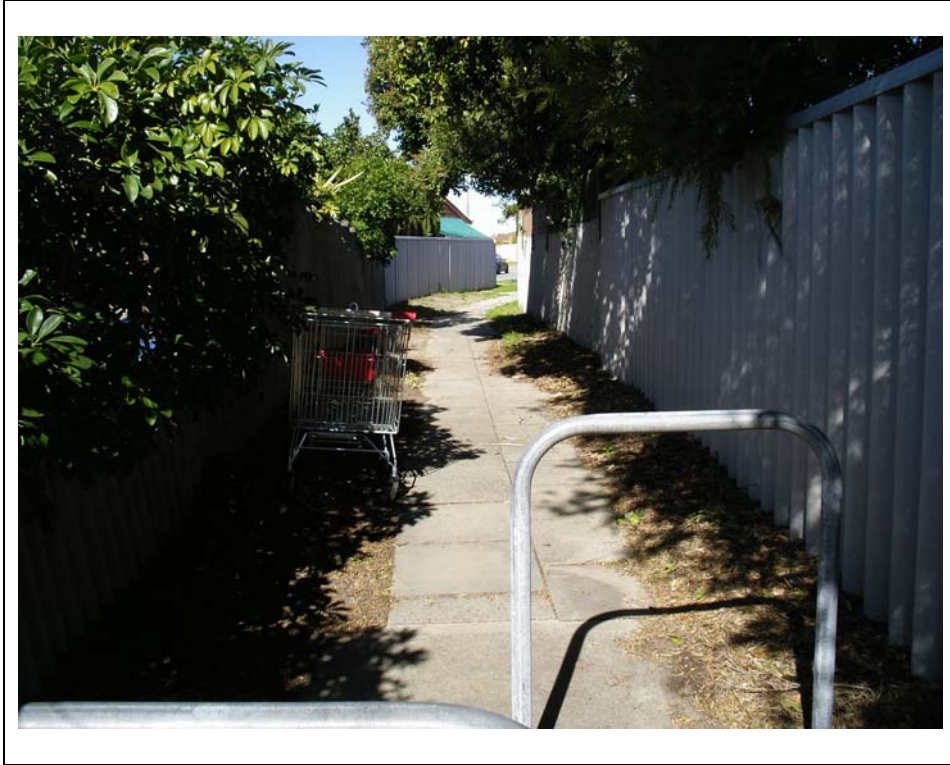
Code No. F10C Map D4

Accessway approx. 3m wide and 40m long. Flat, narrow, bend midway, with bollards at both ends.

Old concrete slabs, 2 x wide, cracked and uneven.

If the accessway is retained, the footpath need to be replaced by a wide concrete path, and the vegetation overhanging the side fences needs to be pruned back.

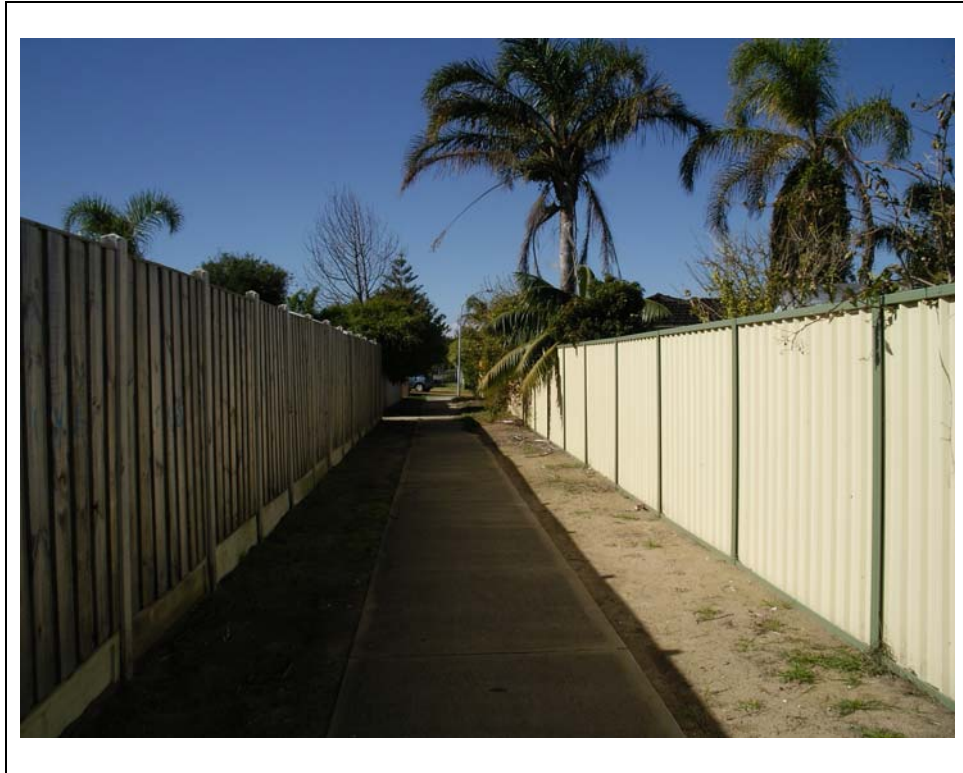
Code No. F11SB Map D5

Accessway approx. 4m wide and 100m long in total. "T"-shaped, flat.

Fair. Some graffiti, rubbish, broken glass, sand over path.

Recommendation No. 22 was to widen the path to 2.5m. **Note:** The recommendation included **all** of the connecting accessways, but most of these have been closed using gates.

Email received 12/08/09 from resident of 13 Galleon Court complaining about people climbing over the closed gates and causing damage & theft. Request # made to close the gated sections and sell to adjoining landowner(s).

Recommendation #: that the request for closure & purchase be supported, so long as the below-ground services question can be sorted out satisfactorily.

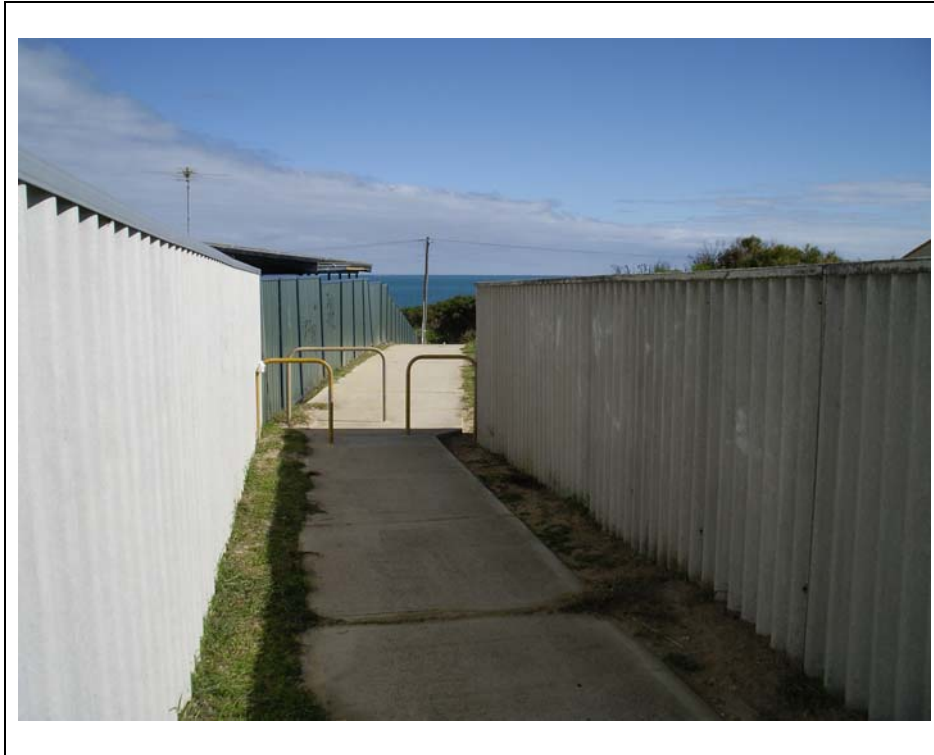
Code No. F12WK Map D6

Accessway approx. 2.4m wide and 100m long. Flat in parts, steeply sloping in others. Long and narrow, slight bend half-way, with triple set of bollards half way, and a single bollard at the west end.

Whilst not essential to the local pedestrian/cycle network, this accessway appears to be operating satisfactorily, and is in fair condition. It could be retained.

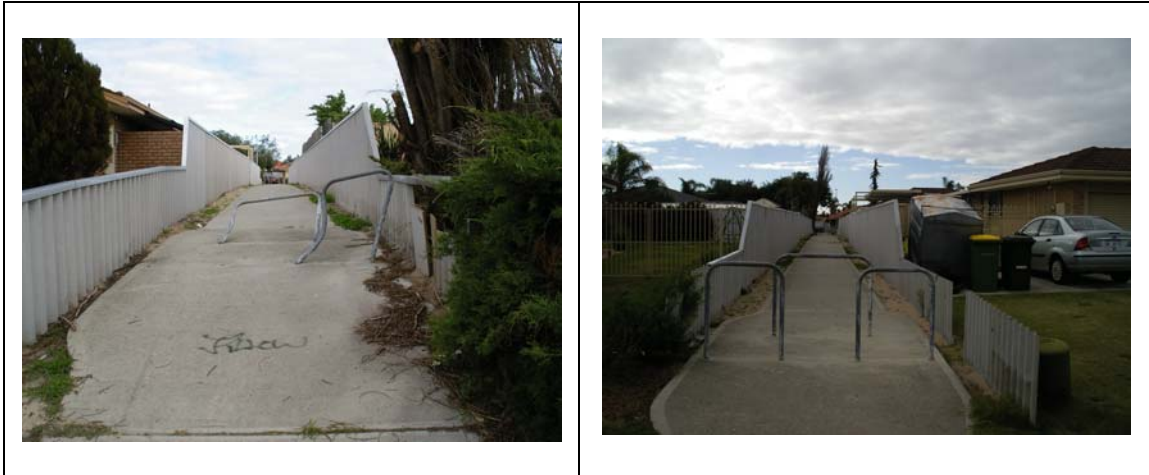
Code No. F20PK **Map** E8

Accessway approx. 3m wide and 60m long. Straight, slightly undulating, with bollards at both ends. The bollards at the north end have been severely damaged.

Fair. Some graffiti, broken glass and rubbish, damaged bollards.

Concrete path approx. 1.9m wide. Uneven in parts. Trip hazards.

The damaged bollards need to be replaced as soon as possible.

The damaged section of the pathway needs to be repaired.

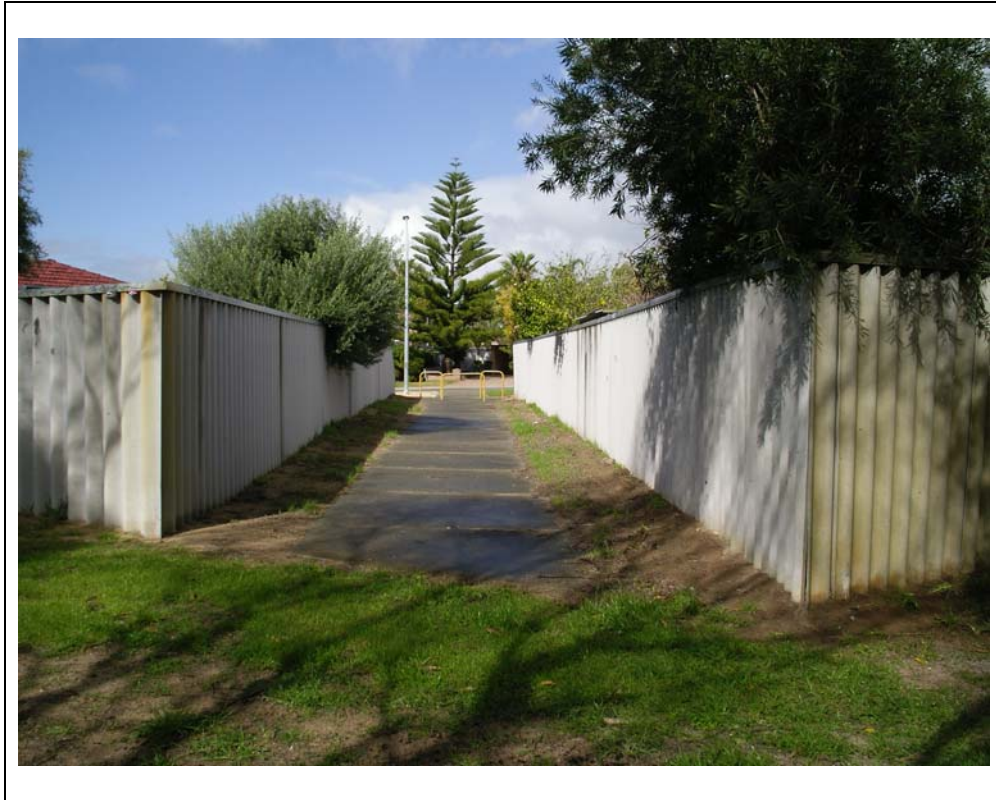
Code No. F23C **Map** F4

Accessway approx. 4m wide and 27m long. Straight, flat, with bollards at cul-de-sac end only.

Fair. Some weeds, broken glass, rubbish & high sand margins.

Whilst not essential to the local pedestrian/cycle network, this accessway appears to be operating satisfactorily, and is in fair condition. The road pattern in the area is very convoluted, and this accessway assists pedestrians and cyclists by providing a short-cut to the park and other destinations to the north. There seems to be no reason to remove the accessway at present.

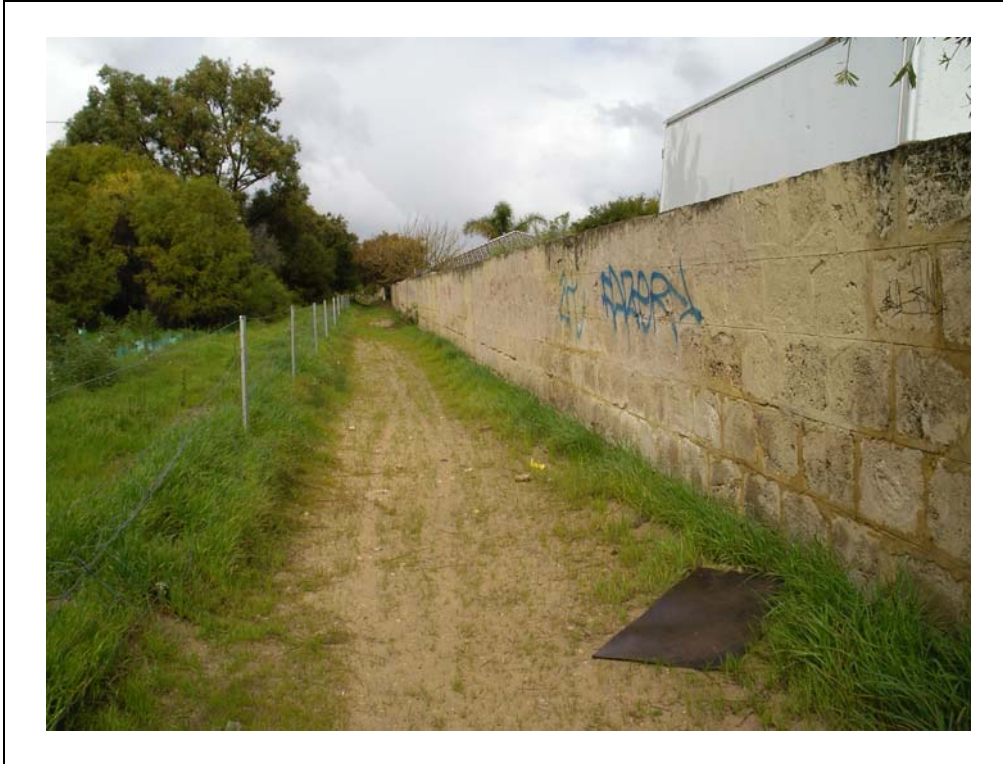
Accessway is straight, undulating. Approx. 3m wide and 73m long. No bollards.

Very poor. Lots of graffiti, dumped rubbish, weeds, leaves, broken glass, dog faeces and deep sand. No constructed path.

High limestone wall on west side of long north-south section. Other side consists of a badly damaged low wire fence.

This PAW is in very poor condition. It is being used as a *de facto* rubbish tip. It provides very little access benefits for local residents. Access to Skye Close is blocked off with a high fence. Alternative and superior pedestrian access to Ennis Avenue can be gained from Bondi Crescent nearby. This PAW could probably be closed without any significant disadvantage to the local community.

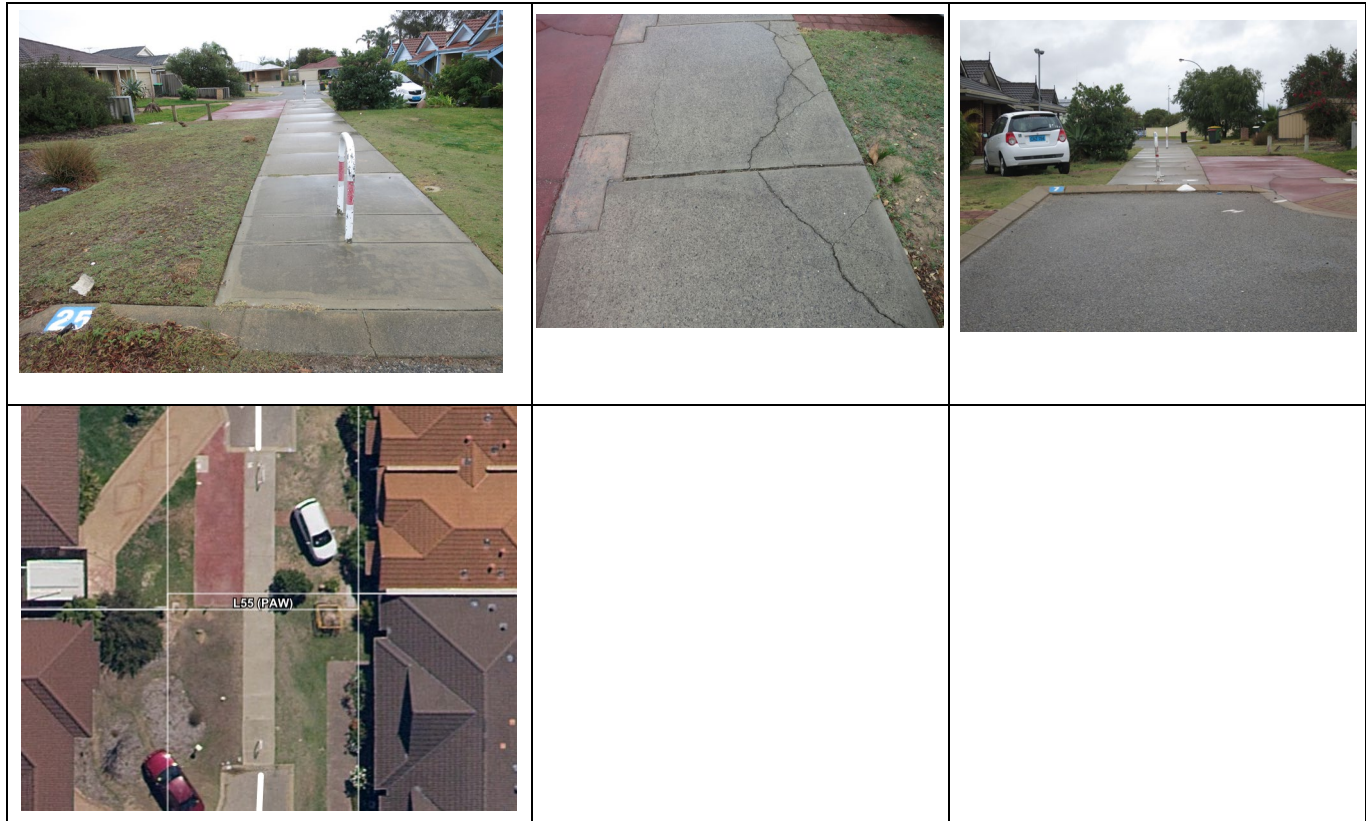
PAW is 12m long and 1m wide. Short and flat.

Fair to good. Cracks in pathway.

Where paved, it is made from concrete. Fair condition, path is significantly cracked.
