SUBURB: Port Kennedy

PAW Code No. PK84, PK87 Map E8

Connects Antibes Cove to Bayeux Avenue.

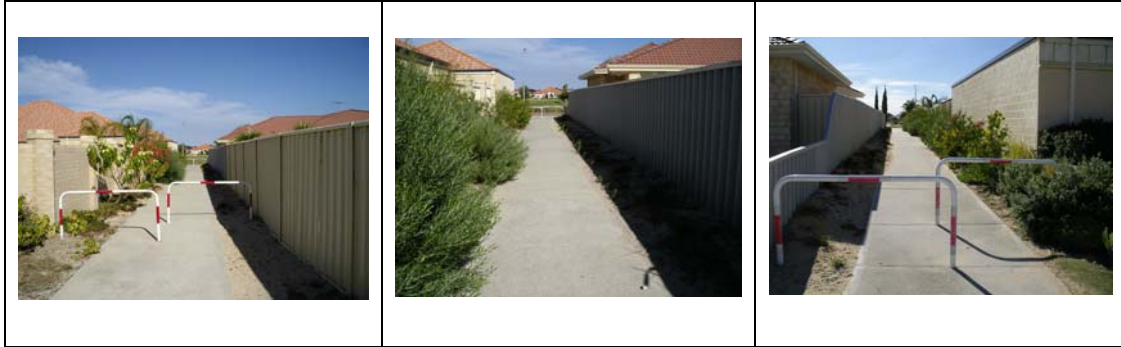
Fair to good. Some weeds, rubbish and sand over path

Poor due to high side fences, but can see end-to-end.

High Super six, brick and steel panels in generally good condition.

Due to the convoluted street pattern in the area this PAW plays an important role in helping to redress the considerable accessibility shortcomings experienced by local cyclists and pedestrians. The PAW should be retained.

The plants in the PAW require some cutting back.

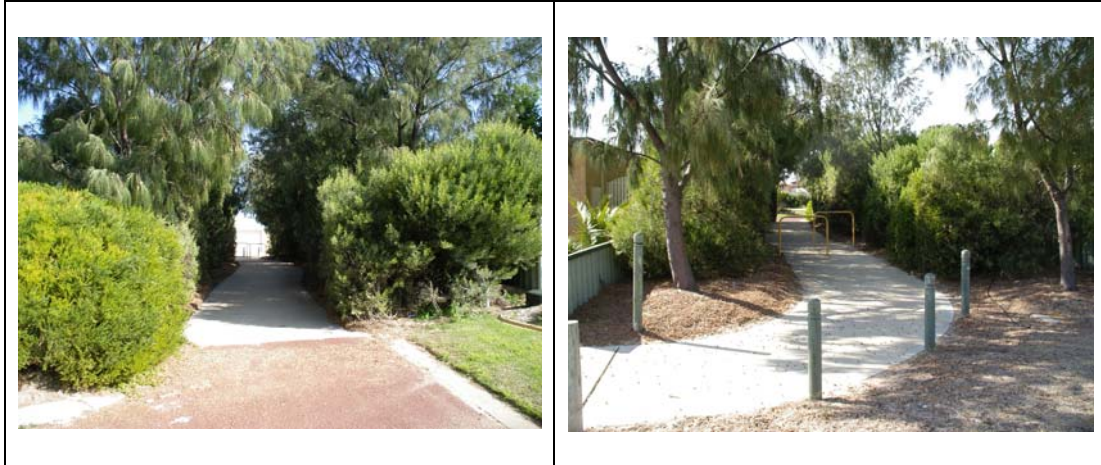
Map E10

Good.

Poor, due to high side fences and thick vegetation, but can see end-to-end.

This PAW connects with two other PAWs (PK108 & PK105/7) and several aligned streets to provide an east-west pedestrian and cycle route in an area with a very convoluted street pattern. This route also enables local residents to more directly access several parks and the local primary school. The PAW is well-maintained and is in good condition. It should be retained.

Lighting could be provided if required/requested.

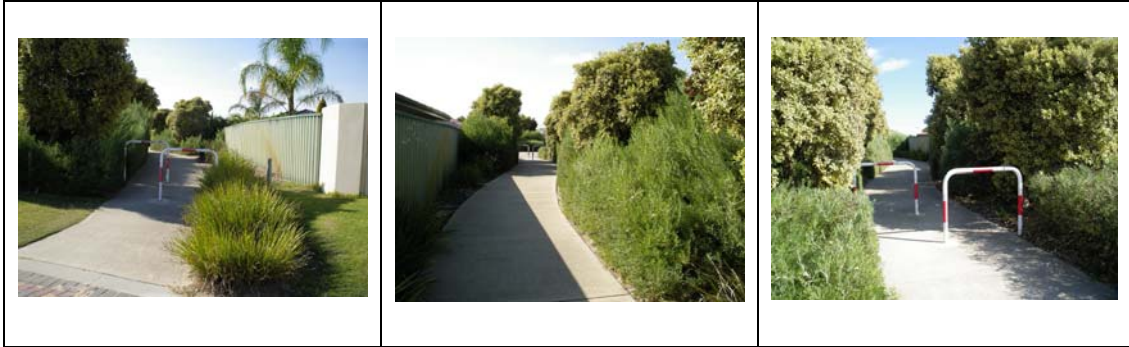
PAW Code No. PK105, PK107

Good. Small amount of graffiti.

Poor, due to high side fences, thick vegetation, and cannot see end-to-end.

This PAW connects with two other PAWs (PK108 & PK103) and several aligned streets to provide an east-west pedestrian and cycle route in an area with a very convoluted street pattern. This route also enables local residents to more directly access several parks and the local primary school. The PAW is well-maintained and is in good condition. It should be retained.

Lighting could be provided if required.

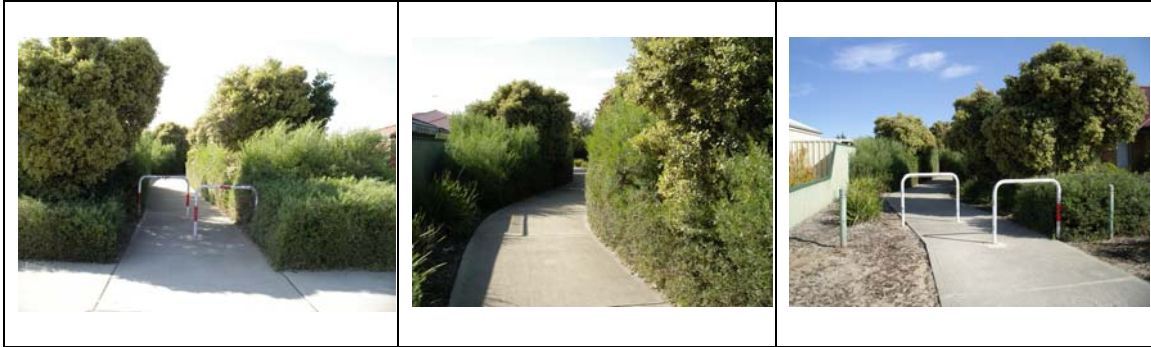
PAW Code No. PK108

Good. Small amount of graffiti.

Poor, due to high side fences, thick vegetation, and cannot see end-to-end.

This PAW connects with two other PAWs (PK105/7 & PK103) and several aligned streets to provide an east-west pedestrian and cycle route in an area with a very convoluted street pattern. This route also enables local residents to more directly access several parks and the local primary school. The PAW is well-maintained and is in good condition. It should be retained.

Lighting could be provided if required.

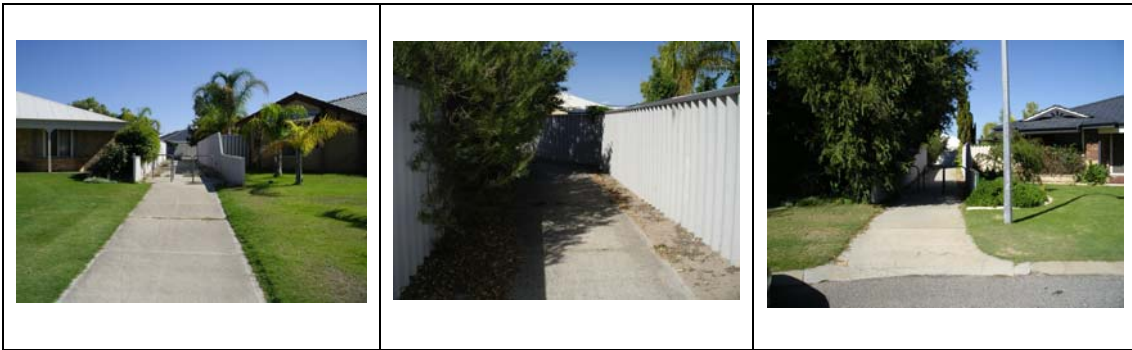
PAW Code No. PK109, PK110

Fair to good. Small amount of graffiti.

Poor, due to high side fences, and cannot see end-to-end.

Some trees overhanging side fences mid-way.

This PAW connects two minor culs-de-sac, and provides convenient north-south access for those residents. However, nearby Discovery Cr. provides an alternative, convenient north-south route. Using the public street would also probably be safer than using this PAW with its poor level of casual surveillance. The retention of this PAW is therefore not essential.

If it is to be retained, however, the overhanging trees should be cut back, and lighting improved to try and overcome its design fault (i.e., the mid-way bend).

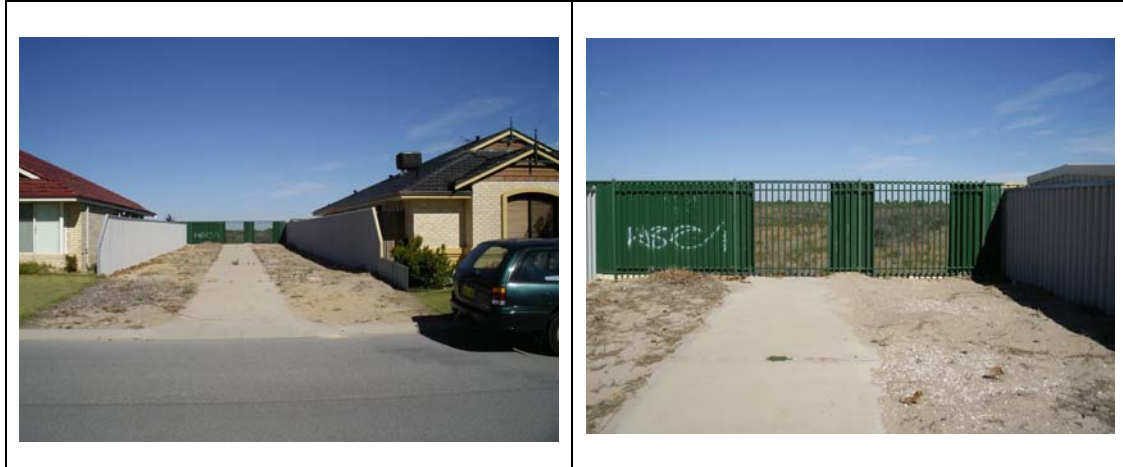
PAW Code No. PK130

PAW reserve approx. 8m wide and 30m long. Straight, wide and flat. No bollards. Fence across southern end. Abrupt change of level at southern end where the adjacent vacant land is approx. 1m lower than the PAW.

Fair. Some graffiti, weeds, rubbish & broken glass. High sand margins.

The subdivision design in this locality is such that this PAW provides the only potential access between houses to the vacant land beyond within a distance of 1km. As the future design of the vacant land is unknown at this stage, it would be prudent to retain this PAW for possible future access purposes.

It may be, however, that the PAW is not needed, or not desirable, in the future, depending upon the subdivision design of the adjacent vacant land. At the time of subdivision the status of this PAW should be reassessed.

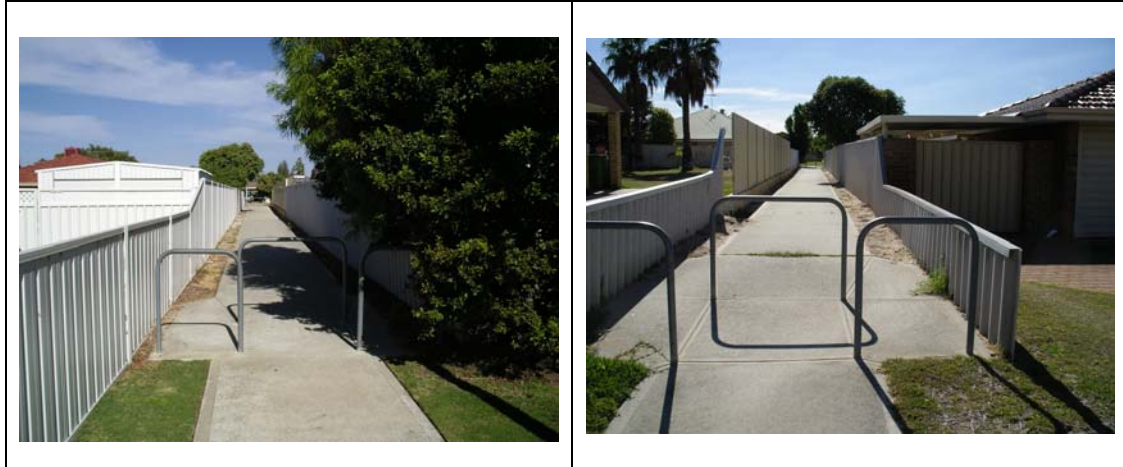
PAW Code No. PK133

Fair to good. Small amounts of graffiti, weeds, rubbish & broken glass.

Poor, due to high side fences and long length, but can see end-to-end.

Some overhanging side fences.

This PAW provides improved north-south connectivity for Whitechurch Mews residents. It allows them ready access to southerly destinations including a bus route, cycle path and shops in an area that has a very convoluted road system. This PAW provides convenience for approx. 17 households, and is in fair to good condition. It should preferably be retained.

The overhanging vegetation requires cutting back.

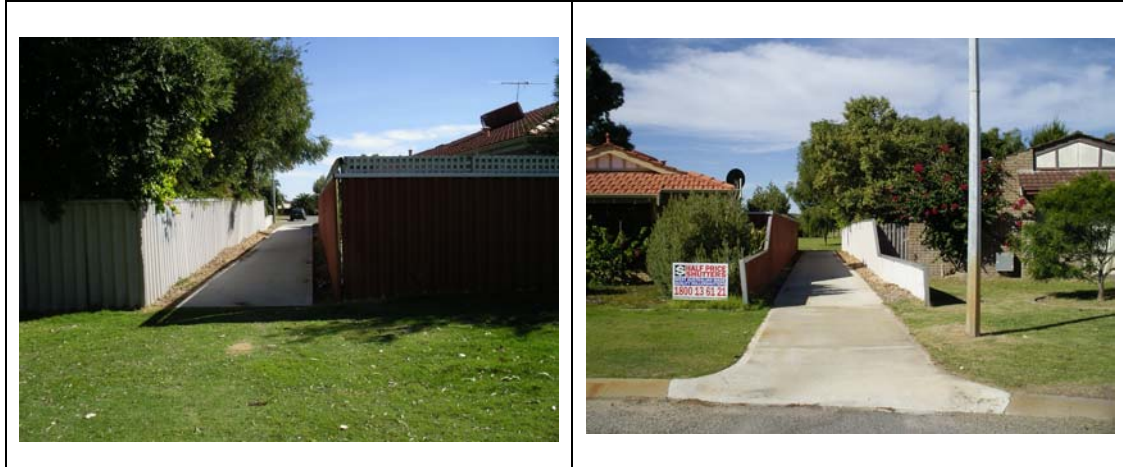
Fair to good. Some graffiti, leaves, rubbish and high sand margins.

Poor to fair, due to high side fences and abrupt exit into unlit park, but can see end-to-end.

The number of dwellings in Canterbury Mews is only 12. Alternative access to the park and Warnbro Sound Avenue is available from the two streets running parallel and either side of Canterbury Mews. The continuing presence of this PAW is not essential for access, and not preferable from a safety and security aspect.

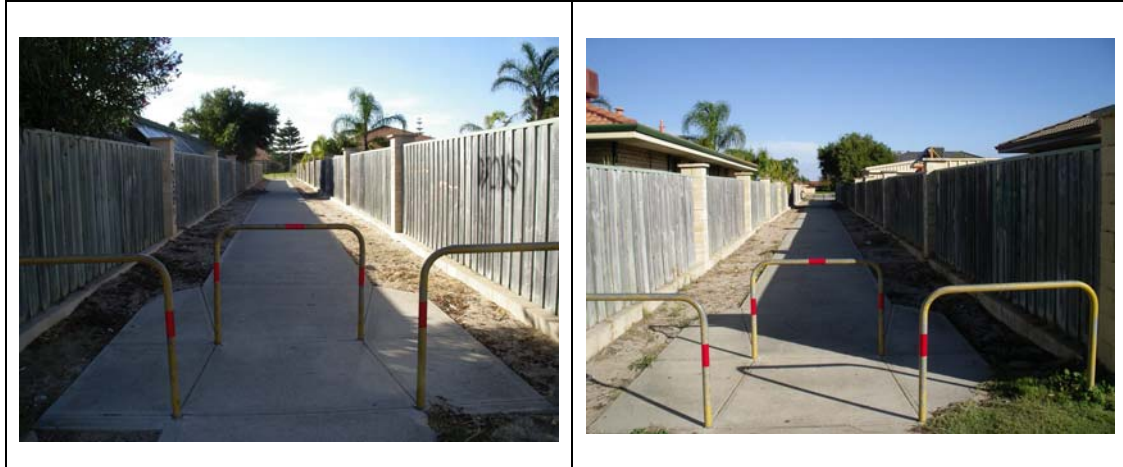
PAW Code No. PK160,161

Poor to fair. Lots of graffiti, some weeds, leaves, broken glass, bottles, rubbish and dumped lawn clippings.

Poor, due to high side fences but can see end-to-end.

This PAW provides an important north-south pedestrian/cycle link in an area with a very convoluted street pattern. The nearest parallel north-south alternative routes to the east and west are approx. 480m apart. Grand Ocean Boulevard is a bus route and has a cycle path. North of Grand Ocean Boulevard opposite this PAW are located the library, a high school and the aquatic centre. Retention of this PAW is essential.

The PAW needs to be cleaned up.

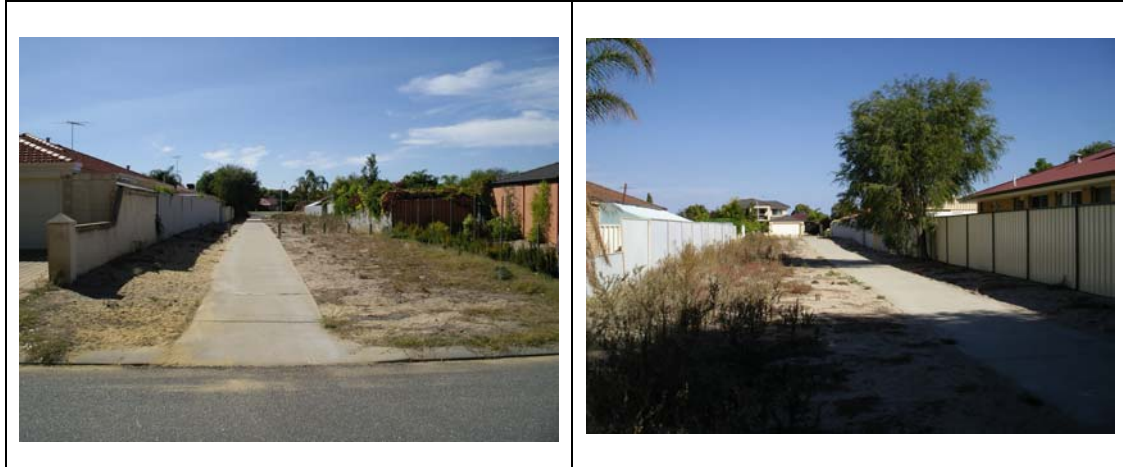
PAW Code No. PK163 **Map** E9

Poor to fair. Lots of tall weeds, dog faeces and rubbish.

There is a peppermint tree growing on the northern edge of the PAW. There are numerous tall weeds growing in the path margins.

The PAW is not essential to the wider needs of the pedestrian/cycle community, but should preferably be retained to overcome the shortcomings of the subdivision design.

The PAW is in a poor state and requires urgent cleaning up.

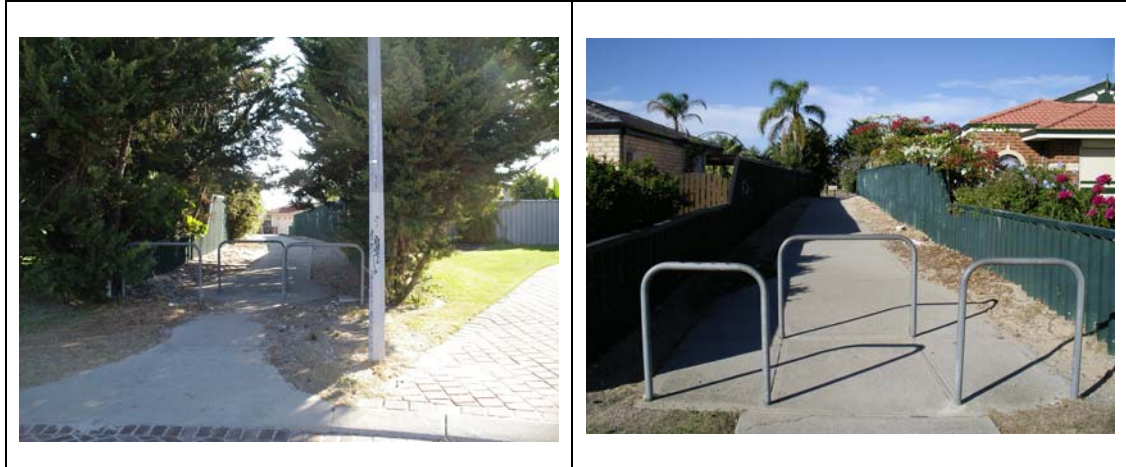
PAW Code No. PK174,5 **Map** E8

Poor to fair. Lots of graffiti, some leaves, broken glass, rubbish and sand over path

Poor, due to high side fences but can see end-to-end.

Some overhanging side fences.

This PAW is located amidst a very convoluted street pattern, and provides the only east-west connection in this locality between the parallel streets of Chelmsford Avenue in the south and Grand Ocean Boulevard to the north, which are separated by more than half a kilometre. Retention of this PAW is therefore essential.

The overhanging vegetation needs cutting back, and the PAW cleaned up.

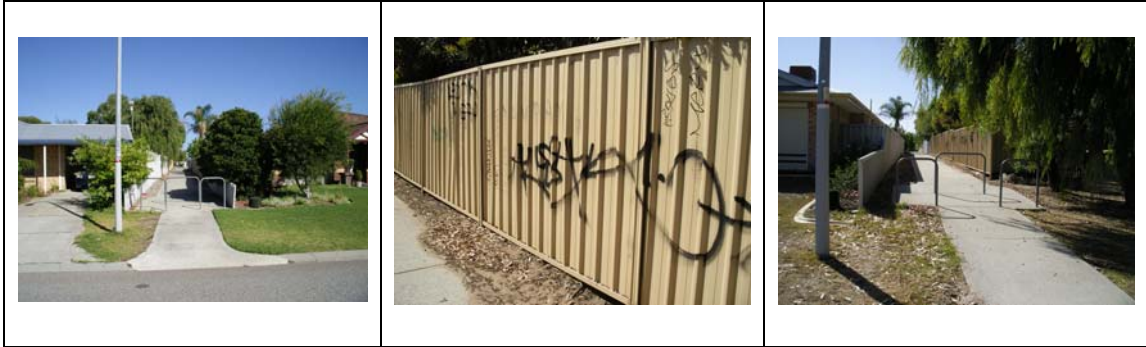
SUBURB: Port Kennedy **PAW Code No.** PK179, PK181 Map E9

Fair. Lot of graffiti, leaves, rubbish, weeds, broken glass.

Poor to fair, due to high side fences and long length, but can see end-to-end.

This PAW is aligned with another PAW (PK184, PK185) and roads to provide east-west pedestrian access in an area that has a very convoluted road system and no direct east-west roads. It needs to be retained.

The PAW does, however, require cleaning up.

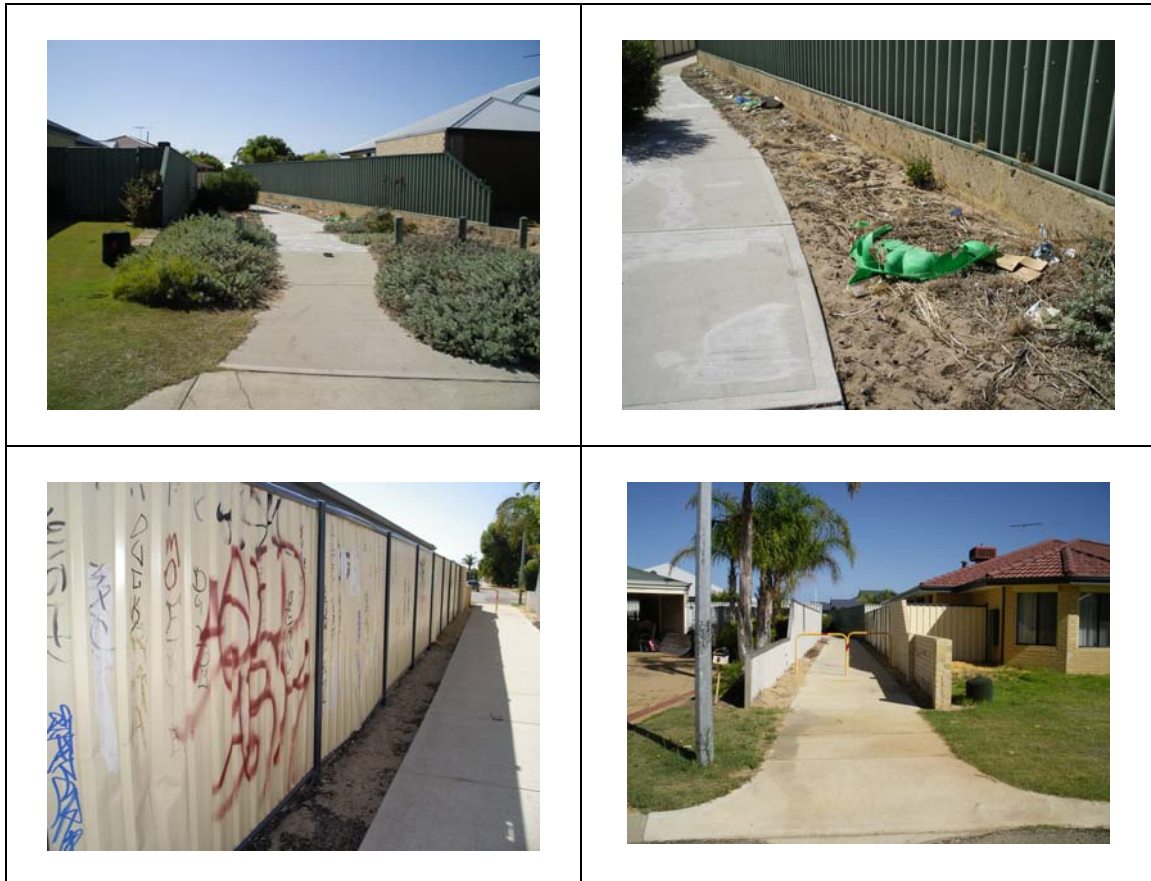
SUBURB: Port Kennedy **PAW Code No.** PK184, PK185

PAW reserve approx. 3m wide, flared at western end to 8m. Approx. 62m long. Flat with a bend mid-way. Steel bollards at east end, pine bollards at west end with one missing from the middle of the pathway.

Poor. Lot of graffiti, rubbish, weeds, broken glass. Damaged fences.

Poor, due to high side fences, and mid-way bend which means users cannot see end-to-end.

Very high Super six and steel panels, some elevated on limestone footings/walls. The steel panels have been damaged and are covered in graffiti.

Some low plants at western entry. Large shrub overhanging path at west end.

This PAW is aligned with another PAW (PK179, PK181) and roads to provide east-west pedestrian access in an area that has a very convoluted road system and no direct east-west roads. It needs to be retained for the benefit of the whole local community.

The PAW does, however, require cleaning up and regular maintenance. It would also be preferable to provide lighting (bollard lights?) along its length to try and counter its design inadequacy (i.e., the mid-way bend.)

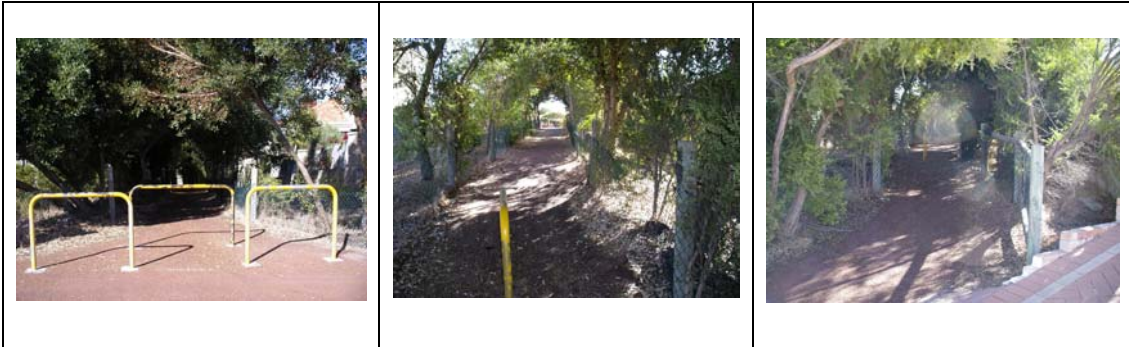
PAW Code No. PK198

Fair. Leaves, rubbish & dog faeces.

Almost nil, due to heavy planting.

Significant amounts overhanging the path, but it doesn't impede access.

Street light at east end only, but heavy planting renders this useless for lighting the PAW.

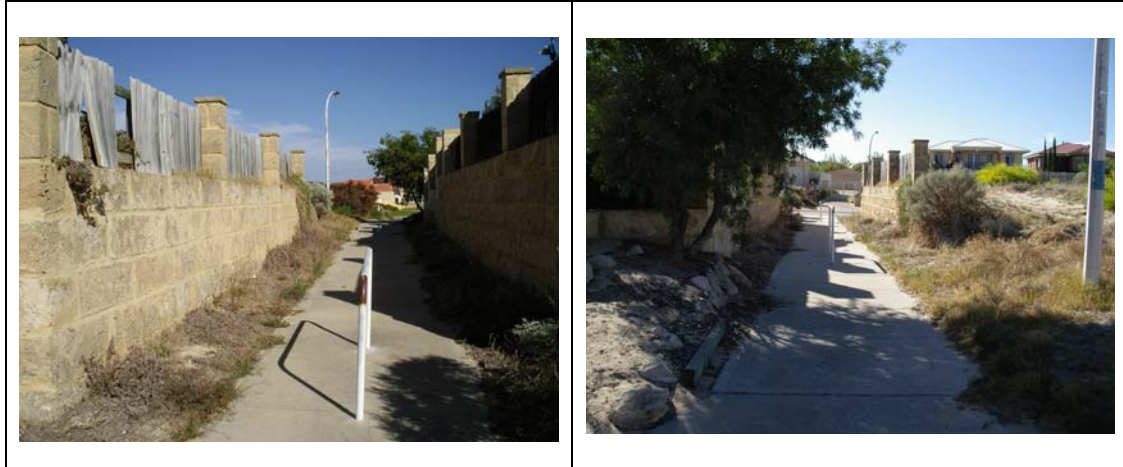
Limestone walls topped with timberlap in poor condition.

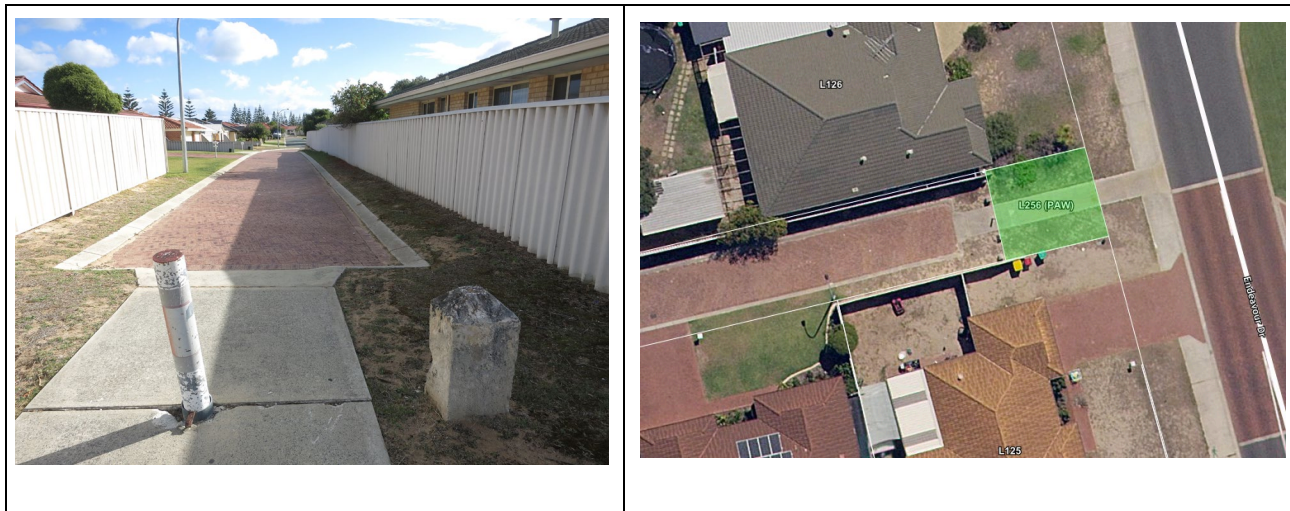
PAW is 7m wide and 8m long. Concrete bollards (bad condition), provided at the end of the laneway/ start of the pathway on the PAW. Slopes slightly upwards from east to west.

Fair condition. No graffiti or sand over the path.

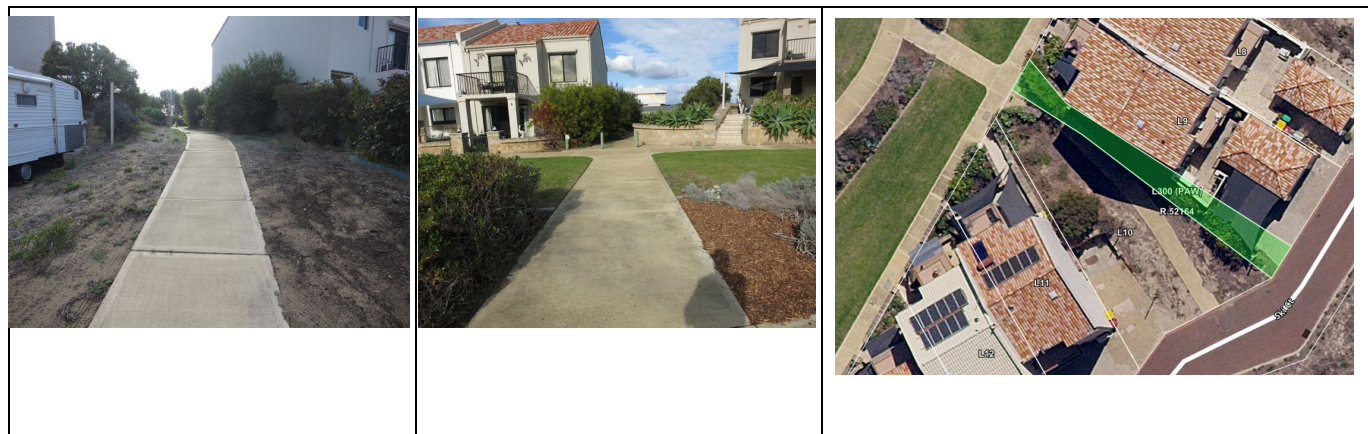
Concrete path. Fair condition, some cracks.

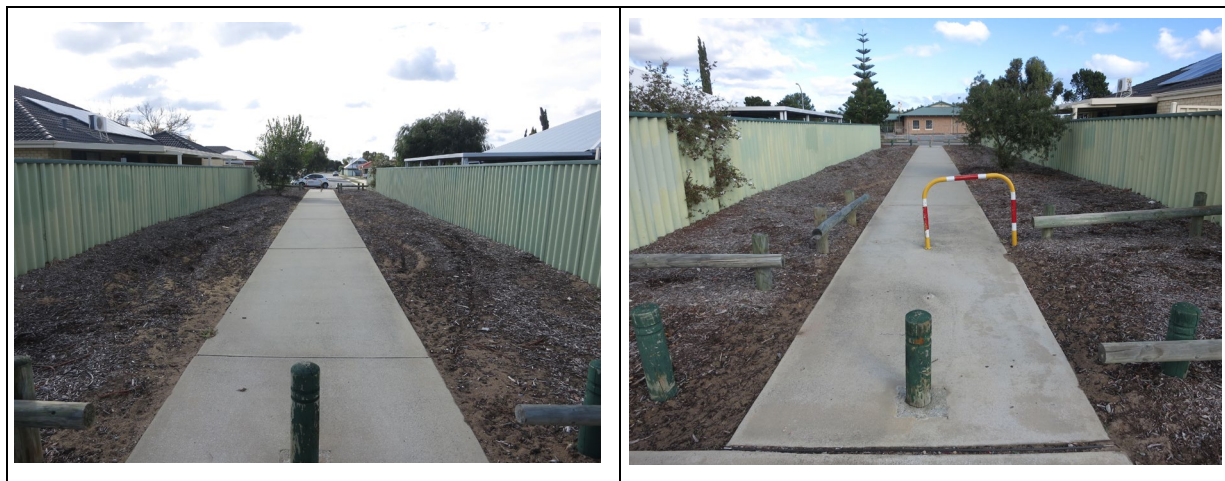
Concrete pathway approximately 2m wide. Good condition.
