SUBURB: Safety Bay

PAW Code No. SB 276

PAW location:

Connects Tobago Place to Kingston Way and Read Street.

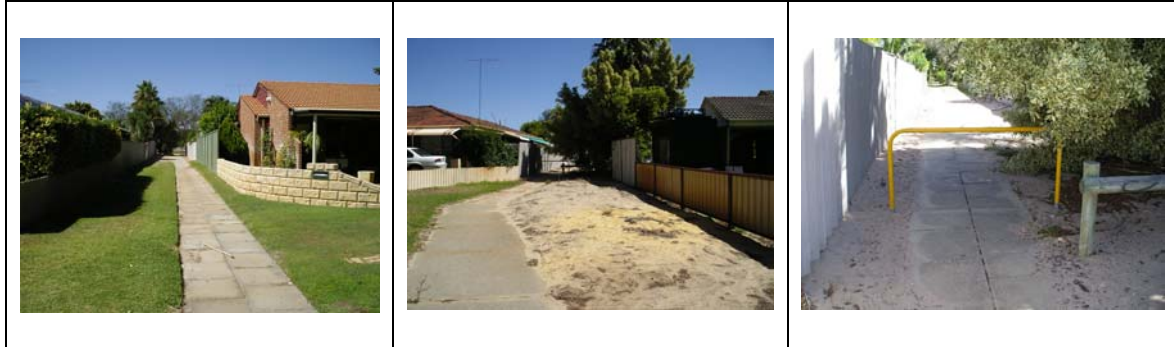
PAW reserve approx. 4m wide, flaring to approx. 12m wide at its eastern end. Approx. 68 m long. Straight, long and flat. Bollard at east end only, but across path and obstructs easy access.

Poor to fair. Sand over parts of path, which is in poor condition. Leaves, rubbish and graffiti. Western entry margins are mown, grassed and reticulated. East end margins are grass and sand.

Concrete slabs, two x wide (1.2m). Narrow and uneven.

Significant amount overhanging side fence at eastern end.

The path in the PAW needs to be replaced and widened, and the overhanging vegetation cut back significantly. The steel bollard across the path at the eastern end needs to be relocated, as it currently obstructs access.

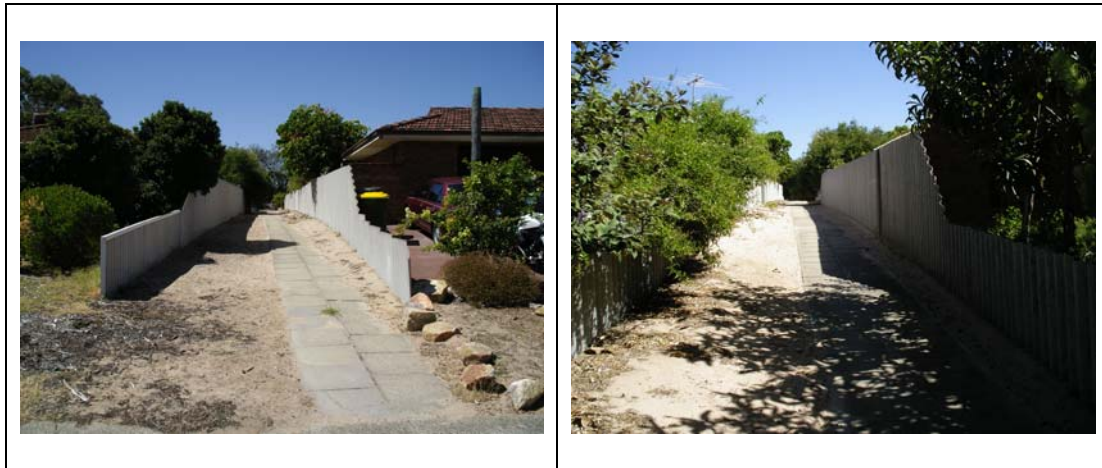
PAW reserve approx. 4m wide and 68 m long. Straight, long and with a hump in the middle of the end-to-end profile. The footpath is laid diagonally within the reserve.

Poor to fair. Sand over parts of path, which is in poor condition. Broken glass, rubbish, leaves.

The path in the PAW needs to be replaced and widened, and the overhanging vegetation cut back.

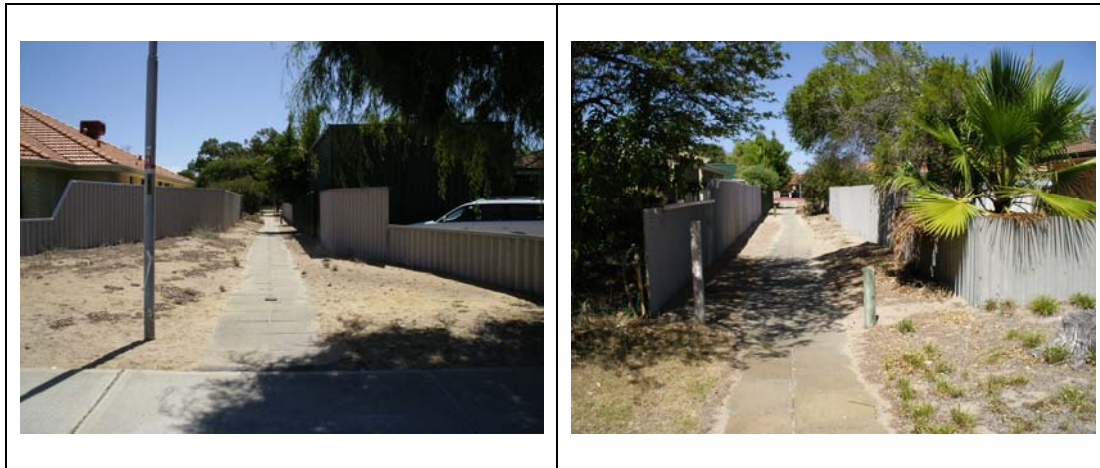
Poor to fair. Path in poor condition. Banked up sand margins. Tree branches lying on ground. Weeds, rubbish, broken glass, small amount of graffiti.

The path in the PAW needs to be replaced and widened, and the PAW cleaned up.

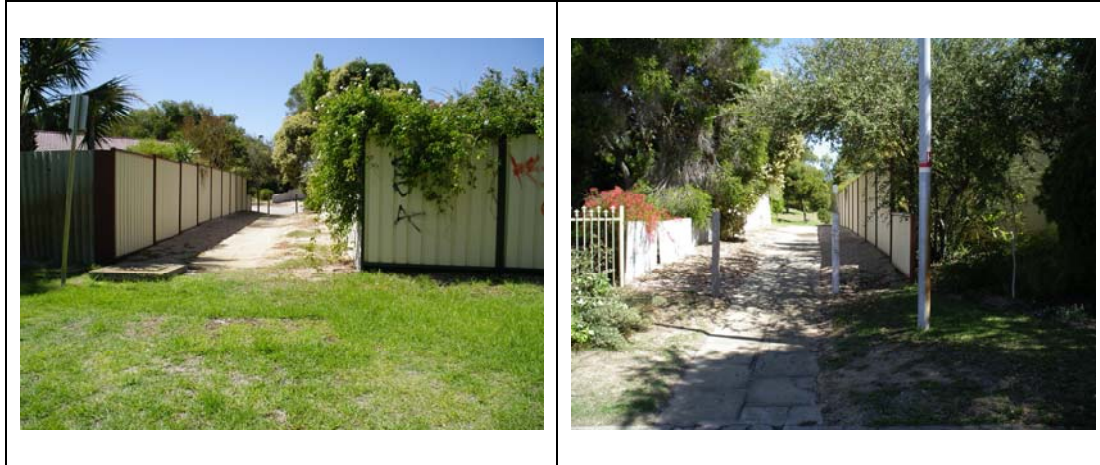
Poor. Sand over parts of path, which is in poor condition. Banked up sand margins.

The path in the PAW needs to be replaced and widened, and the overhanging vegetation cut back.

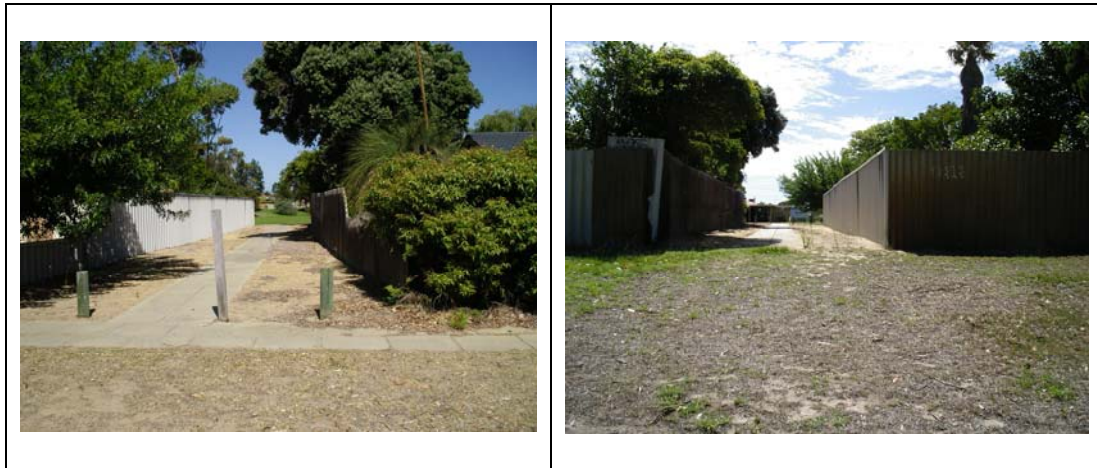
Fair. Sand over parts of path, which is in poor condition. No graffiti.

Concrete slabs, two x wide (1.2m). Narrow, cracked and uneven.

The path in the PAW needs to be replaced and widened, and the overhanging vegetation cut back.

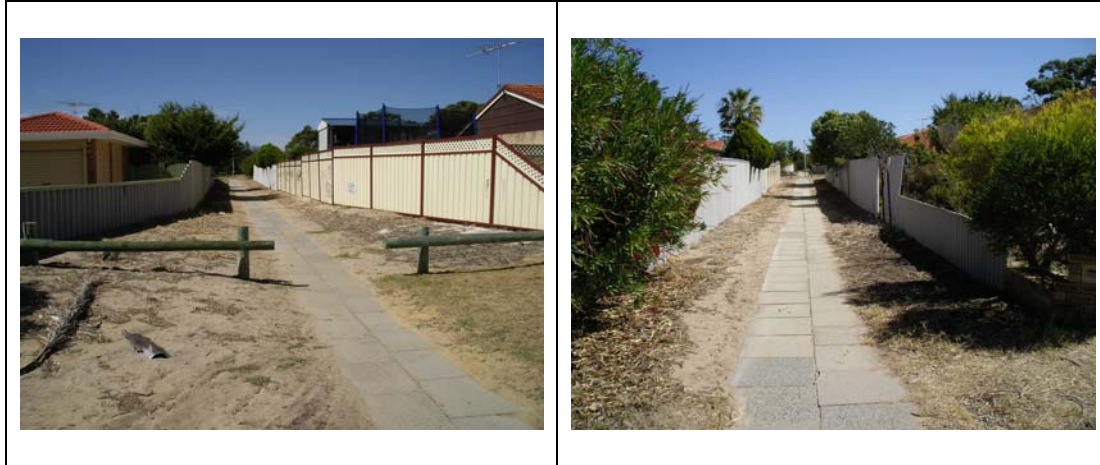
Poor. Sand over parts of path, which is in poor condition. Banked up sand margins. Leaves, rubbish, graffiti. Damaged side fences.

High Super six and steel panels – some panels damaged.

The path in the PAW needs to be replaced and widened.

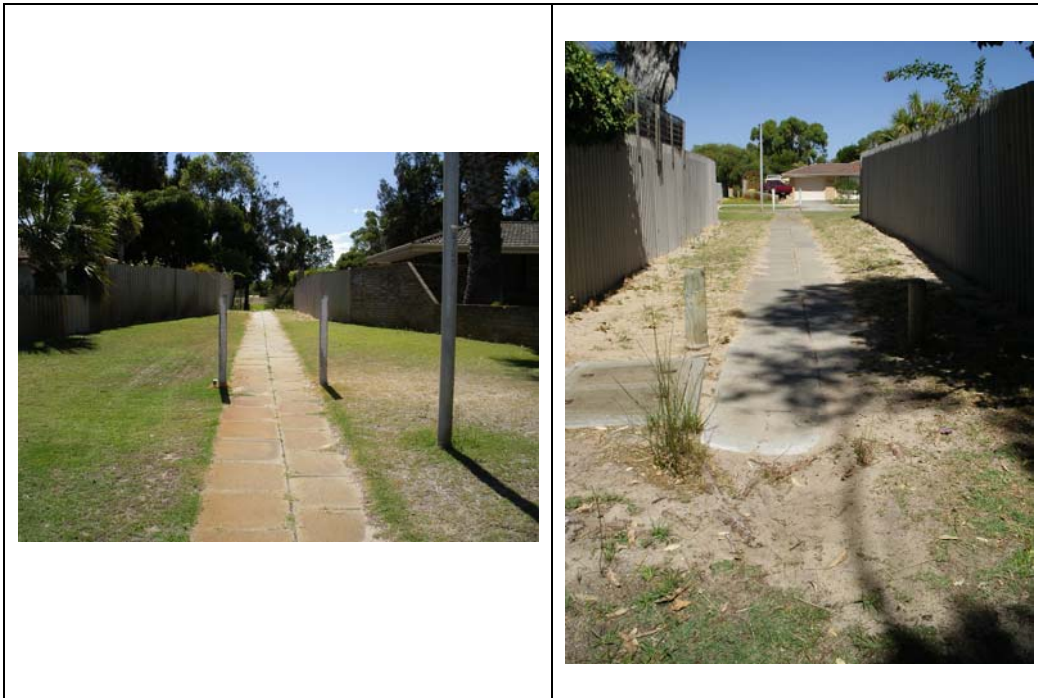
Poor to fair. Grassed margins in poor to fair condition. Some graffiti. Path in poor condition, especially at park end.

Concrete slabs, two x wide (1.2m). Narrow, uneven and cracked.

The path in the PAW needs to be replaced and widened.

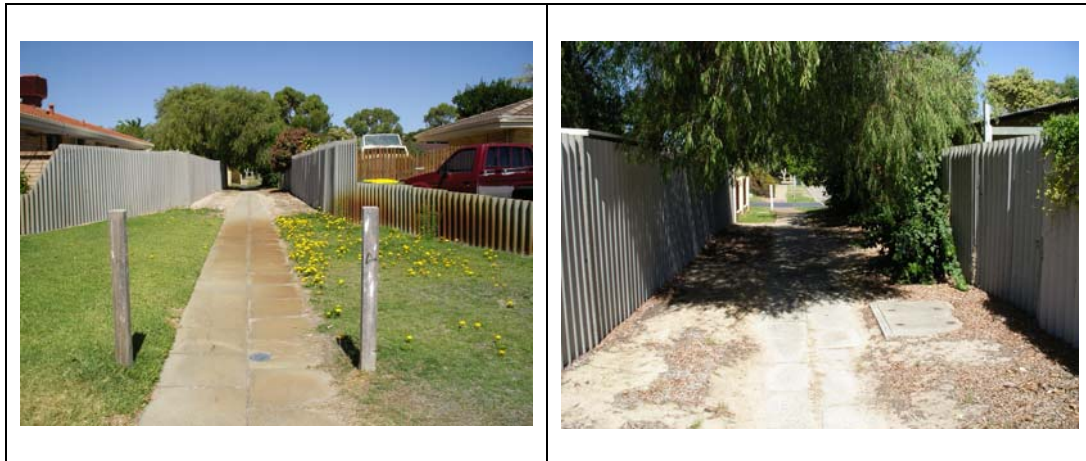
Fair. Sand across path, leaves, debris. Overhanging vegetation. Grass on northern margins. Path in poor condition.

The path in the PAW needs to be replaced and widened, and the overhanging vegetation cut back.

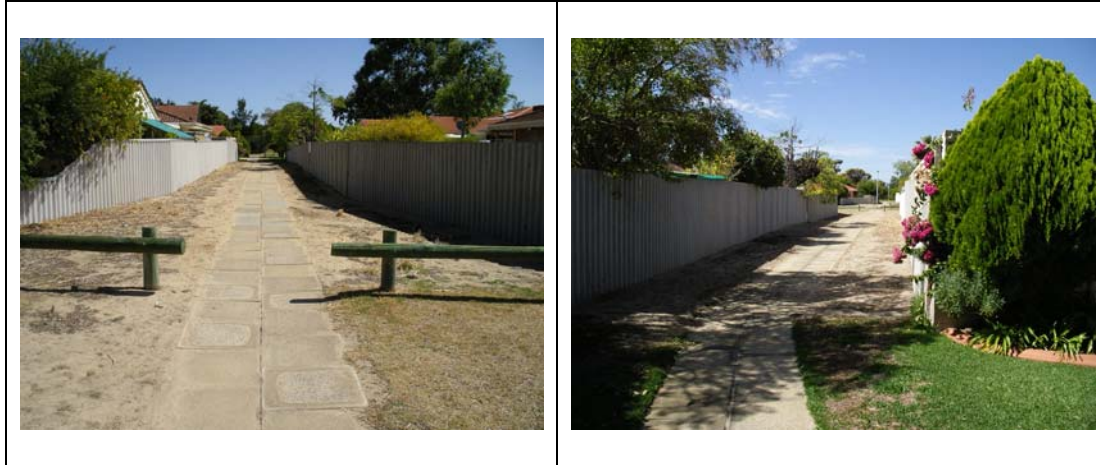
Poor to fair. Sand over parts of path, which is in poor condition. Banked up sand margins, leaves, dead bird.

The path in the PAW needs to be replaced and widened.

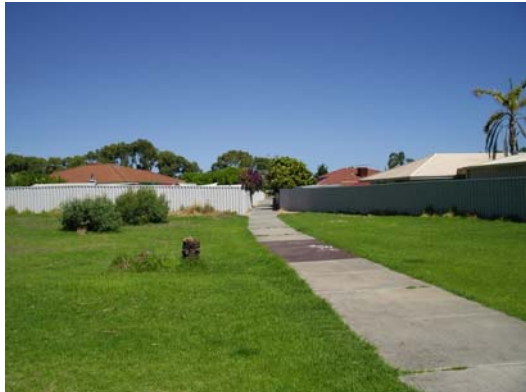
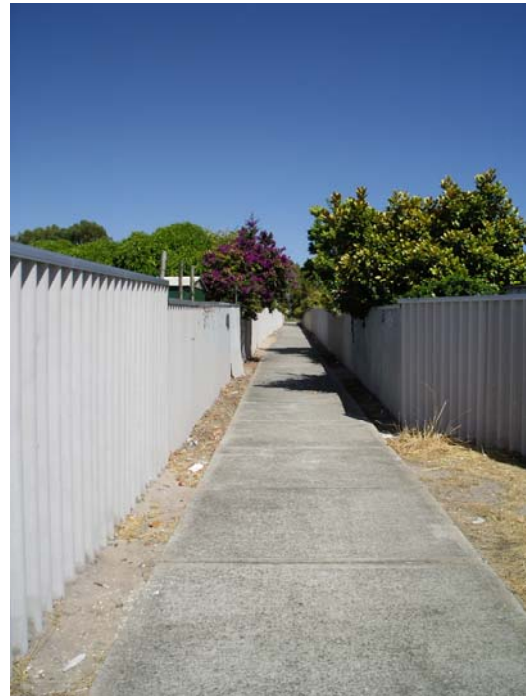
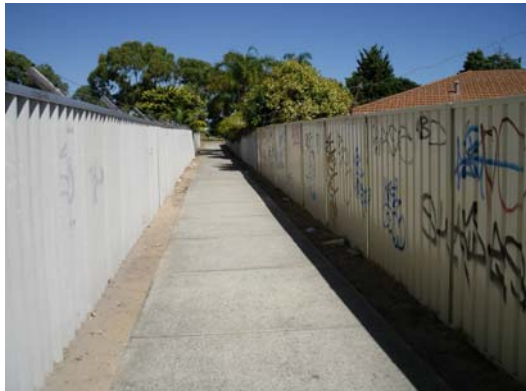
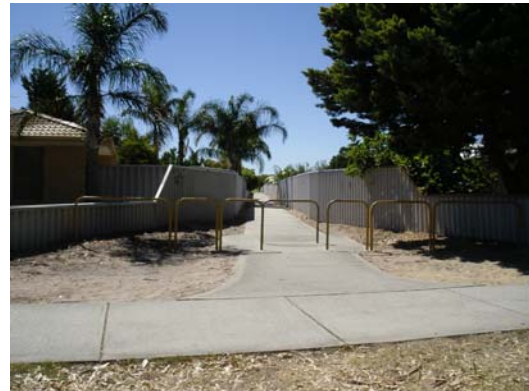
Very poor. Extensive quantities of graffiti, rubbish and broken glass.

High Super six and steel panels in varying conditions. Several super six panels damaged. Some fences are topped with barbed wire.

The PAW is, however, exceptionally long, unlit, in a very poor state, and judging by the damage and the presence of barbed wire on top of some of the fences, a place where anti-social behaviour and vandalism takes place.

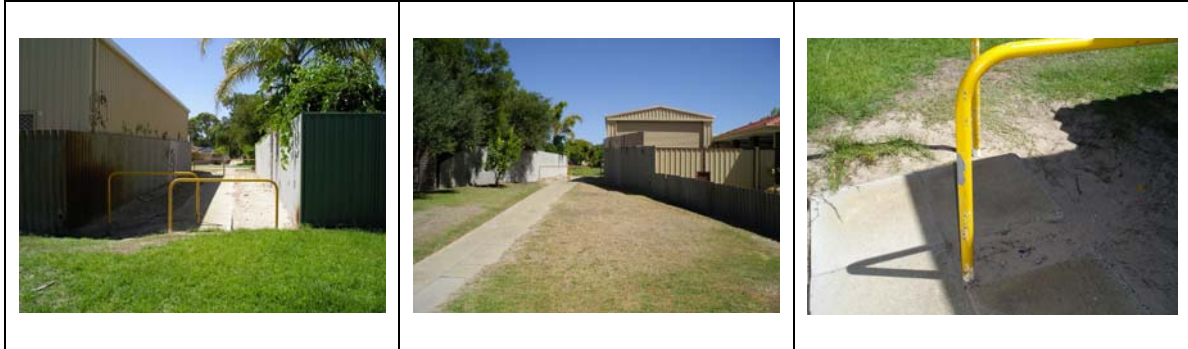
Concrete slabs, two x wide (1.2m). Narrow and uneven. Some slabs missing. The path at the western end through the bollards is a trip hazard.

The path in the PAW needs to be replaced and widened, and the area around the western bollards upgraded significantly.

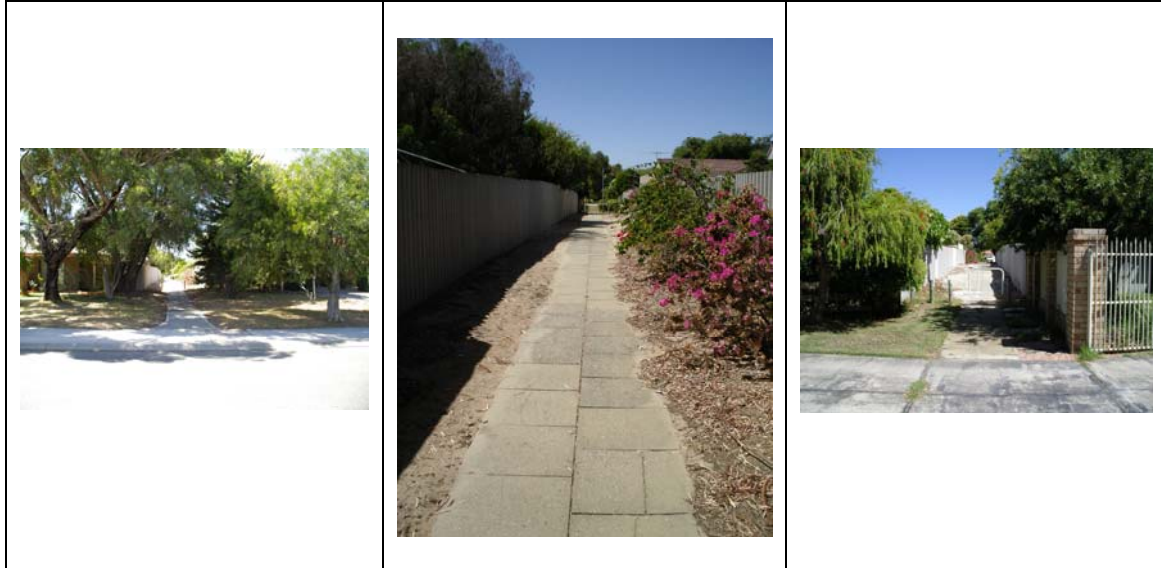
Poor to fair. Piled up sand, leaves, some graffiti, broken glass, poor path.

High Super six varying from poor to good condition.

The path in the PAW needs to be replaced and widened, and the tree obscuring the street light cut back.

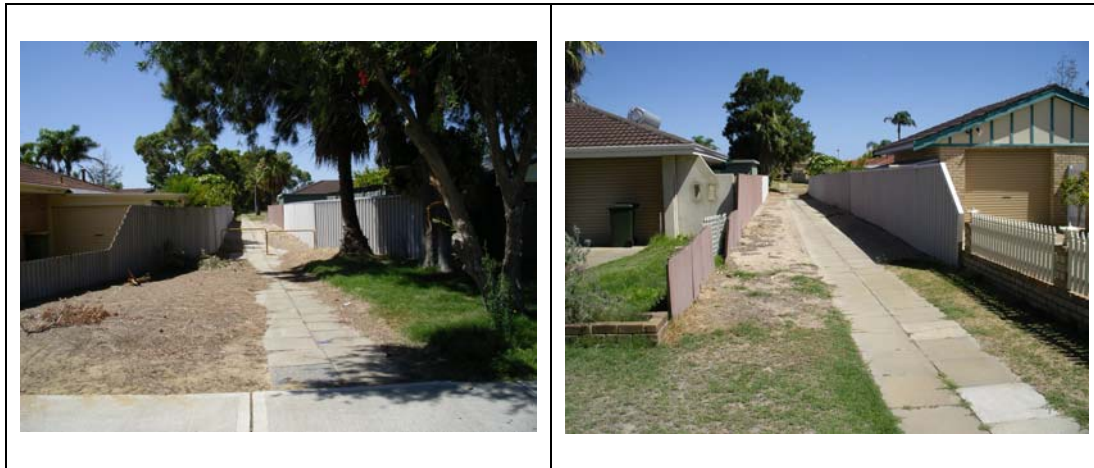
Poor to fair. Piled up leaves over parts of path, which is in poor condition. Banked up sand margins.

Concrete slabs, two x wide (1.2m). Narrow and uneven. Some slabs broken.

The path in the PAW needs to be replaced and widened, and the tree obscuring the street light cut back.

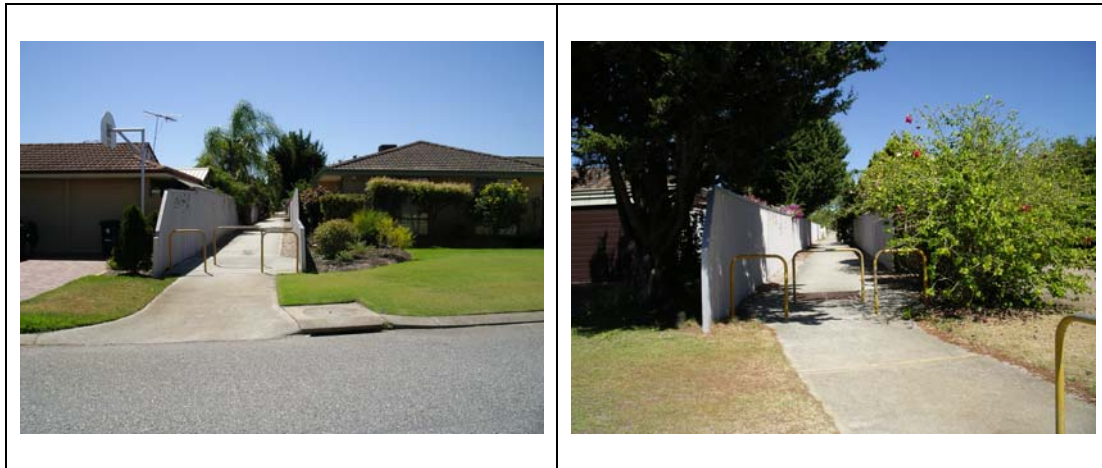
Fair. Weeds, broken glass, rubbish, graffiti.

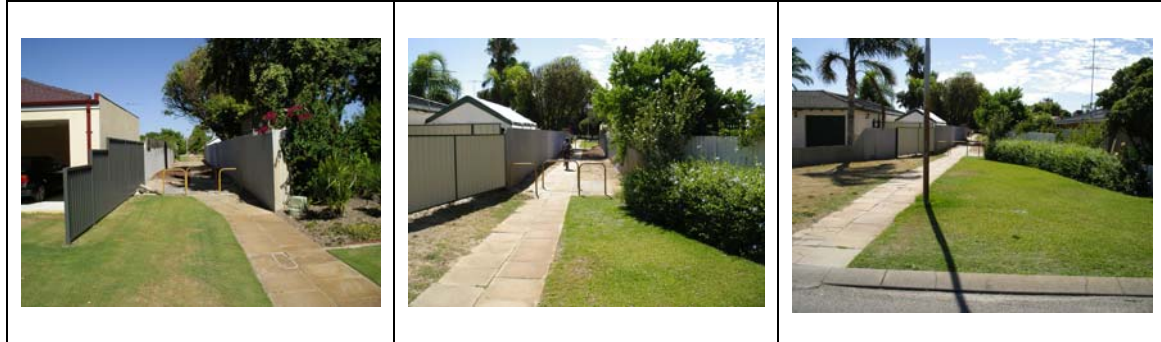
Fair. A great deal of sand and leaves spread over parts of path, which is in poor condition. Broken glass, some graffiti. Both entrances to the PAW are grassed and quite attractive.

The path in the PAW needs to be replaced and widened.

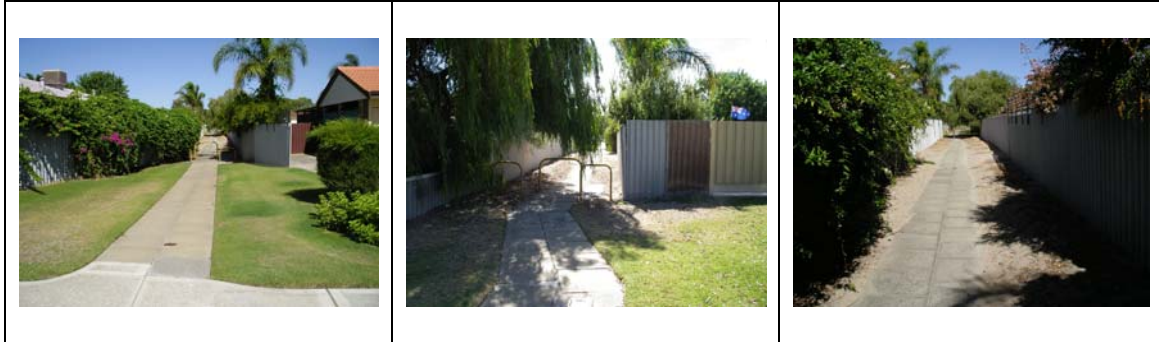
Fair. Sand over parts of path, which is in poor condition. Banked up sand margins. Weeds, rubbish, graffiti. Overhanging vegetation. Both entrances/ approaches to the PAW are well maintained and attractive.

The path in the PAW needs to be replaced and widened, and the overhanging vegetation cut back, especially the tree at the southern end.

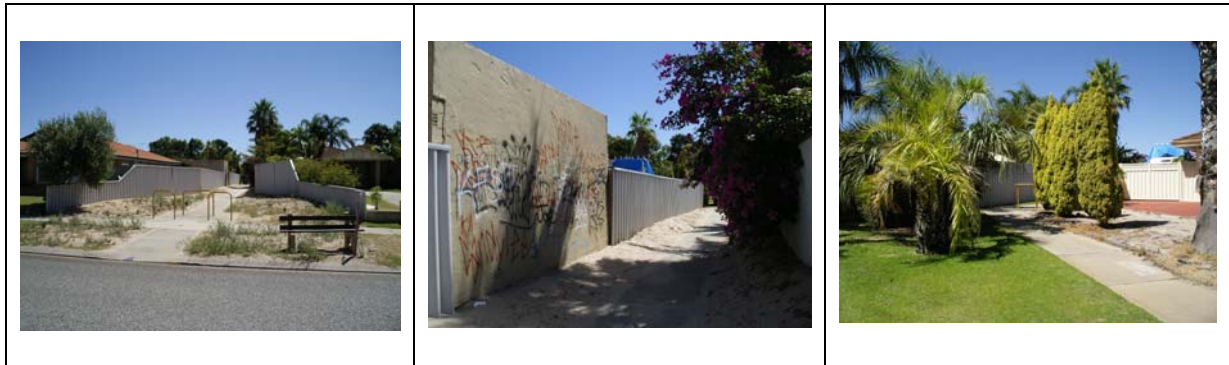
Fair. Sand piled up, rubbish, broken glass, graffiti.

High Super Six in very good condition. One section consists of a high masonry wall which is covered in graffiti.

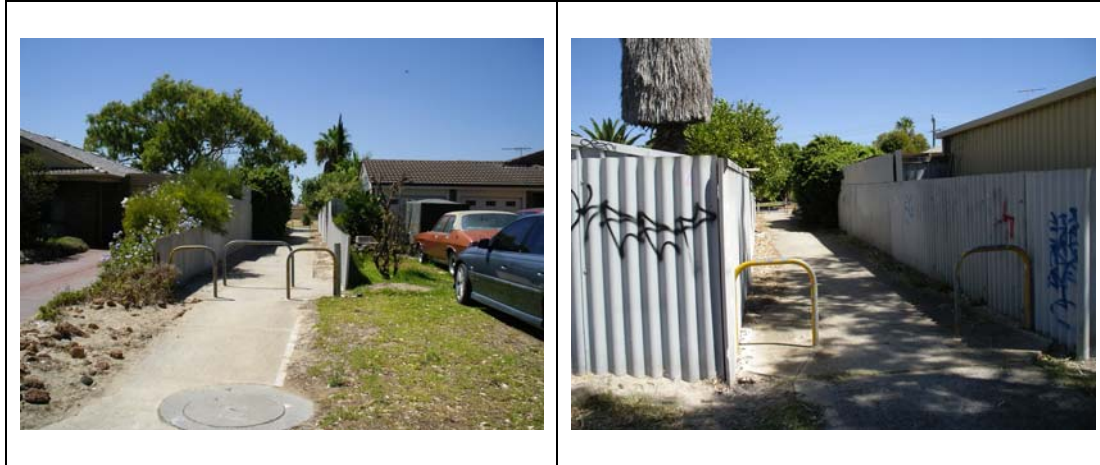
Fair. Some sand, weeds, rubbish, broken glass, graffiti.

High Super Six in fair condition. Some damage, graffiti.
