SUBURB: Singleton **PAW Code No.** S383 Map E14

SUBURB: Singleton **PAW Code No.** S384 Map E14

PAW Code No. S385-NP

SUBURB: Singleton

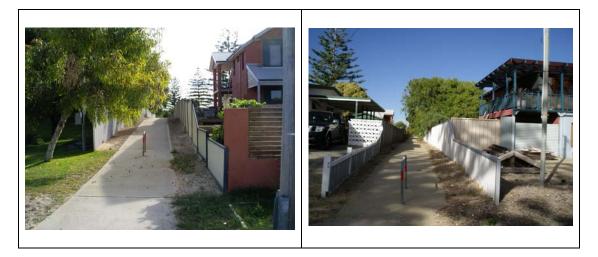
Connects Heath Street to Treasure Road.

PAW reserve approx. 4m wide and 86m long. Very long, very undulating, with side-on style bollards at each end.

Fair. Some leaves over path, rubbish and dog faeces.

Some trees overhanging side fences.

The overhanging trees need cutting back.

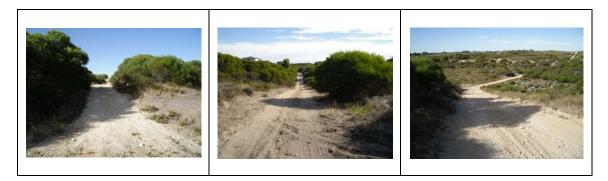
Connects Emerald Court to Mandurah Road reserve.

PAW reserve approx. 5m wide and 300m long. Very long, narrow and very hilly (over sand dunes). Dog-leg bend approx. one-third the way along.

Fair (accessible).

Bushes growing into reserve in places.

Clear evidence that it is used by vehicles.

This PAW appears to function as a fire access track. Emerald Court is a very long cul-de-sac, and the PAW offers the only formal escape route. Retention of the PAW for this reason is therefore essential.

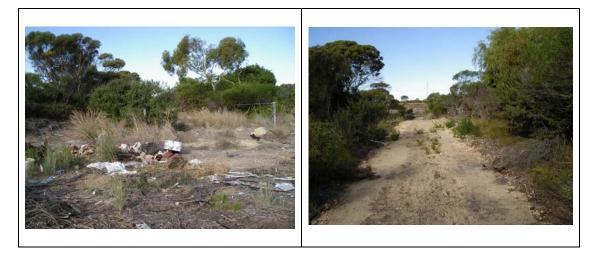
Connects Jade Court to Mandurah Road reserve.

PAW reserve approx. 5m wide and 86m long. Straight, long and undulating.

Very poor. Western end used as *de facto* rubbish tip.

Some bushes growing into track.

Does not look like it is being used. The rubbish at the western end would prevent ready access.

This PAW's main function is probably as a fire access track. Jade Court is a long cul-de-sac, and this PAW provides a formal escape route from the head of the cul-de-sac in the event of fire. It should therefore be retained for fire safety purposes.

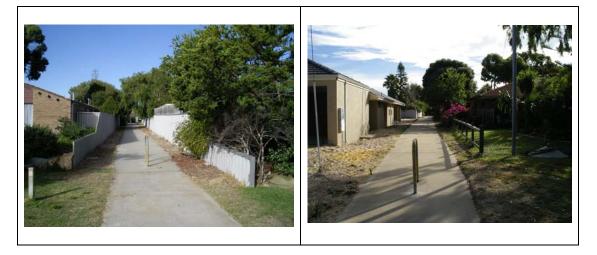
Connects Prosser Way to Wenn Road.

PAW reserve approx. 4m wide and 80m long. Long, straight and flat with bollards at both ends (side-on type).

Fair. Some weeds, leaves, rubbish and fruit over path.

Some vegetation overhanging side fences.

Nearby Bight Reefs Road does, however, provide an alternative parallel route which would be convenient for some, especially those travelling from east to west. This PAW should therefore be rated "preferably retain" rather than "essential".

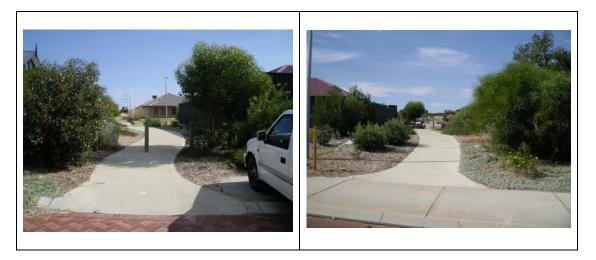
Connects Dorado Street to Impressions Way.

PAW reserve approx. 8m wide and 27m long. Short with a winding flat path. Bollard at east end only.

Good.

Dorado Street is a bus route and there is a bus stop at the western end of the PAW. The PAW is in good condition and needs to be retained.

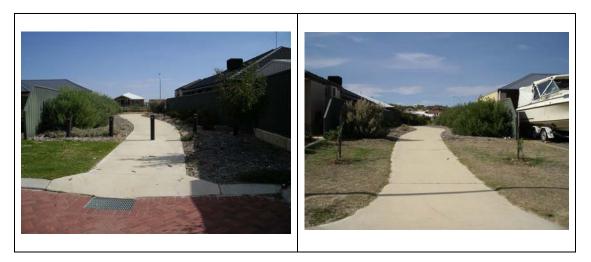
Connects Dorado Street to Creel Rise.

PAW reserve approx. 8m wide and 30m long. Short with a winding, slightly undulating path. Bollard at east end only.

Fair to good. Some graffiti and rubbish.

This PAW is not essential to local connectivity, but is in fair to good condition and should preferably be retained.

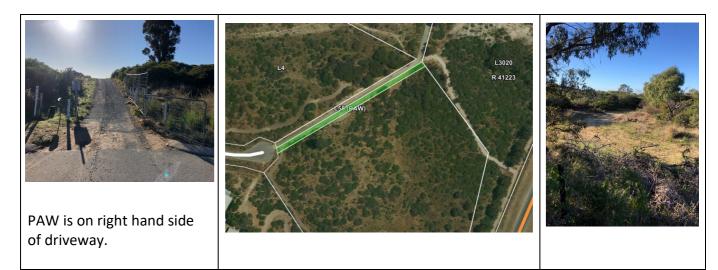
Connects Pescatore Place to a Reserve 41223 (zoned 'Rural' under Metropolitan Region Scheme and 'Public Open Space' under Local Planning Scheme). PAW is surrounded by rural residential lots that are owned privately.

PAW is approximately 164m long and 5.5m wide. From west to east the PAW slopes upwards from 18m to maximum of 23m (over approximately 60m from the western entrance). The slope then drops from 23m to 16m at the eastern entrance of the PAW (over approximately 104m from the maximum height of 23m). Bollards are at the western entrance.

No path. PAW is overgrown. Adjacent private driveway would be used for access purposes instead of the PAW.

Weeds, scrubs and trees are located over the PAW.

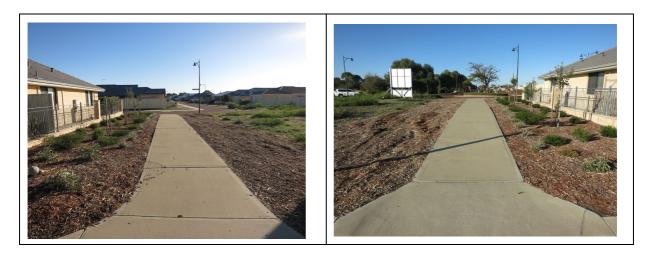
Connects the Navigator Drive roundabout from the south through a pathway system to Seashells Crescent to the north.

PAW is approximately 10m wide and 20m long. Straight, short and flat. No bollards.

Very good. No graffiti, sand, rubbish. Some mulch located over the path.

Good condition. Concrete slabs approximately 25m, 2m wide. No weeds.

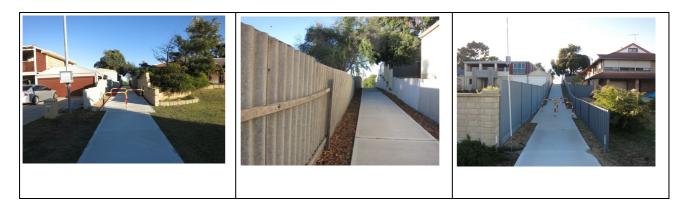
Connects Reilly Street (east) through a pathway system to Murdoch Drive (west).

Approximately 100m long and 3m wide. Straight. Slopes upwards from west (5m) to east (9m in the middle and 8m at the eastern entrance). Bollards provided at each end.

Very good condition. Little rubbish or weeds.

Strip of landscaping (mostly sand) along the southern edge. Large trees overhanging from adjacent properties.

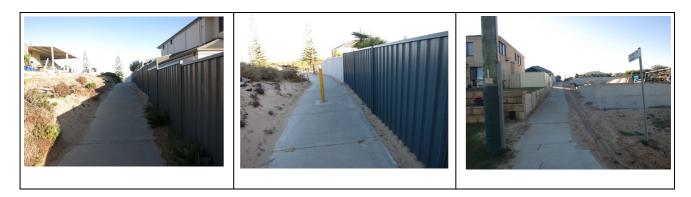
Connects Indiana Parade in the east to Foreshore Drive in the west.

Approximately 80m long and 4m wide. Slight bend. Slopes upwards from Indiana Parade (6m) to the highest point of 9m in the middle of the PAW and back down to Foreshore Parade in the west (4m). One bollard .

Fair. No graffiti, rubbish and glass. Sand over the path and weeds in-between concrete path.

Concrete paving. Cracks located on the eastern side of the PAW.

Vegetation overhanging from the southern edge.
