# Day Cottage, East Rockingham

## Conservation Management Plan (2<sup>nd</sup> Ed)

June 2024 | 21-559

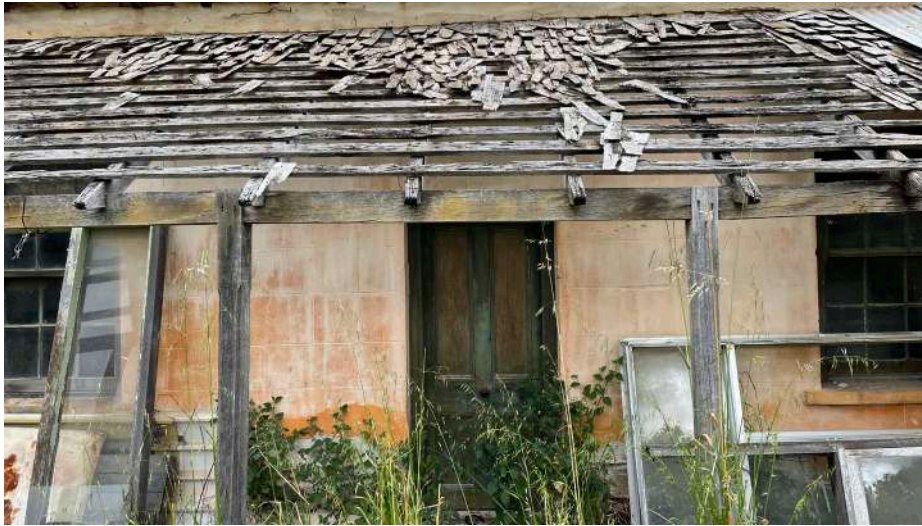
Figure 26. Front entry door to *Day Cottage* noting original shingles visible where corrugated sheeting has failed and ashlar lined external walls (element, 2021)

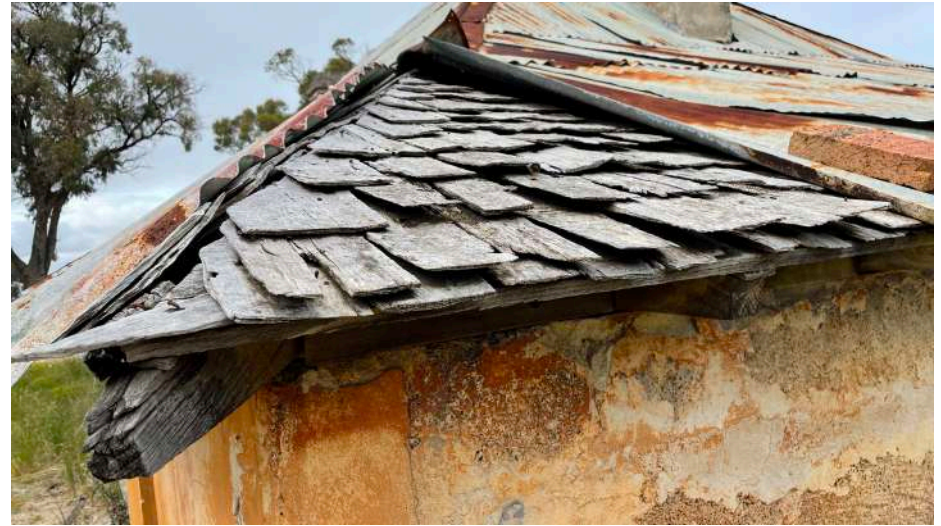
Figure 28. Detail of timber shingles to north-east corner where corrugated sheet covering has failed. Ashlar lined external wall finish visible below applied only to the front facade (element, 2021)

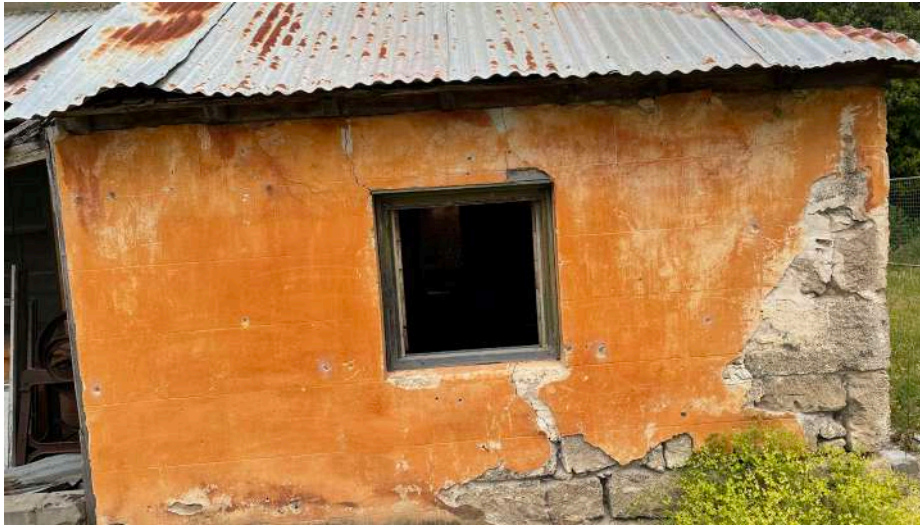
Figure 34. View of northern projecting room to front facade noting square window missing internal joinery. Ashlar lining finish is deteriorated to the northernmost corner, but otherwise visible. Orange pigmentation highly visible to this face (element, 2021)

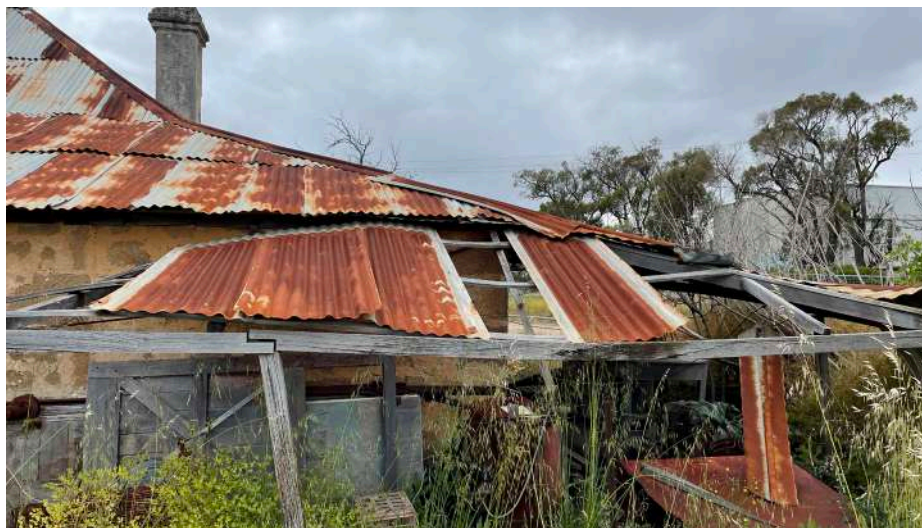
Figure 38. Remnants of the external verandah structure to the south-west corner of the cottage (element, 2021)

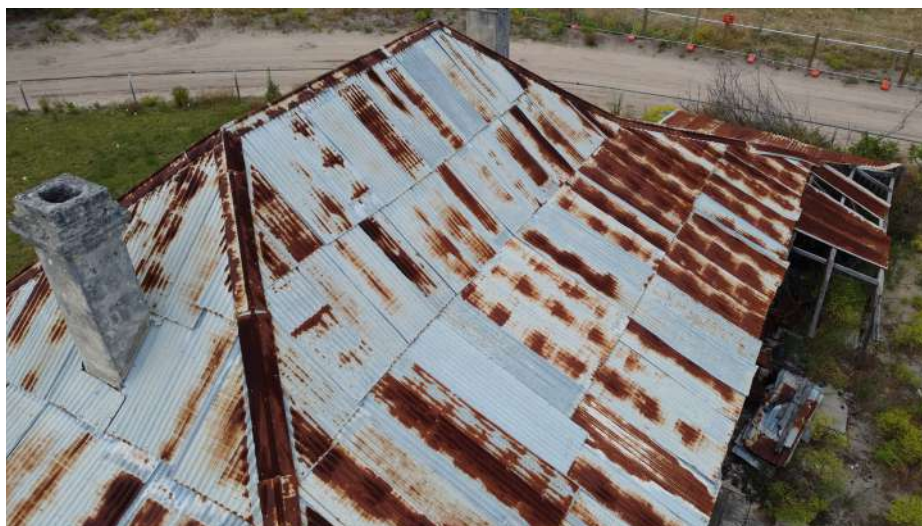
Figure 39. Aerial view of the cottage noting remnants of the external verandah structure to the south-west corner (element, 2021)

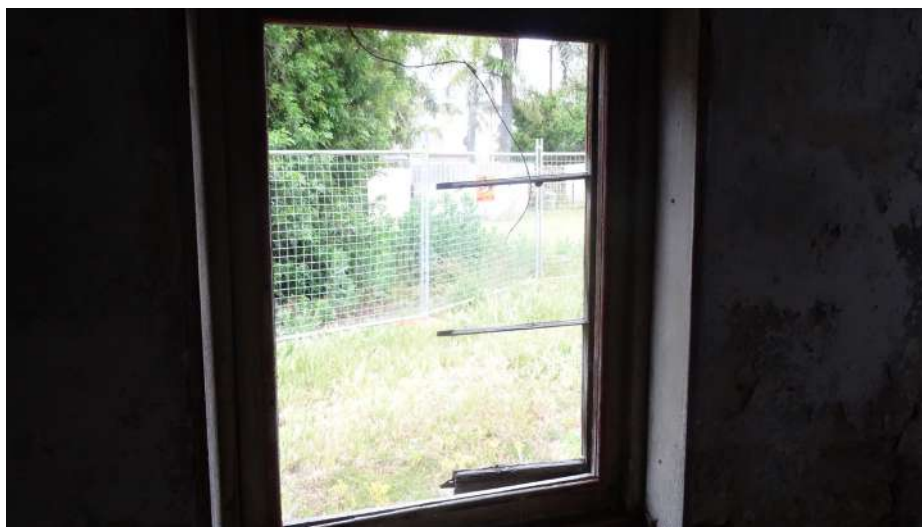
Figure 63. Northern window to detached kitchen noting missing timber joinery and glazing (element, 2021)

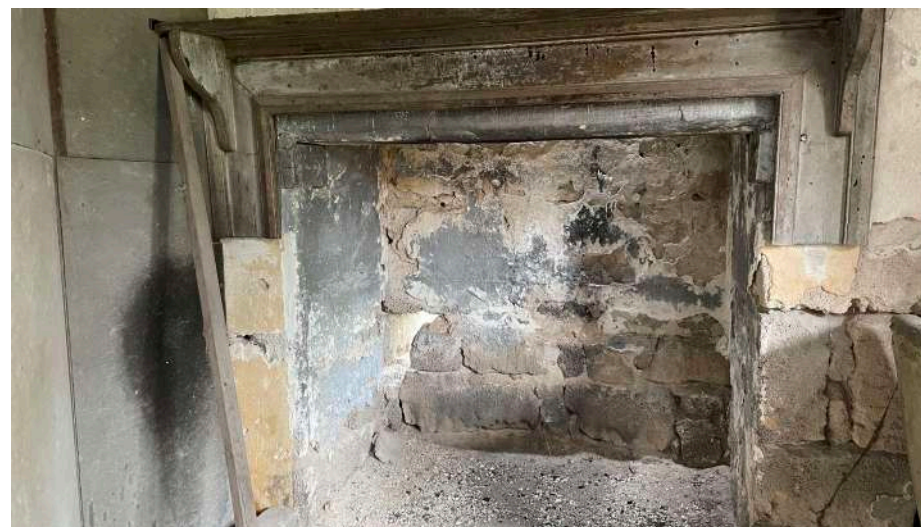
Figure 65. Fireplace to detached kitchen noting significant holes to low level stonework (element, 2021)

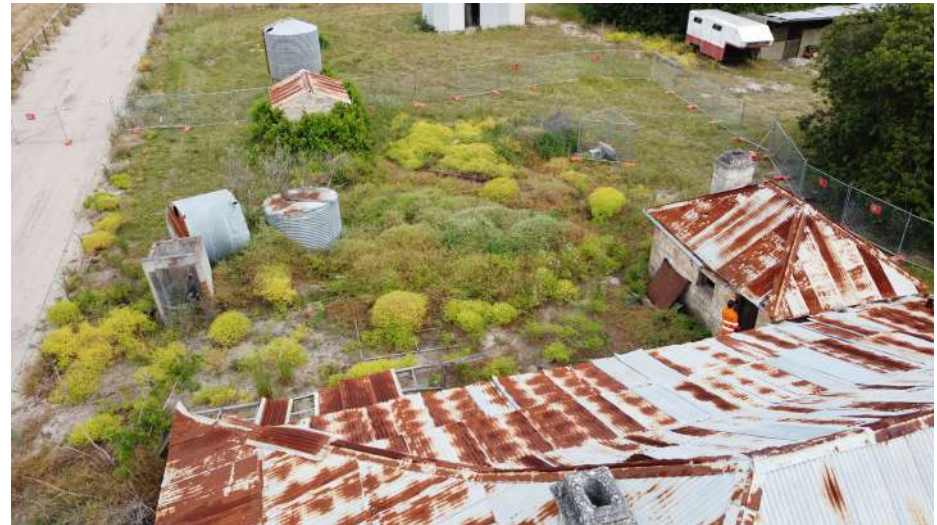
Figure 67. Aerial view to rear of the lot looking west noting exposed toilet structure, collapsed water tank and overgrown laundry structure beyond (element, 2021)

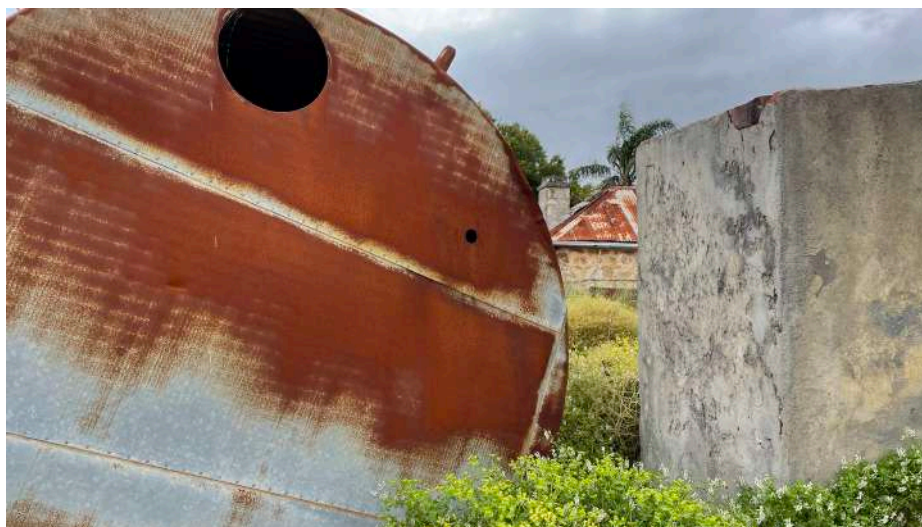
Figure 70. Collapsed water tank and roofless toilet outhouse with cottage visible beyond (element, 2021)

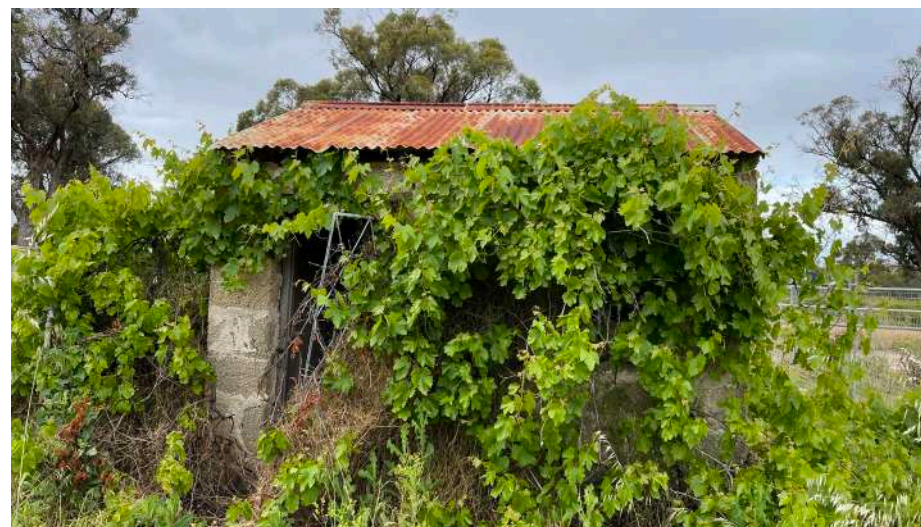
Figure 72. View of laundry looking south. Access opening can just be seen through the creeper overgrowth (element, 2021)
