# Point Peron “K” Battery Conservation Management Plan

South West Corridor Development Foundation Inc.

**HOCKING**  
HERITAGE STUDIO

March 2016

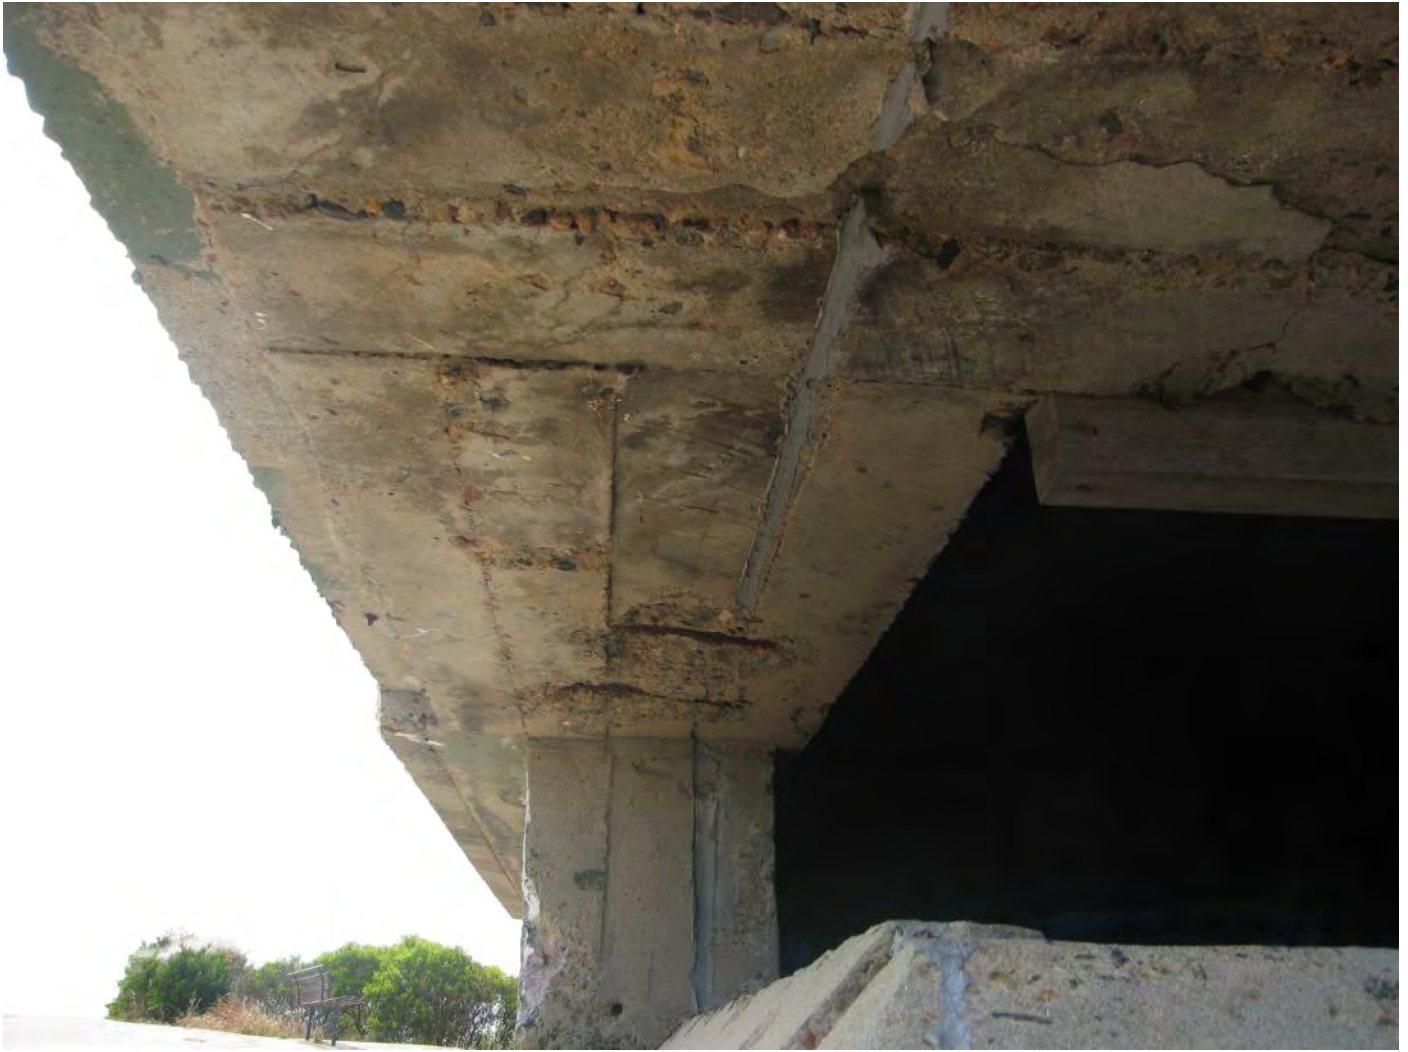
Research has shown that in similar structures, the ground level often came up to the bottom of these projection or slightly above providing support. Over time the ground level has eroded or has been manually removed to provide a flat walking surface around the structure which has removed all support for the projecting element. As a consequence, the weight of the projecting storage area is pulling the wall away from the rest of the structure which is evident in the cracking seen along the brick joints.

**Figure 61:**      **Underside of Concrete Overhang to Observation Opening**

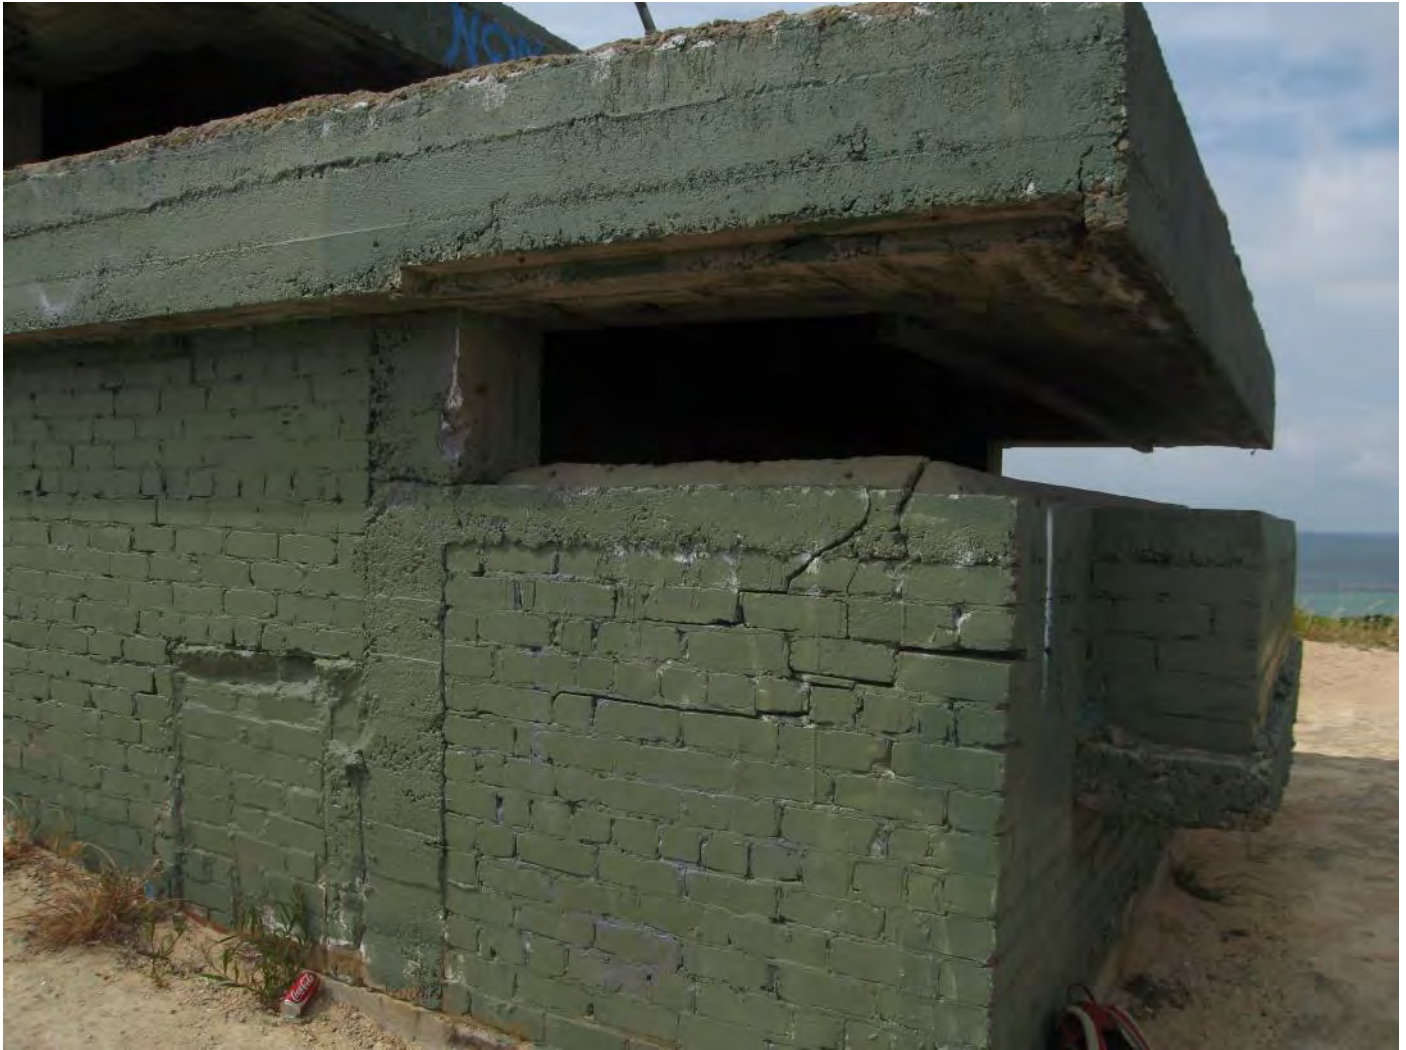
**Figure 63:** North Elevation – western corner being pulled away from the main elevation

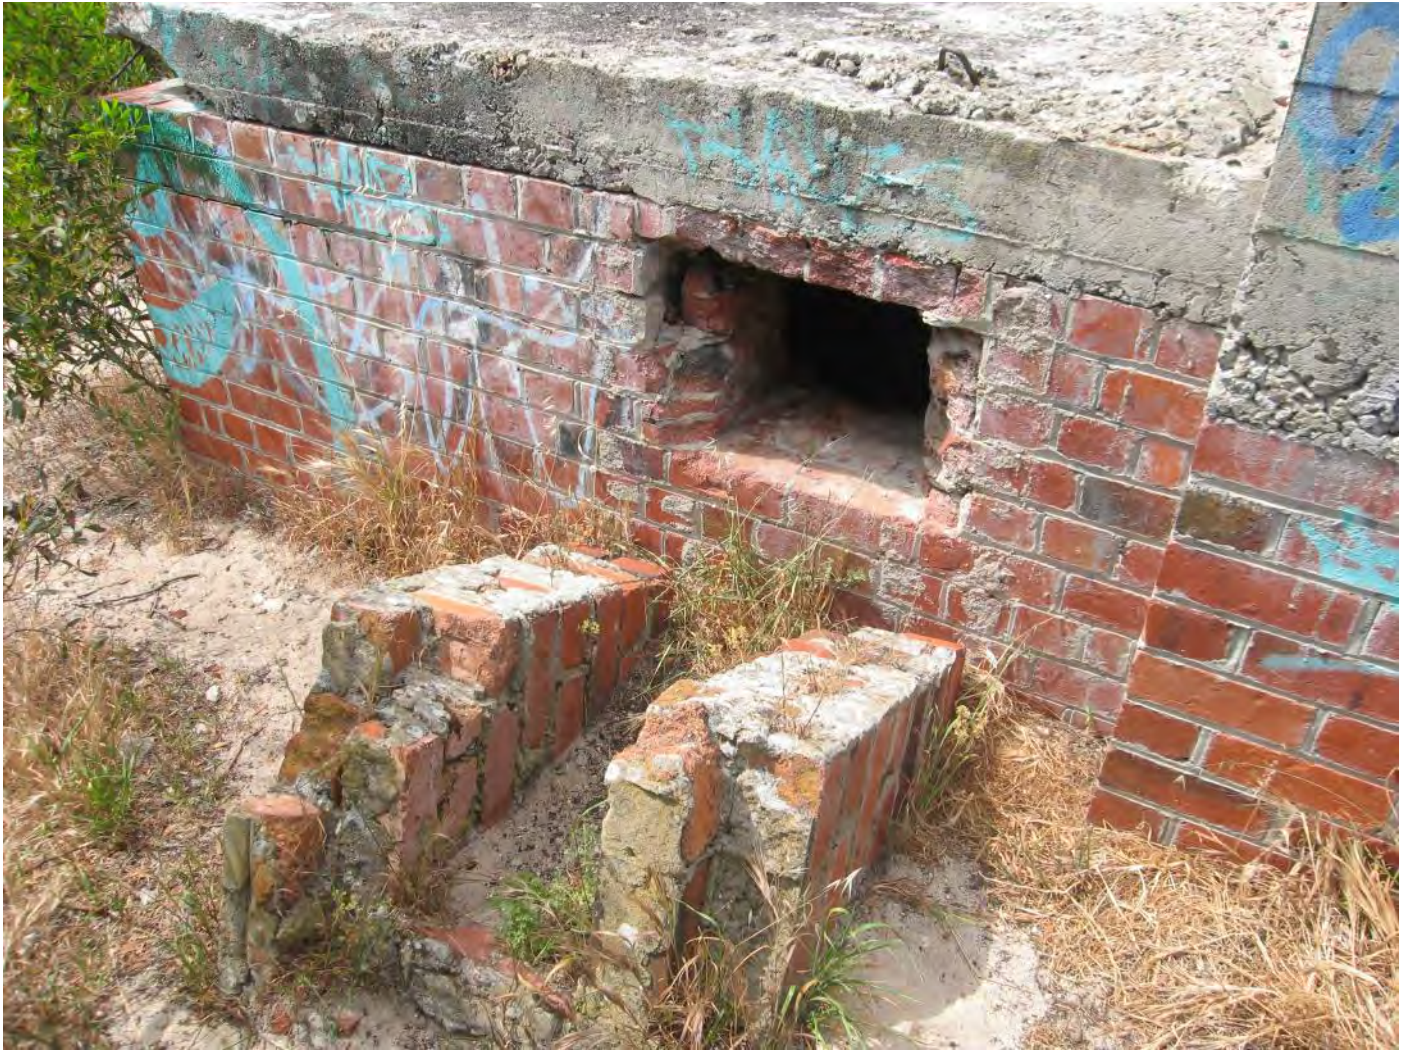
The brickwork immediately to the west of the opening, closest to the west elevation, is deteriorating. Bricks are missing with much of the damage being caused by the rusting and failing reinforcing steel. Previous repairs have been carried out with some evidence of localised repointing.

**Figure 86: Operations Bunker – Openings in north elevation and remnant fabric**

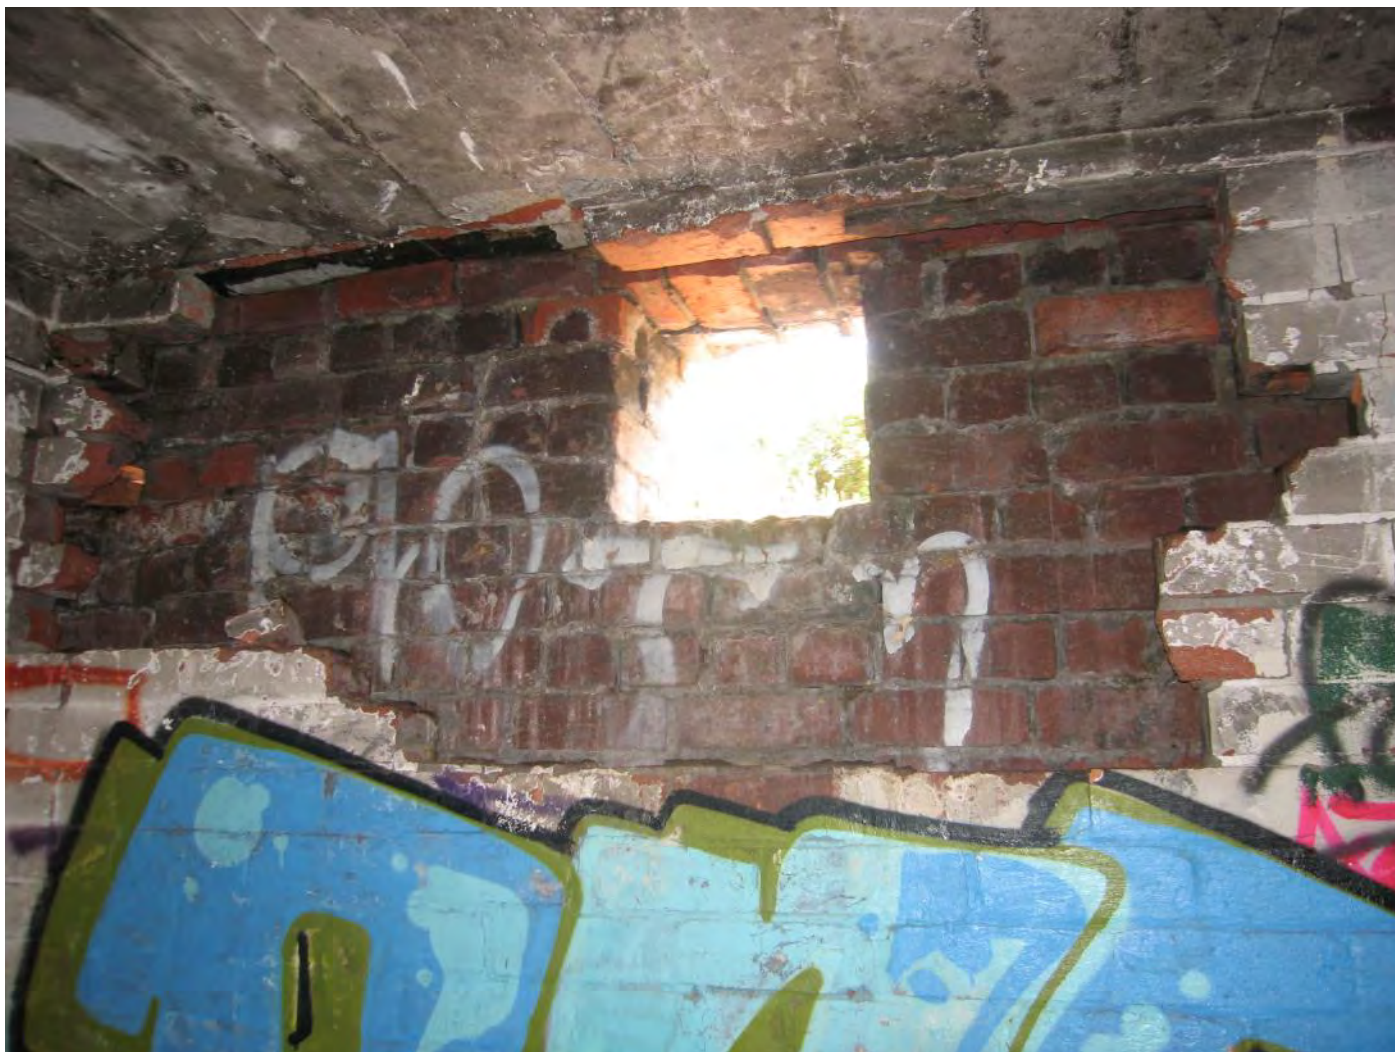
**Figure 94:** Operations Bunker – Small opening in north wall with damaged brickwork

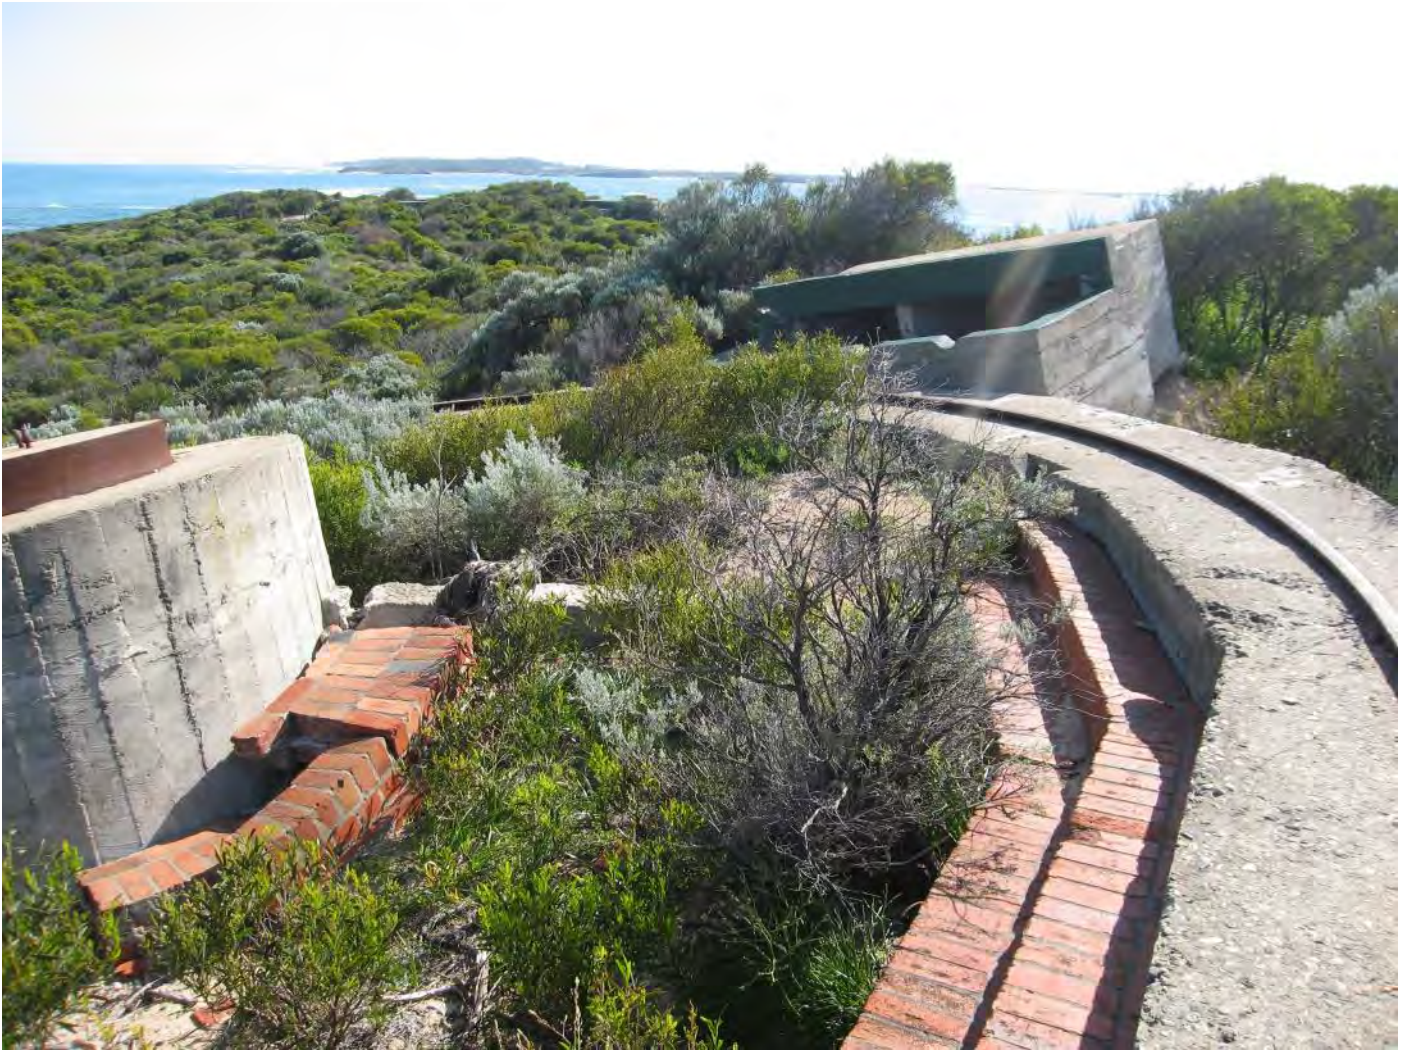
**Figure 98:**      **Gun Emplacement**

Gun Emplacement No. 1 is not in a good condition, clearly demonstrating how the instable land formation has impacted on the structural stability of the gun emplacement. Over time, the ground levels have changed with much of the sand being eroded revealing the structure of the gun emplacement and eventually undermining its stability as the land has moved away. Much of the original fabric remains in and around the structure but a full understanding of the planning of the gun emplacement and its related structures and functions is no longer clearly visible.

- Policy 6.17 Gun Emplacement No. 1 is in poor condition due to the instability of the underlying ground conditions. The Gun Emplacement has slipped and is no longer in its original form or position. It is not recommended that this feature be reconstructed as its current condition contributes to the story of the site. However, visitor safety and structural stability is essential and works are required to stabilise the structure before it slips any further. Stabilisation works are to be undertaken to the engineer’s and heritage architect’s specifications.*

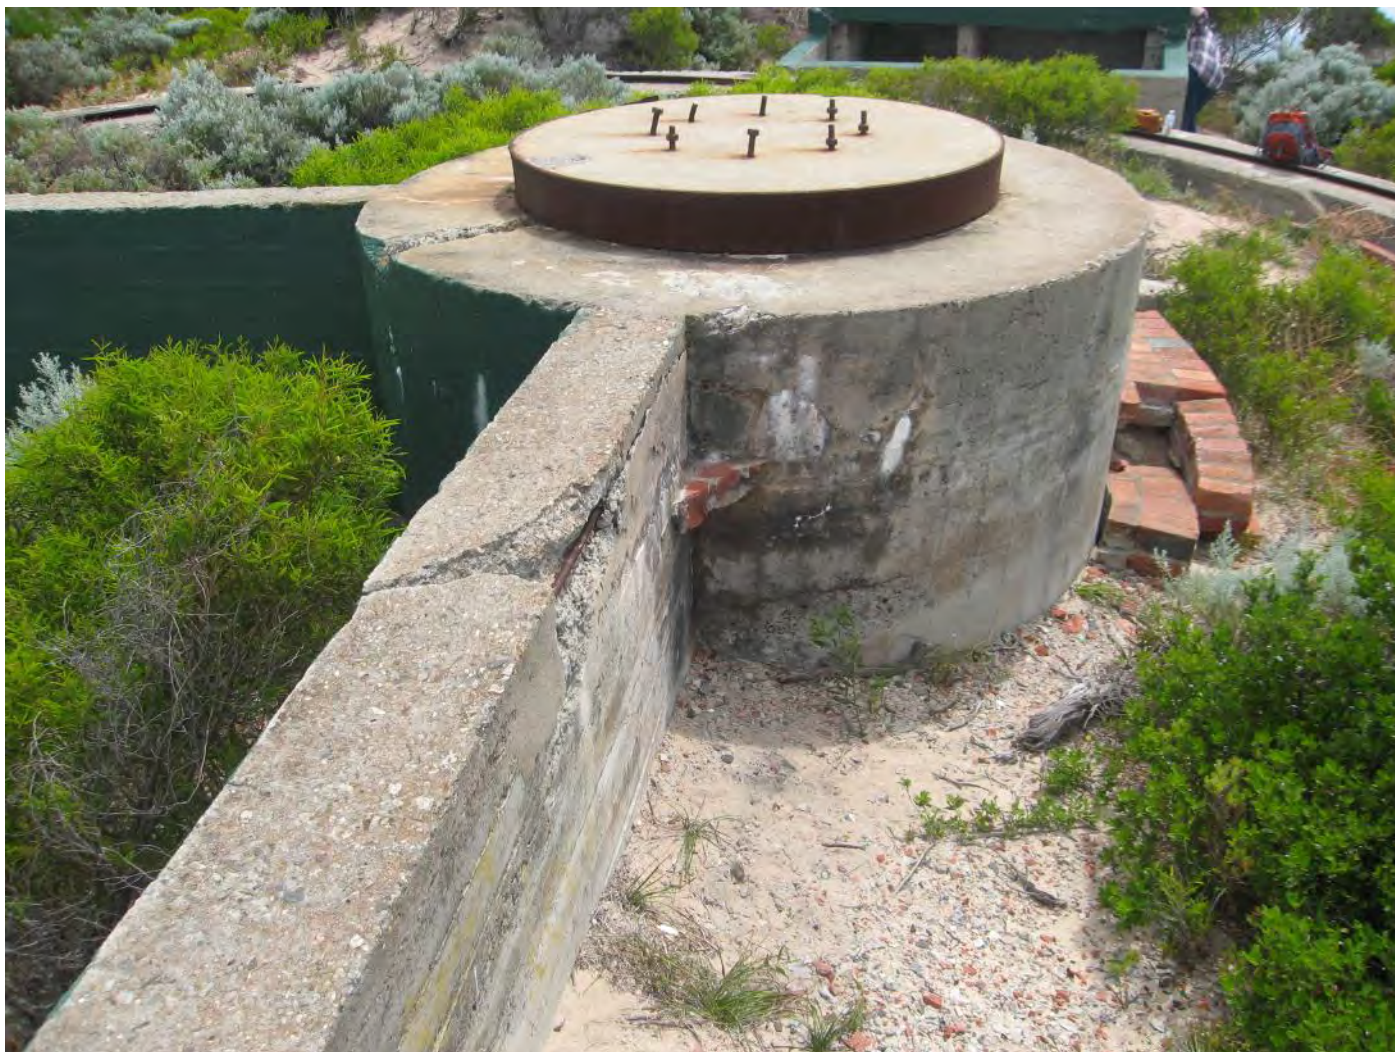
**Figure 101:** Gun Emplacement - rusted steel reinforcements causing chunks of concrete to blow and break off

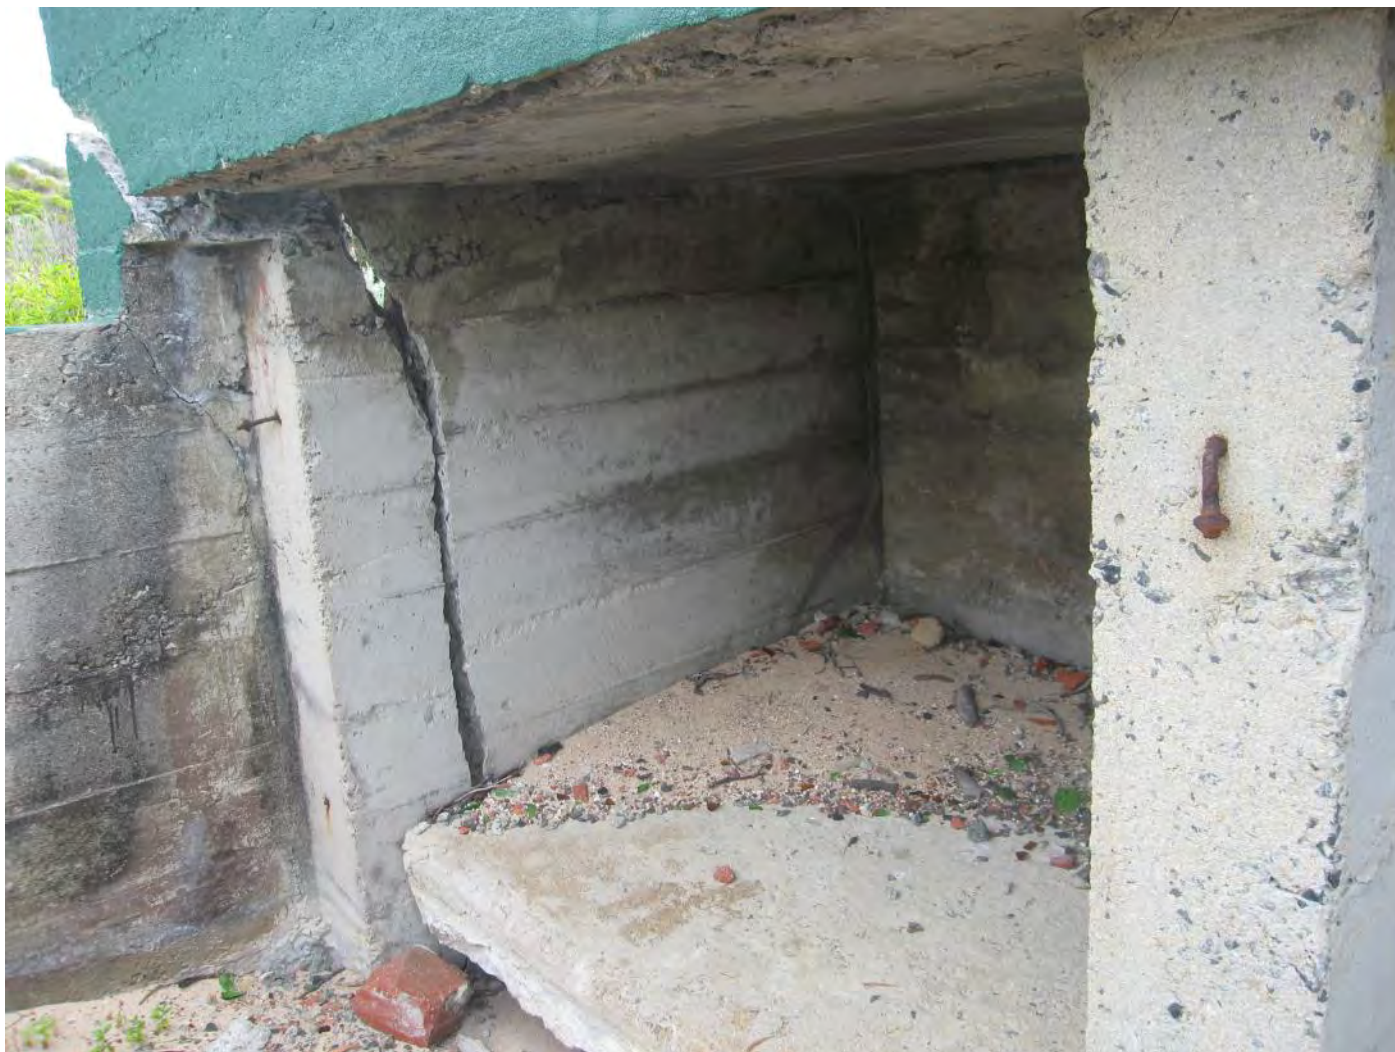
**Figure 110:** Gun Emplacement - Cracking in the framework of Ammunition Store No. 1

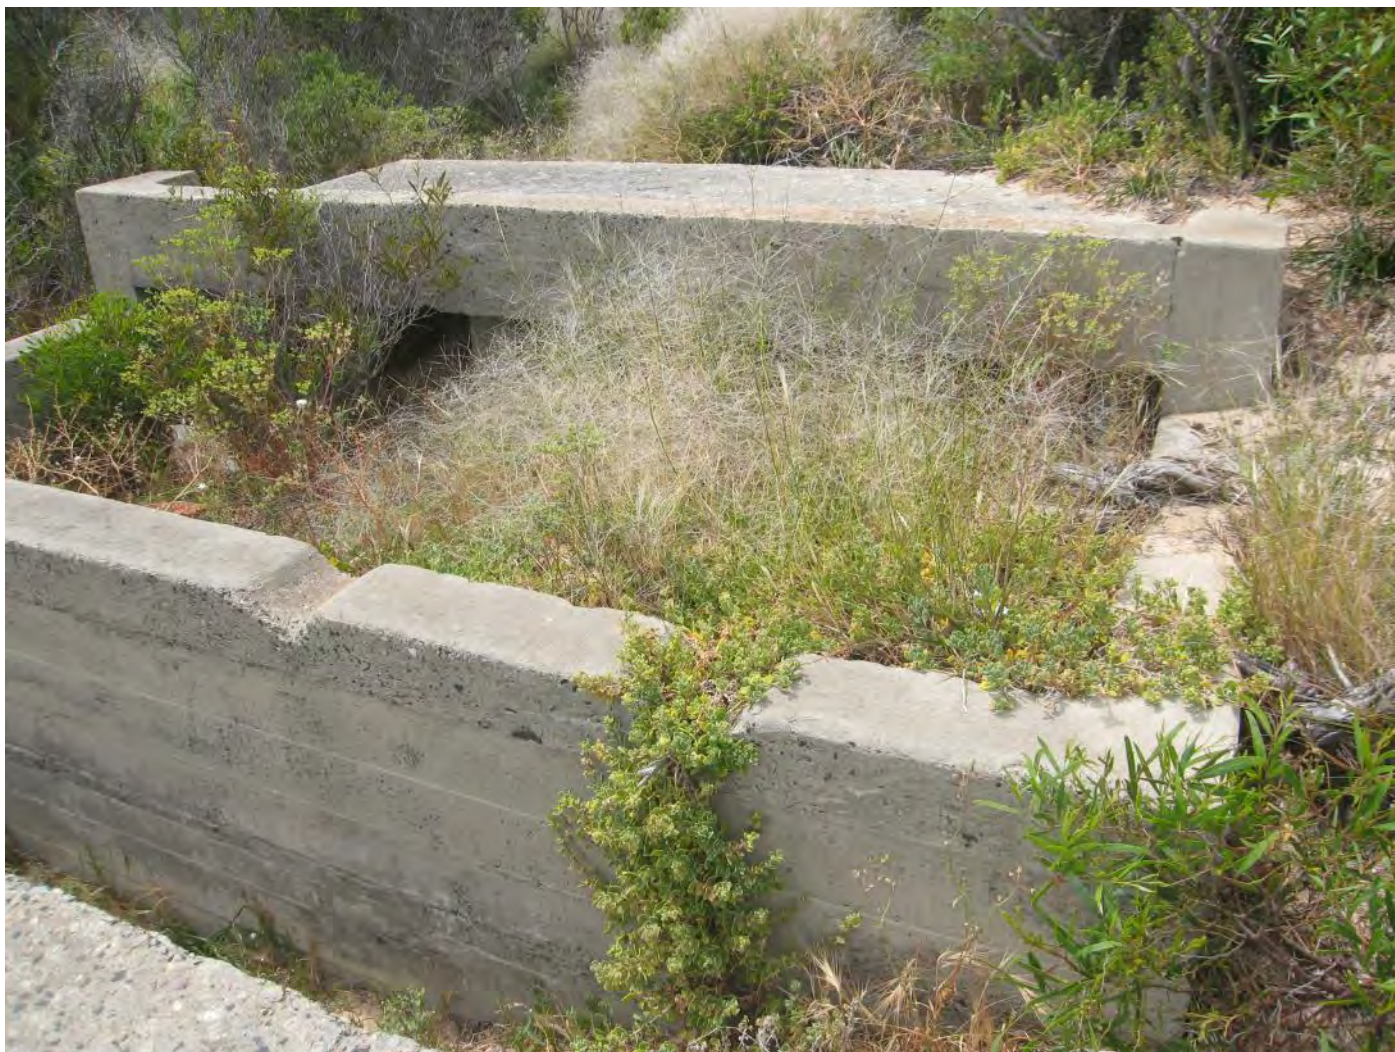
**Figure 112:** Gun Emplacement - Ammunition Store No. 2, sand in fill with vegetation growth

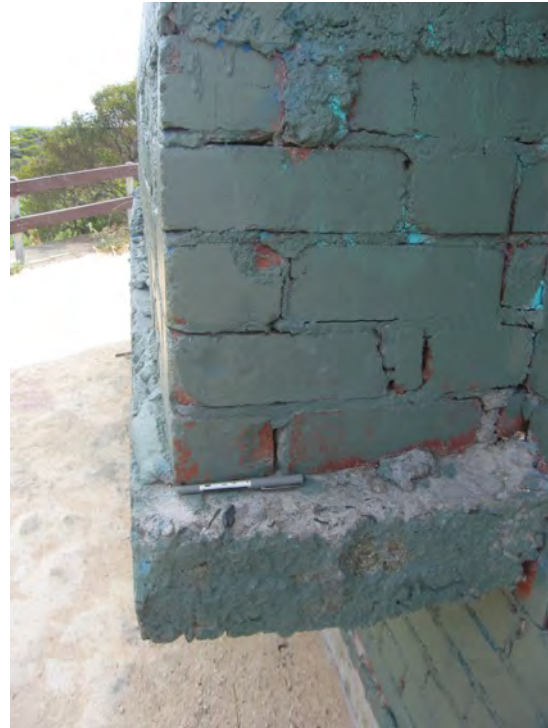
| Building Name | Condition Rating | Defect and Location | Work to Rectify Defect | Priority Ranking |
|---|---|---|---|---|
| | | <p>Loose mortar in brick joints</p> <p>Non-original paint finish</p> <p>Rusted reinforcements in the concrete causing sections of concrete to spall and fall off</p> | <p>Peelaway paint removal system can be used or Westox's DeLam which applies a poultice to the paint and will be ready to be removed within a few days. Not all paint traces will be removed due to the texture of the bricks and concrete.</p> <p>Repoint all joints showing sign of deterioration by raking out loose mortar to a depth that will ensure new mortar will hold. Mortar is to match existing ensuring that the mortar is a softer mix than the brick.</p> <p>Concrete elements are to be remediated. Rusting to the structural elements encased by the concrete is becoming visible causing the concrete to spall and break off. The high salt content in the air contributes to the accelerated rate of deterioration as does inadequate protection from water ingress.</p> <p>It is not recommended that the damaged concrete be removed in its entirety, utilising patch repairs to try and retain the original fabric. Where the steel reinforcement has rusted causing the concrete to spall, the concrete needs to be cutback and the steel cleaned, treated with an anticorrosive treatment such as Sika Ferro Guard and new concrete patched in to match existing. Due to the harsh environmental conditions at Point Peron, it is recommended that a corrosion barrier coating is applied to all concrete surfaces to reduce/delay further deterioration.</p> | <p>1</p> <p>1</p> |

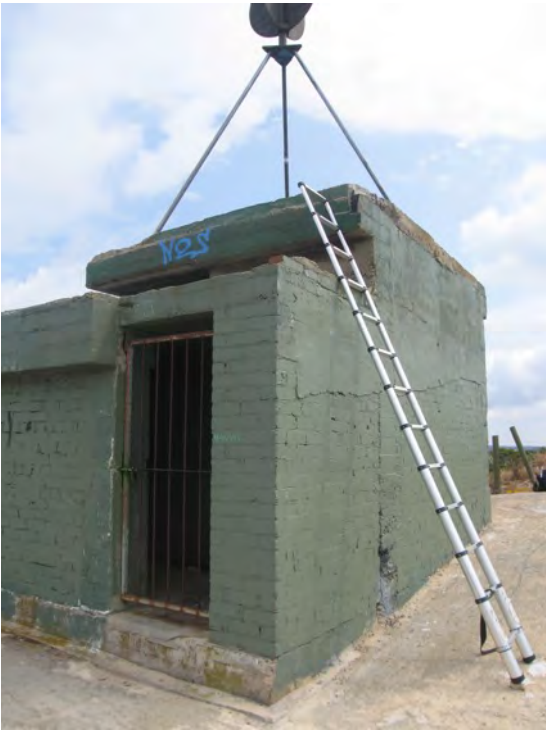
| Building Name | Condition Rating | Defect and Location | Work to Rectify Defect | Priority Ranking |
|---|---|---|---|---|
| | | <p>The main area of deterioration is the underside of the roof overhang over the observation opening. The rusted steel reinforcements are clearly visible illustrating the extent of concrete failure.</p> <p>Painted finish</p> | <p>Concrete elements are to be remediated. Rusting to the structural elements encased by the concrete is becoming visible causing the concrete to spall and break off. The high salt content in the air contributes to the accelerated rate of deterioration as does inadequate protection from water ingress.</p> <p>It is not recommended that the damaged concrete be removed in its entirety, utilising patch repairs to try and retain the original fabric. Where the steel reinforcement has rusted causing the concrete to spall, the concrete needs to be cutback and the steel cleaned, treated with an anticorrosive treatment such as Sika Ferro Guard and new concrete patched in to match existing. Due to the harsh environmental conditions at Point Peron, it is recommended that a corrosion barrier coating is applied to all concrete surfaces to reduce/delay further deterioration.</p> | 2 |

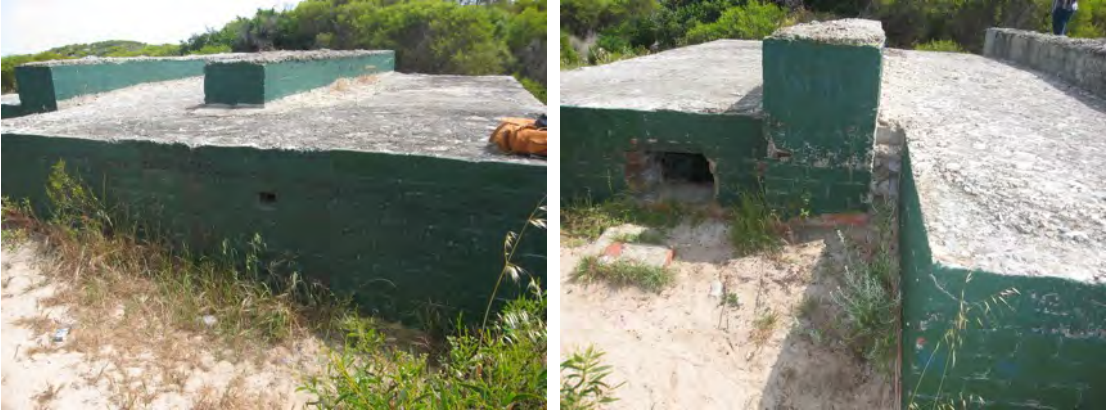
| Building Name | Condition Rating | Defect and Location | Work to Rectify Defect | Priority Ranking |
|---|---|---|---|---|
| South Elevation | B | <p>Upper sections of brick walls are showing signs of failure due to water damage from the flat roof causing the steel reinforcement bars to rust and expand causing failure to the brickwork.</p> | <p>Remove paint from entire elevation as this can contribute to the deterioration of the fabric. Paint removal should not unduly damage the substrate and mortar and test panels in discrete locations should be established prior to embarking on the full removal. Non-caustic solvent based methods or low pressure steam removal can be tried.</p> <p>Peelaway paint removal system can be used or Westox's DeLam which applies a poultice to the paint and will be ready to be removed within a few days. Not all paint traces will be removed due to the texture of the bricks and concrete.</p> | 2 |

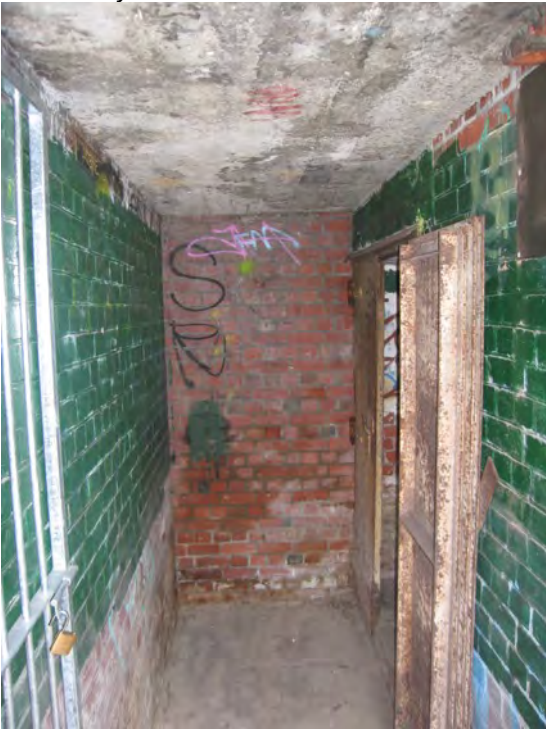
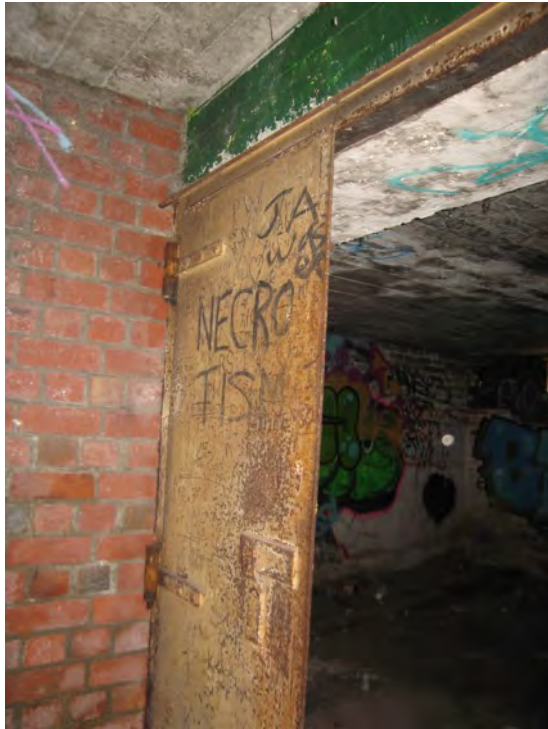
| Building Name | Condition Rating | Defect and Location | Work to Rectify Defect | Priority Ranking |
|---|---|---|---|---|
| Interior – Entry | C | <p>Walls are partially painted, with the paint stopping before floor level.<br/>Areas of graffiti.<br/>Tendency for sand accumulation.</p> | <p>Remove paint from entire elevation as this can contribute to the deterioration of the fabric. Paint removal should not unduly damage the substrate and mortar and test panels in discrete locations should be established prior to embarking on the full removal. Non-caustic solvent based methods or low pressure steam removal can be tried.<br/>Peelaway paint removal system can be used or Westox's DeLam which applies a poultice to the paint and will be ready to be removed within a few days. Not all paint traces will be removed due to the texture of the bricks and concrete.</p> <p>Graffiti should be removed without the need to apply an anti-graffiti coating.</p> <p>Ensure all sand is removed regularly as this can contribute to damp at the lower levels of the walls.</p> <p>The metal grille gate can be removed or retained depending on owner requirements.</p> | <p>2</p> <p>1</p> |

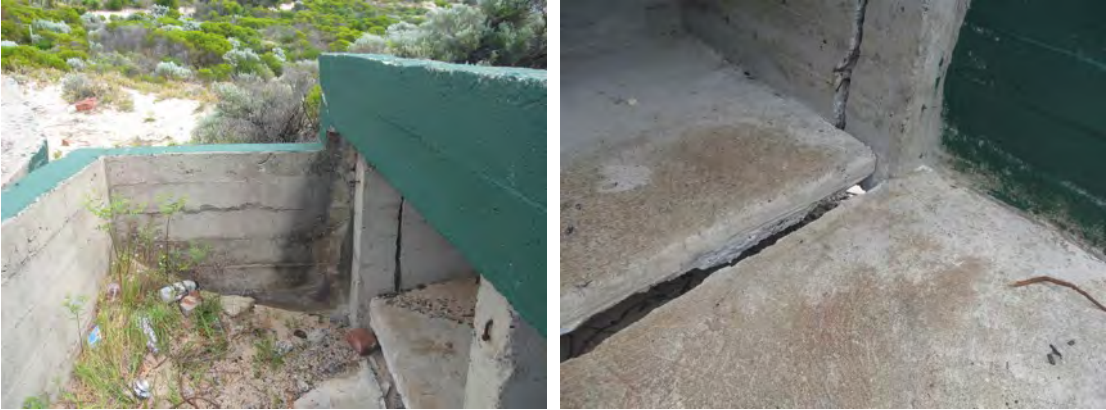
| Building Name | Condition Rating | Defect and Location | Work to Rectify Defect | Priority Ranking |
|---|---|---|---|---|
| <b>Ammunition Store 1</b><br><br>Reinforced concrete | D | <p>Ammunition Store No. 1 has also suffered from the land movement and has slipped into the the gun emplacement, twisting and cracking the reinforced concrete structure. Although the ammunition store has remained relatively in tact, the concrete slab floor has pushed up in places and cracks have occurred in the walls.</p> <p>Part of the external walls have been painted.</p> <p>Sand accumulation and vegetation growth within the structure.</p> | <p>Works to the Ammunition Store will be limited to crack repairs and concrete cancer. As with the main gun emplacement structure, it is not the intention to restore the Ammunition Store. The structure is taking the majority of its structural support from the gun emplacement and following the structural works to the gun emplacement, the store should still be able to use it for its main support without further substantial movement. Some new footings may be required but all work is to be guided by the structural and geotechnical engineers together with the heritage architect.</p> <p>Crack stitching will be required to tie the walls back together and provide some increased structural strength.</p> <p>The paint should be removed as per the methodology outlined elsewhere in this report.</p> <p>The sand accumulation and vegetation growth within the structure should be removed.</p> | <div>2</div> <div>2</div> <div>2</div> <div>1</div> |

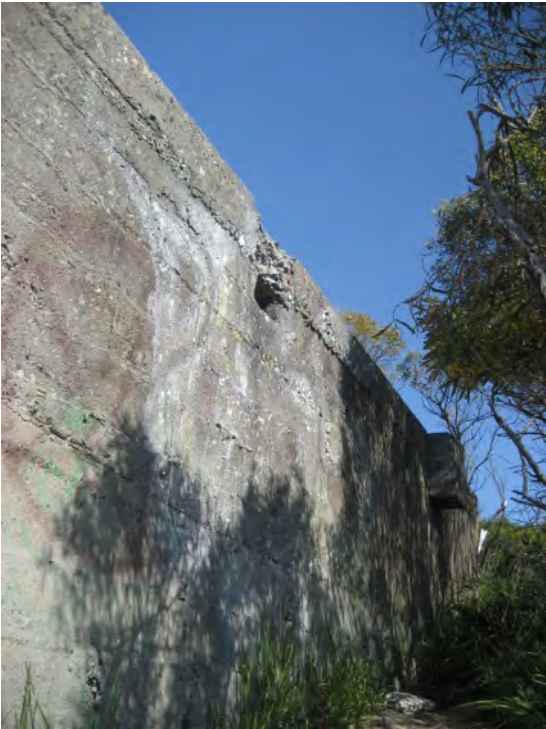
| Building Name | Condition Rating | Defect and Location | Work to Rectify Defect | Priority Ranking |
|---|---|---|---|---|
| West Elevation | C | <p>Slight concrete damage. Loss of ventilation shaft and deterioration to underlying concrete. Water drainage issues from roof causing some of the deterioration.</p> | <p>Repair concrete around the air vent. To prevent further damage the air vent shaft should be reconstructed based on the design of extant air shafts. Protection of the opening will safeguard the vulnerable fabric around the opening and also prevent water ingress into the building.</p> | 2 |

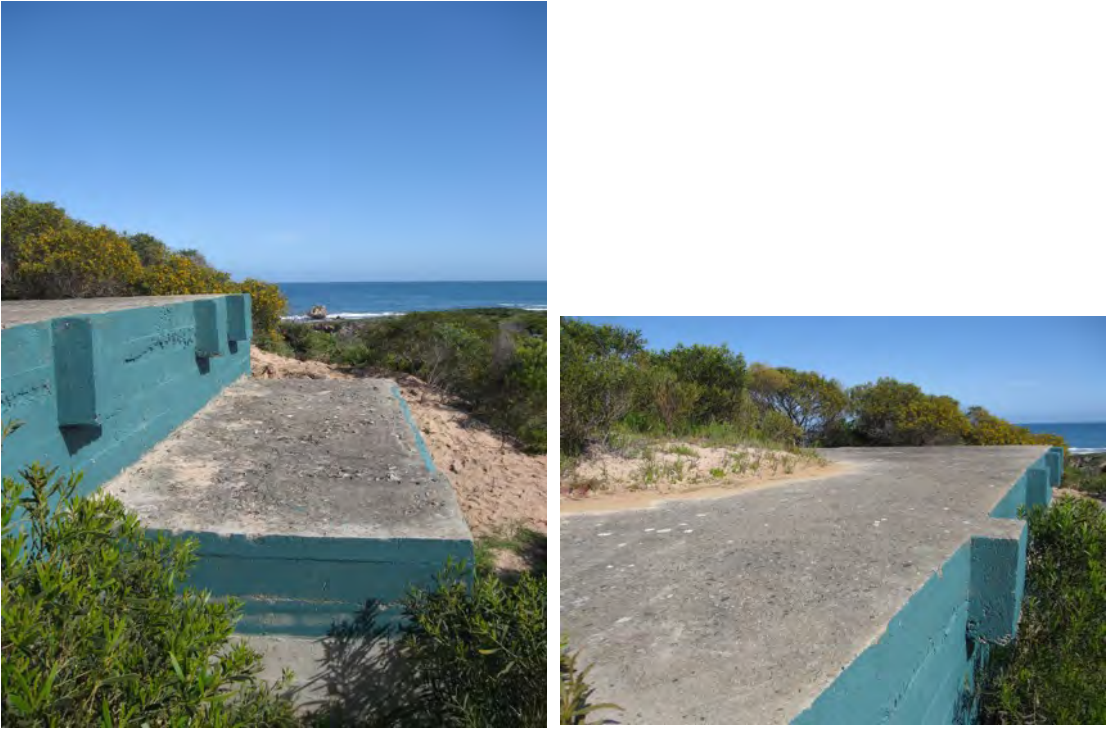
| Building Name | Condition Rating | Defect and Location | Work to Rectify Defect | Priority Ranking |
|---|---|---|---|---|
| Roof | C | <p>Appears to be in sound condition with only hairline cracking. Water drainage issues causing some damage to the air vent shafts and edge of the concrete roof. Sand build up on the roof with subsequent vegetation growth.</p> | <p>Consideration to be given to adding a new top screed, angled to allow run off for rain water. Roof to be coated with waterproof breathable membrane or other coating to reduce water penetration into the fabric and subsequent damage.</p> <p>Sand removal from the roof is required if full roof inspection to be undertaken.</p> | 2 |

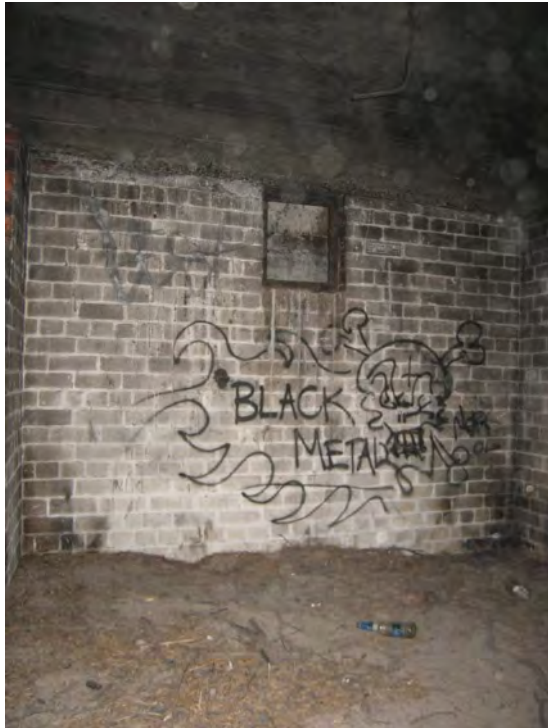
| Building Name | Condition Rating | Defect and Location | Work to Rectify Defect | Priority Ranking |
|---|---|---|---|---|
| Room 2 plus blast corridor | C | <p>Brick internal walls with concrete outer walls. Clouded paint finish to walls with graffiti. Sand accumulation.</p> <div></div> | <p>Remove graffiti. There is no requirement for an anti-graffiti coating to be applied if public access is going to be controlled. Removal of graffiti should not damage the underlying brick and concrete.</p> <p>Remove painted finish to the walls as per specifications above or other suitable alternative conservation method.</p> <p>Slight signs of concrete deterioration to the ceiling. Further deterioration to be monitored.</p> <p>Sand accumulation to be monitored and removed prior to substantial build-up.</p> | <p>2</p> <p>2</p> |

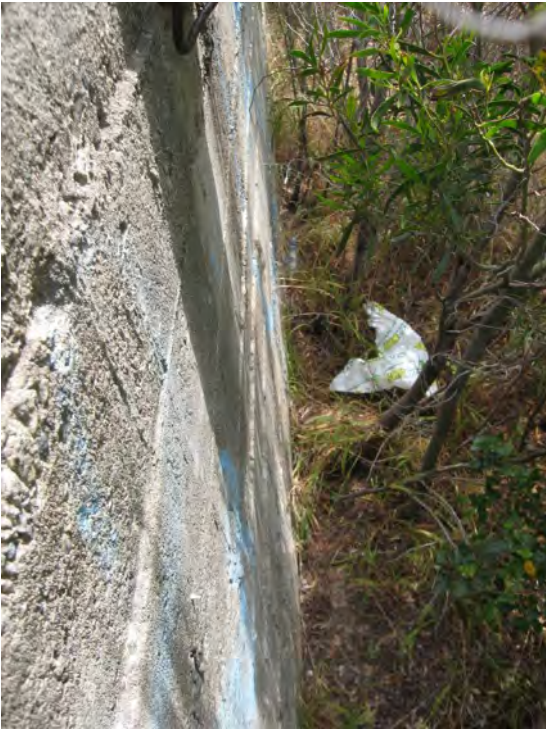
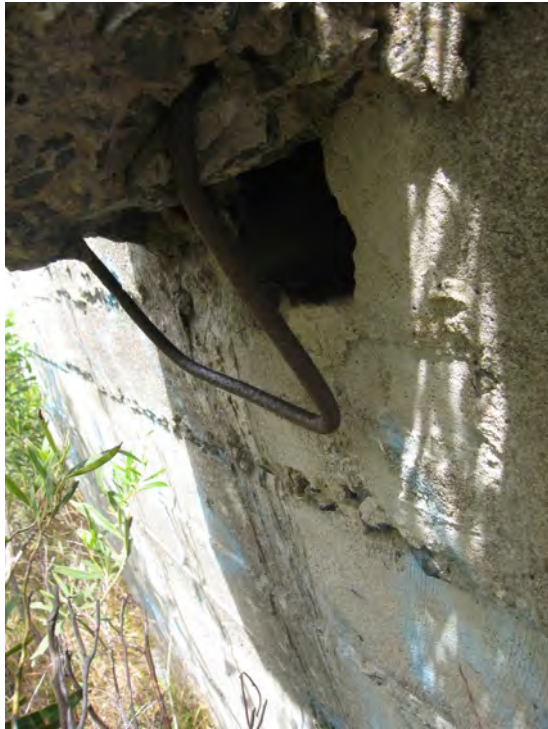
| Building Name | Condition Rating | Defect and Location | Work to Rectify Defect | Priority Ranking |
|---|---|---|---|---|
| North Elevation | C | Mainly obscured by vegetation and steep drop in the land form. Unpainted concrete construction with some graffiti.<br>The visible sections of the elevation generally appear to be in sound condition but the projecting air vent shafts have succumbed to concrete cancer with the bottom sections completely eroding in places, revealing the reinforcing steels.<br> | A full inspection of the north elevation is required to accurately determine its condition. From the limited access available the main elevation appears in sound condition with deterioration being limited to the base of the air vent shafts. This is caused by water run off from the roof and proximity to the surrounding vegetation. Some of the vegetation may need to be cleared to reduce impacts on the fabric of the building. The steels need to be cleaned and treated with an anti-corrosive treatment prior to the concrete being reapplied. The concrete may then be coated with a barrier to reduce the amount of water ingress and subsequent deterioration. | 2 |

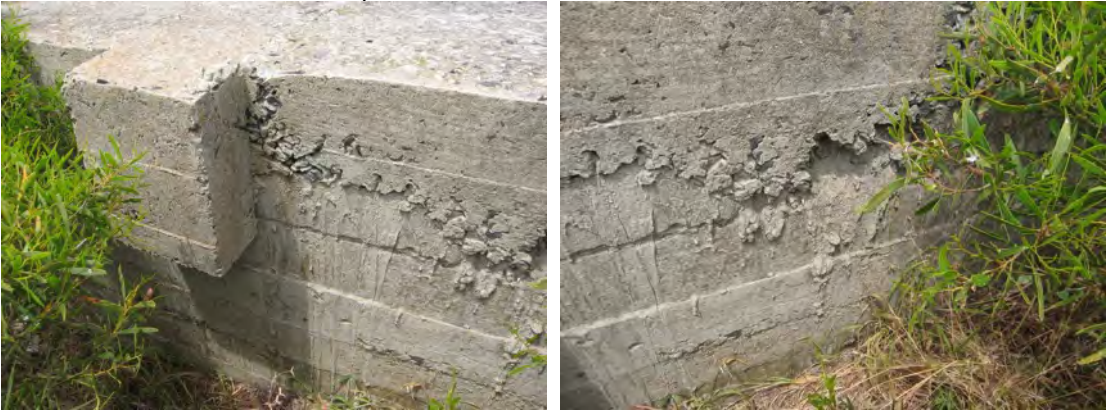
| Building Name | Condition Rating | Defect and Location | Work to Rectify Defect | Priority Ranking |
|---|---|---|---|---|
| West Elevation | | <p>Much of the west elevation is obscured by vegetation. The elevation is partially submerged. Projecting air shafts extending from the roof level down approximately three block courses. The underside of the vents showing signs of concrete cancer and erosion in some instances.</p> <p>This elevation has not been painted.</p> | <p>Full inspection of elevation is required to determine condition. This may require the removal of some vegetation.</p> <p>Monitor condition of elevation. Patch repairs to the air shaft vents to reduce further deterioration.</p> | <p>1</p> <p>3</p> |

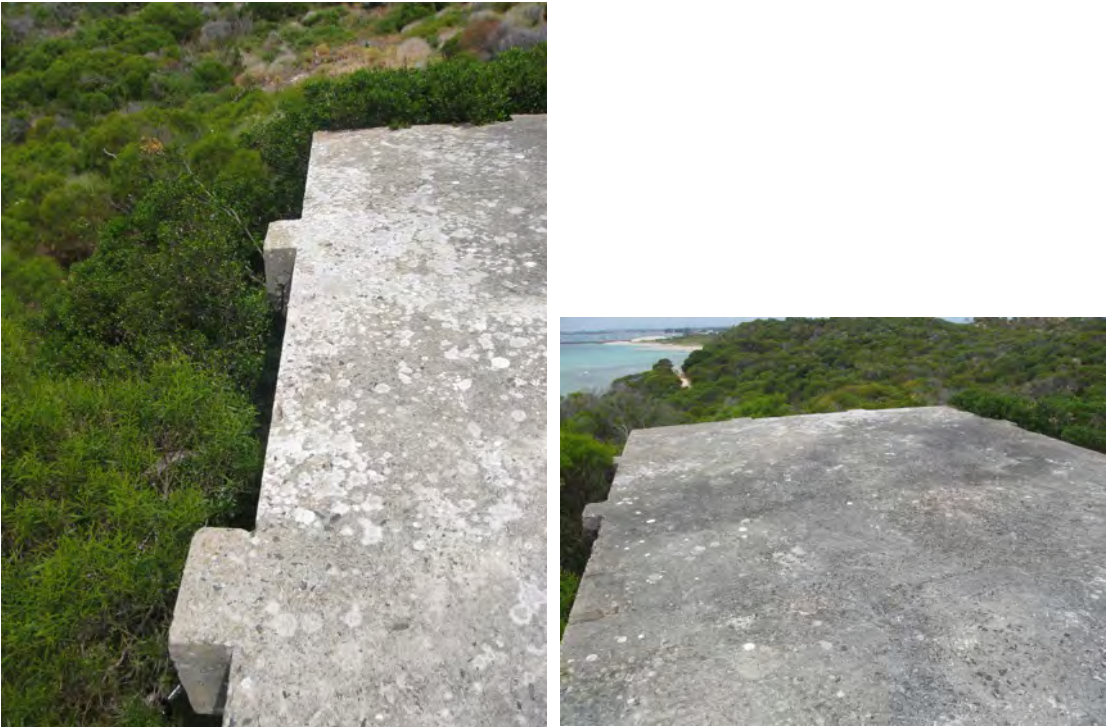
| Building Name | Condition Rating | Defect and Location | Work to Rectify Defect | Priority Ranking |
|---|---|---|---|---|
| Roof | C | <p>Slight cracking , especially at the edges of the roof, resulting in water ingress into the interior. If left unchecked this will result in eventual concrete cancer.</p> <p>Generally in good condition.</p> | <p>The cracking in the roof are to be addressed and remediated in association with the structural engineer's specification. Full extent of the cracking and associated damage to be determined to inform appropriate solution.</p> <p>Water collection is an issue for the structure as there is no specific drainage escape. Roof plumbing is not an option. An additional screed top coat built up at one side to create a fall to enable water to flow off the roof may be a solution. Water dripping from the roof and down the elevations and air vent shafts and close proximity to the planting are the predominant causes of decay for the base of the air vent shafts. A waterproof membrane or coating may be added to the roof and air vents to prevent water ingress into any weaker areas of the structure and also to reduce the rate of water related concrete deterioration. Any coating should not be to the detriment of the underlying fabric.</p> | <p>1</p> <p>2</p> |
