# Point Peron “K” Battery Conservation Management Plan

South West Corridor Development Foundation Inc.

**HOCKING**  
HERITAGE STUDIO

March 2016

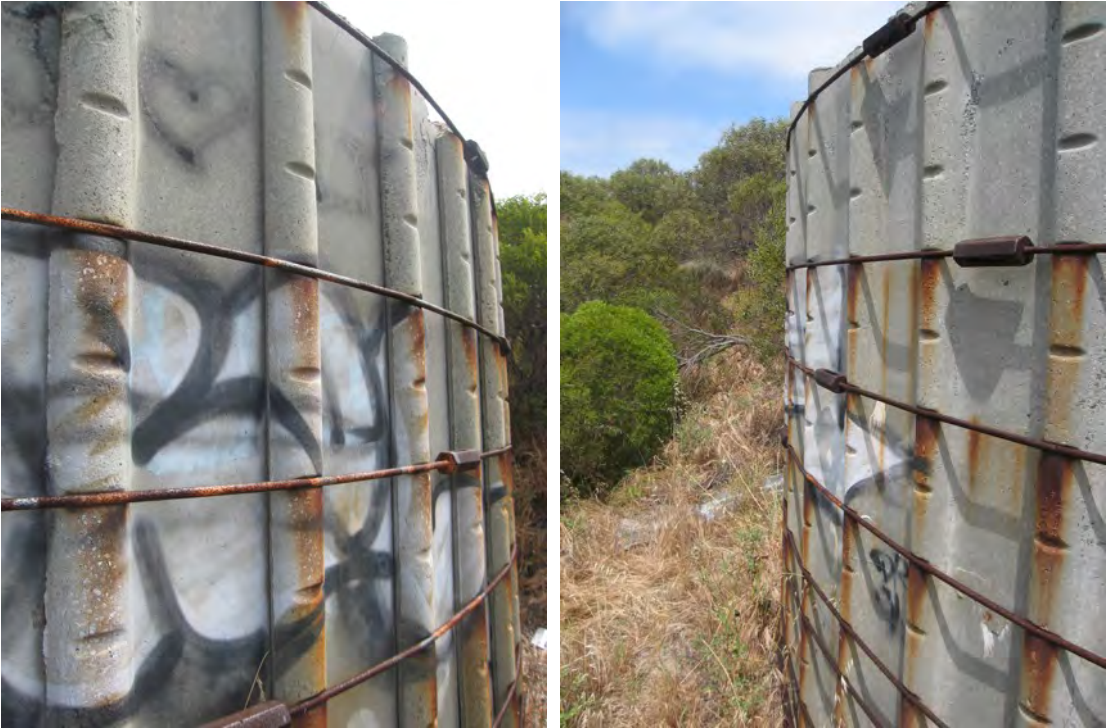
| Building Name | Condition Rating | Defect and Location | Work to Rectify Defect | Priority Ranking |
|---|---|---|---|---|
| <p><b>Water Tank</b></p> <p>Reinforced concrete, corrugated iron roof no longer extant but possible remnant roofing material lays in and around the tank</p> | C | <p>Slight signs of concrete cancer, rusted steel tension bands and substantial graffiti to the interior. Roof no longer extant but remnant fabric may exist in the foot of the tank and around the structure.</p> | <p>Retention or removal is a decision for the owners of the site. Concrete cancer is beginning to occur which will require remediation if the structure is to be retained for interpretation purposes.</p> <p>There is no requirement to reinstate the corrugated iron roof.</p> <p>Removal of graffiti from the interior of the tank is recommended and consideration should be given to coating the structure with an anti-graffiti coating ensuring that this does not cause harm to the underlying fabric.</p> | 2 |
