SUBURB: Baldivis

PAW Code No. B574, B575

Connects Ukich Place to Friedlander Road.

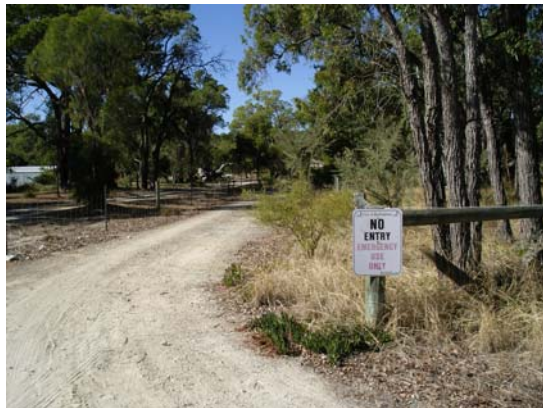
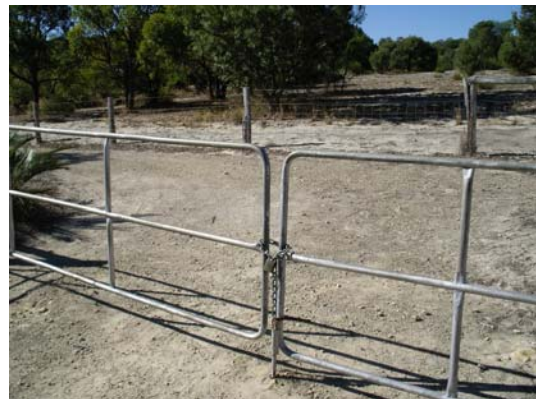
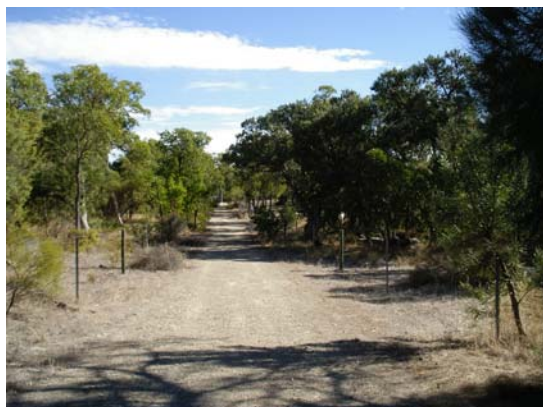
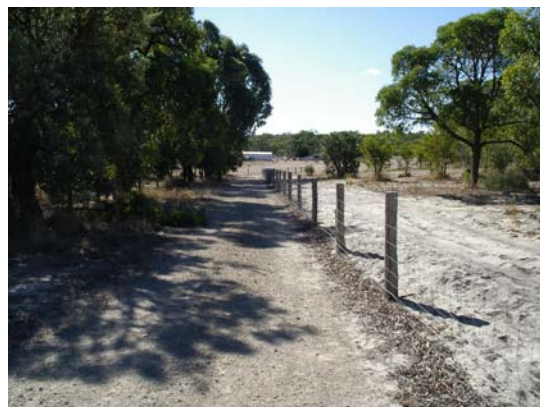
PAW reserve approx. 6m wide and 315m long. Dog-leg alignment. Undulating. Padlocked gate halfway.

Fair.

This PAW functions as a fire access track. The padlock on the gate across the track halfway along its length is apparently accessible to City of Rockingham fire authorities.

Although not operating as a “pedestrian accessway”, this PAW is essential for firefighting vehicle access and must be retained.

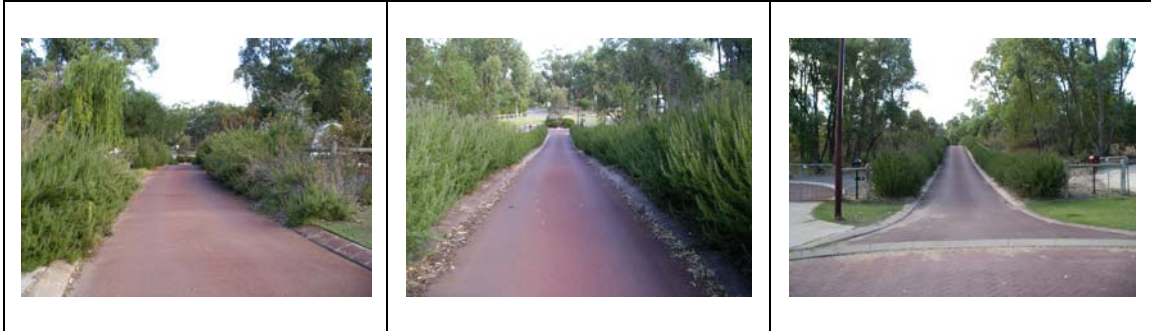
PAW Code No. B580

PAW reserve approx. 6m wide and 78m long. Straight, undulating.

Very good.

Red/brown asphalt with mountable kerbs both sides. Approx. 3m wide.

It is in very good condition and well-maintained.

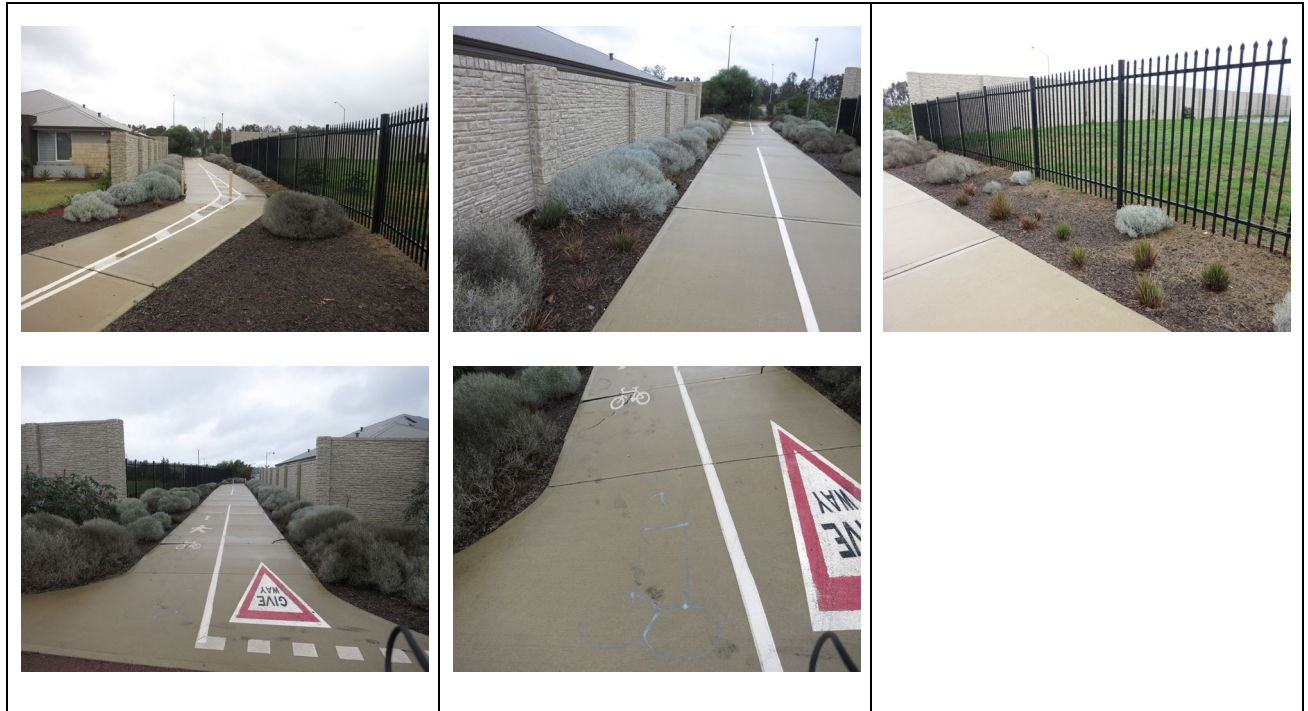
PAW Code No. B583-E

PAW is 50m long and 4m wide. Straight and flat. Bollard located at the western entrance.

Good. No sand and graffiti. Small amount of rubbish located along the path. Only one graffiti tag located on the path near freeway.

Concrete path. Good condition however cracked in places towards the freeway.

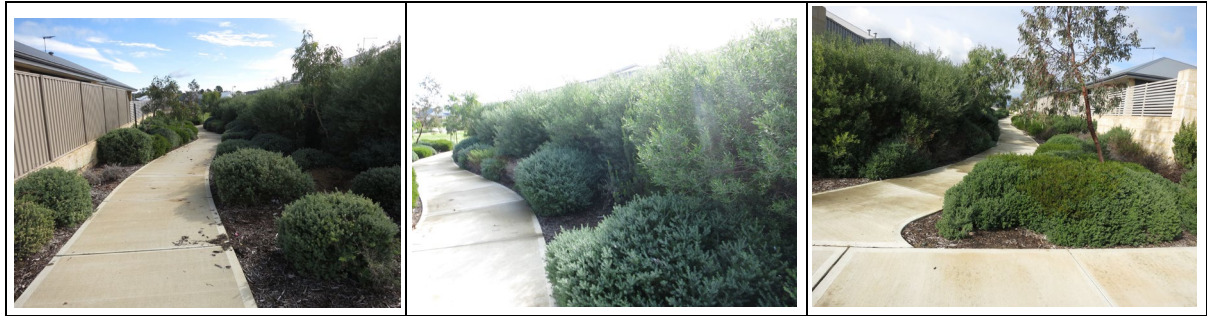
PAW Code No. B584-R

Approximately 33m long and 10m wide. Slopes slightly downward from east to west. Pathway is slightly bent. No Bollards.

Good. PAW is new and very well landscaped. There is no rubbish, glass or leaves. Some sand and mulch is located next to path.

Concrete paving. Good condition, limited cracks, weeds etc.

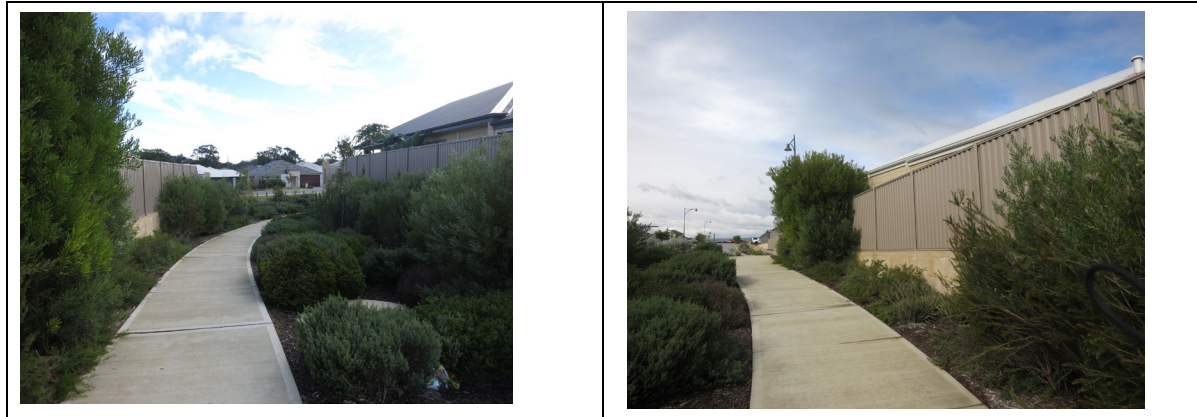
PAW Code No. B585-R

Approximately 33m long and 10m wide. Slopes slightly downward from east to west. Pathway is slightly curved. No Bollards.

Very good. PAW is new and well landscaped. There is no rubbish, sand, leaves and glass.

Concrete paving. Good condition. No cracks and weed.

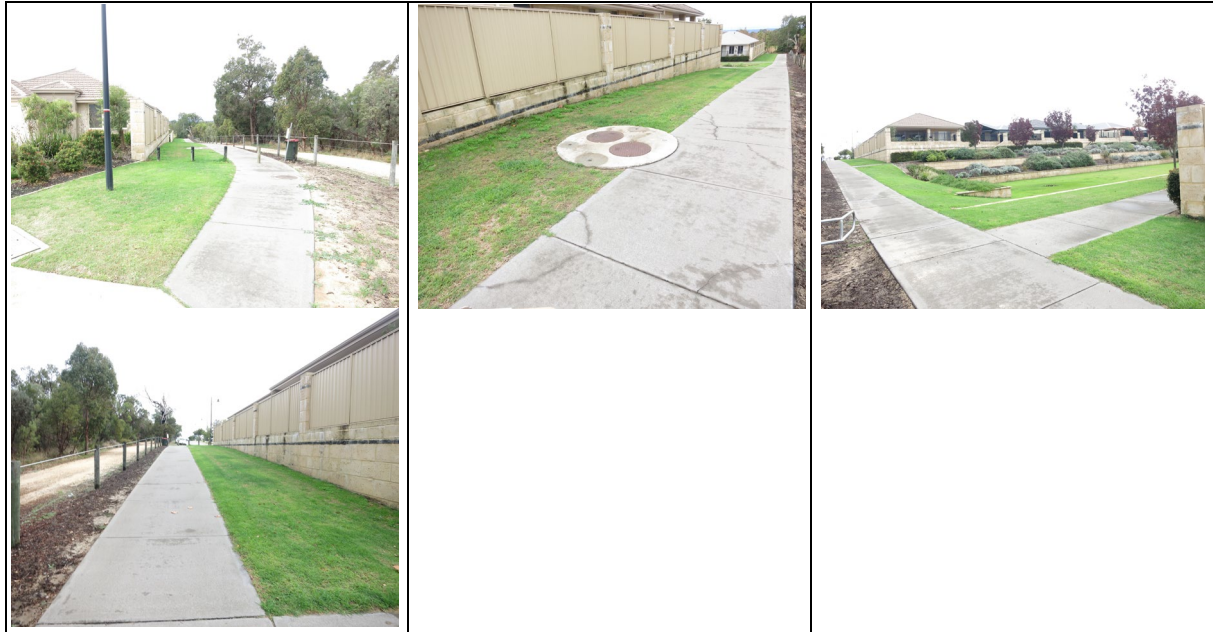
PAW Code No. B586 – R

PAW is approximately 34m long and 6m wide. Straight. Slopes slightly towards the neighbourhood park to the east. Bollards located at the western entrance off Valour Bend.

Very good. No rubbish, leaves, glass, graffiti.

Path is made from concrete. Minor crack on Valour Bend section.

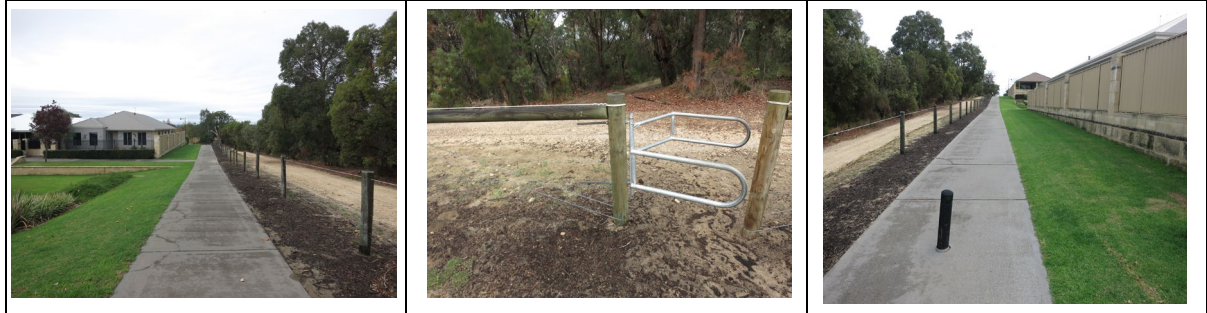
PAW Code No. B587-R

PAW is approximately 34m long and 6m wide. Straight and flat. Bollards located at the eastern entrance off David Fisher Loop.

Very good. No rubbish, leaves, glass, graffiti.

Path is made from concrete.

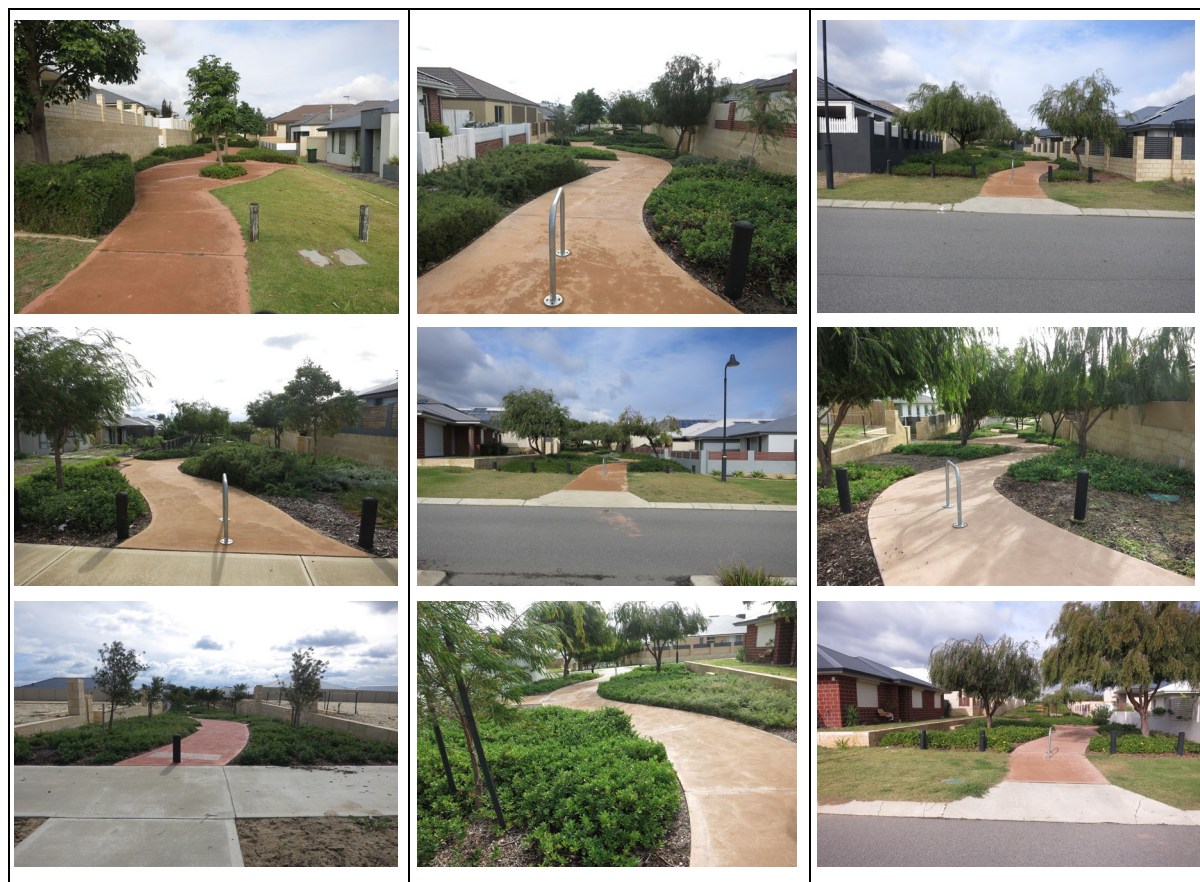
PAW Code No. B588 (A,B,C,D)-R

The four segments vary in length from approximately 64m (shortest) to 70m (longest). Each PAW is approximately 10m wide. Bollards and slow pedestrian arch are provided at each end of the individual segments.

Good. Limited leaves and sand on the path. No graffiti and rubbish.

Concrete pathway. Very good condition.

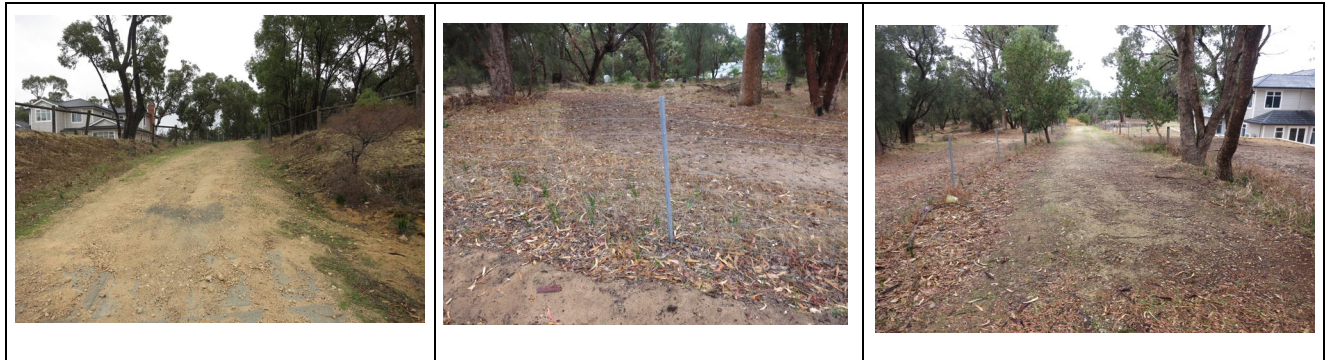
ROW Code No. R14B (Previous PAW code B582)

ROW is 76.50m long and 6m wide. Slopes slightly upwards from south to north. Straight.

Poor. Gravel road. Overgrown vegetation along the side of the road.

Overgrown native vegetation.

Poor. No lighting.

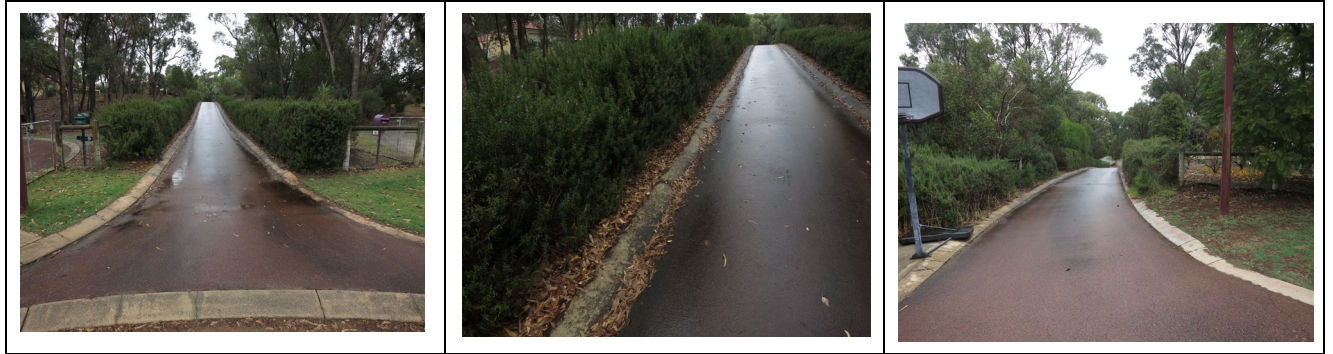
ROW Code No. R15B

Approximately 80m long and 6m wide. Long and straight. Slopes slightly upwards from south to north.

Very good. No graffiti, glass or sand.

Sealed road.

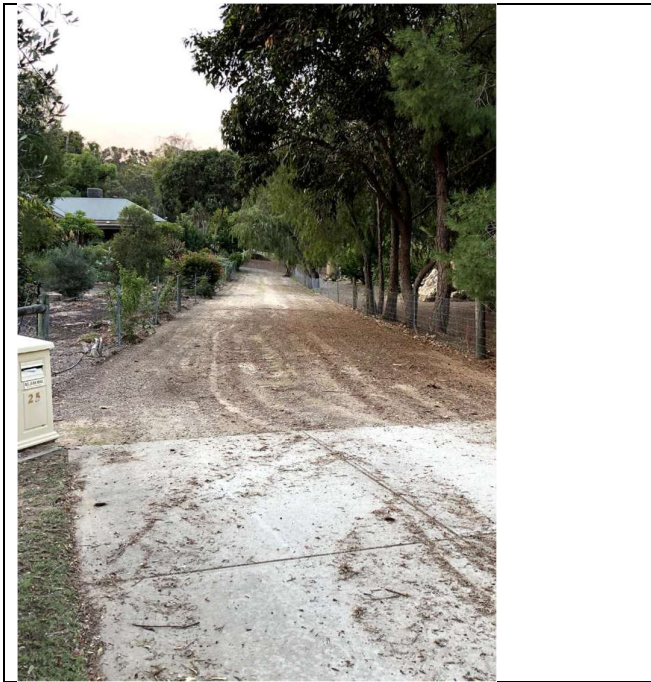
ROW Code No. R21B

ROW is approximately 98.50m long and 6m wide. Slopes slightly upwards from south to north. Straight.

Average. Gravel road with concrete crossover. Vegetation appears well maintained along the side of the road up until the neighbour's garage.

Overgrown native vegetation.

Poor. No lighting.
