SUBURB: Hillman**PAW Code No.****F36H****PAW location:**

SUBURB: Hillman

PAW Code No. H55

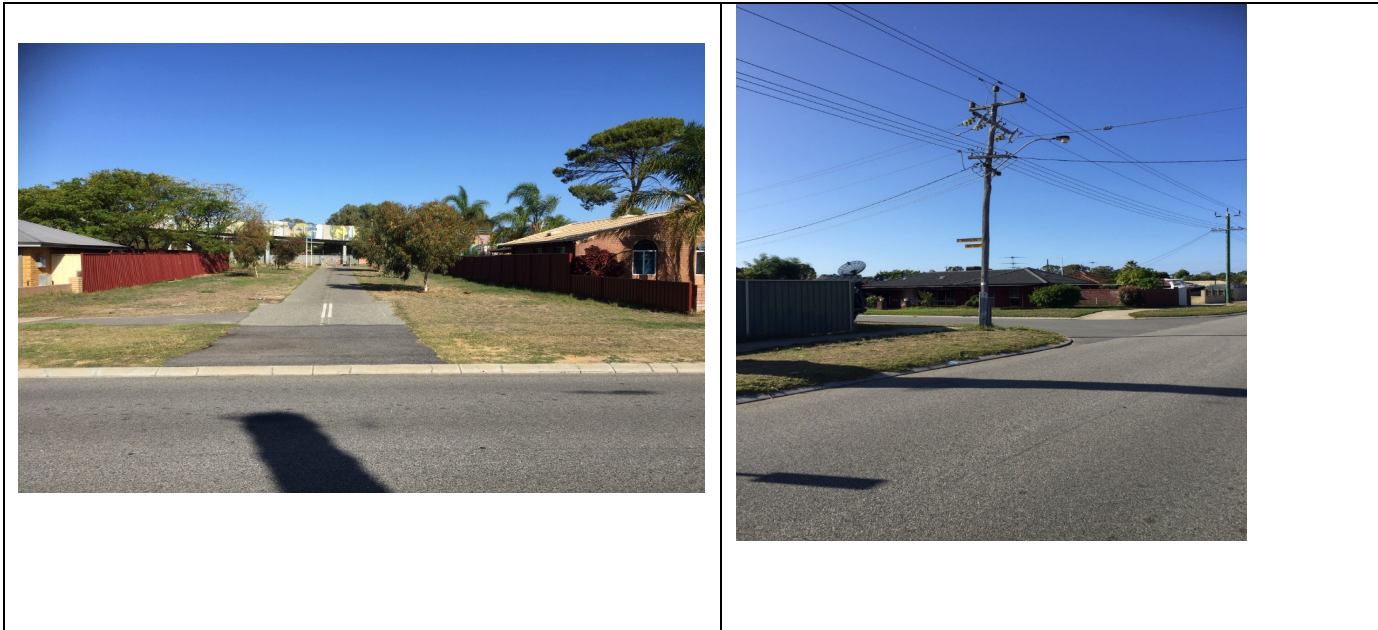
The asphalt pathway reduces in width from approximately 4.0m where it joins with Milina Street to 2.5 for the majority of its length. It is centrally located on the lot and appears to be connected to an informal pathway to the west of the northern section of the pathway.

Appears to be in good condition.

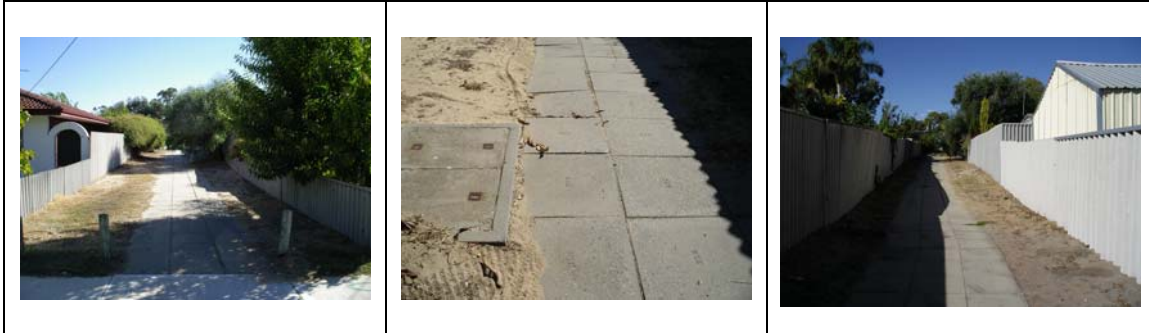
Poor. Weeds, rubbish, cut tree branches and dog faeces.

Poor, due to long length and high side fences.

Concrete slabs, three wide (approx. 1.8m total width). Uneven, gaps, trip hazards.

Some overhanging side fences. Tree growing in PAW overhanging path.

If the PAW is retained, the slab path should be removed and replaced by a wide concrete path, and the overhanging vegetation cut back.

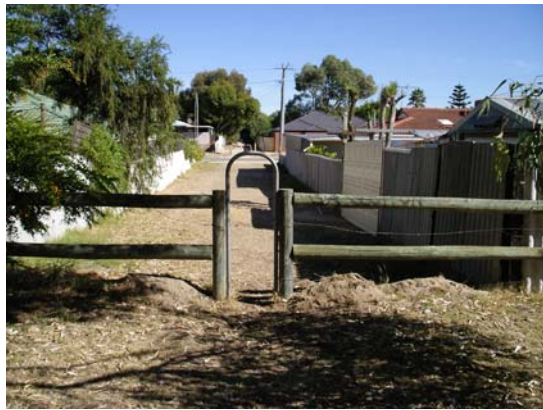
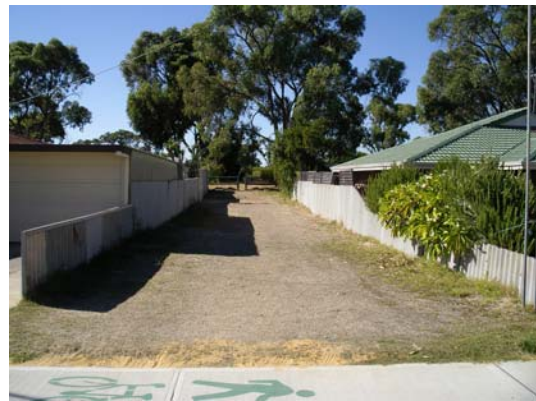
PAW Code No. H56

PAW reserve is approx. 5.5m wide, flaring to approx. 11.5m wide at its western end. Approx. 37m long. The reserve is straight and slightly undulating. There are no bollards at the street end. There is a pine post & rail fence at the eastern end with a curiously-shaped little arched steel frame set into it which allows pedestrians to pass through (see photo on left). There is no constructed path.

Poor. Sand & weeds.

There is no constructed path, just a slightly-worn track in the sand.

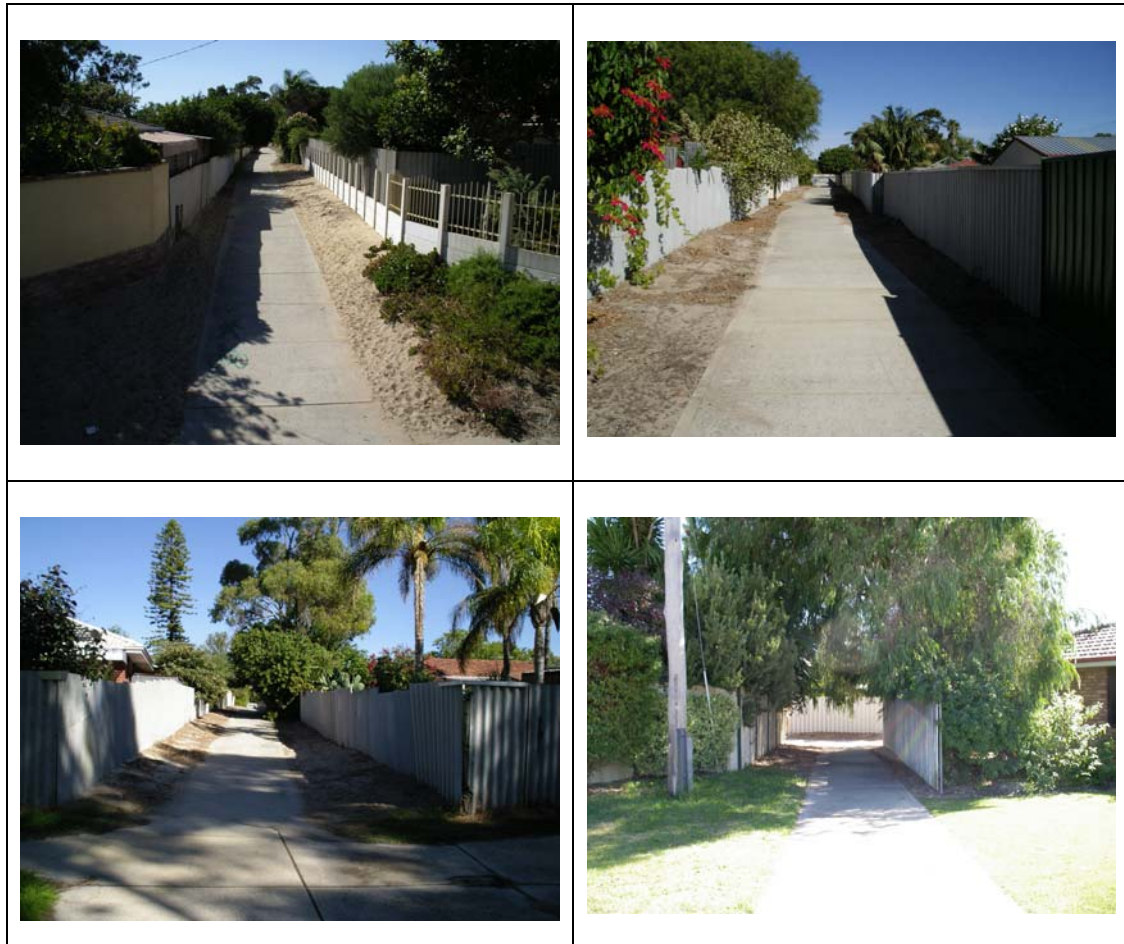
PAW Code No. H57 & H60 Map F3

Poor. Graffiti, rubbish, high sand margins with sand and leaves over path, broken glass, rubble, cut tree branches and dog faeces.

Very poor, due to high side fences, bends, and long length.

High Super six and steel panels varying in condition from poor to fair.

Lots of vegetation overhanging side fences.

The PAW should be cleaned up, and the installation of bollard lighting should perhaps be considered. The overhanging vegetation requires pruning.

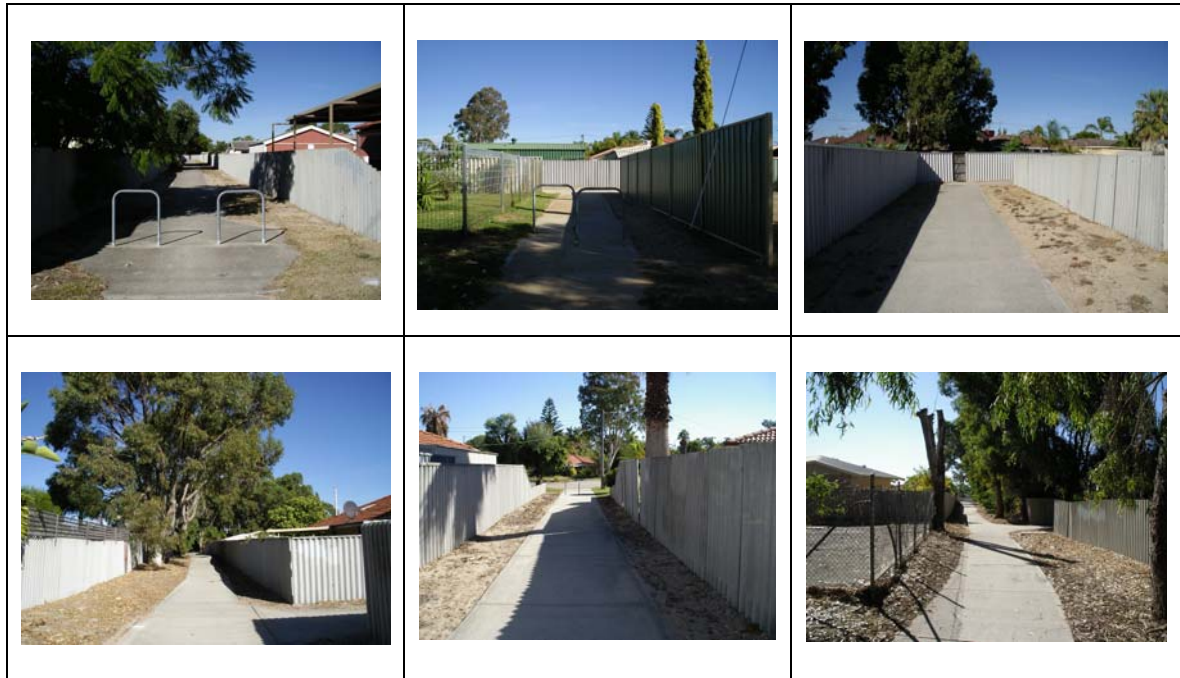
PAW Code No. H58, H61 Map F3

Poor to fair. Graffiti, broken glass, rubbish and some tree branches.

Very poor, due to high side fences, bends, and extreme length.

Concrete path approx. 1.9m wide. Cracked and uneven in places, lifted by tree roots.

The Paw should be cleaned up, the lifted and cracked path repaired, and the installation of bollard lighting should perhaps be considered.

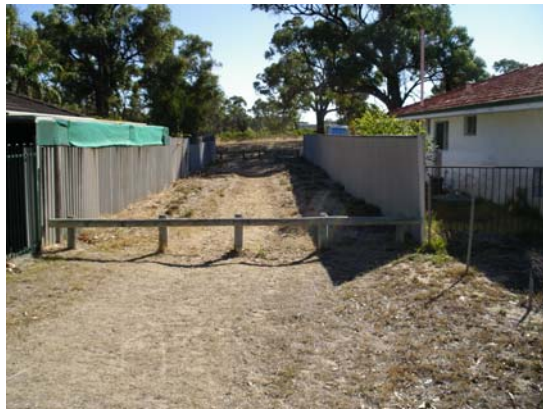
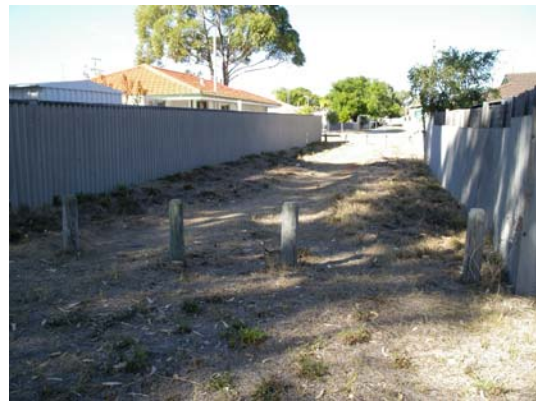
PAW Code No. H59

Poor. Sand, weeds, rubbish, graffiti.

There is no constructed path, just a worn track in the sand.

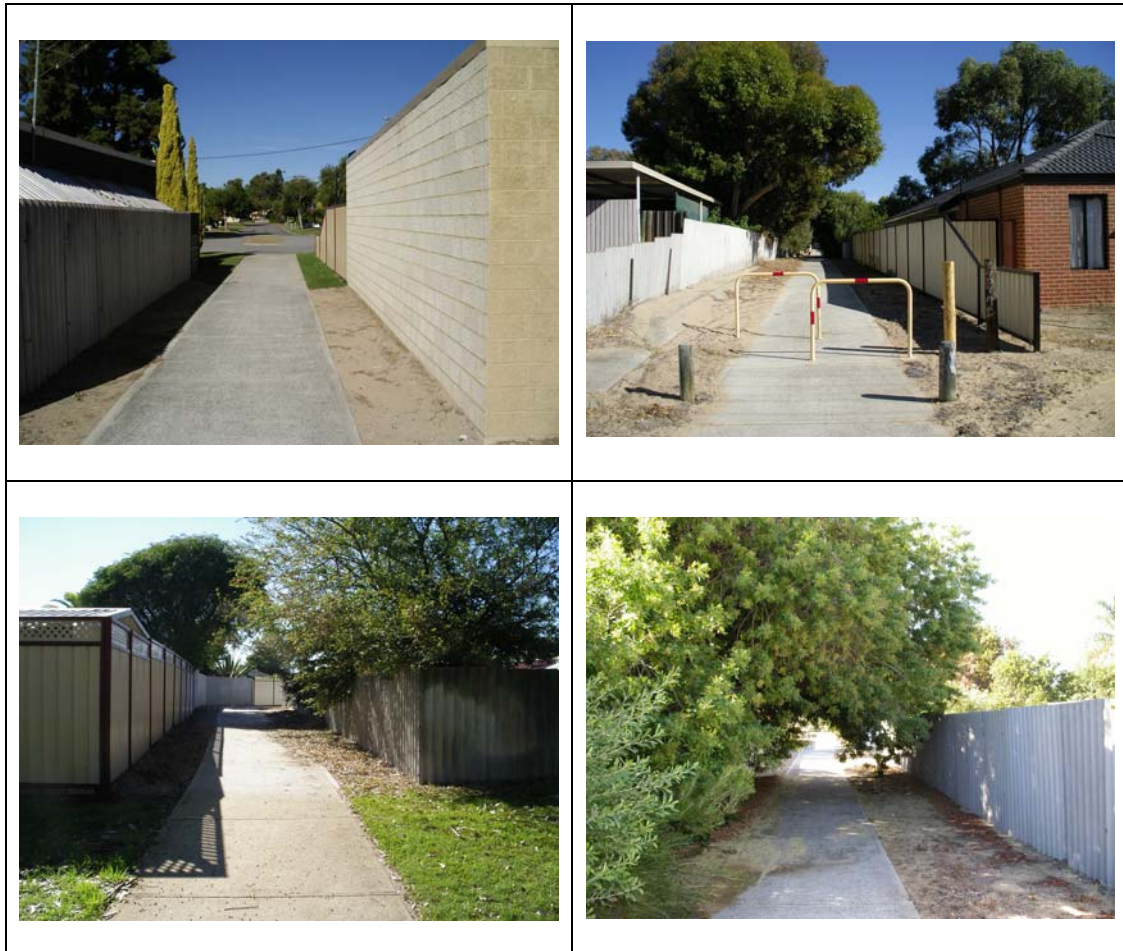
PAW Code No. H62 **Map** F3

Poor. Graffiti, rubbish, high sand margins with sand and leaves over path.

Very poor, due to high side fences, bends, and long length.

Large trees overhanging side fences.

The Paw should be cleaned up, and the installation of bollard lighting should perhaps be considered. The overhanging vegetation requires severe pruning.

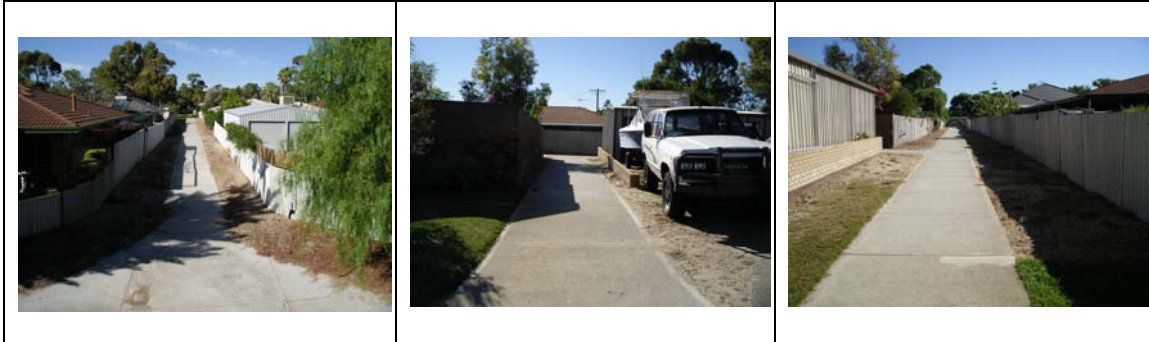
PAW Code No. H63, H65 & H66

Fair. Small amount of graffiti and weeds.

Poor, due to long length and blind corner.

Some overhanging side fences, especially at north end.

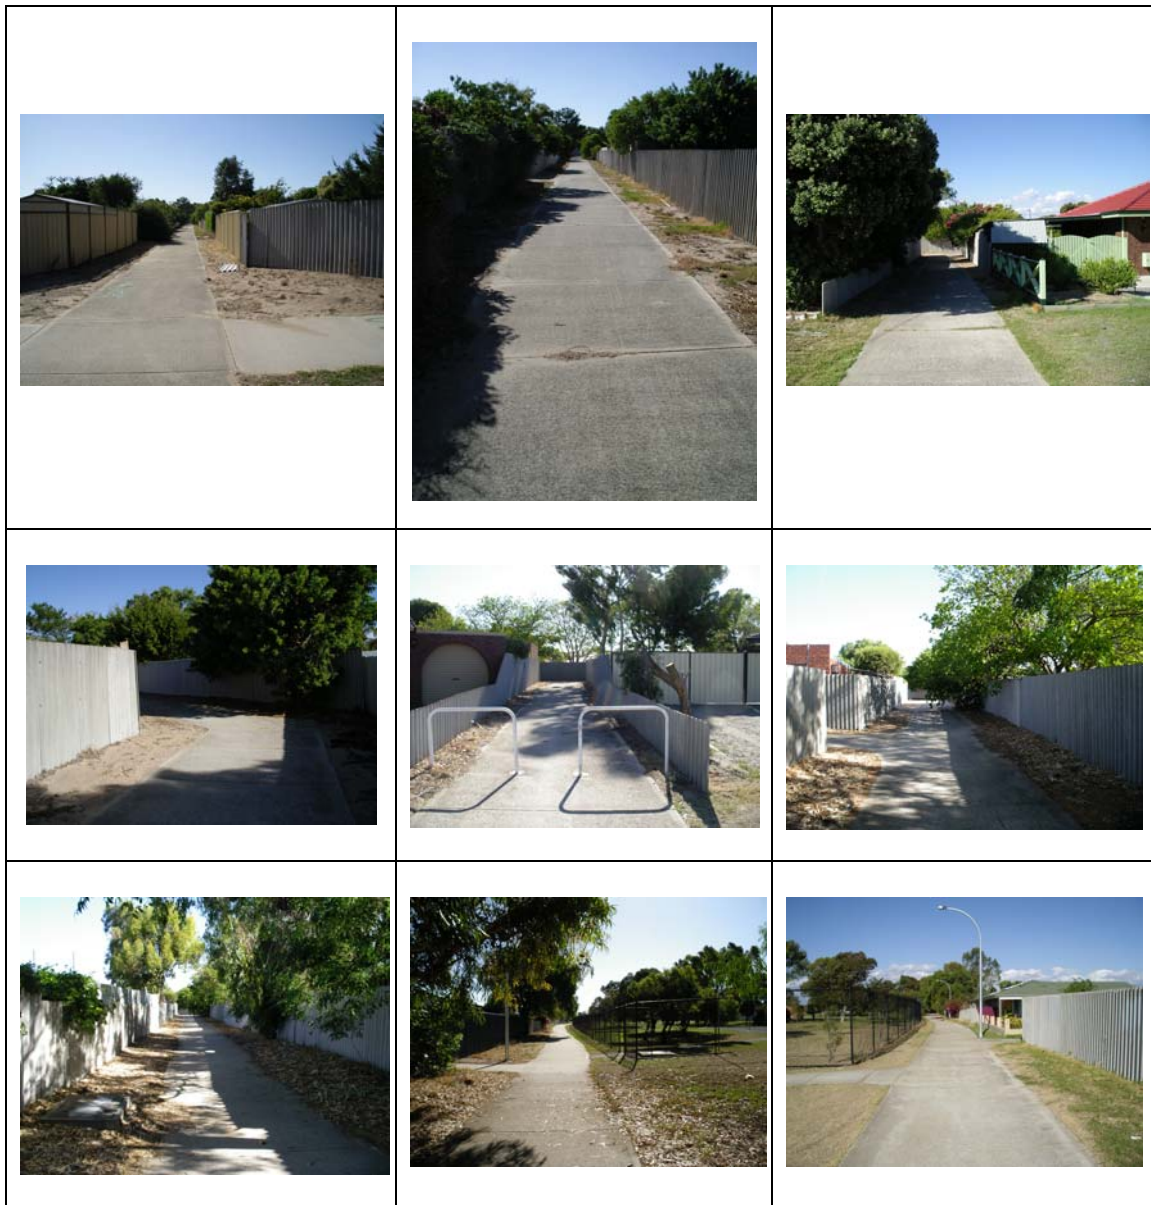
Concrete varying in width from approx. 2.0m to 2.5m. Cracked and broken in parts.

The section of PAW H69 located south of PAW H67 is unnecessary, as Doradeen Close is an adjacent, parallel route alternative. This section of H69 is also unsafe and intimidating to use. If possible it should be closed.

If retained, the overhanging vegetation should be cut back and the paving repaired.

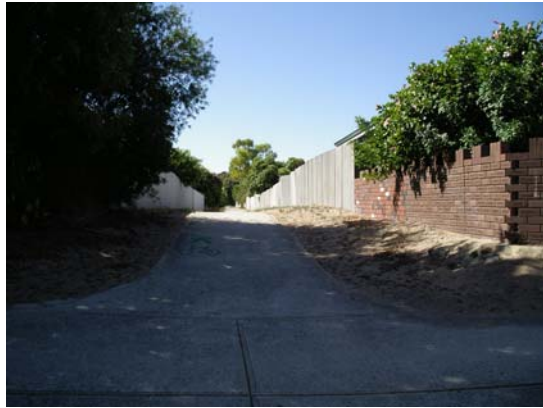
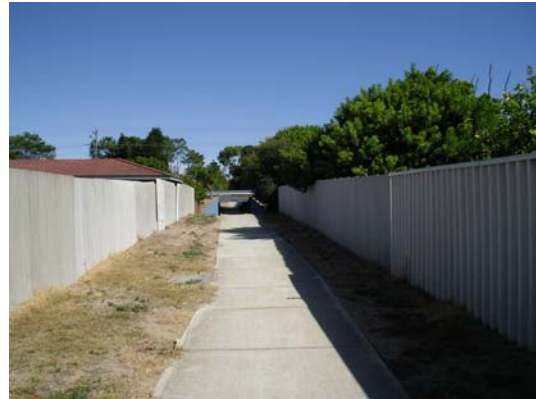
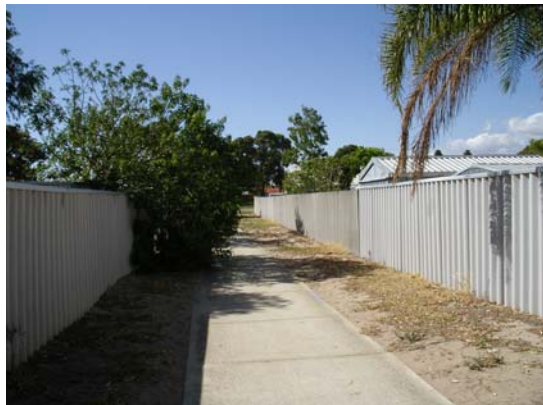
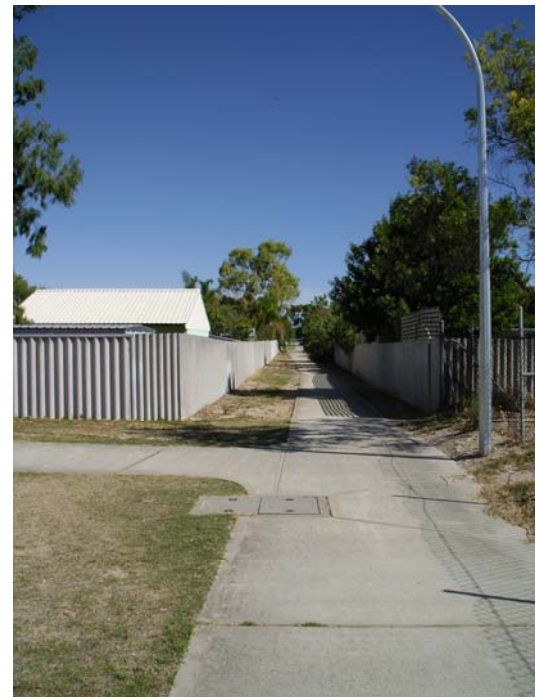
High Super six varying in condition from poor to good. Some panels damaged.

It is recommended that this PAW be closed if possible.

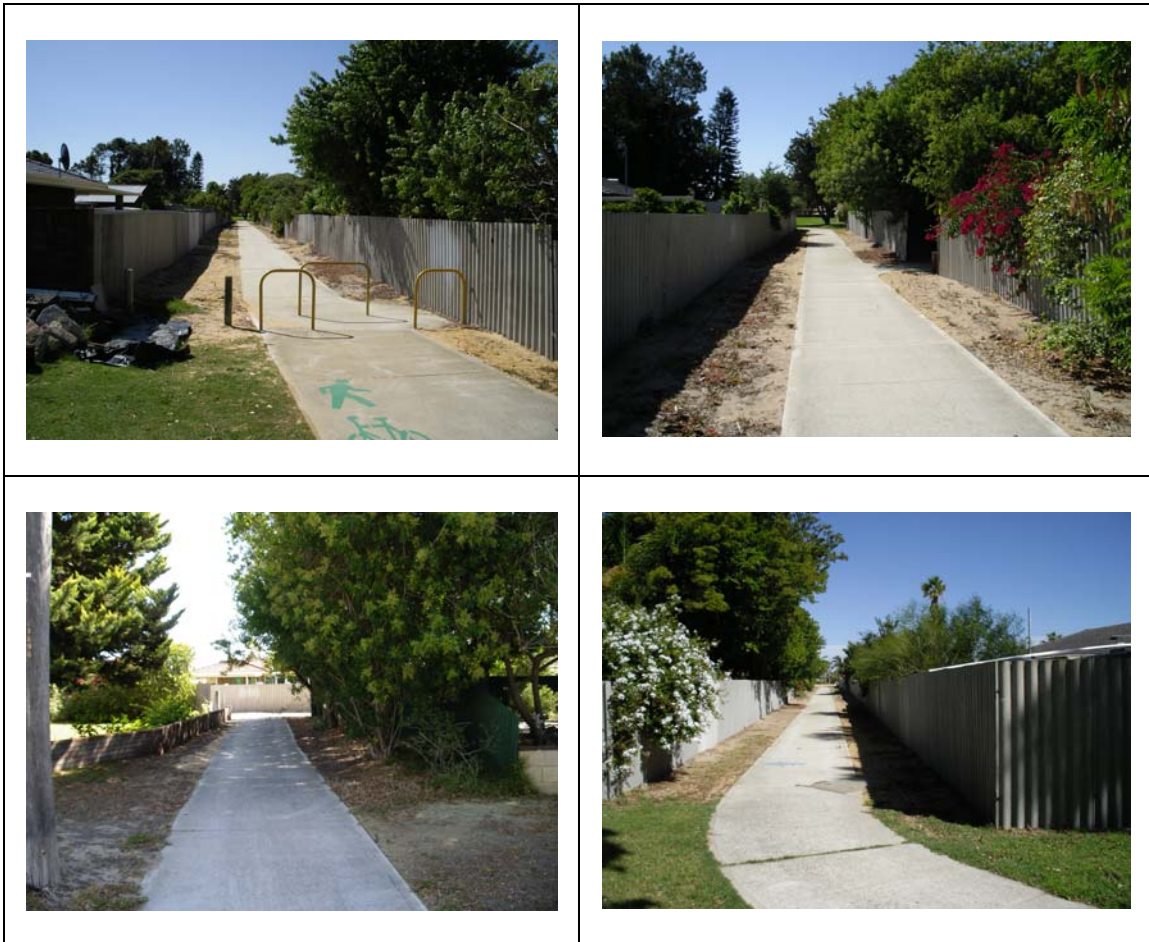
Lots overhanging side fences, but due to wide nature of the PAW, this doesn't cause a problem. There are approx. a dozen pepper trees planted in the PAW leg off Mannaw Place. These need pruning.

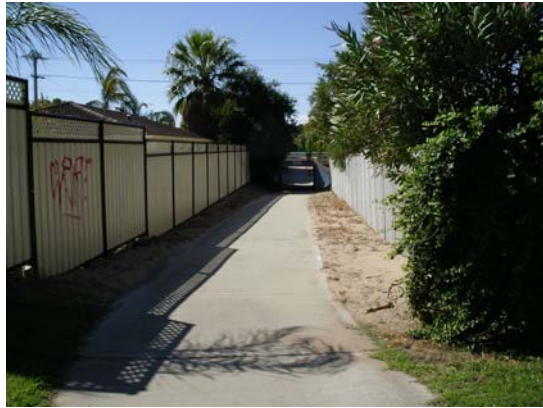
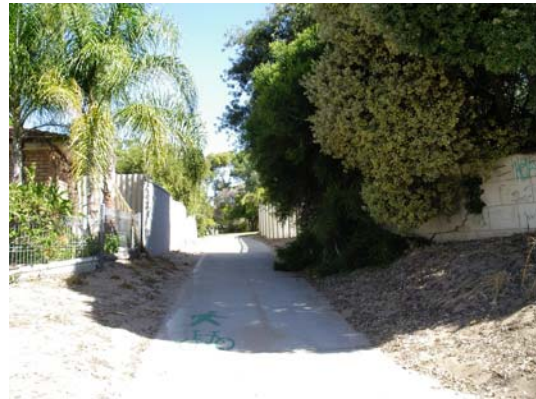
High Super six and steel panels in fair to good condition, also badly damaged masonry wall and open wire mesh fence.

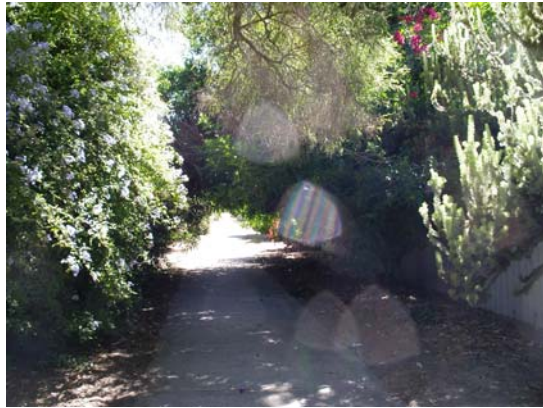
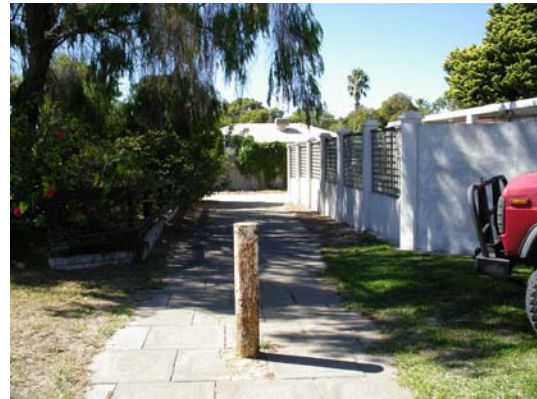
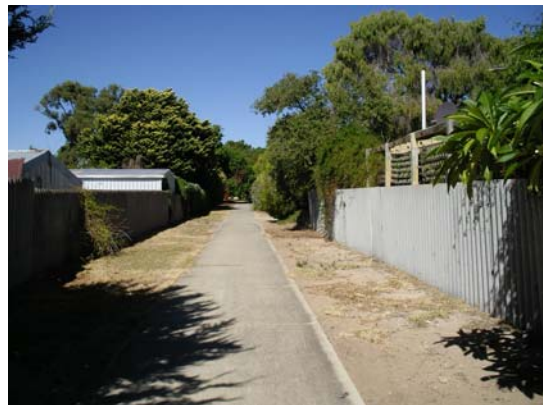
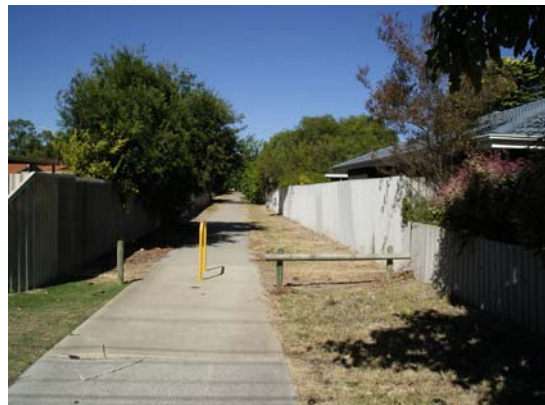
Concrete, about 1.8m wide, broken and lifted in parts. The short section connecting to Malbeling Close is paved with concrete slabs, 3½ wide.

This PAW is part of a designated cycle path, however it appears to be largely superfluous. It lies close to, and parallel to, Moorine Court, a public street, which similarly connects the park to Calume Street. This PAW is unnecessary, very long and potentially unsafe for users. It could be closed.

The overhanging vegetation in the PAW needs to be pruned back. The concrete slab path within the section of PAW connecting to the cul-de-sac head should be replaced with a wide concrete path. There are sections of the concrete path which are badly cracked and lifted and should be repaired.

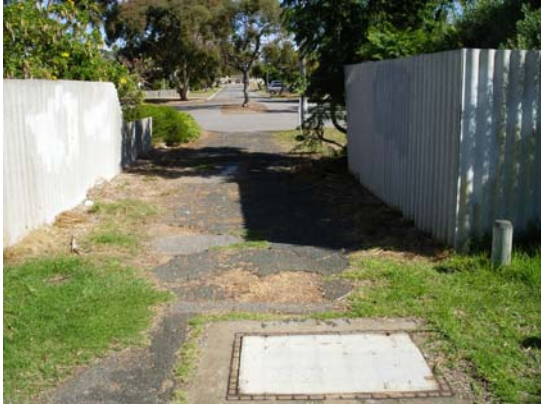
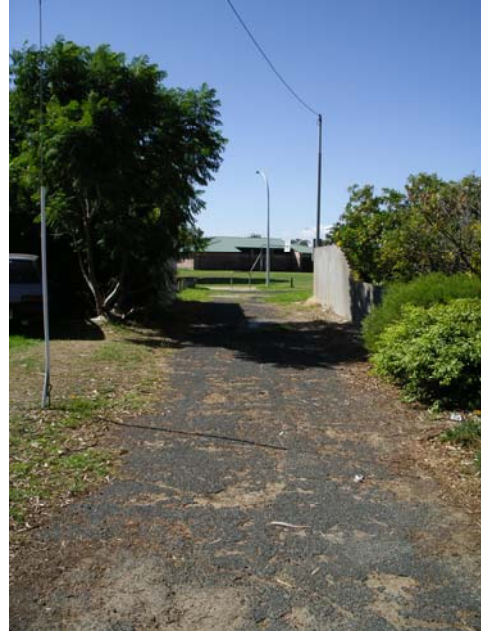
Old broken asphalt.

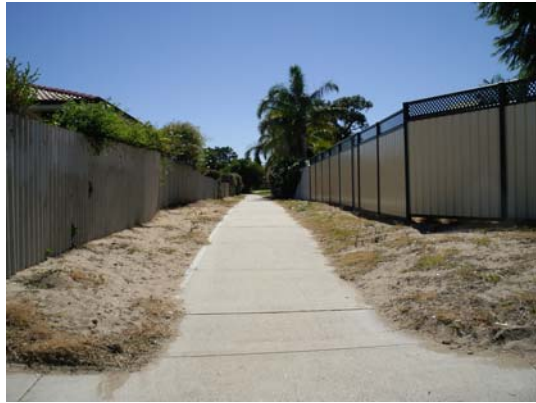
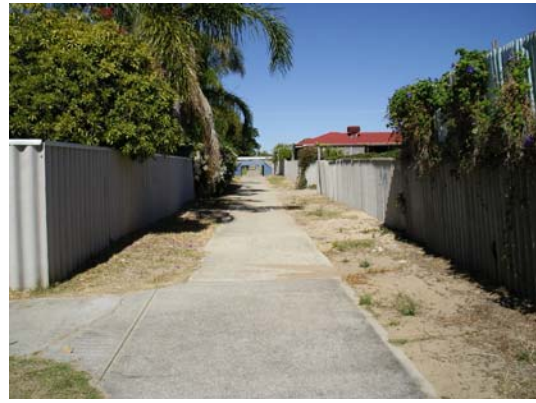
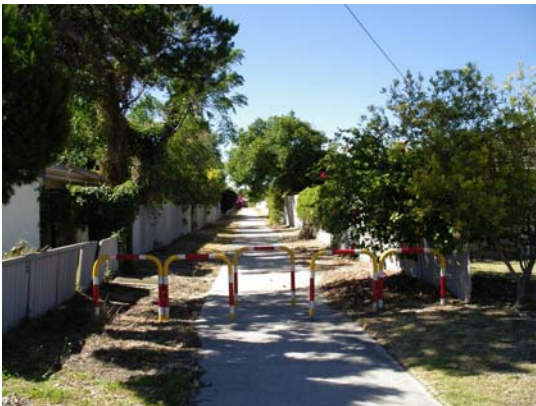
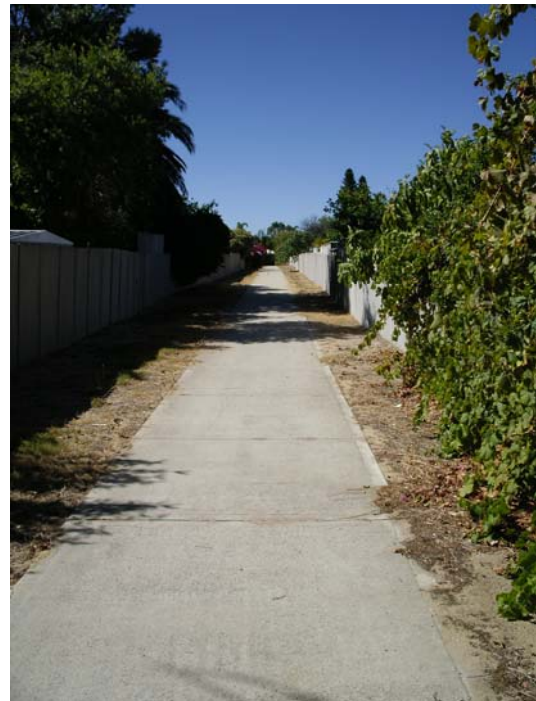
Poor to fair. Graffiti, weeds, broken glass.

Mostly high super six in poor to fair condition. One section of new steel panels in very good condition.

The major length of this PAW – the base of the "T" – is superfluous for pedestrian/cycle access. It lies near, and parallel to, Unnaro Street and Mimbalup Close which both provide superior alternative public street access. This section of the PAW is unnecessary, very long and potentially unsafe for users. It could be closed.

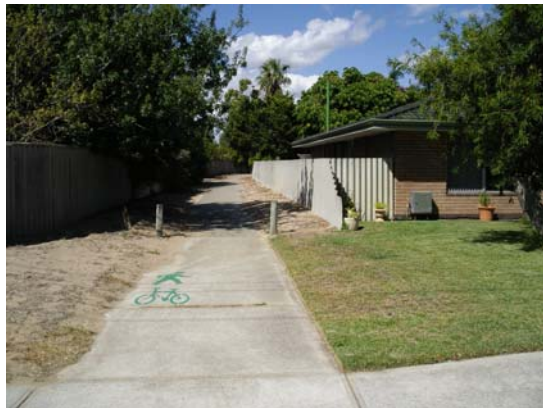
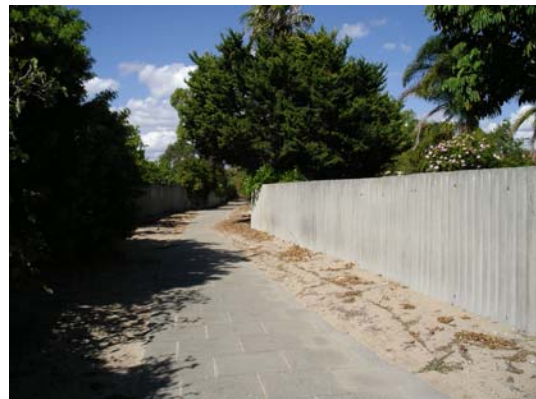
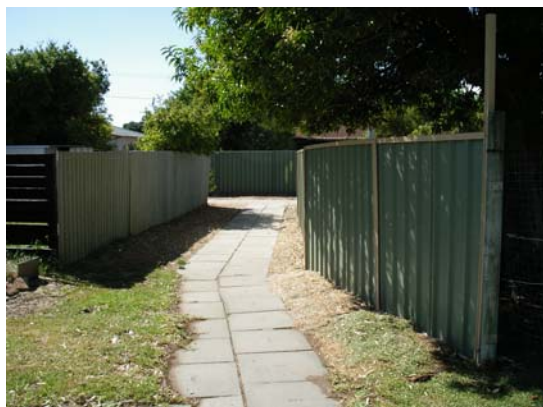
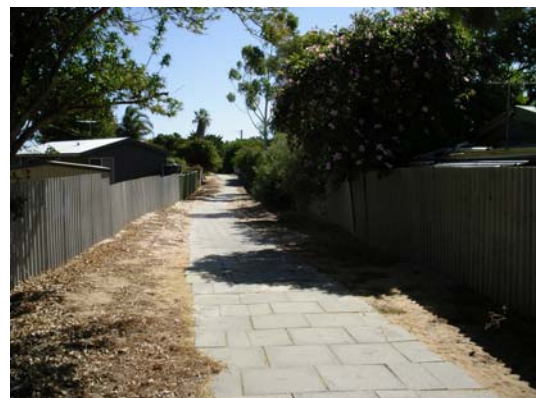
Poor. Path very uneven, sand, weeds, rubbish, graffiti, broken glass, overhanging vegetation.

High Super six and steel panels in fair condition.

This PAW is in poor condition, and, given the subdivision layout in the locality, is not essential to the local pedestrian/cycle network. It does, however, provide some convenience of access for Cubbine Close residents wishing to access Gabyon Park, as well as PAW H71 which connects Gabyon Park to Carvie Street and destinations north.
