**SUBURB:** Rockingham

**PAW Code No.** R1R (Previous PAW R262)

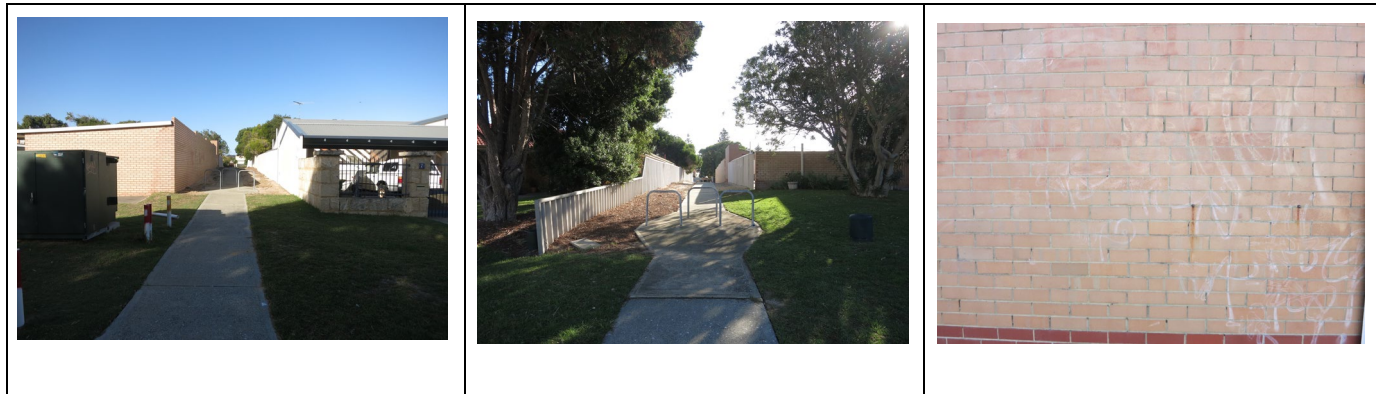
Approximately 64m long and 5m wide. Straight and flat. Bollards located on either side.

Fair. Concrete paving one slab wide. No cracks. Path is slightly uneven in places.

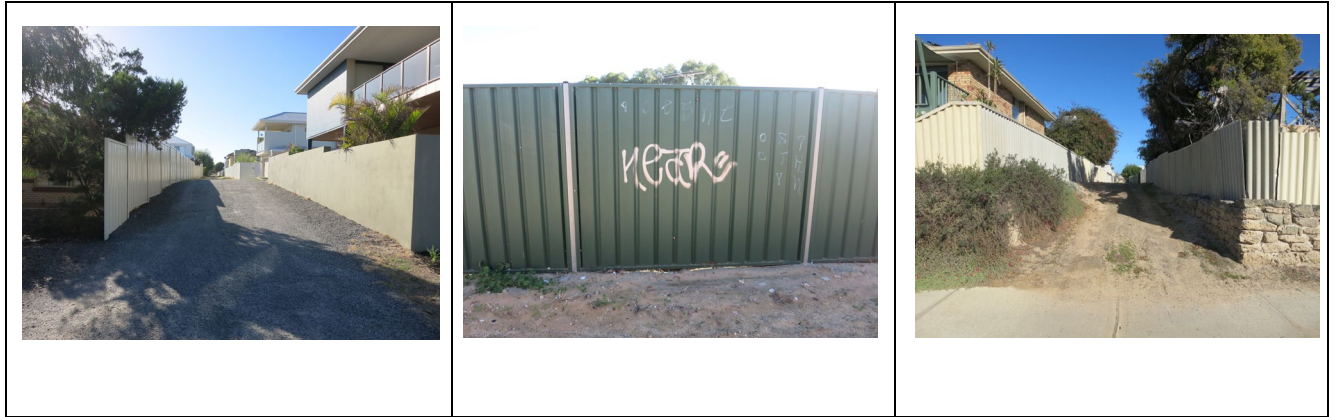
Approximately 184m long and 5m wide. No bollards. Straight and relatively flat, however dips and pot holes present.

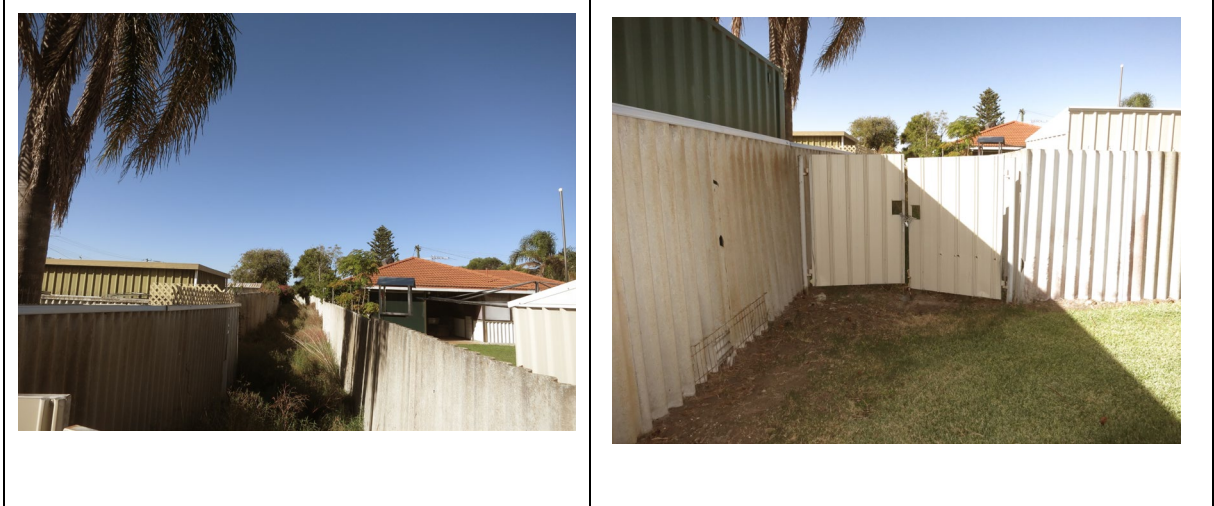
45m long by 3m wide. Straight with a slight bend. Long and flat. Uneven surface. ROW is fenced off from the park.

Very poor condition. Overgrown vegetation, no vehicular or pedestrian access.

- Ownership: Australian Telecommunications Commission (Telstra)
- ROW does not lead anywhere.
- No pedestrian or vehicular access.
- Very poor condition.

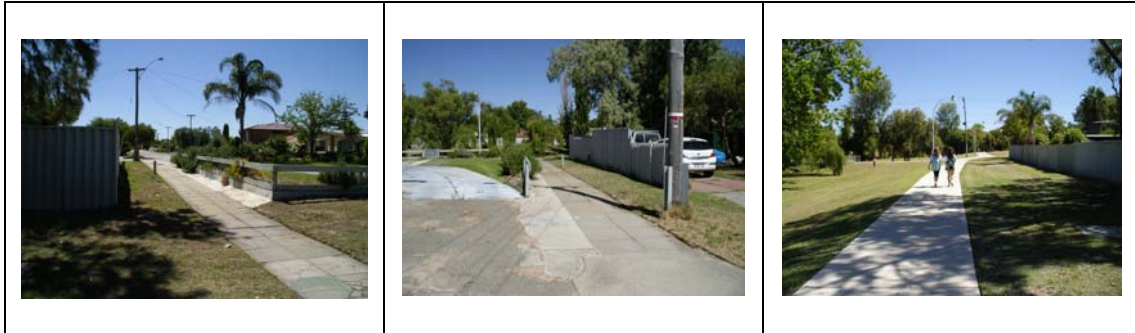
Concrete slabs two wide. (approx. 1.2m) and offset from centre. Many slabs cracked. Grassed margins.

The path in the PAW needs repairing/replacing.

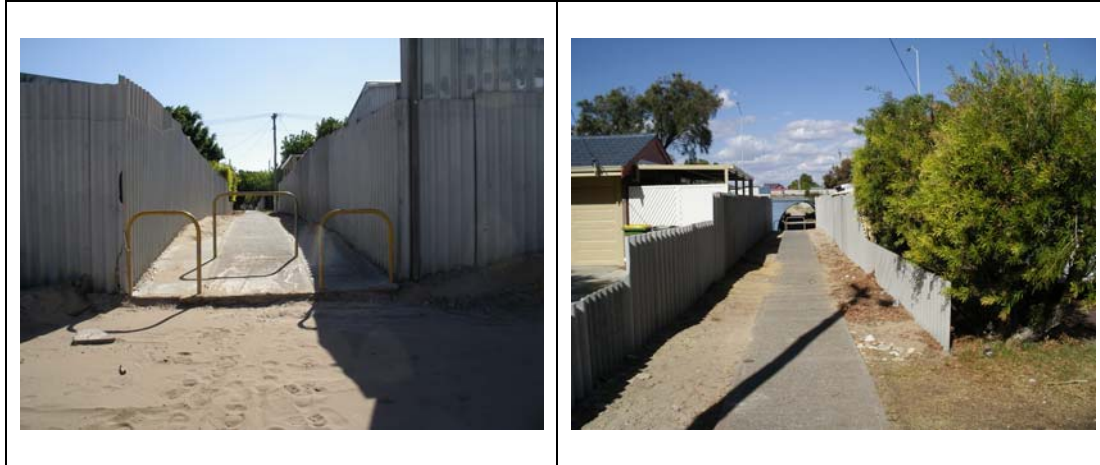
Poor. Some graffiti, rubbish, broken glass, rocks and small tree branches.

The path should be replaced and widened.

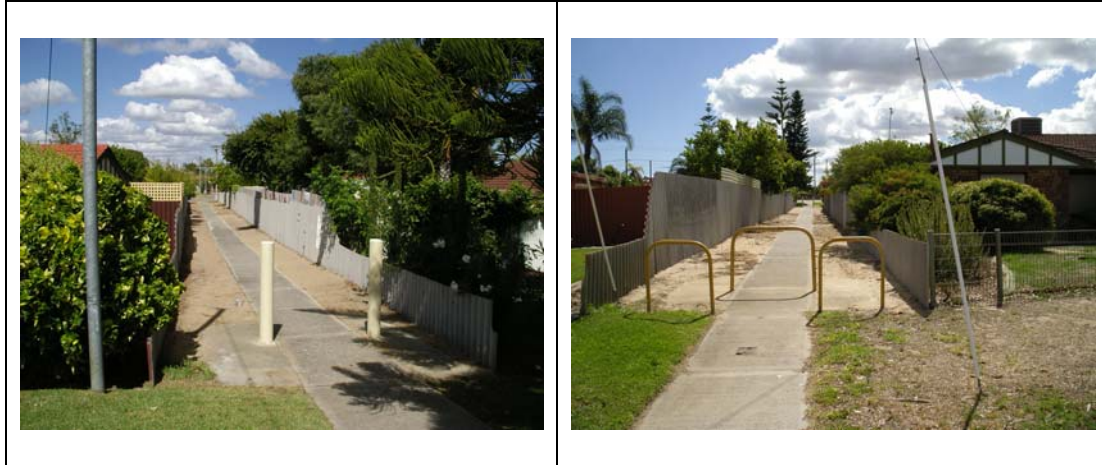
High super six in fair condition. Some panels damaged.

This PAW provides convenient access for Sycamore Place residents to Simpson Avenue, which is a bus route, as well as to the educational precinct on the north side of Simpson Ave. It also forms part of an access chain which includes two other PAWs to the south (PAWs R209 & R218). Retention is recommended. The path should be replaced and widened.

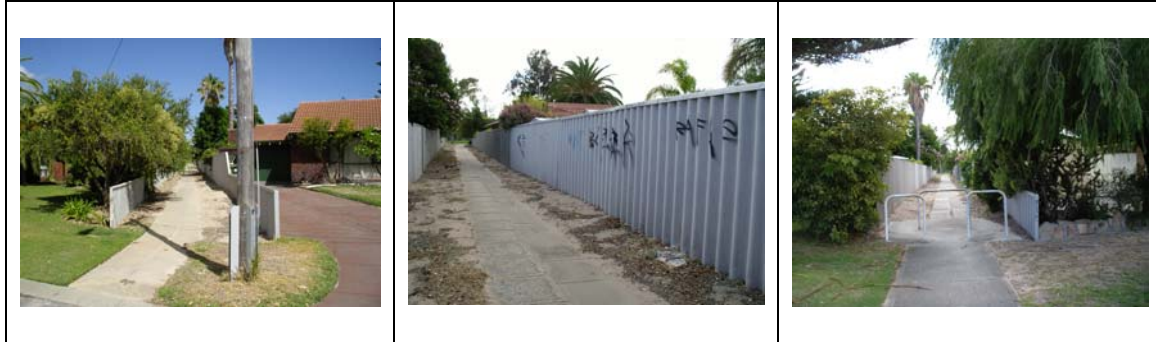
High super six in fair condition.

Concrete slabs 2 x wide, approx. 1.2m. Narrow, uneven and cracked.

This PAW forms part of an access chain which includes two other PAWs (PAWs R208 & R218). Together they provide convenient access to the educational precinct on the north side of Simpson Ave and bus routes. Retention is recommended. The path should be replaced and widened, and the PAW generally cleaned up. The overhanging vegetation needs pruning.

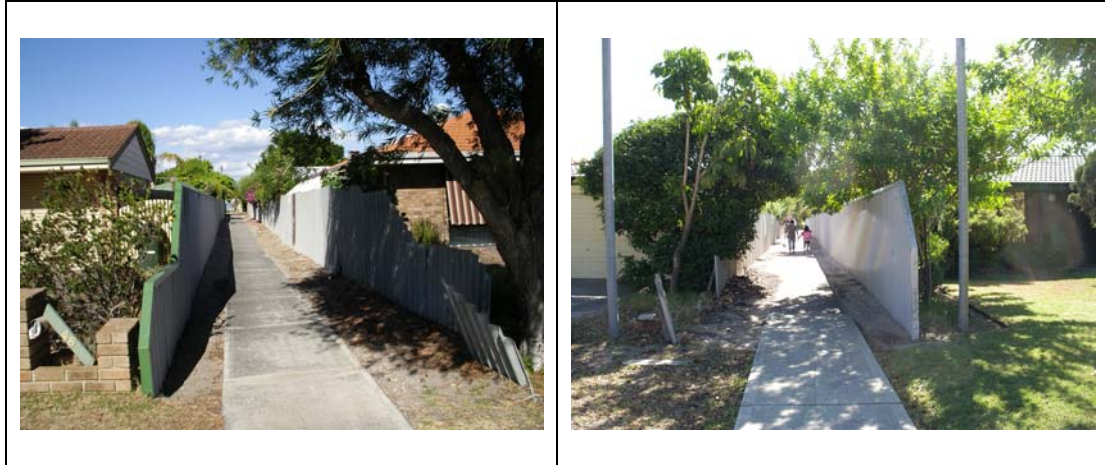
Fair. Some graffiti, rubbish, broken glass, leaves.

High super six in fair to good condition.

The path should be replaced and widened. Overhanging vegetation needs to be cut back.

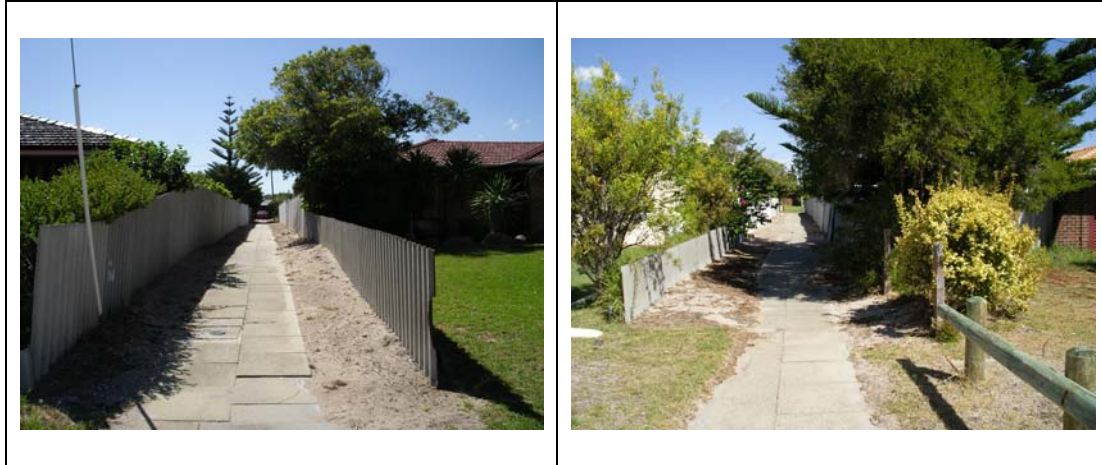
Poor to fair. High sand margins, rubbish, rocks, broken glass, leaves, small amount of graffiti.

Low to high super six – varies from poor to very good condition.

Concrete slabs x 2 wide. Approx. 1.2m. Narrow, uneven, some broken.

If the PAW is to be retained, the path should be replaced and widened.

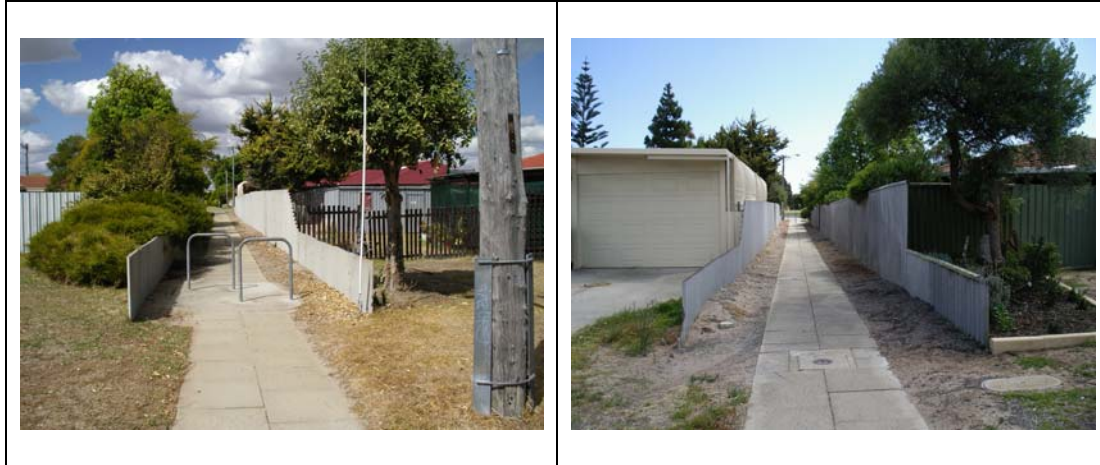
Poor to fair. Rubbish, leaves, broken glass, dog faeces.

High super six in fair to good condition (varies).

Concrete slabs 2 x wide, approx. 1.2m. Narrow, uneven and cracked.

The path should be replaced and widened.

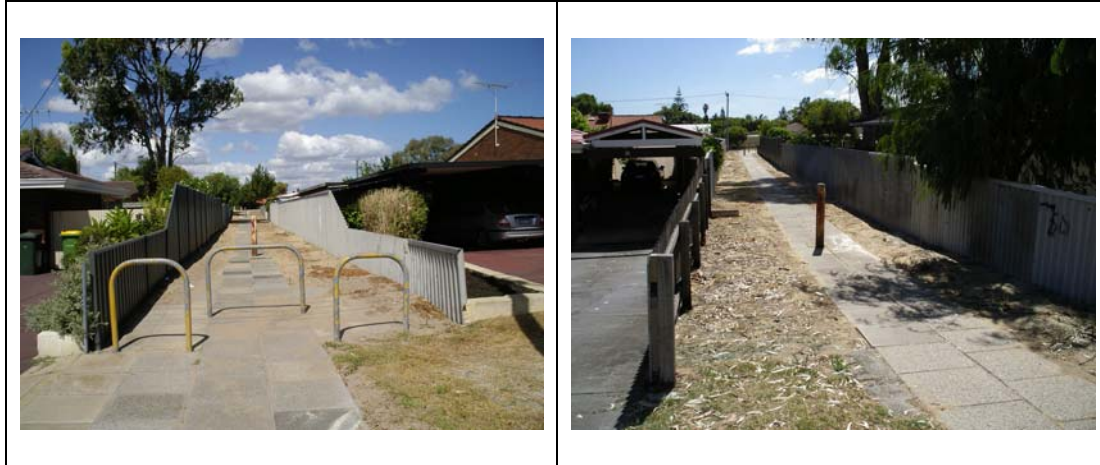
Poor. Some graffiti, as well as rubbish, sticks, leaves and sand over path. Path in poor condition.

High super six and steel panels in fair condition, as well as one section of moderate height timber pickets.

Concrete slabs 2 x wide, approx. 1.2m. Narrow, uneven and cracked.

The path should be replaced and widened.

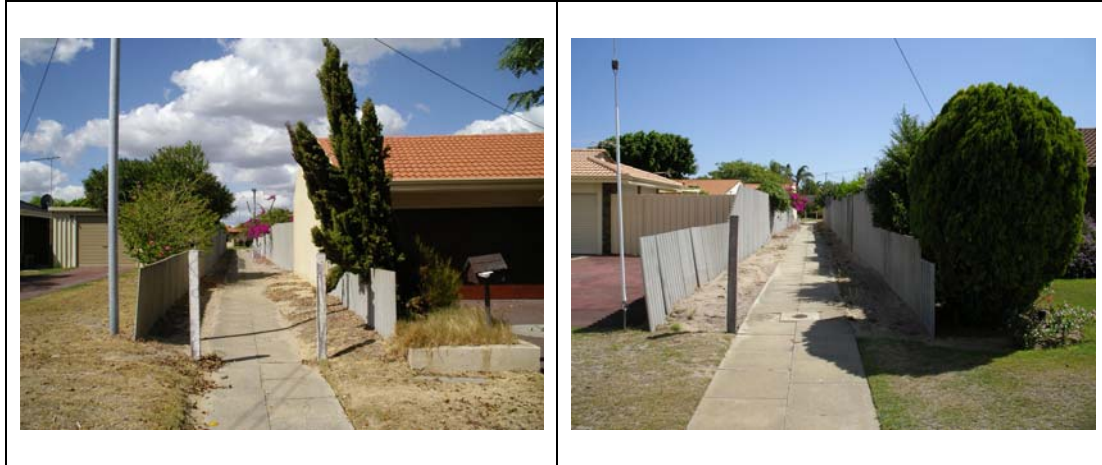
High super six in fair condition. Some sections with trellis on top. One masonry wall.

Concrete slabs 2 x wide, approx. 1.2m. Narrow, uneven and cracked.

The path should be replaced and widened, and the PAW generally cleaned up. The overhanging vegetation (bougainvillea) needs pruning.

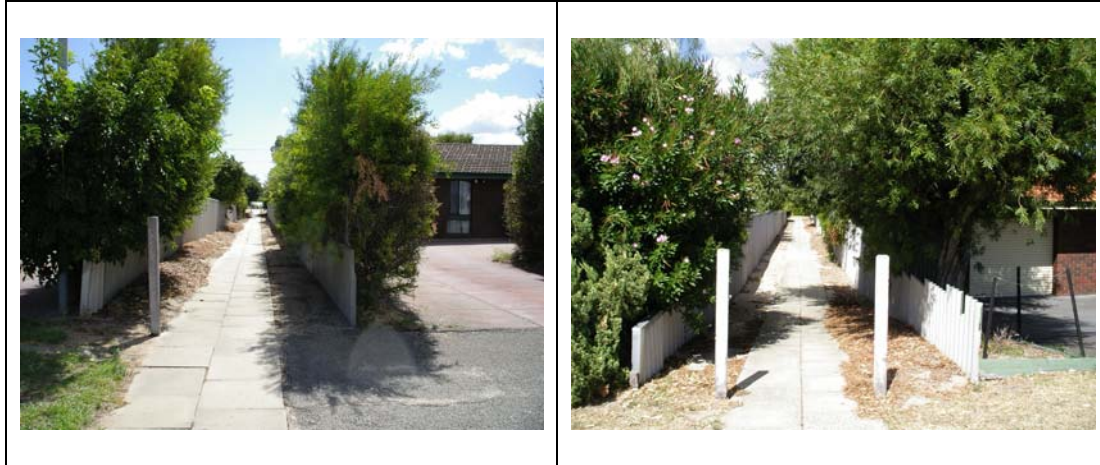
High super six in fair condition.

Concrete slabs 2 x wide, approx. 1.2m. Narrow, uneven and cracked.

This PAW forms part of an access chain which includes two other PAWs (PAWs R208 & R218). Together they provide convenient access to the educational precinct on the north side of Simpson Ave and bus routes. Retention is recommended. The path should be replaced and widened, and the PAW generally cleaned up. The overhanging vegetation needs pruning.

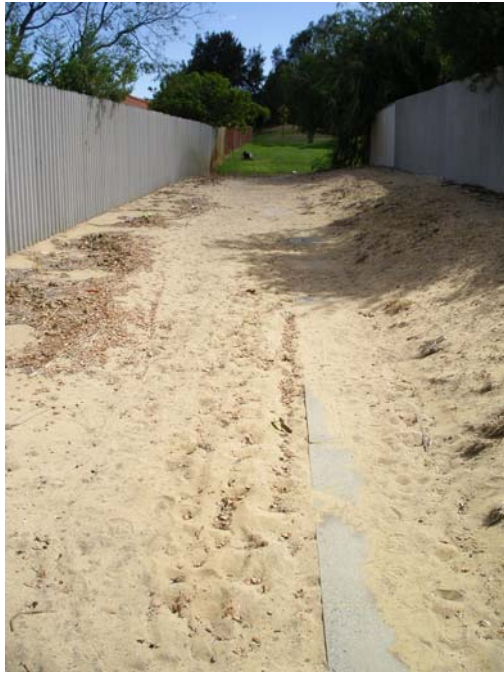
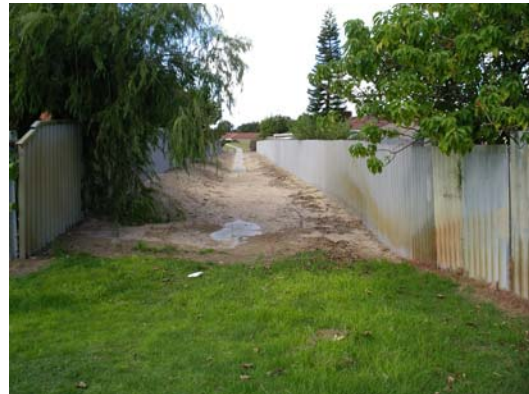
Very poor. Sand across path which is in poor condition. Leaves, rubbish and some graffiti.

High super six in fair to good condition. There are a half dozen gates along the fence on the north side of the PAW.

Concrete slabs 2 x wide. Approx 1.2m. Narrow, many missing, sand covering many slabs.

This PAW provides a pedestrian connection from Simpson Avenue to the Ashford Avenue Reserve. The park is very rough in condition, and has no paths or lights. Because of its configuration, Ashford Avenue provides an adequate alternative access to this PAW. It is in very poor condition, little used and could be closed if requested.

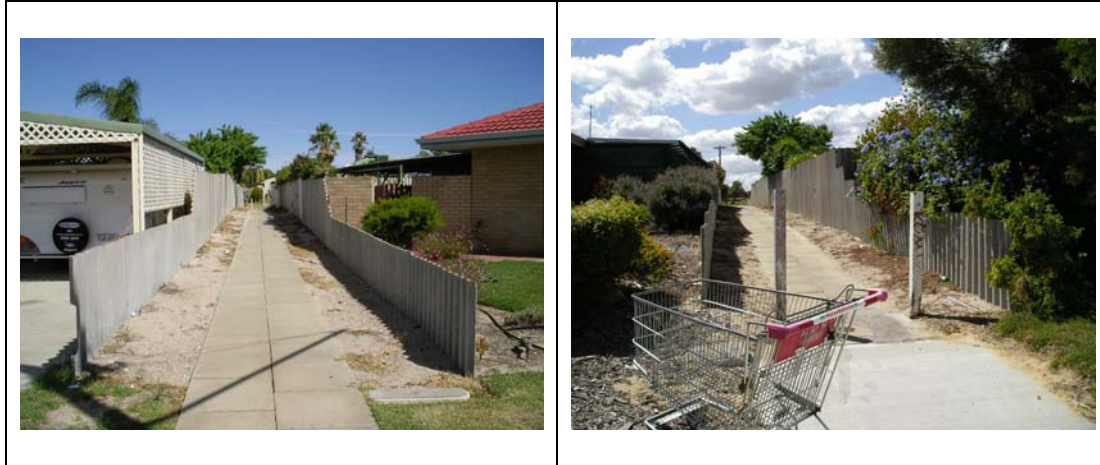
Poor. Some graffiti. Also some rubbish, bottles, broken glass, leaves and an abandoned shopping trolley.

High super six in fair condition. Some panels cracked.

Concrete slabs 2 x wide, approx. 1.2m. Narrow, uneven and cracked.

The path should be replaced and widened, and the PAW generally cleaned up.

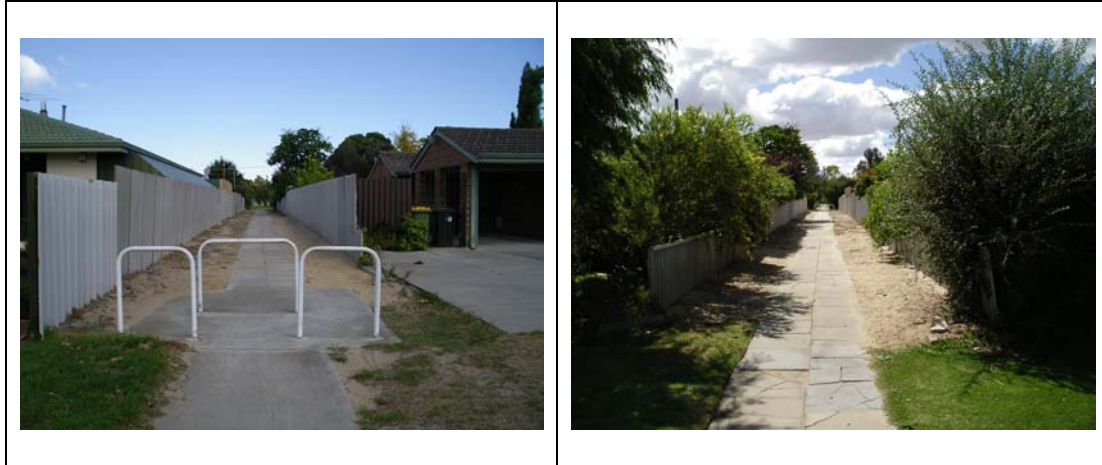
Poor to fair. Graffiti, rubbish, leaves, broken glass, dirty nappy.

High super six in fair condition. Some additional height trellis on one section.

Concrete slabs 2 x wide, approx. 1.2m. Narrow, uneven and cracked. Very bad condition.

This PAW forms part of an access chain which includes two other PAWs (PAWs R208 & R209). Together they provide convenient access to the educational precinct on the north side of Simpson Ave as well as bus routes. Hawkins Street has a cycle path. Retention of this PAW is recommended. The path should be replaced and widened, and the PAW generally cleaned up.

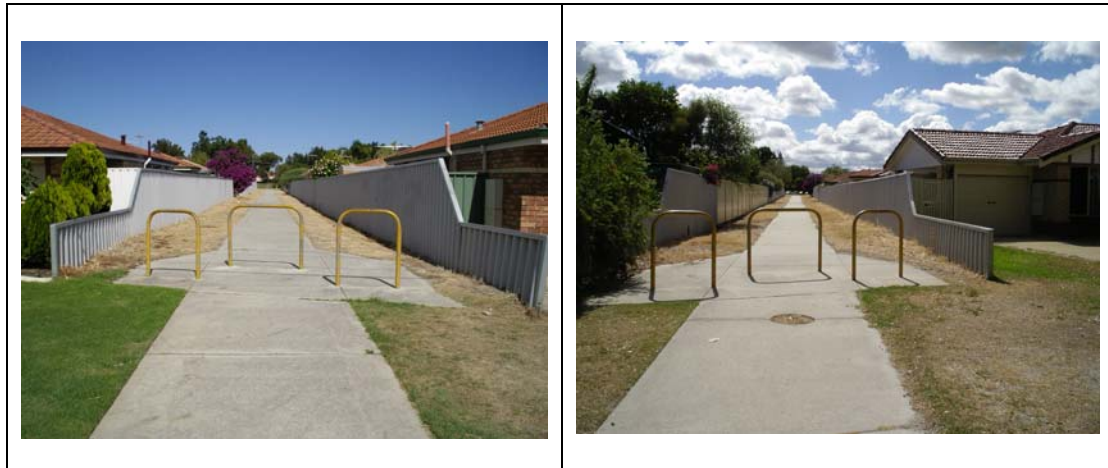
Concrete approx. 1.85m wide, central. Sand margins. Paving in good condition, but is uneven and cracked at the mid-way point.

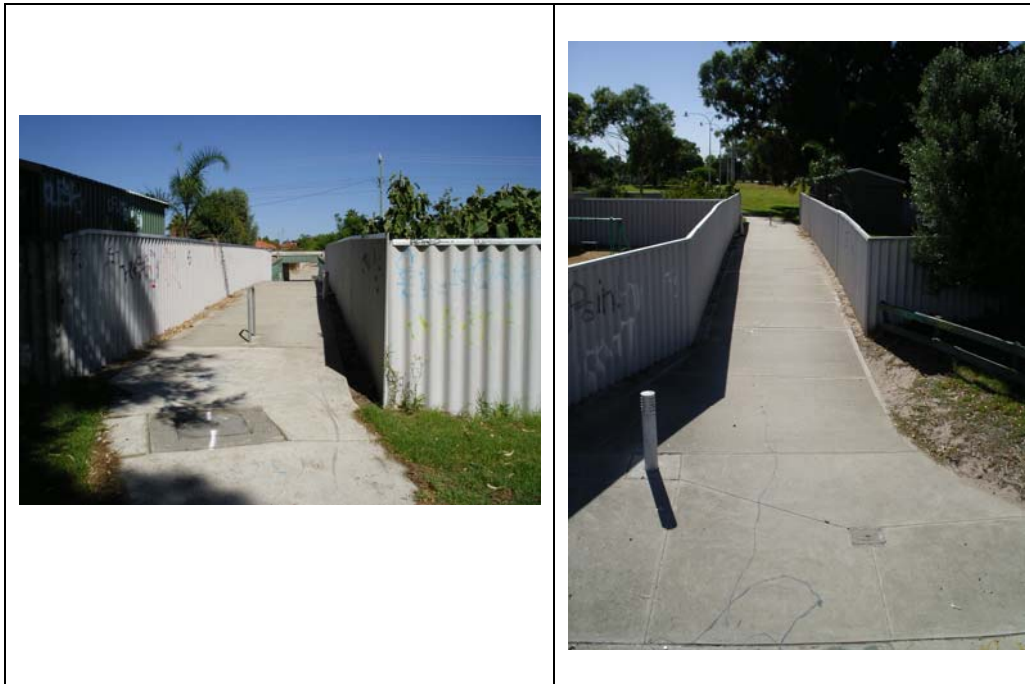
Fair to good. Graffiti. Underpass poor - abandoned shopping trolley, broken glass, rubbish and sand strewn across the path.

Street light at each end, two bollard lights – one broken.

The broken bollard light requires fixing.

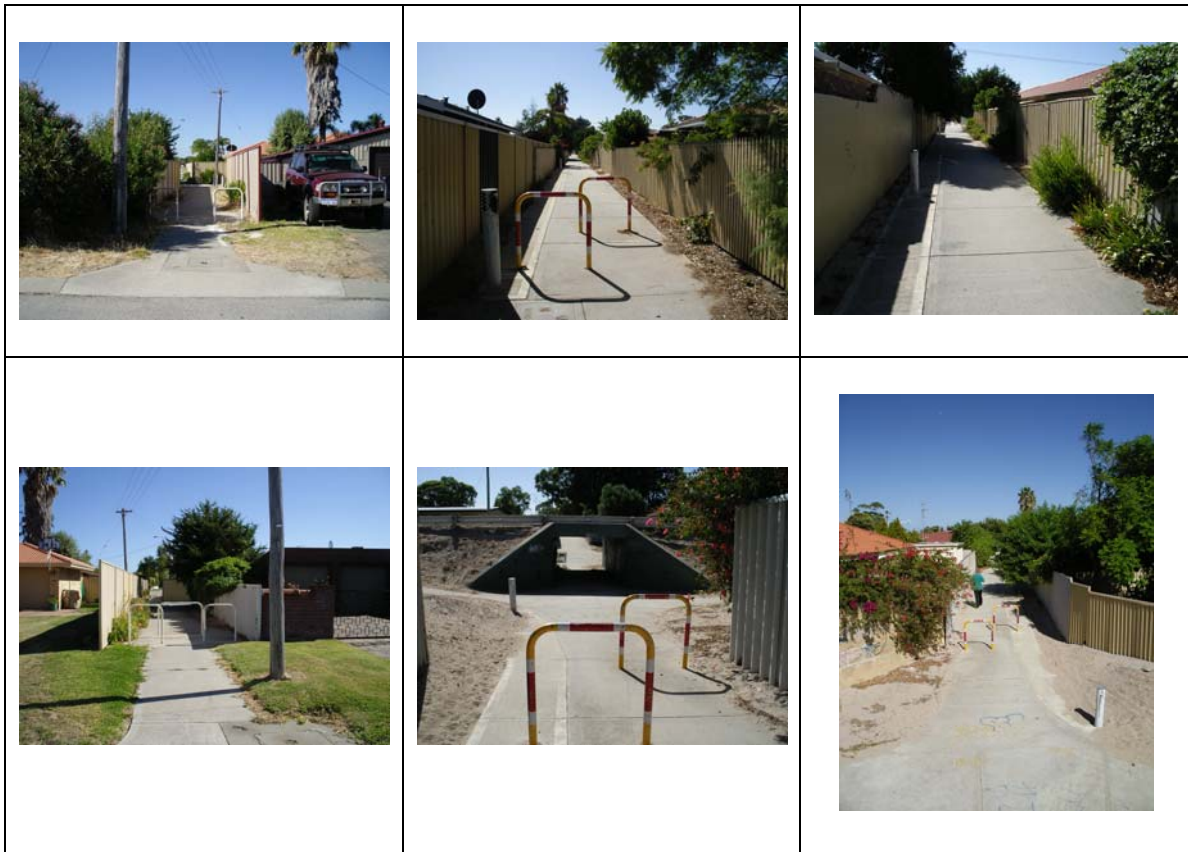
Good. Street lights located at the two entries of the adjoining culs-de-sac, and bollard lights located along the main spine. However, several of these bollard lights are broken.

The broken bollard lights require repairing, and graffiti removed.

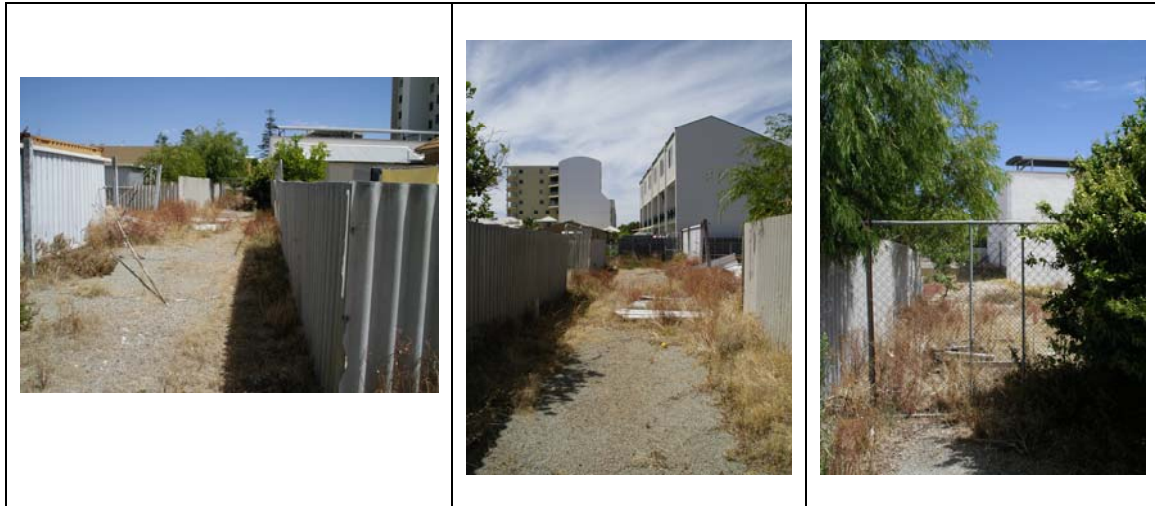
Wire, Super Six in poor condition, and sections without fencing.
