**SUBURB:** Secret Harbour

**PAW Code No.** SH361

**PAW Code No.** SH362-NP

**PAW Code No.** SH363-E

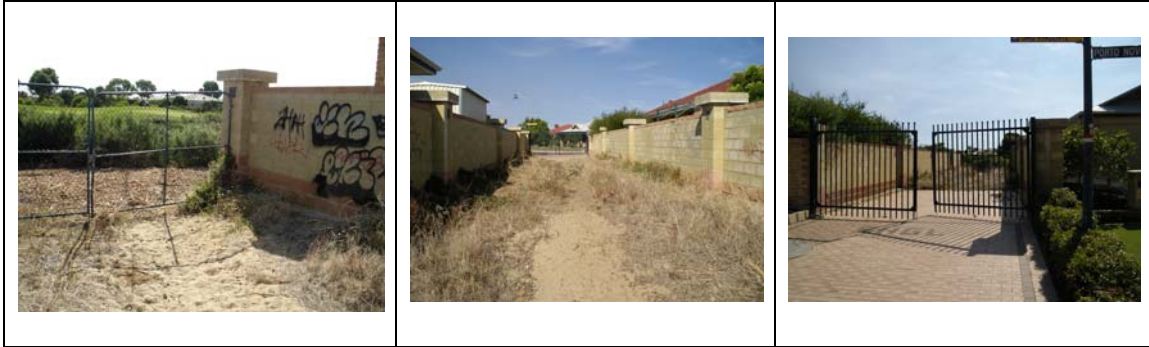
PAW reserve approx. 5m wide and 30m long. Wide, sloping gently down towards the north end. Gates at both ends. On day of site visit northern gate was padlocked, southern gate was ajar.

Very poor. Lots of graffiti, weeds, rubbish, deep sand.

Used by locals. There is a hole in the northern fence and evidence that locals use the PAW and hole in the fence to access the golf course and destinations north.

This PAW may be used periodically by service vehicles. It is clearly used by locals who climb through the hole in the high mesh-link gate at the northern end to access the golf course, and areas to the north.

The street pattern in this area is extraordinarily convoluted. This PAW provides the only means whereby residents in this locality can walk northwards out of their subdivision to access green space. Access should therefore preferably be retained.

There is no public access across the Secret Harbour Golf Course. The Golf Course is privately owned land and as access is not available retaining the PAW is not supported due to public liability issues.

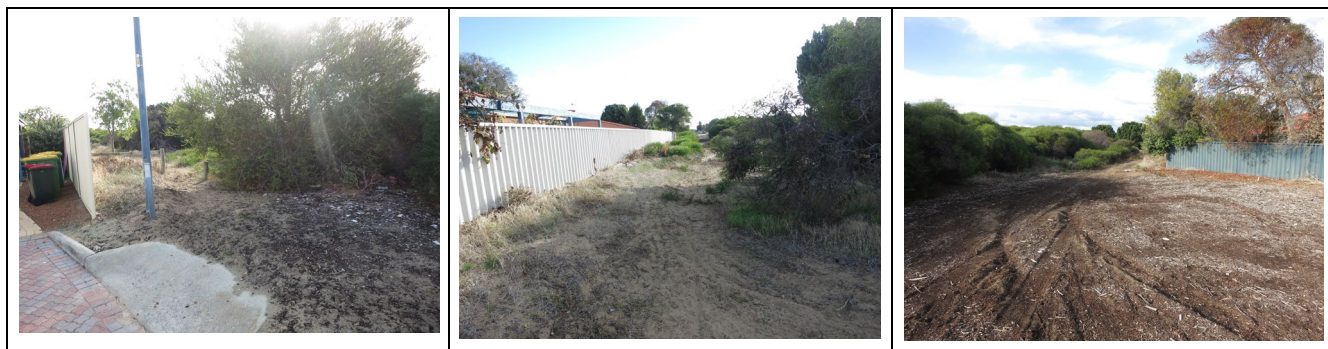
Very poor. No clear path provided.

Poor. There are only two adjacent residential neighbours to the south, being the only form of casual surveillance. Port Kennedy Scientific Park offers no casual surveillance.

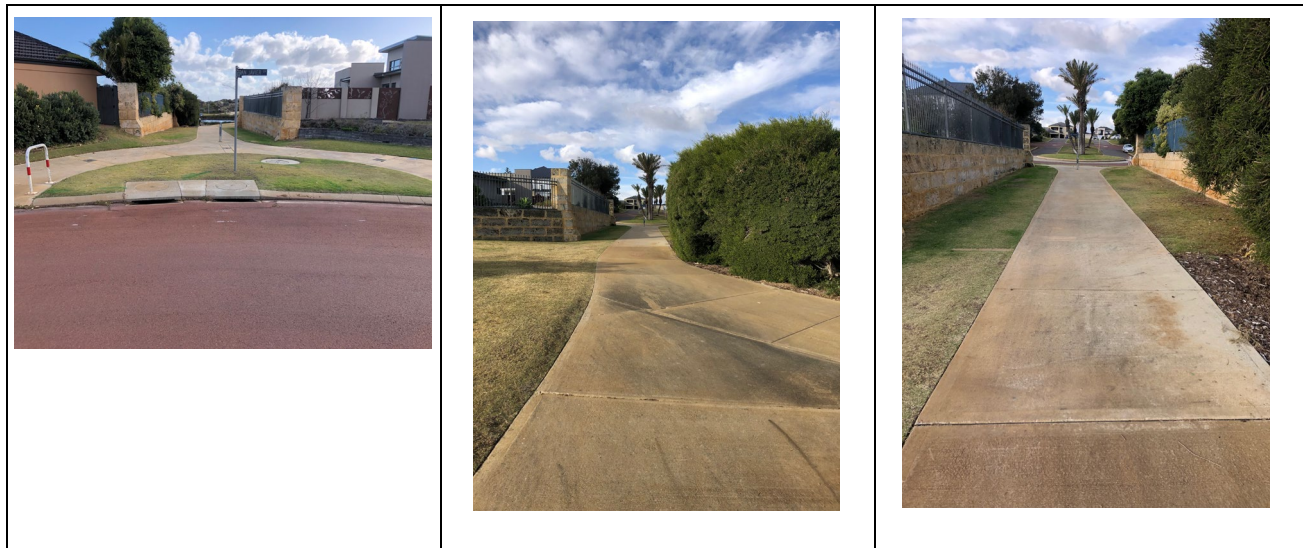
Very good. Small amount of weeds. No rubbish, graffiti or sand.

Concrete approximately 2.5 wide. Very good condition. No cracks.

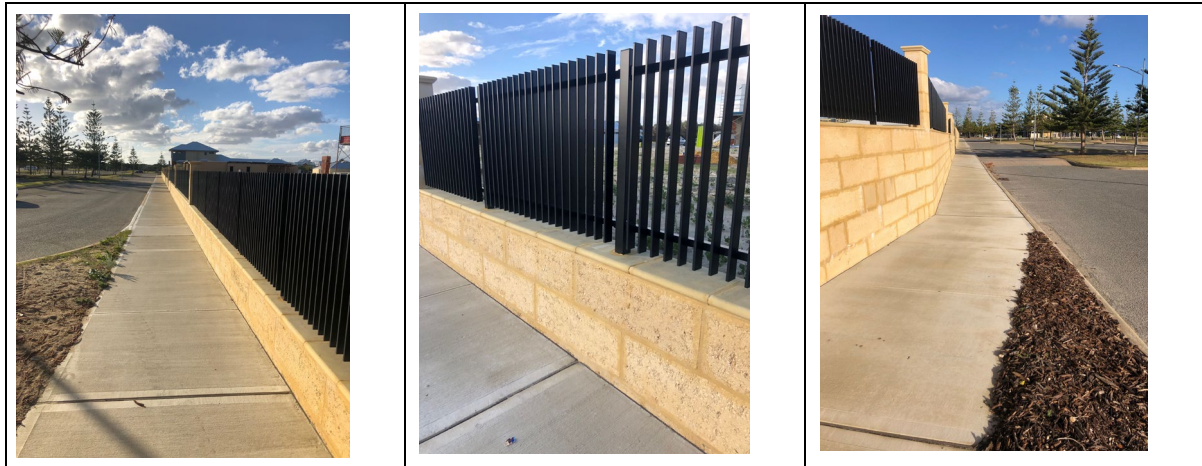
**PAW Code No.** SH364-E

Very good, new condition. No graffiti, sand or rubbish.

Concrete path. Good condition.

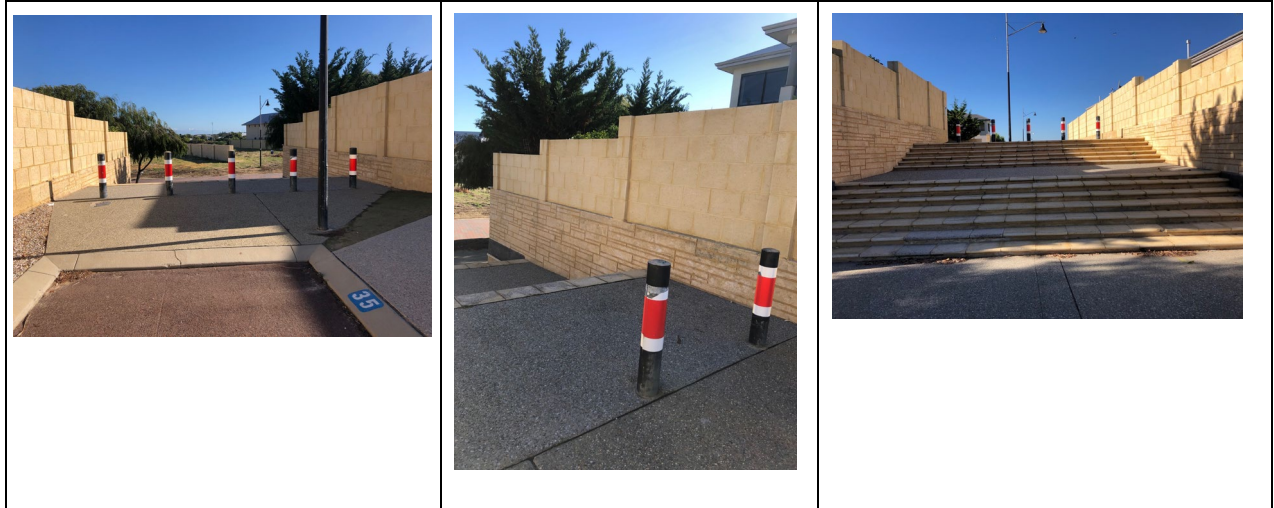
**PAW Code No.** SH365-E

Very good. New, no graffiti, sand, rubbish or glass.

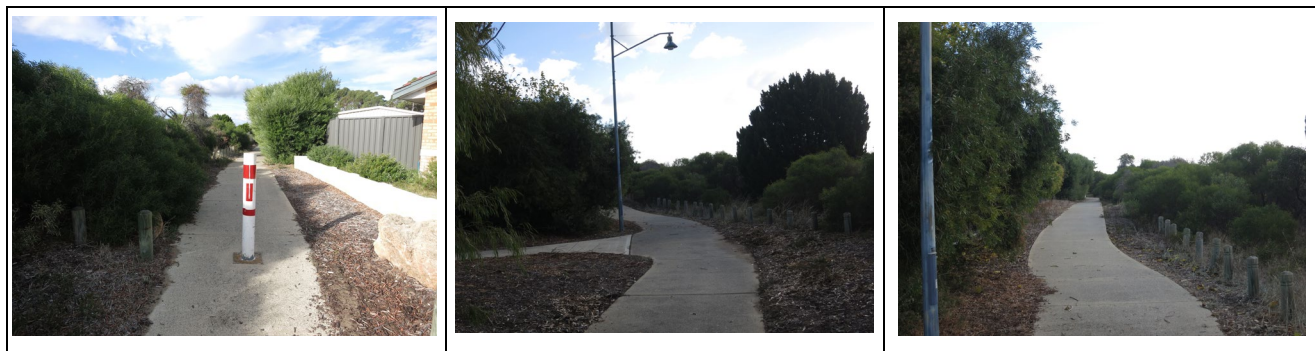
**PAW Code No.** SH366-R

Fair to good. No graffiti, rubbish or glass. Sand and leaves located over the path near Taki Place.

Poor. Some surveillance from residential properties adjacent to the south. No surveillance provided along the northern edge.

Over hanging vegetation along the southern boundary from residential properties. Mulch and sand provided along the northern edge of the PAW. Northern vegetation starting to grow over PAW.
