**SUBURB:** Waikiki

**PAW Code No.** WK 389

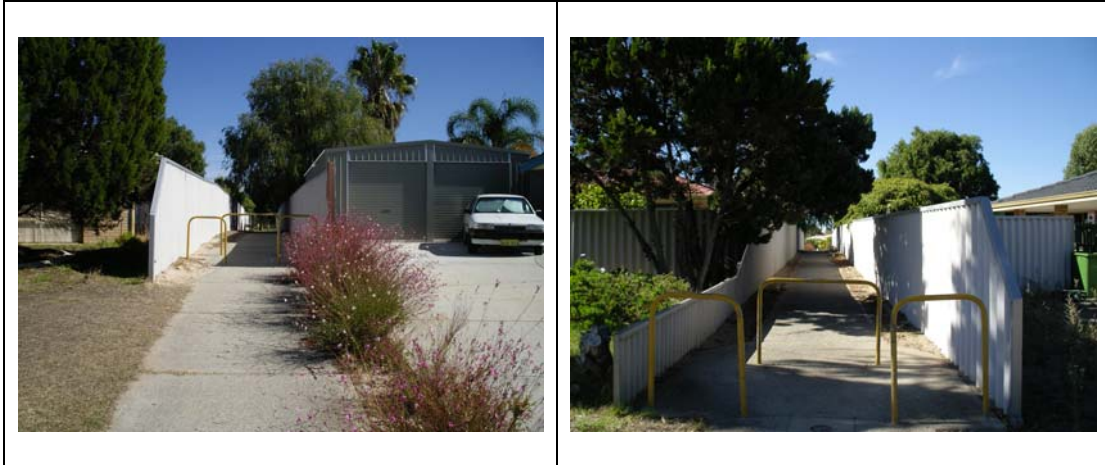
Poor to fair. Some graffiti, sand over path, rubbish, dirty nappies, leaves, broken glass & abandoned shopping trolley.

Poor, due to high side fences and hump in middle.

The PAW needs to be cleaned up.

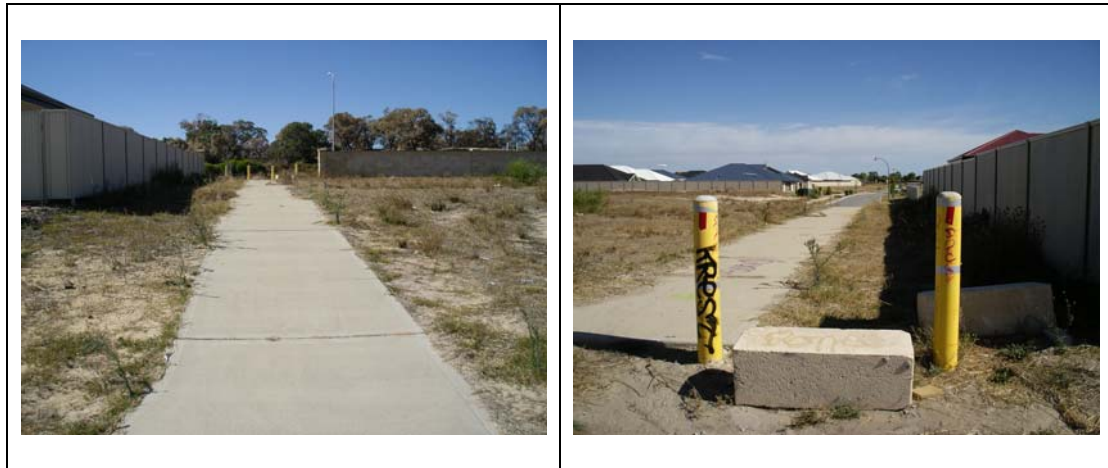
**PAW Code No.** WK 392

Poor. Graffiti, weeds, rubbish, and sand & weeds over path.

Weeds & grass encroaching over path.

The encroaching weeds and grass should be removed from the path.

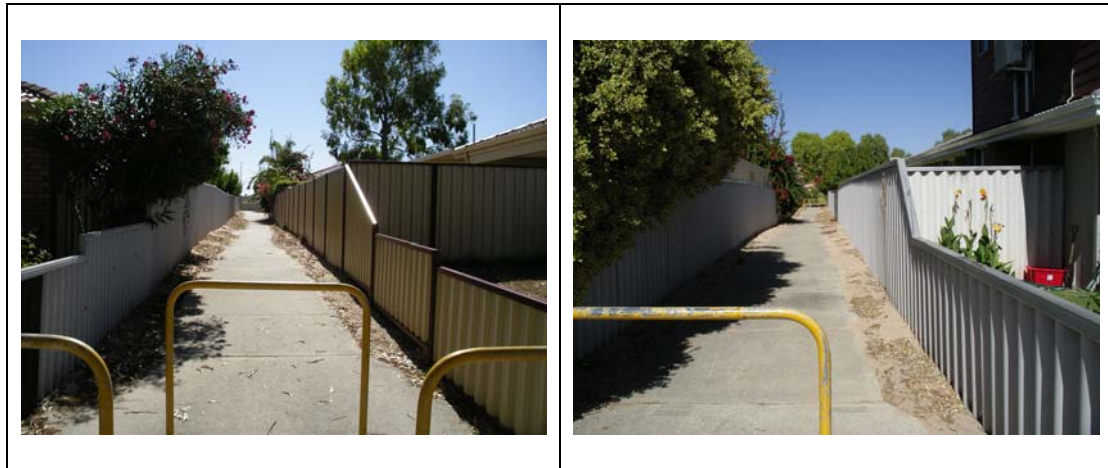
**PAW Code No.** WK 393 Map E5

Fair. Small amount of graffiti, high sand margins, sand over path, rubbish, weeds and broken glass.

Some bougainvillea overhanging side fence.

The overhanging vegetation requires cutting back.

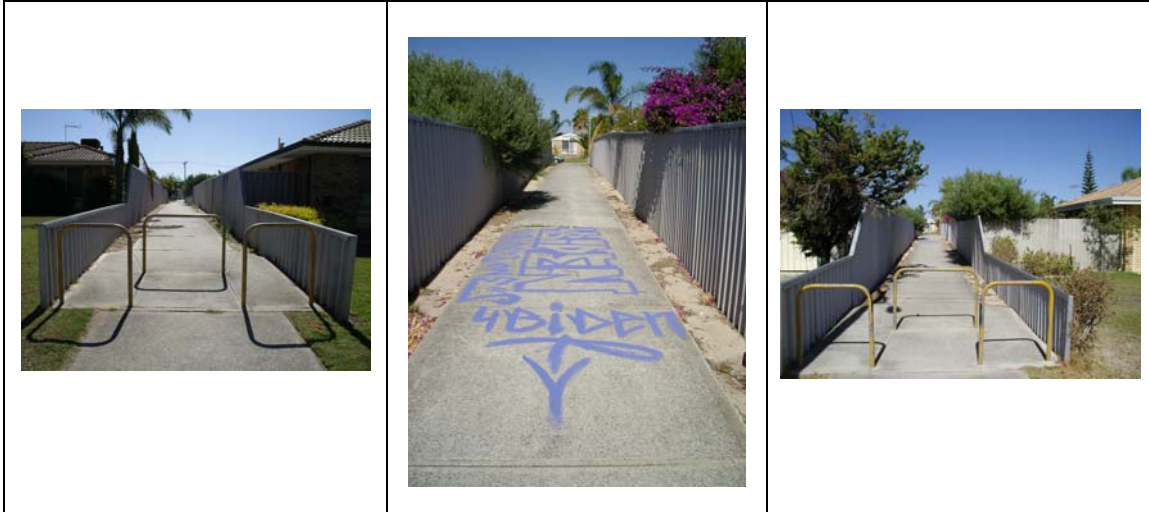
**PAW Code No.** WK 394 Map E5

Fair. Graffiti, weeds, broken glass and rubbish.

The graffiti needs to be removed.

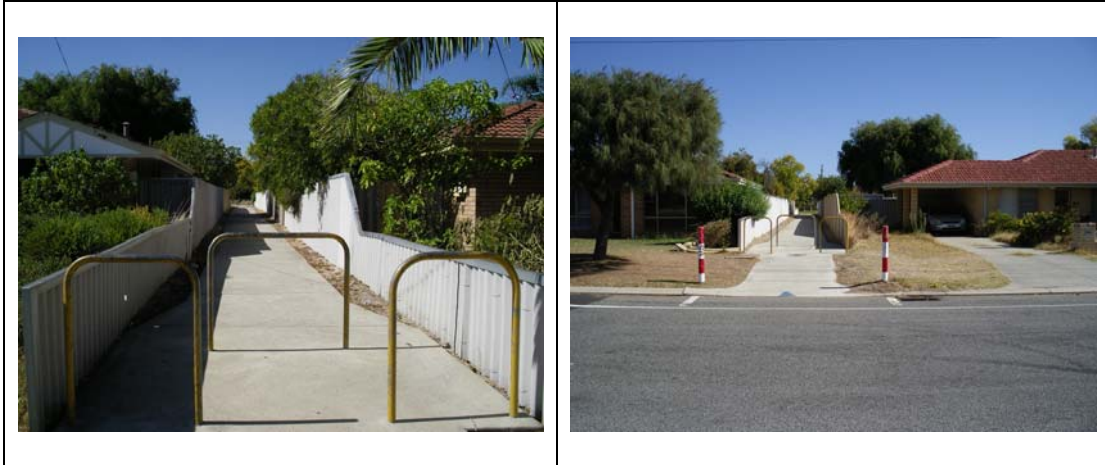
**PAW Code No.** WK 395

Fair. Some graffiti & rubbish.

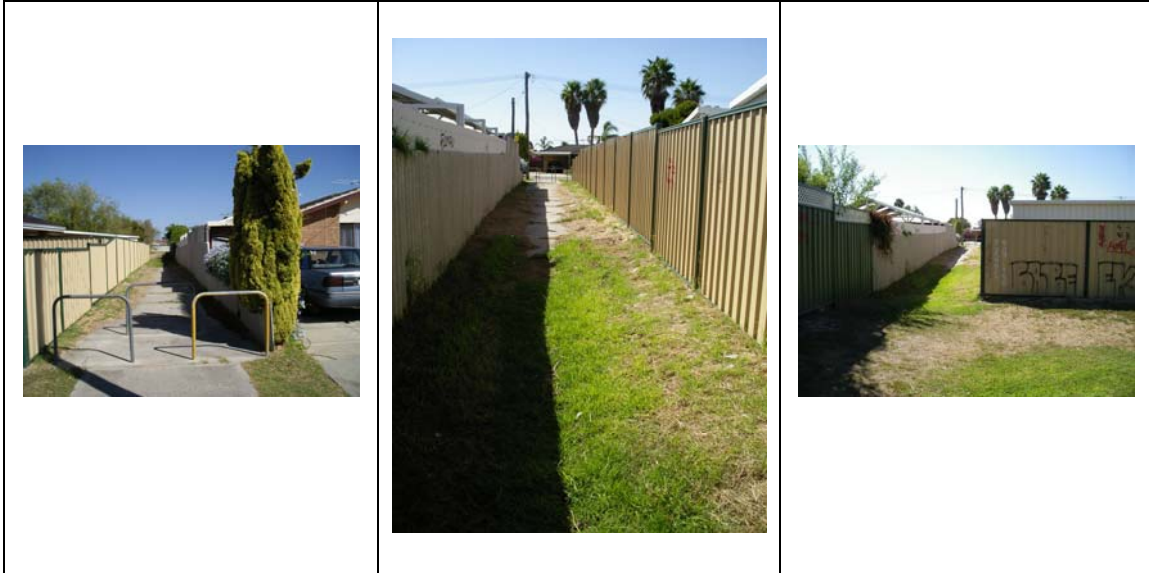
Poor. Graffiti, weeds, broken glass, rubbish, dog faeces, only 75% of the PAW paved.

This PAW provides pedestrian access from Auld Court into a remote and unused corner of the park. This PAW is not part of a comprehensive pedestrian/cycle network. 25% of the constructed path in the PAW is missing. Far superior and safer access routes to the park are provided by 5 other alternative entry points located around its edges. This PAW should preferably be closed.

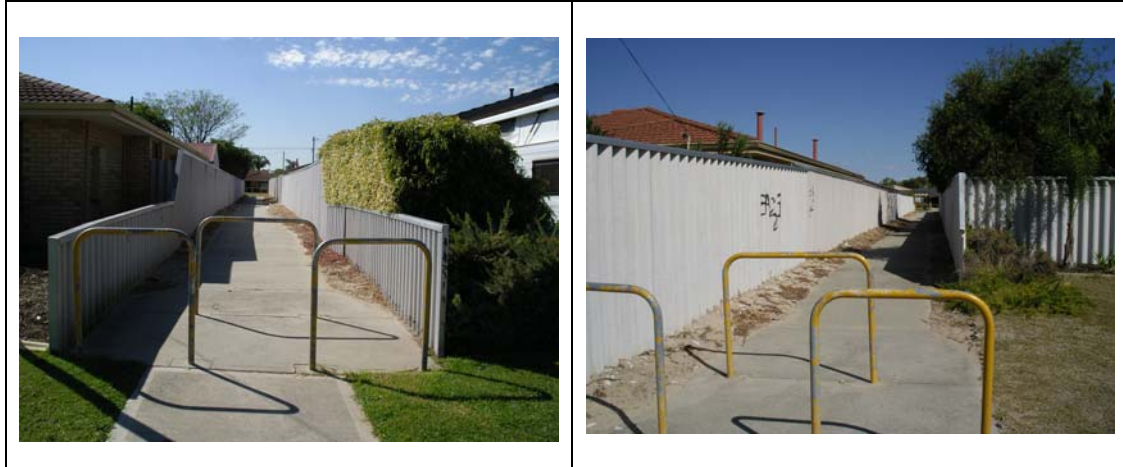
Poor to fair. Graffiti, high sand margins and sand over path, broken glass, rubbish, dog faeces.

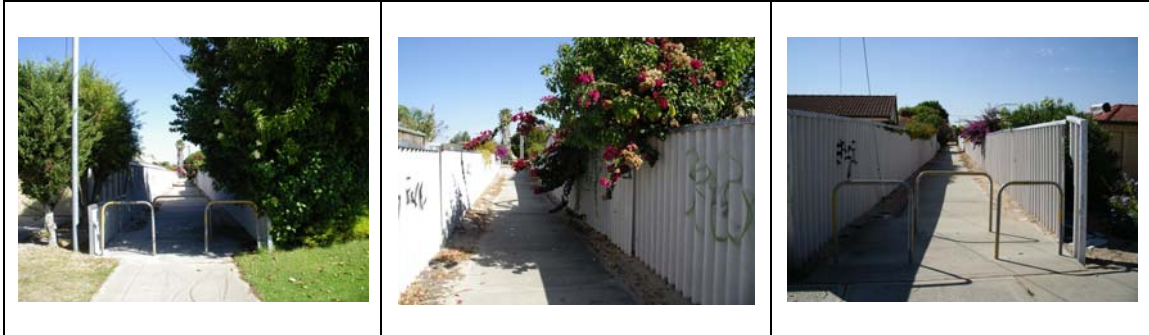
Poor to fair. Lots of graffiti, leaves, broken glass, rubbish and sand over some parts of the path.

High Super six. Some panels damaged.

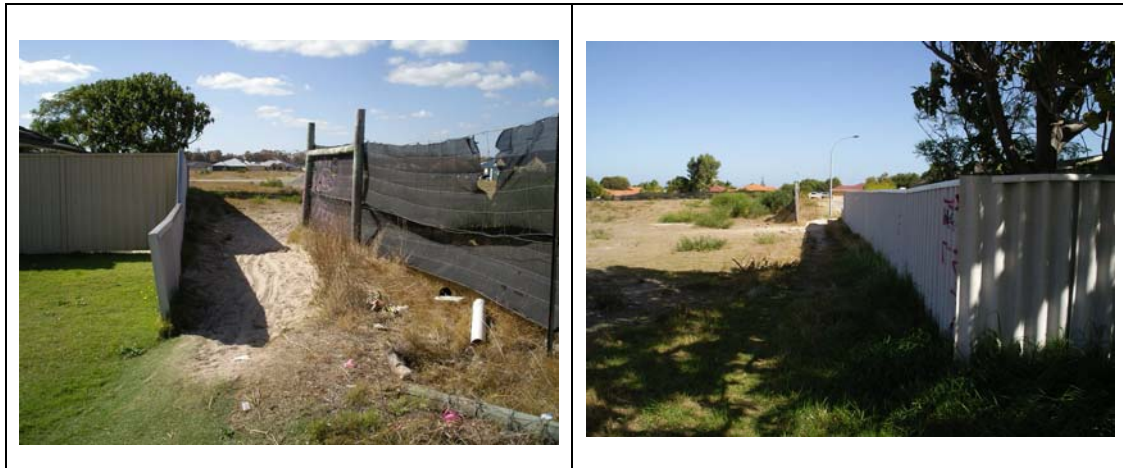
This PAW is being used, but is in very poor condition. It exits into vacant land, and is abutted on its south side by vacant land. The future plans for the development of this vacant land are unknown.

Considering the existing street layout, and the presence nearby of a school and a childcare centre, some form of east-west pedestrian access is required in this locality. How that will be provided in the future is unknown, so as a precaution it is recommended that the PAW be retained to provide this access. The PAW should, however, be provided with a constructed path.

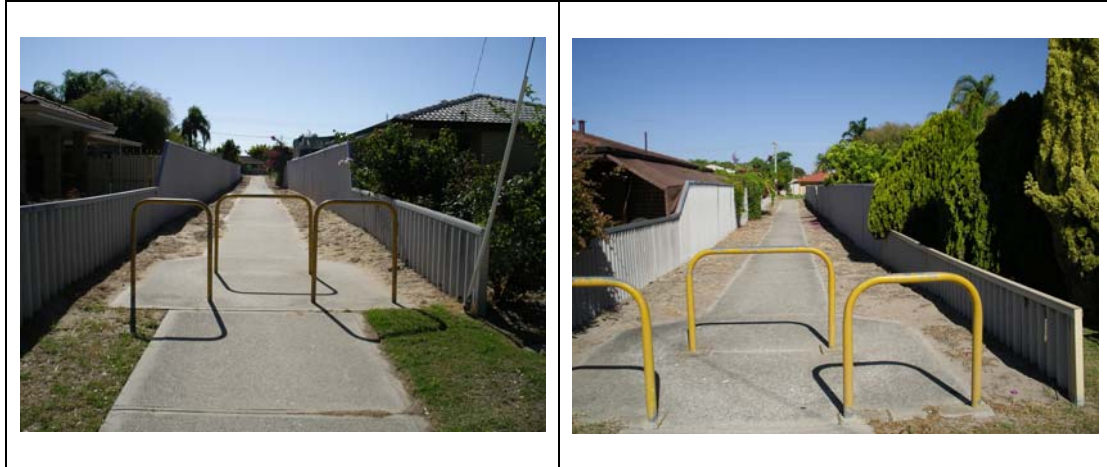
Fair. Graffiti, weeds, broken glass and rubbish, high sand margins and sand over path.

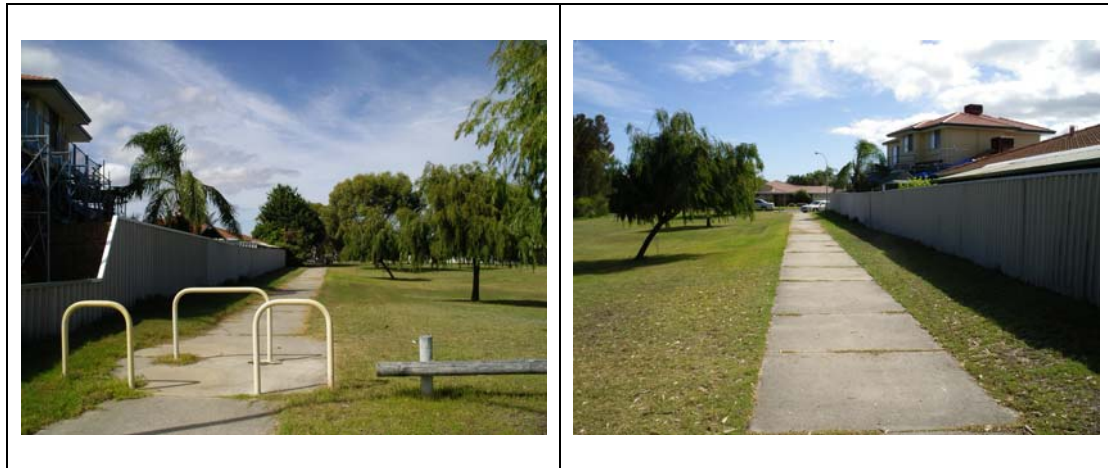
Fair to good. Some weeds in path cracks.

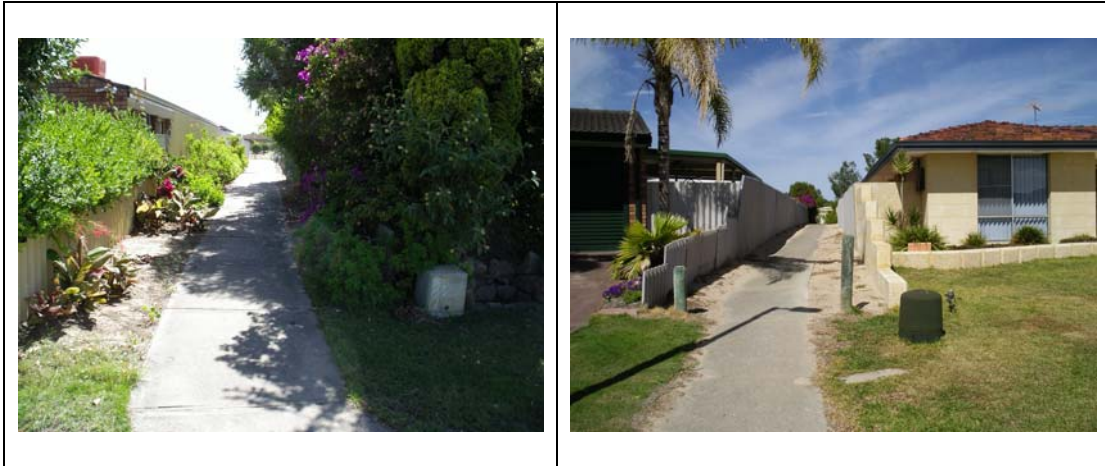
Fair. Small amount of graffiti and rubbish, broken glass.

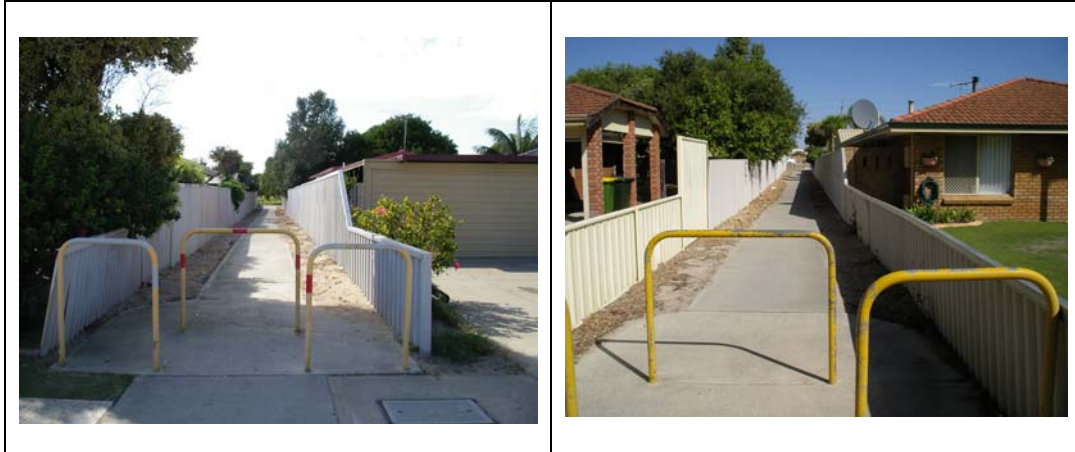
Poor to fair. Graffiti, weeds, leaves, broken glass, rubbish, high sand margins.

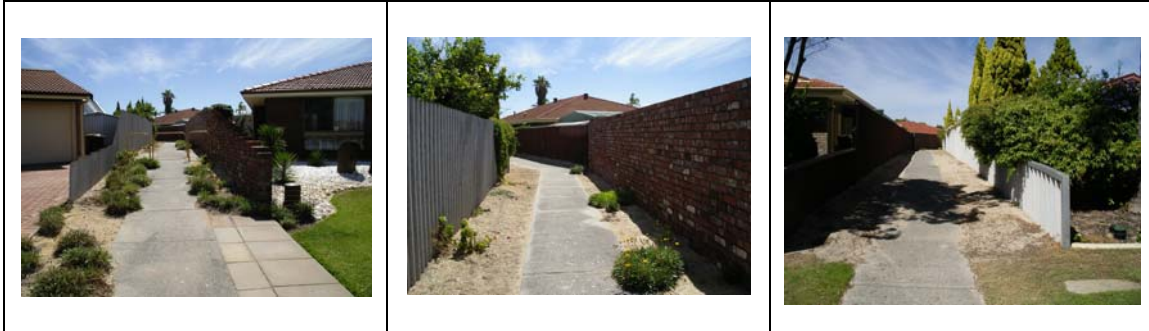
Concrete path approx. 1m wide. Old, narrow, uneven and cracked in parts.

The old path should be replaced and widened.

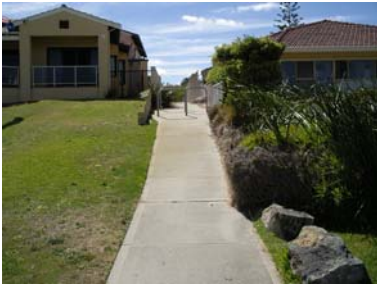
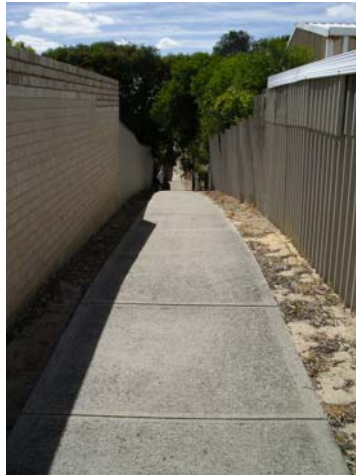
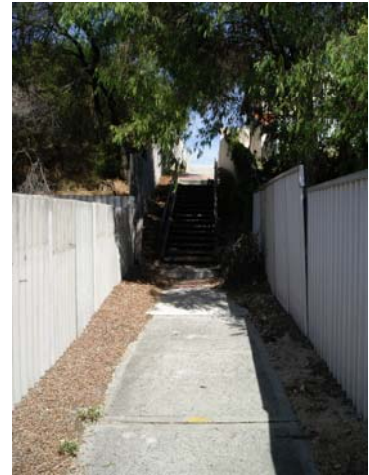
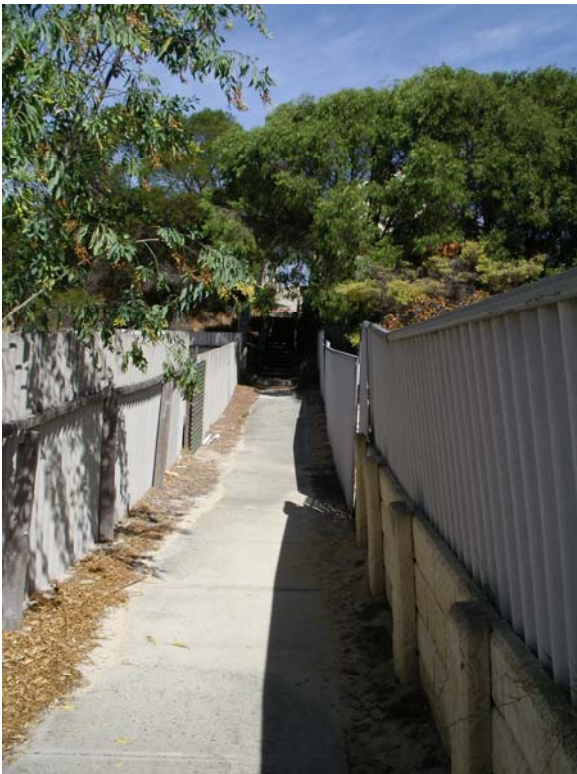
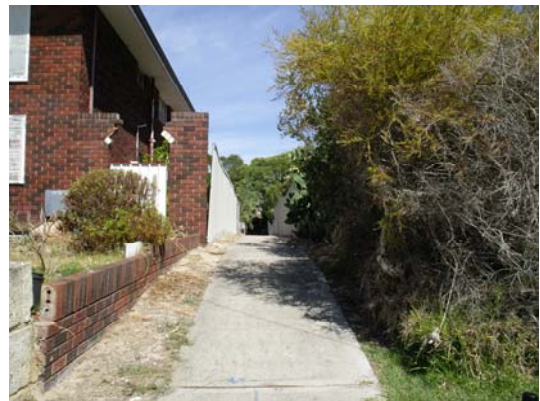
Very poor. Narrow, with rubbish, rough and uneven path surface, graffiti, broken glass, dog faeces, sand and leaves.

Super six and masonry in varying conditions. Several super six panels broken.

This PAW is in very poor condition. It is extremely long, narrow, unlit, and has steep steps (about a dozen) midway. Not suitable for cyclists. It feels unsafe to use.

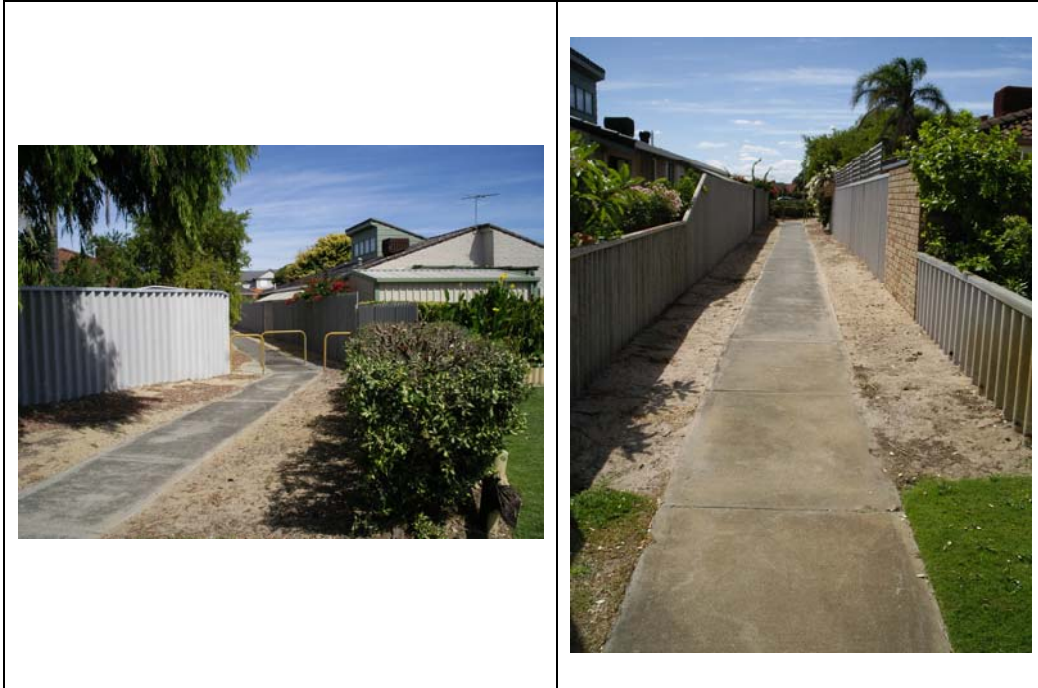
Concrete path approx. 1m wide. Old, narrow, uneven and cracked.

The old path should be replaced and widened.

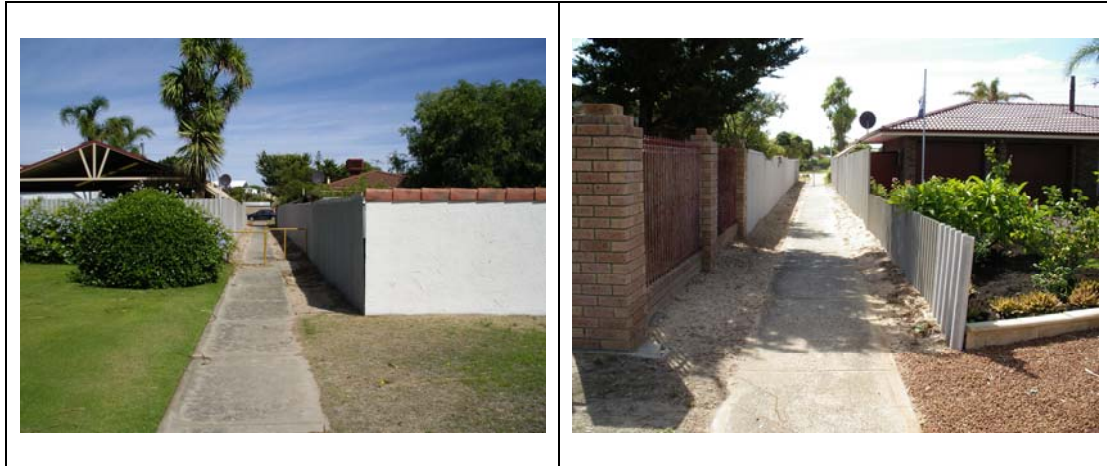
Concrete path approx. 1m wide. Old, narrow and cracked.

The old path should be replaced and widened.

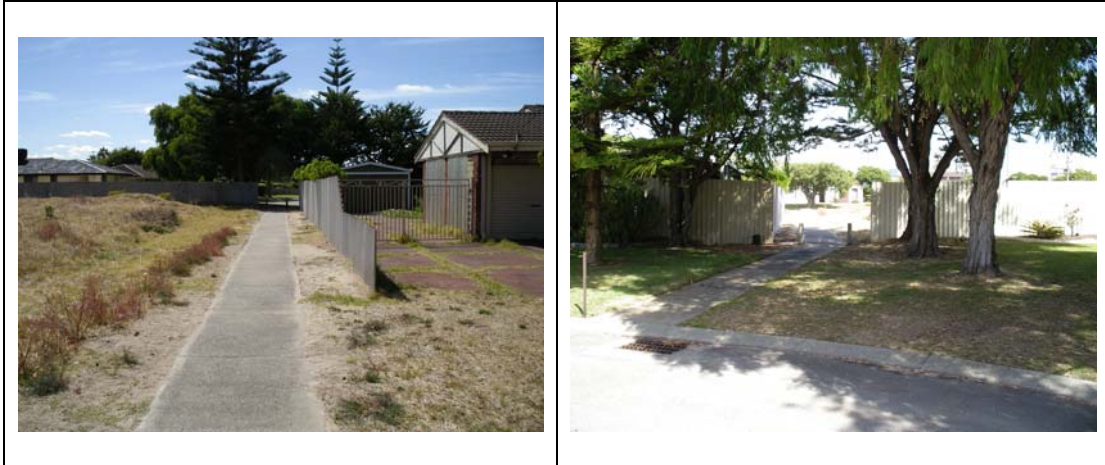
High Super on south side only - in fair condition. Some panels damaged.

Concrete path approx. 1m wide. Old, narrow, uneven and cracked.

The old path should be replaced and widened.

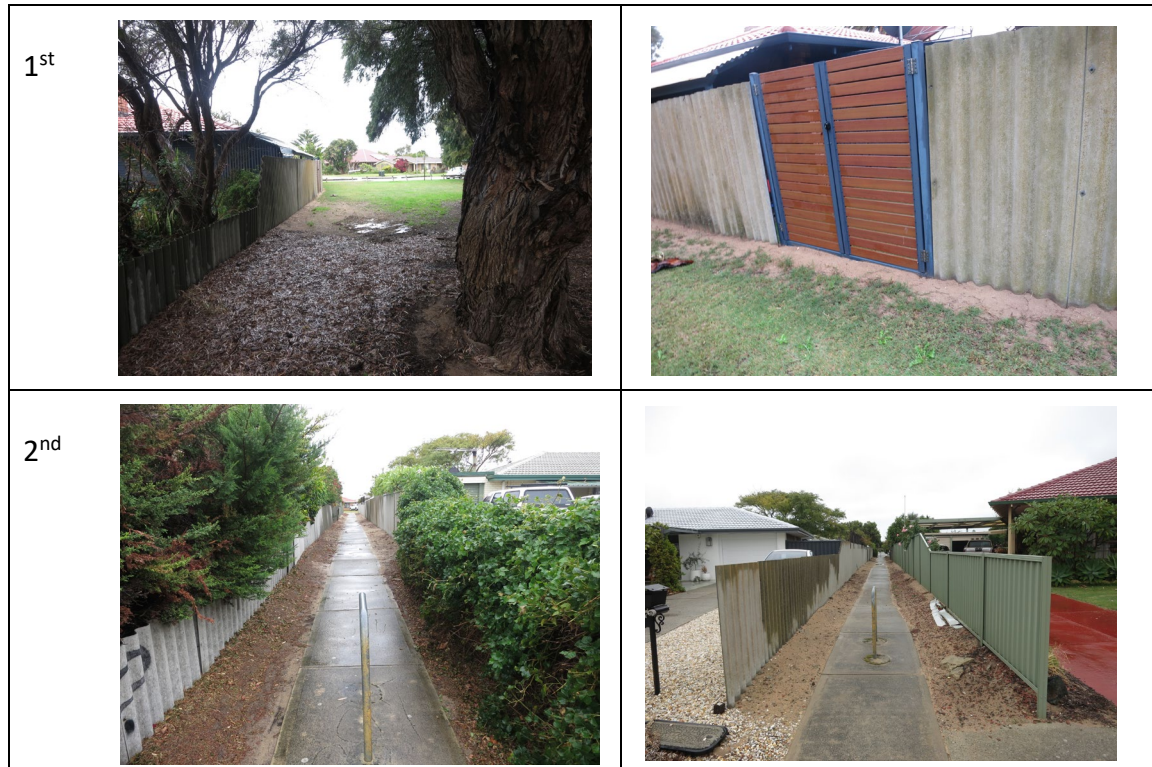
- (1) Has the appearance of being a part of the park. No path.
- (2) Fair condition. A large amount of sand is located on the path. Some graffiti.

- (1) Low wooden fence at the northern and southern entrance.
- (2) Fenced along the eastern and western boundary from adjoining residential properties. 1.8m and possibly asbestos. Fences are deteriorating and are slanted.

- (1) No paving
- (2) Concrete slabs, 1m wide. Minor cracks and relatively even.
