**SAFETY BAY YACHT CLUB**  
Safety Bay Road, Safety Bay  
Archival Record

Prepared for  
City of Rockingham

May 2026

This archive record was produced to satisfy the requirement for a Standard Archival Record. This document has been prepared in accordance with the requirements set out in the "Guide to Preparing an Archival Record" as published by the Heritage Council of Western Australia.

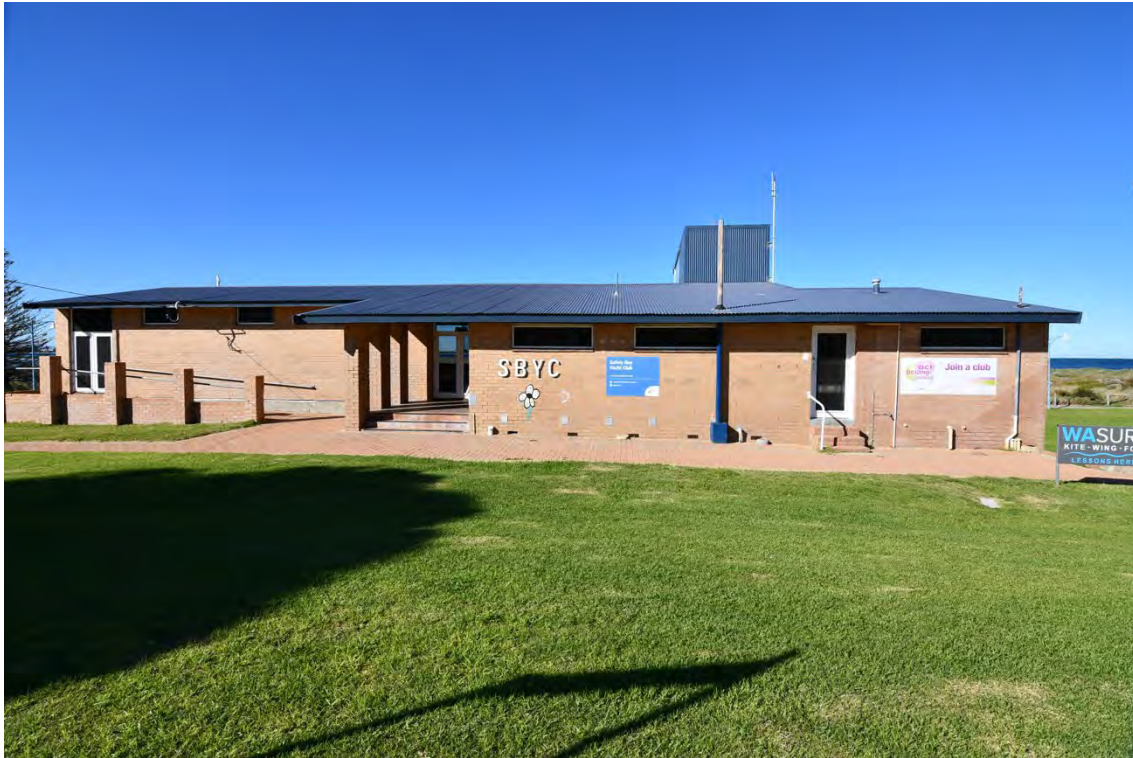
**Photograph 1** Safety Bay Yacht Club viewed from the north. Note the junction between the original building and addition to the right of the door. *Griffiths Architects, May 2026.*

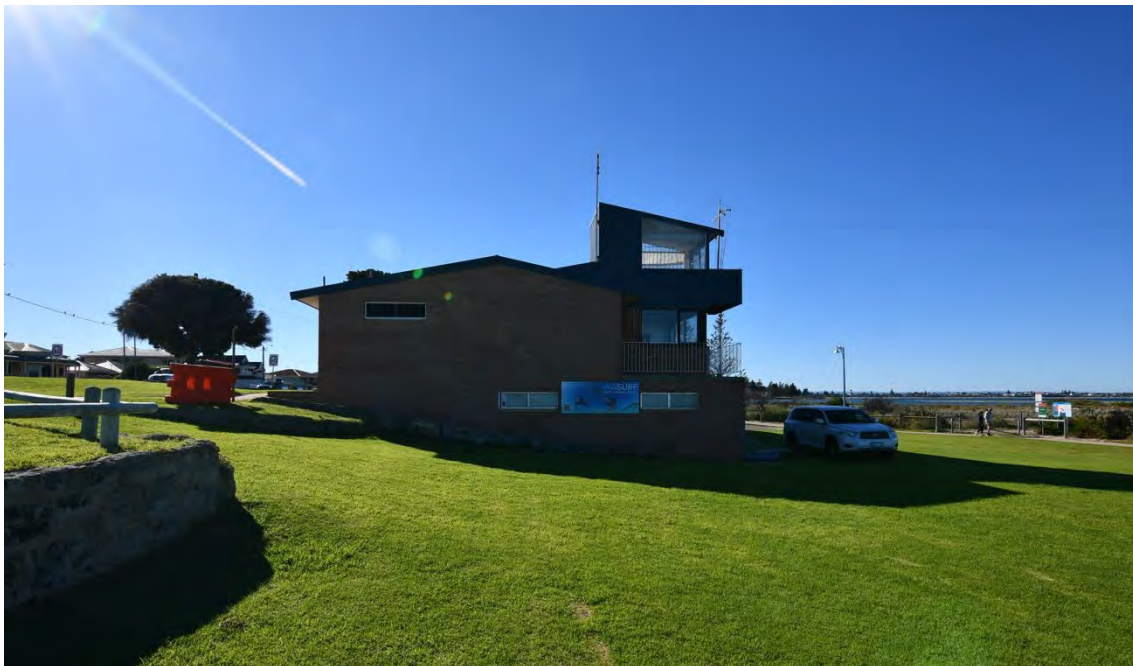
**Photograph 2** View from the west showing the changeroom and toilet addition. The vertical cladding was originally asbestos cement and was replaced with corrugated steel. *Griffiths Architects, May 2026.*

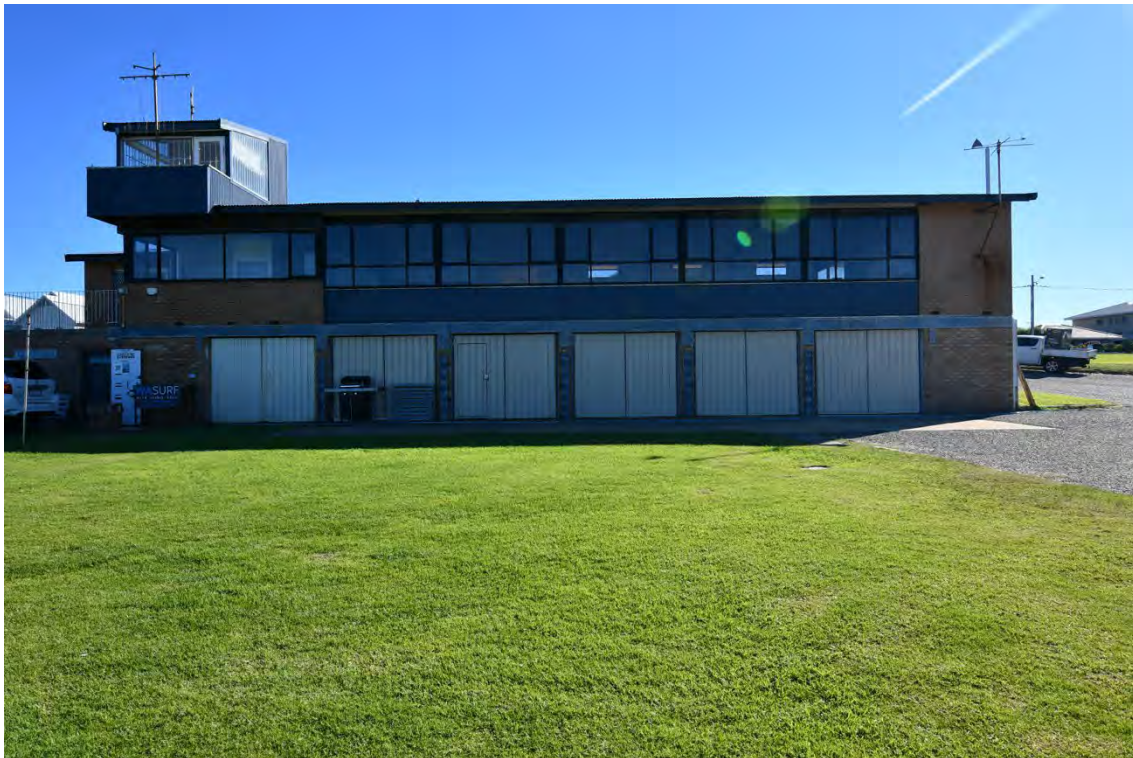
The building has had extensive repairs to support the structure with reinforcement to brick piers and lintols. In addition to this there is deteriorating joinery, fretting and cracked brickwork and some evidence of the building's north wall rotating away from the remainder of the building.

**Photograph 3** South elevation with the later addition to the left. The brick piers have been reinforced and the lintel spans reinforced. *Griffiths Architects, May 2026*

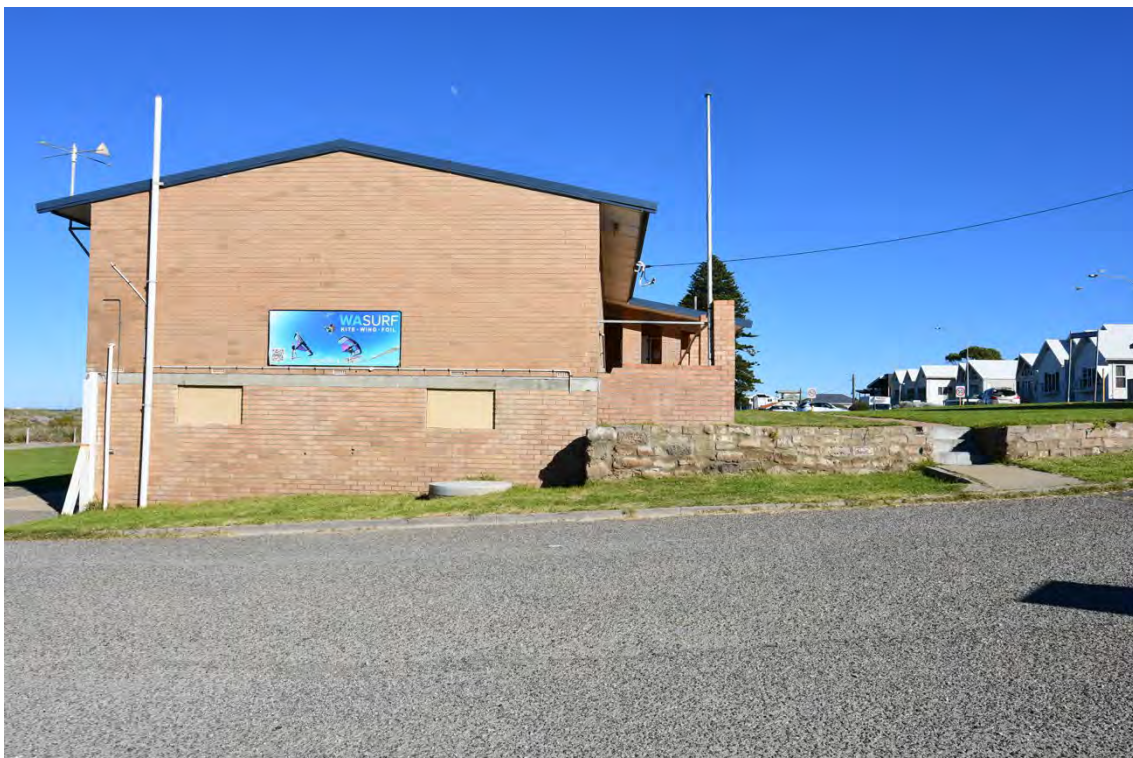
**Photograph 4** The east elevation with structural repairs on the south east corner. *Griffiths Architects, May 2026*

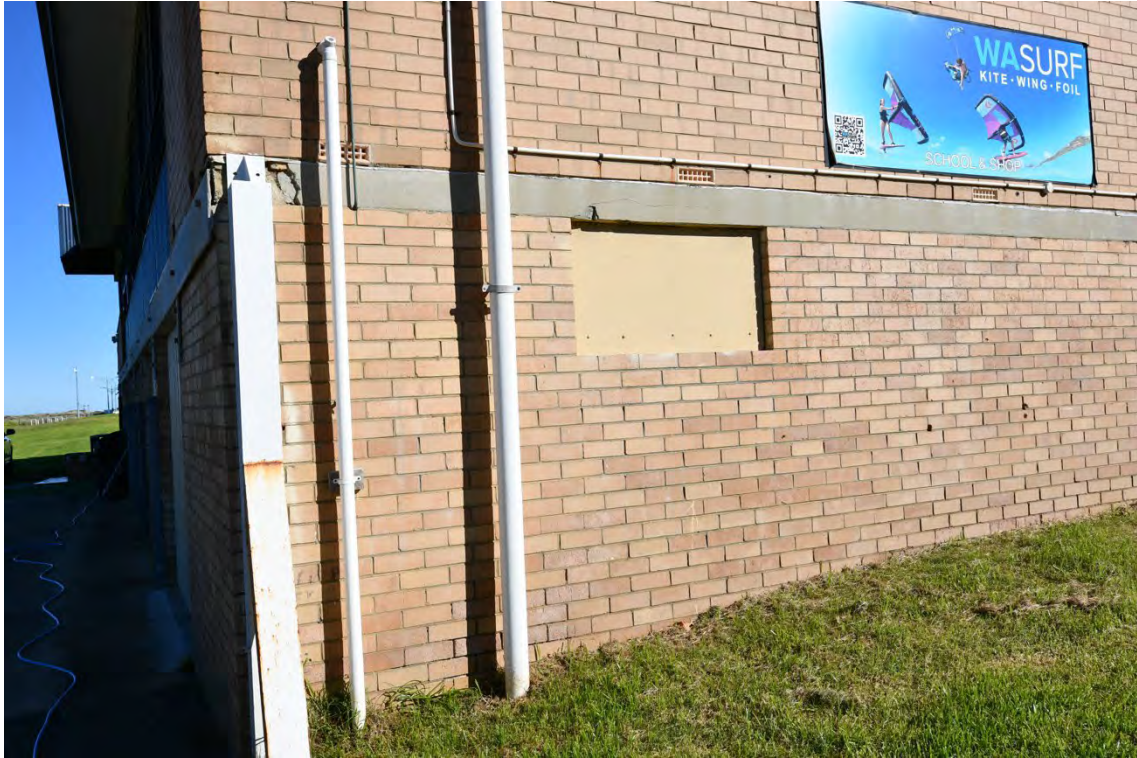
Photograph 5 Detail of structural repairs to south east corner. *Griffiths Architects, May 2026.*

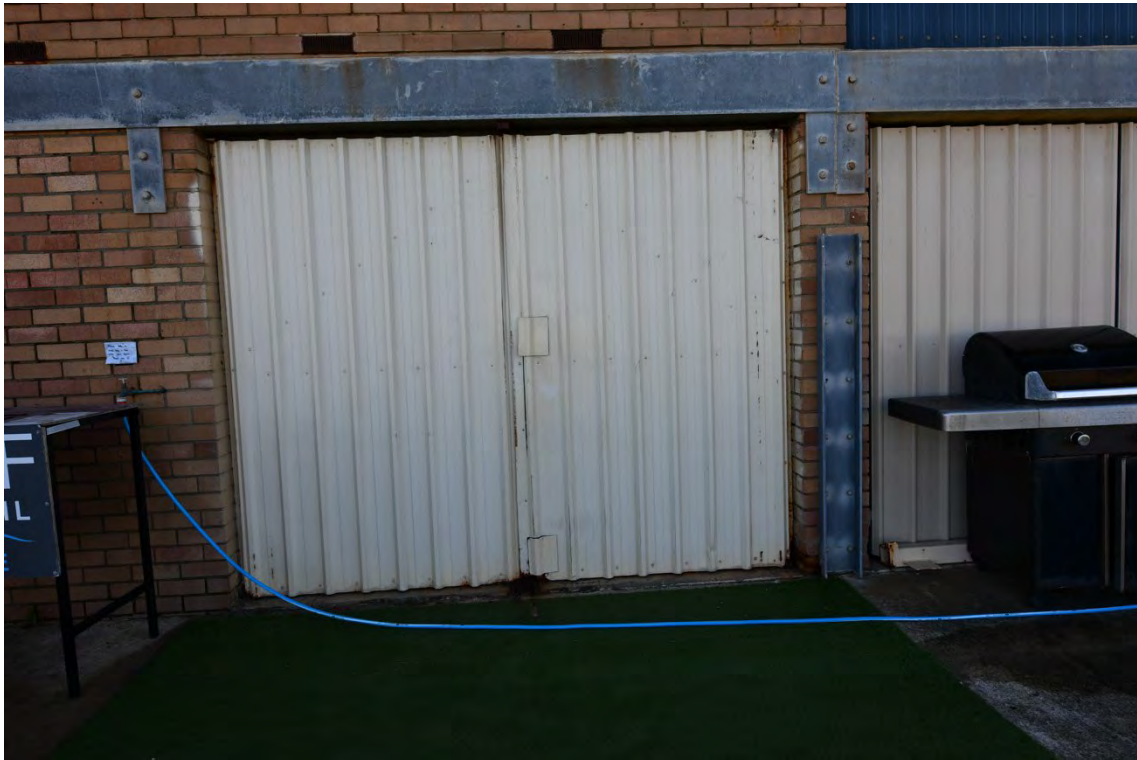
The lower level has a rough concrete floor, face brick piers and walls and a rough concrete soffit. Piers are reinforced and the door openings are steel framed and clad swing doors. There are windows in the end walls.

**Photograph 7** Detail of pier stiffening repairs and lintel repairs. *Griffiths Architects, May 2026*

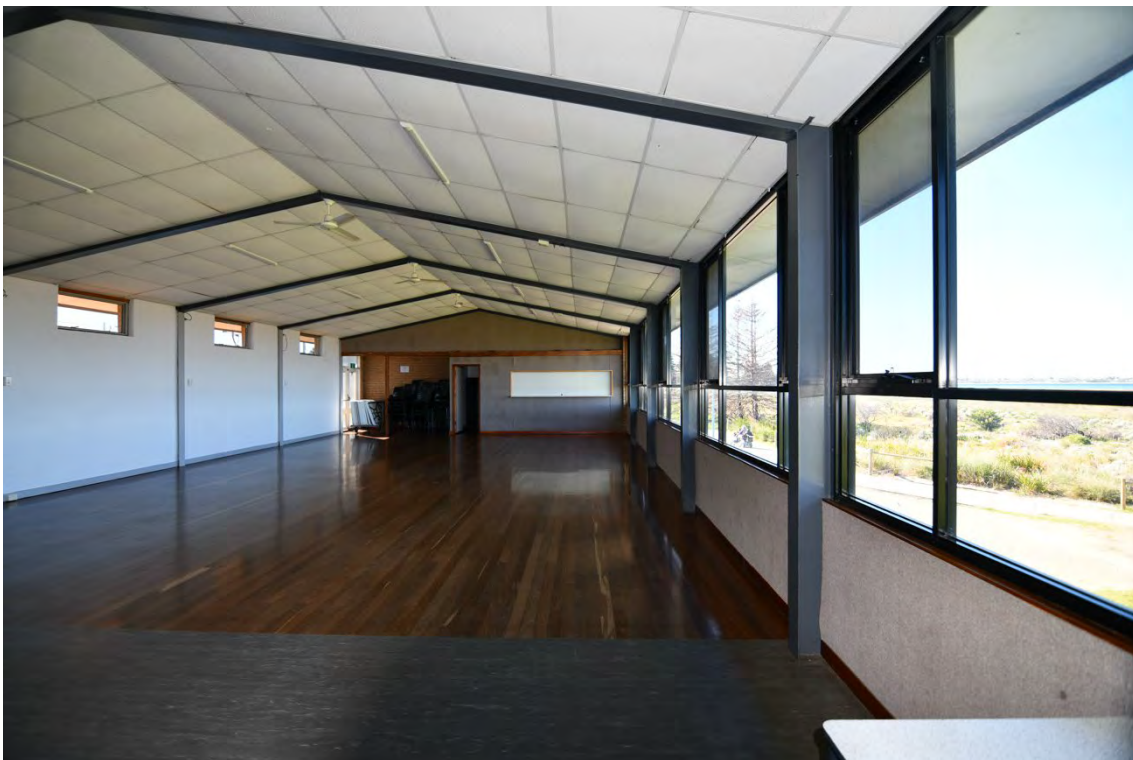
**Photograph 13** Internal view of clubroom looking east showing portal frames and replacement windows, timber floors and mineral fibre ceilings. The bar was a later addition. *Griffiths Architects, May 2026.*
