Urban Wetland Monitoring Program

FOR THE CITY OF ROCKINGHAM

Urban Wetlands Monitoring Program – City of Rockingham

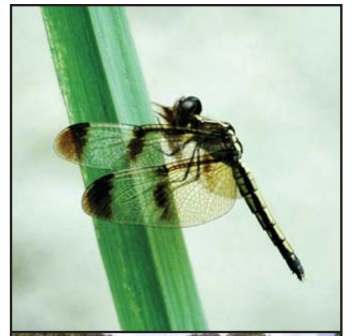
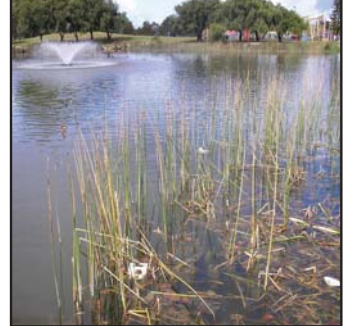
Rotary Park was sampled at two locations, both of which were clean and healthy. Gambusia fish (*Gambusia affinis affinis*) were present in the water and there was bird life observed predominantly Cormorants (*Phalacrocorax varius*), Eurasian Coots (*Fulica atra*) and Silver Gulls (*Larus novaehollandiae*) (**Plate 1 and 2**).

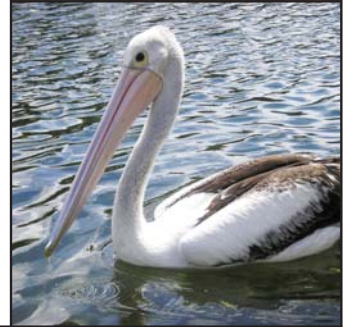
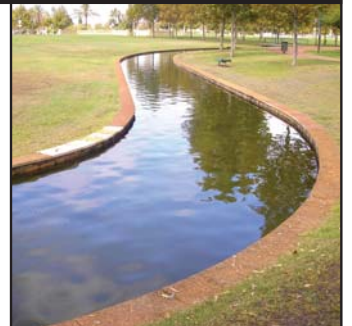
City Park was clean and well-drained although it was noted that rubbish had built up along the edges of the water and was trapped in the vegetation (**Plate 3 & 4**). This wetland had three surface aerators.

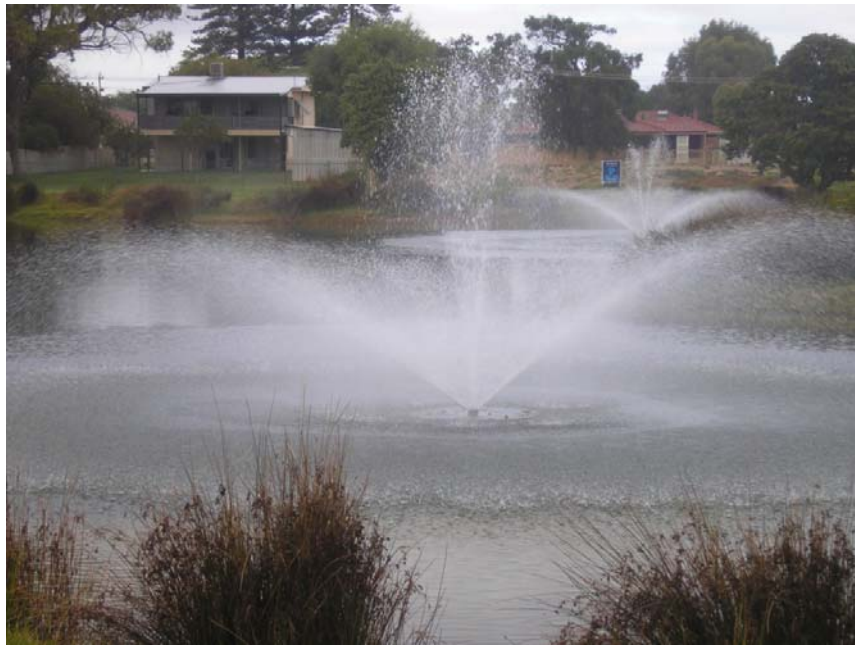
Plate 2: Rotary Park showing surface aerators.

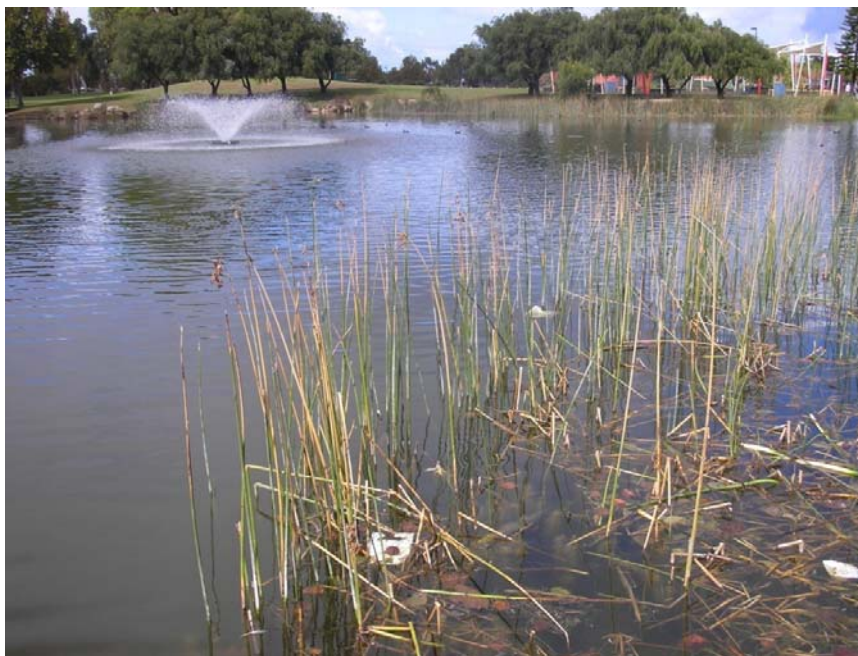
Plate 3: City Park showing surface aerator and rubbish build-up in the reeds at the waters edge.

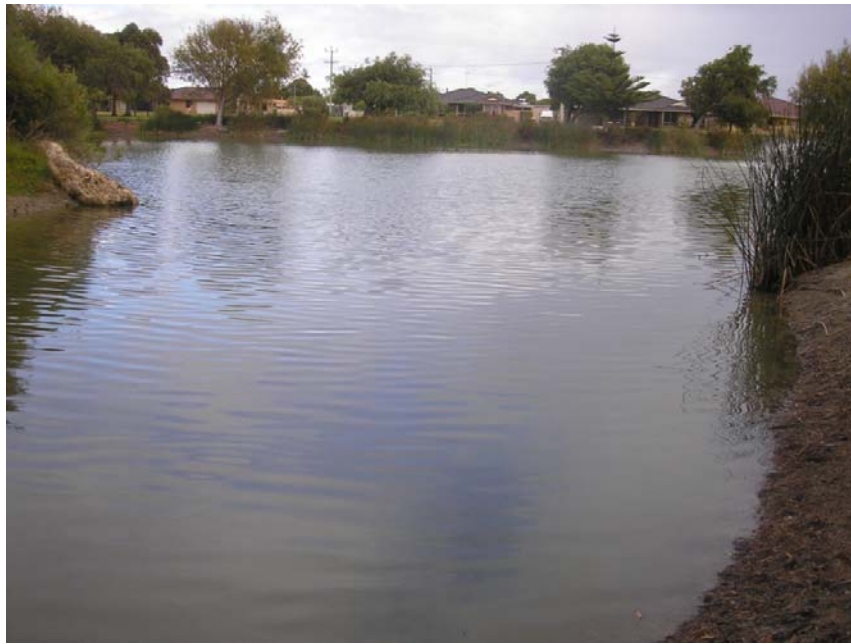
Plate 6: June Road.

The site appeared in good health although the water gave off a strong odour. This wetland was aerated (**Plate 6**).

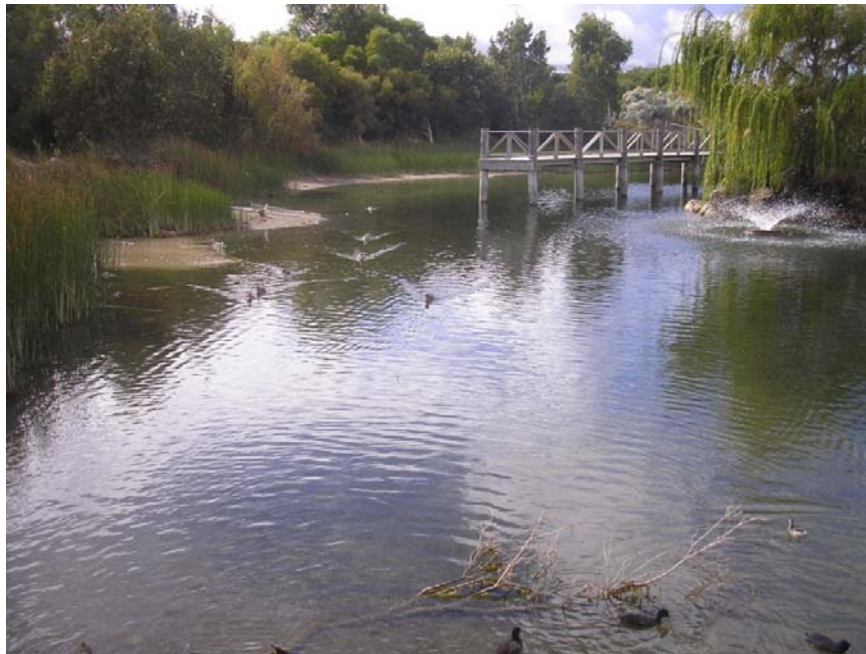
Plate 7: Centenary Park.

Centenary Park was clean and flowing with two surface aerators and a large number of bird species including Pied Cormorants (*Phalacrocorax varius*), Eurasian Coots (*Fulica atra*), Purple Swamphens (*Porphyrio porphyrio*) and the Pacific Black Duck (*Anas superciliosa*) (Plate 7).

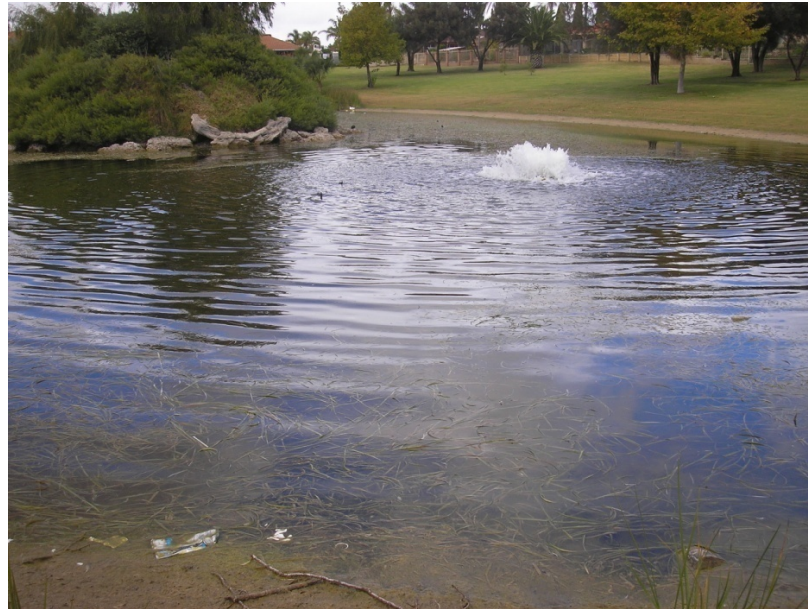
This wetland had swans (*Cygnus atratus*) and other birdlife. Large Koi fish (*Cyprinus carpio*) were also observed. It was well-drained and clean, although floating vegetation was seen congregating along the edge of the water reducing water flow. The single aerator in the main pond of the wetland was not creating adequate movement of water across the whole wetland (**Plate 8**). The build up of vegetation floating in the water is evidence of this restricted flow (**Plate 9**). Any stagnant water and build-up of nutrients presents a potential breeding ground for both mosquitoes and midges.

Plate 8: Don Cuthbertson showing aerating fountain and build-up of vegetation and rubbish along waters edge.

Don Cuthbertson was found to have a build-up of plant material along its edges and areas of stagnant water. Although this presents an issue for midge and mosquito populations the wetland was also home to many bird species (including Eurasian Coots (*Fulica atra*), Purple Swamphens (*Porphyrio porphyrio*) and Pacific Black Duck (*Anas superciliosa*)) and Koi. No Mosquito Fish (*Gambusia*) were seen during the site visit however the presence of this predator in particular in addition to the presence of birds and Koi should help alleviate the risk of these pests occurring.

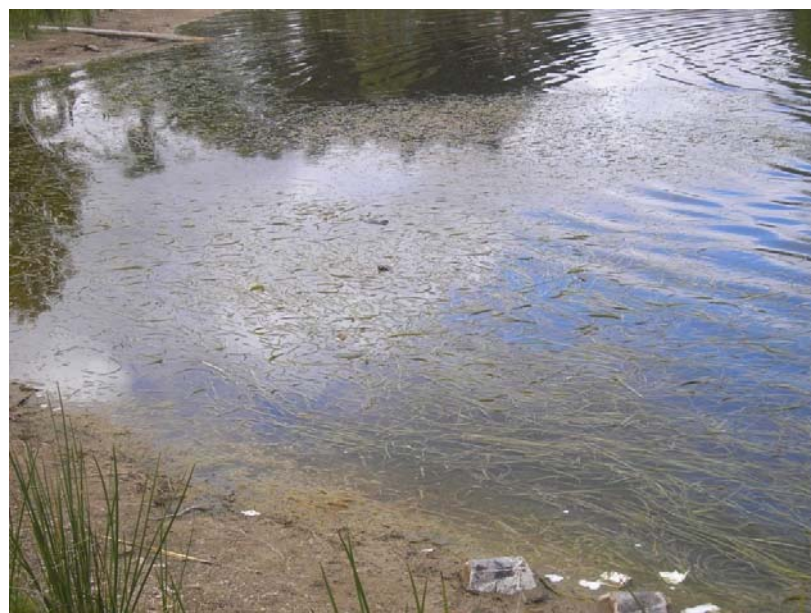
Plate 9: Don Cuthbertson showing congested edge of the wetland.

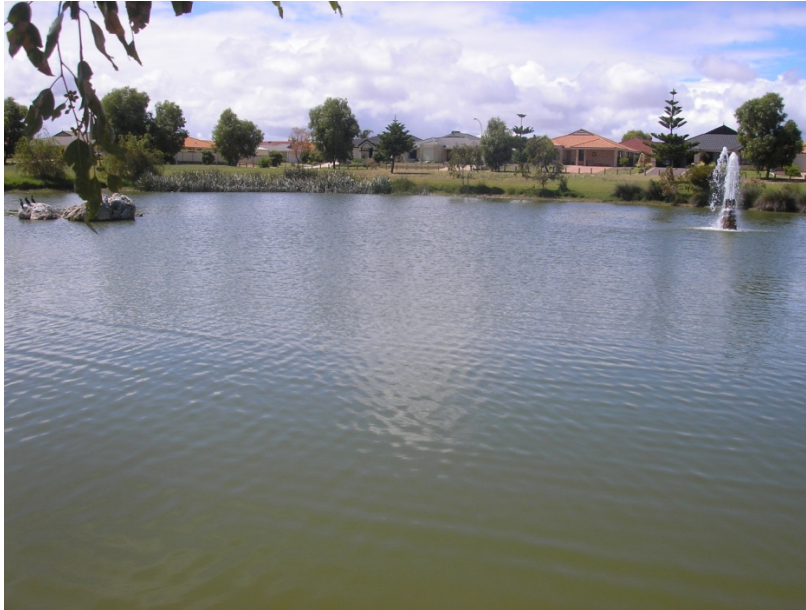
Monmarte was a clean site in good health with two surface aerators (**Plate 10**).

Plate 10: Monmarte showing birdlife in the middle of the lake and aerating fountain.

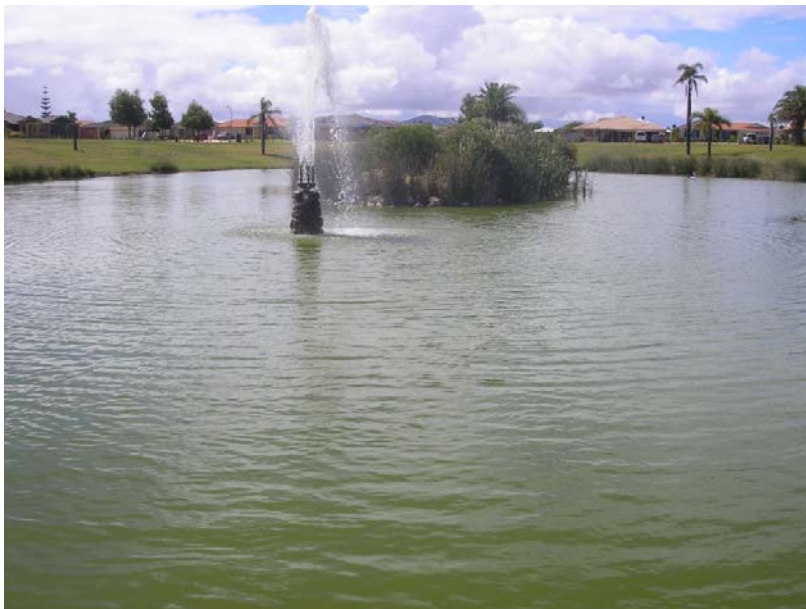
This site had two surface aerators, good drainage, was clean and contained birdlife (swans (*Cygnus atratus*)). There was a green colouration observed in water clarity which may indicate early stages of algae production or possible chemical application (**Plate 11**).

Plate 11: Bayeux showing island in the middle of lake and fountain similar to Monmarte.

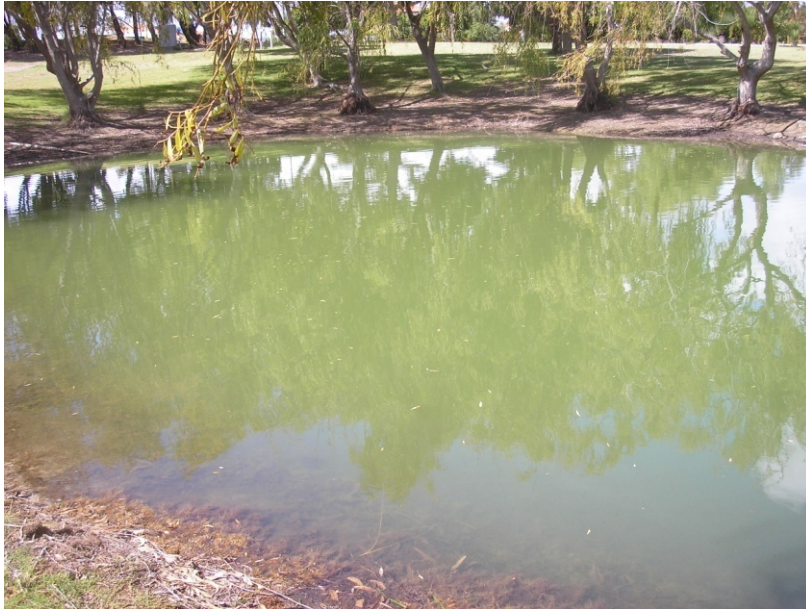
Plate 12: Sovereign Ave PK6A.

Sovereign Ave consisted of PK6A, PK6B, PK6C and PK6D. PK6A was the main wetland. Three other drains (PK6B, PK6C and PK6D) were located at various points around the park. The wetland was in good health but was slightly green in colour (**Plate 12**). All three drains were found to be dry during the site visit (**Plates 13-15**).

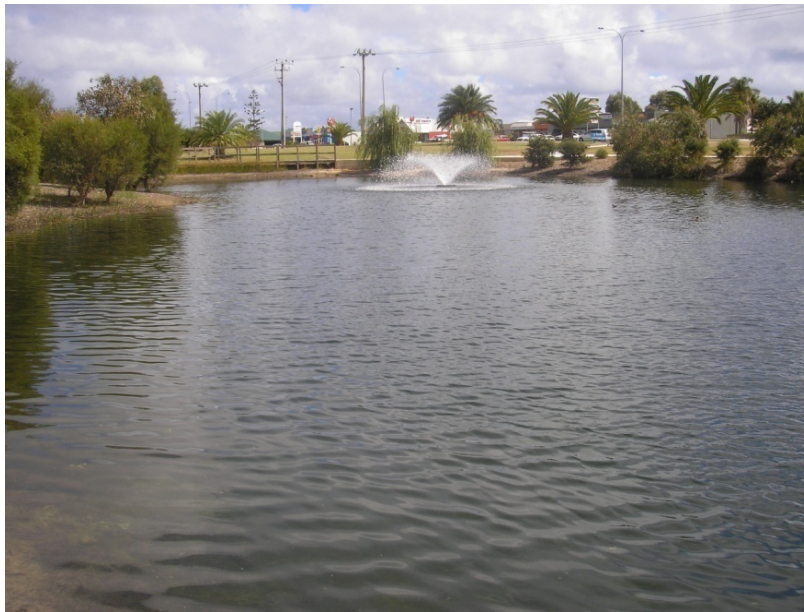
Plate 16: Sunlight Park.

Sunlight Park was clean and in good health, birdlife such as swans (*Cygnus atratus*) were observed. It had one surface aerator which created water movement (**Plate 16**).

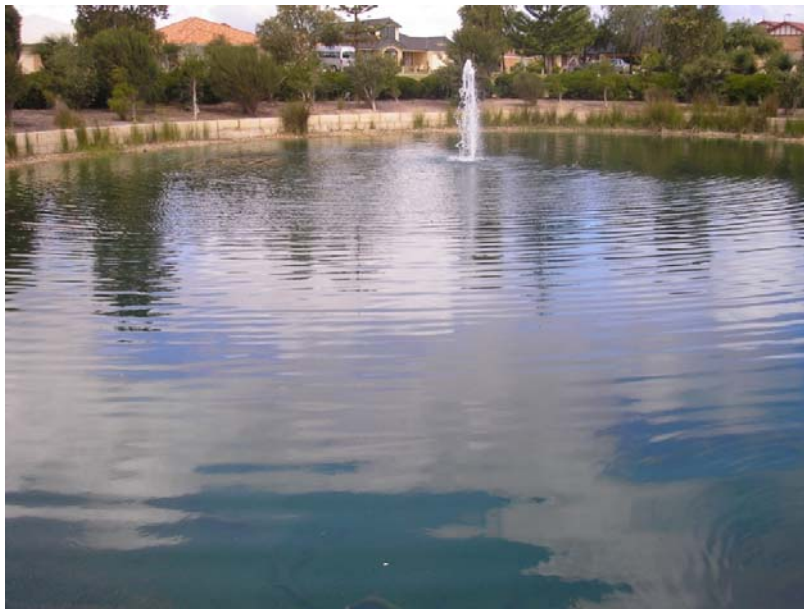
Plate 17: Baltimore.

The water at Baltimore had an abnormal blue-green colour to it. It also let off a strong sulfur odour, when the sediment was disturbed; this is typical of anoxic (low oxygen) conditions (**Plate 17**). No birdlife was observed during the visit.

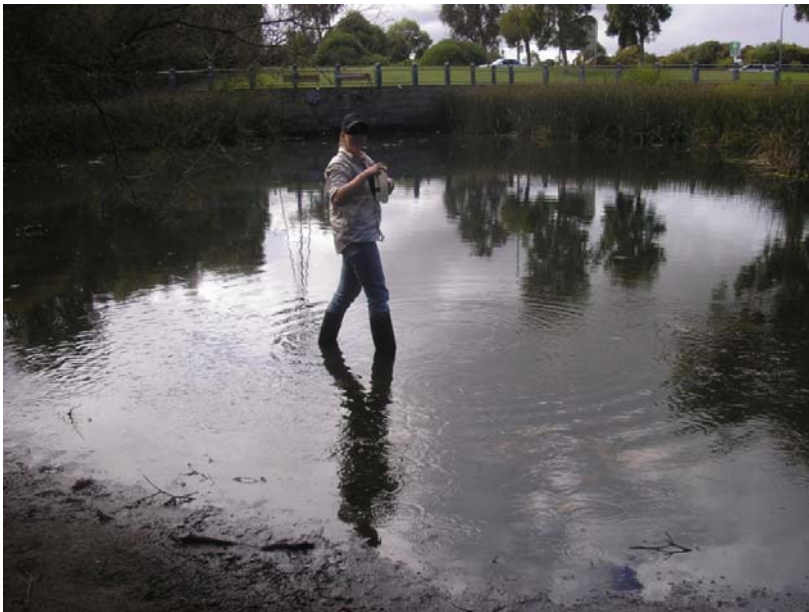
Plate 18: Eighty Road.

Eighty Road had dense vegetation to one side. An algae layer across parts of the water was observed (**Plate 18**). There was almost no movement of water which can present an ideal breeding site for mosquitoes and midges. Gambusia (*G. affinis affinis*) was abundant.

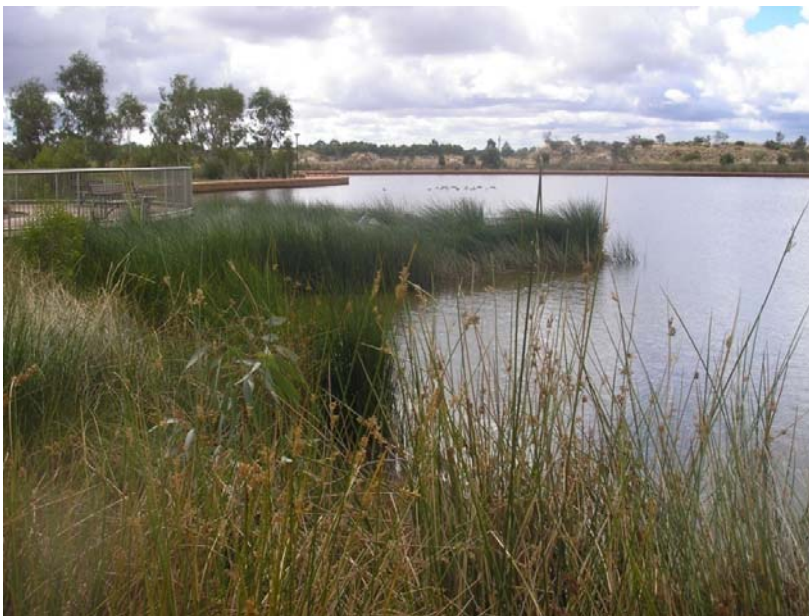
Plate 19: Rivergum Boulevard.

Rivergum was one of the larger wetlands and was in good health. It consisted of one surface aerator and a variety of birdlife were observed (**Plate 19**).

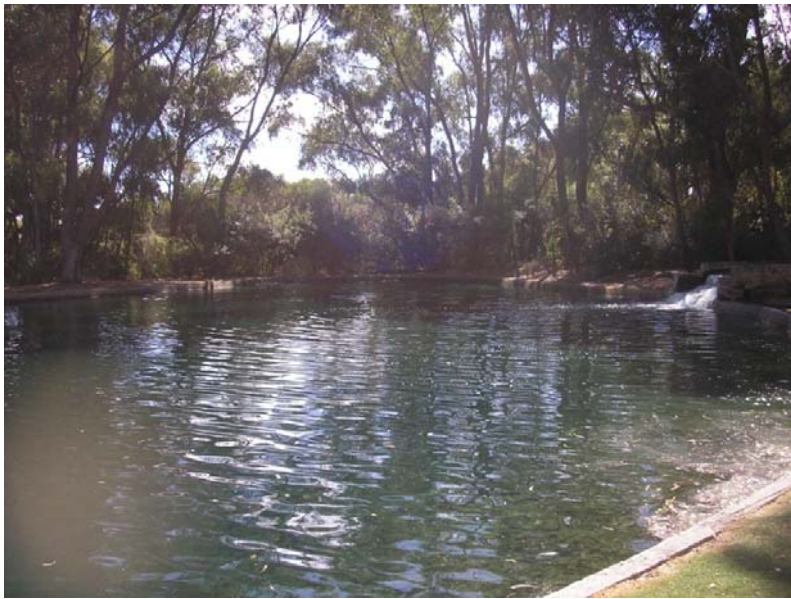
Plate 20: Tuart Grove.

Tuart Grove was aerated with a small man-made waterfall. However, the water was green to aqua in colour (**Plate 20**), further monitoring is suggested as the discolouration was not typical of algal blooms and is not supported by the chlorophyll a counts from the water analysis.

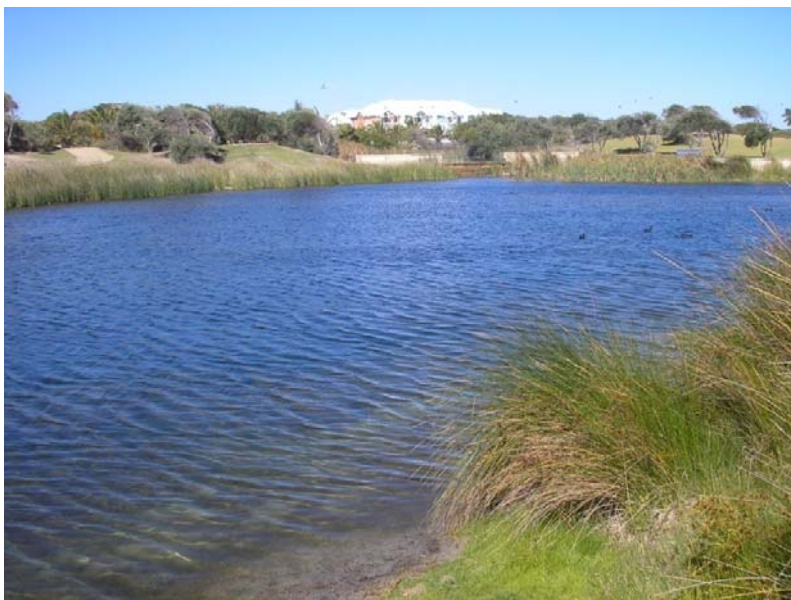
Plate 21: Hidden Swamp.

The largest part of Hidden Swamp had no surface aeration (**Plate 21**). It was relatively clean and well-drained. Native vegetation provided sufficient habitat for the birdlife present. The elevation of the top-part of the wetland created a small drop into the lower-level although it did not appear to sufficiently aerate the water or create any movement. There was a salt crusted algal mat along the waters edge of the lower-level (Waypoint 27 and 28). The upper-level of the wetland was found to be very still and the thick vegetation had created water pooling around it (**Plate 22 & 23**). This could create potential mosquito and midge breeding sites. No *Gambusia (G. affinis affinis)* was seen.

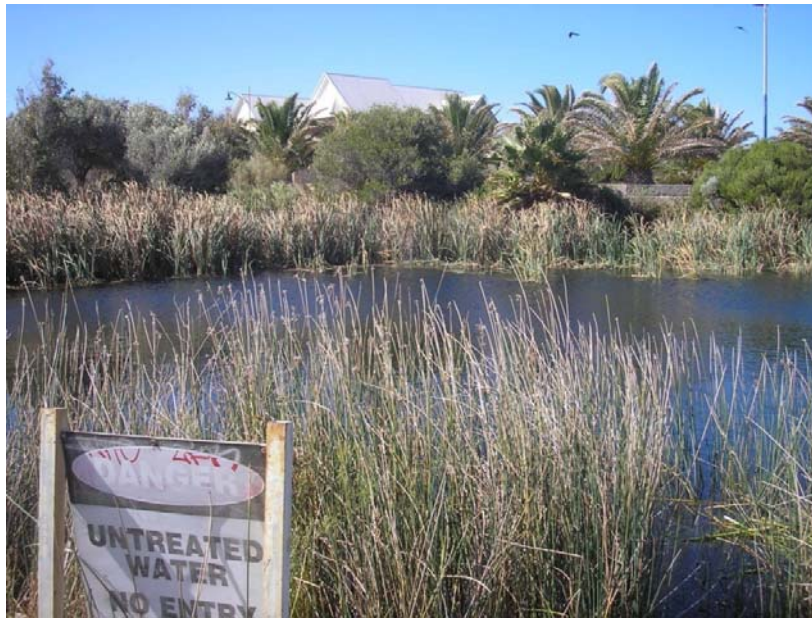
Plate 22: Upper-layer of the lake at Hidden Swamp.

Hidden Swamp however, was found to have pooling water around the upper-level of the lake. This combined with lack of movement or flow (stagnant) created a prime breeding location for both midges and mosquitoes. This was also true for Dress Circle and Eighty Road.

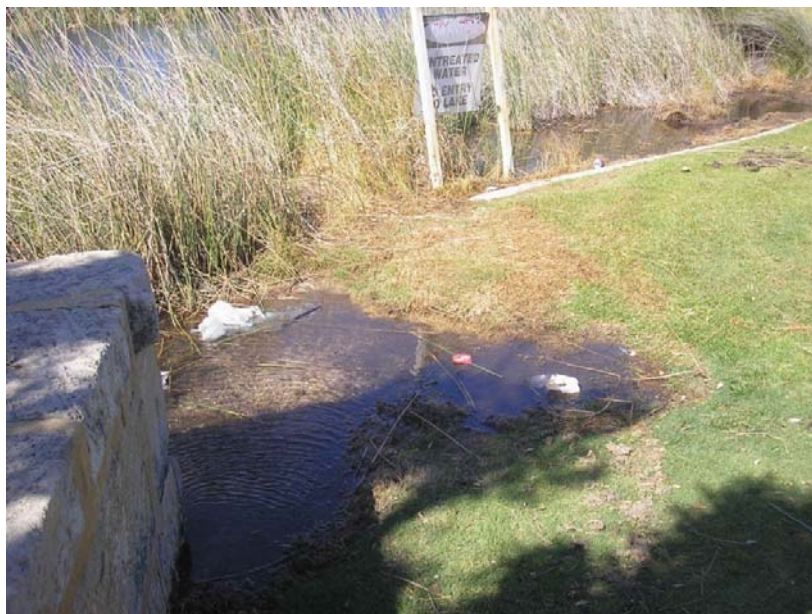
Plate 23: Hidden Swamp showing pooling water and rubbish around the edge of the upper-layer of the lake.

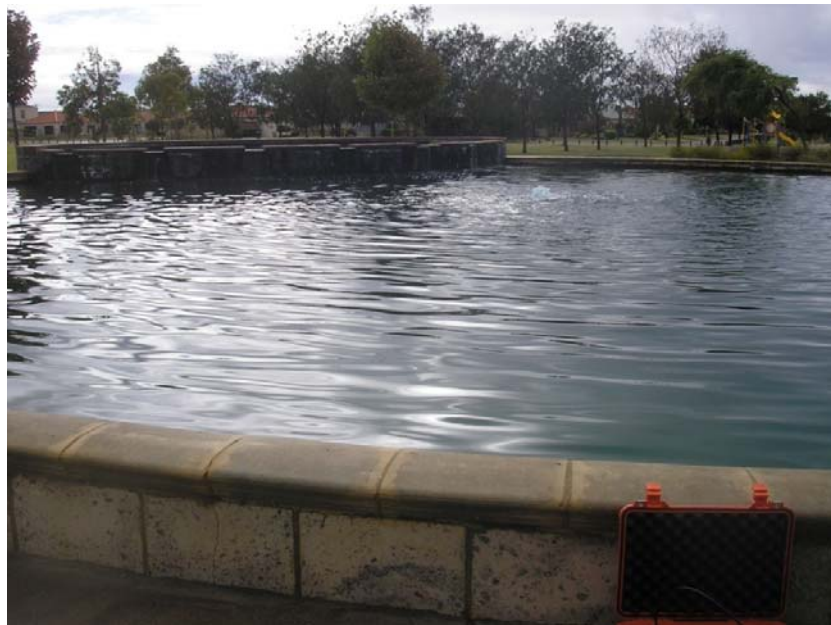
The Proper John site consisted of a small round wetland (**Plate 24**) and a large drain (**Plate 25**). During the site visit the drain was completely dry. The entire area was clean (including the wetland itself) and well-drained.

Plate 24: Proper John urban wetland.

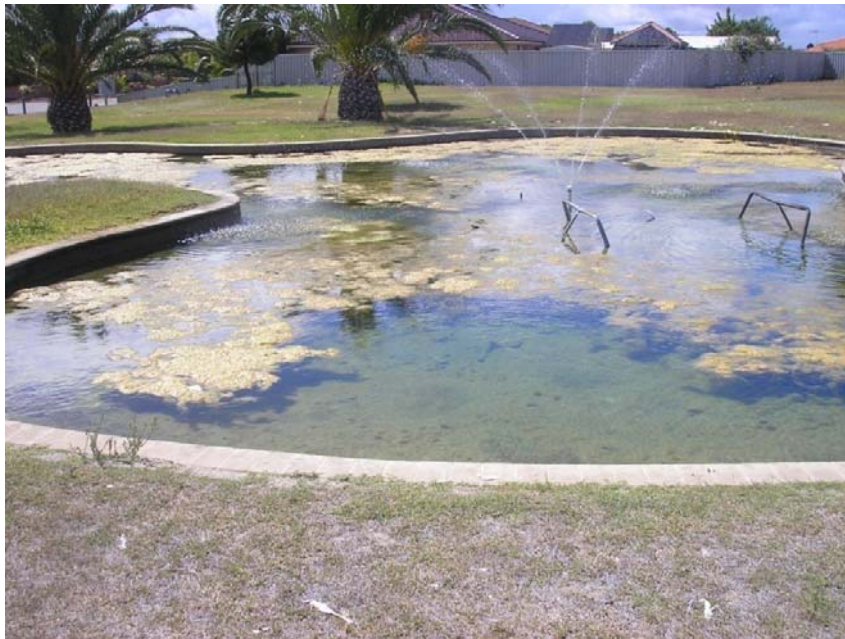
This was the smallest of the sampled wetlands. It had a layer of suspected macroalgae, which is algae that can be seen by the unaided eye and can form through the aggregation of cells (colonies) (Water and Rivers Commission 1998) (**Plate 26**). However, a sample was not taken to confirm this and further investigation is recommended. It is used as a dumping ground for various items (e.g. a trampoline and a phone). It has a small fountain which created limited movement of the water and as such (as a standing body of water) will provide a breeding site for midges and mosquitoes. It also gave off a faint odour.

Plate 26: Dress Circle Basin showing rubbish dumping and suspended matter.

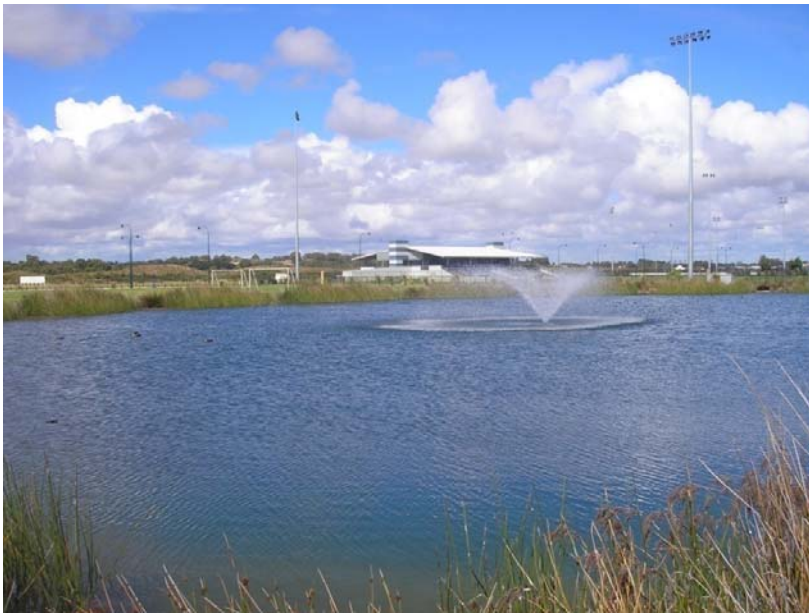
Plate 27: Lark Hill Sporting Complex.

Lark Hill, a rounded wetland at the far end of the Lark Hill Sporting Complex was clean with good water flow and a variety of birdlife (**Plate 27**).

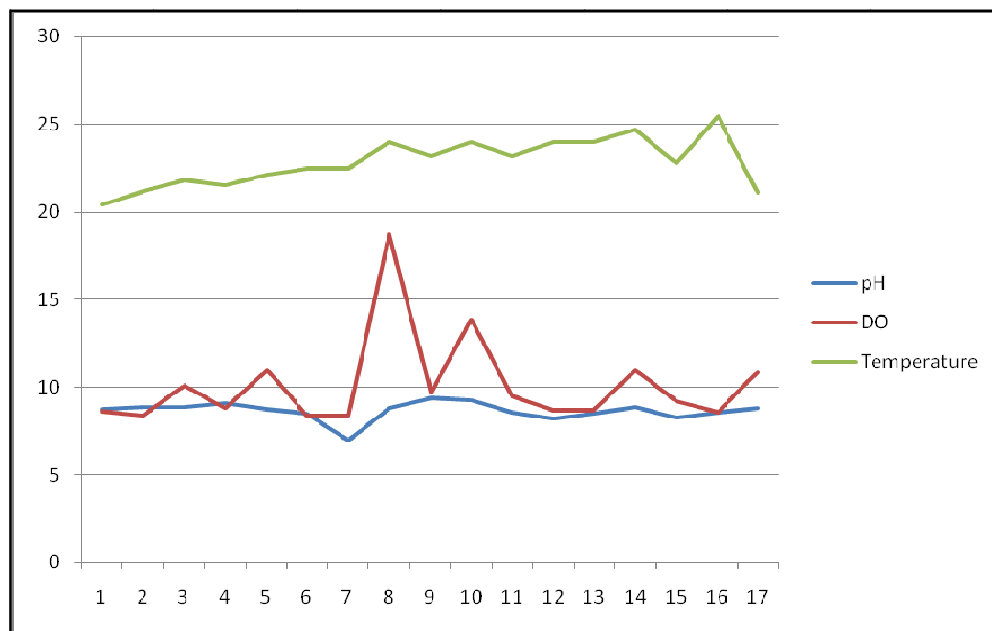
Figure 1: pH, DO and temperature readings from all sites.

Field results showed that the wetlands were all within the ANZECC guidelines (**Table 3**) for environmental water quality of aquatic ecosystems except for the salinity at Rotary Park which was not thought to be unusual due to its close proximity to the ocean (**Appendix 3A, 3B & 3C**). Some of the pH measurements were also above the preferred range specified by the ANZECC guidelines (**Appendix 2**) however these differences were minimal.

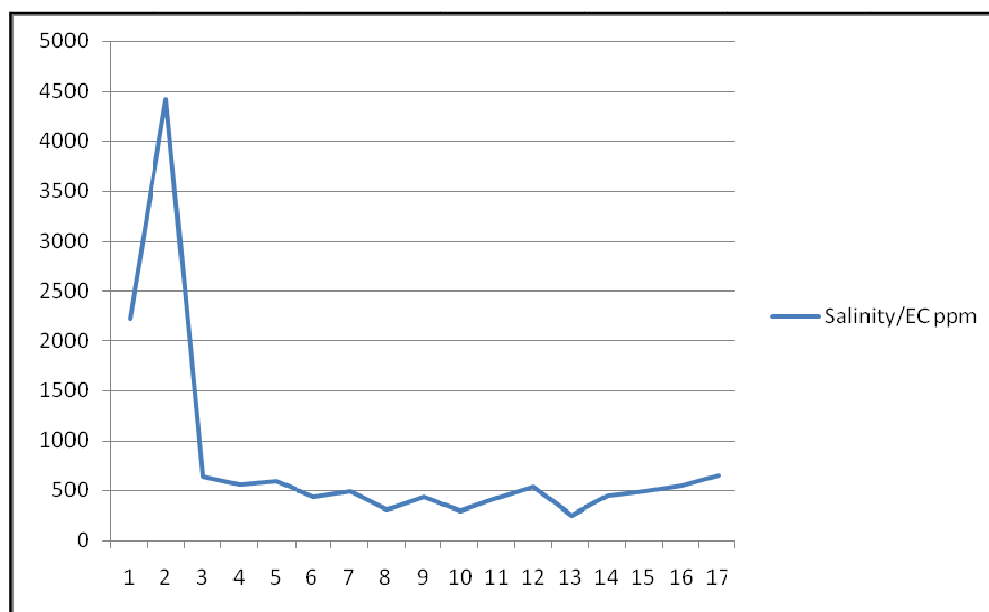
Figure 2: Salinity measures from all sites.

Rotary Park samples showed a high saline result. However, with the sites close proximity to the ocean this result is expected.
