HOCKING HERITAGE + ARCHITECTURE

# East Rockingham Pioneer Cemetery Conservation Management Plan December 2022

## EXECUTIVE SUMMARY

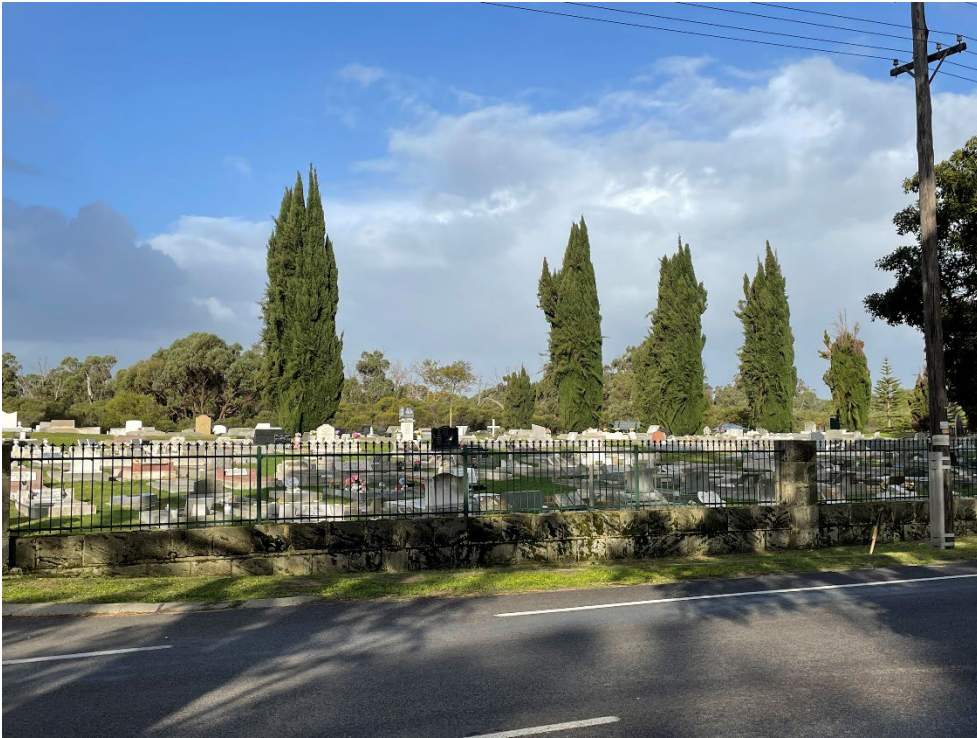
The limestone boundary fence incorporates a break in the panelling to accommodate the wide trunk of the Moreton Bay Fig.

Figure 15 Boundary fence along Mandurah Road

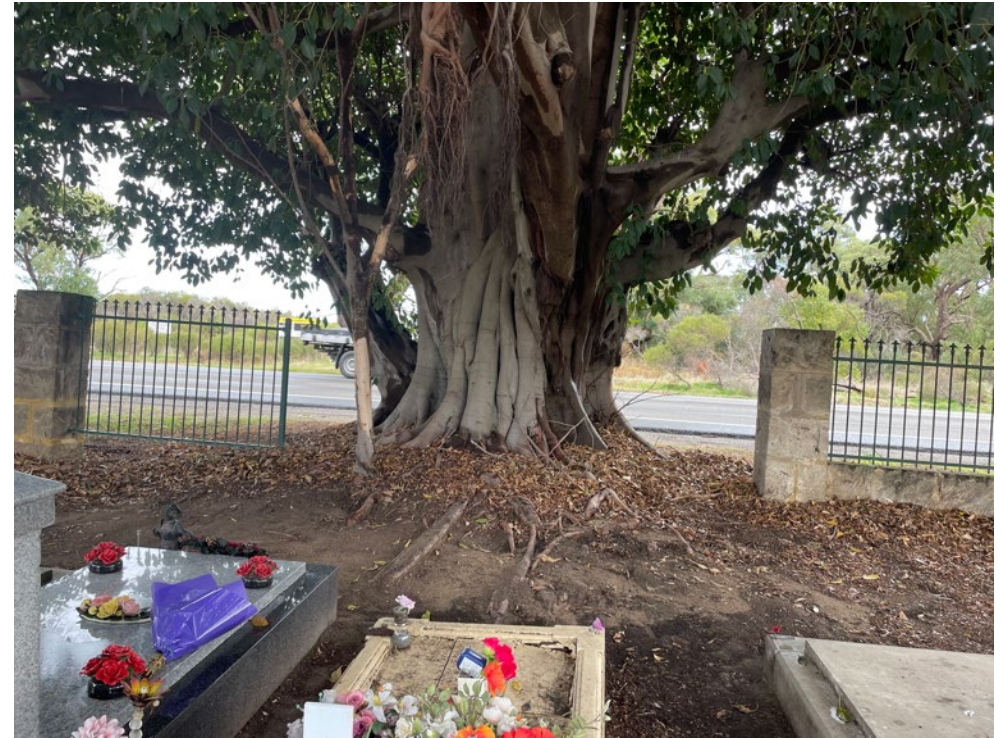
Figure 16 Break in the limestone fence for the Moreton Bay Fig

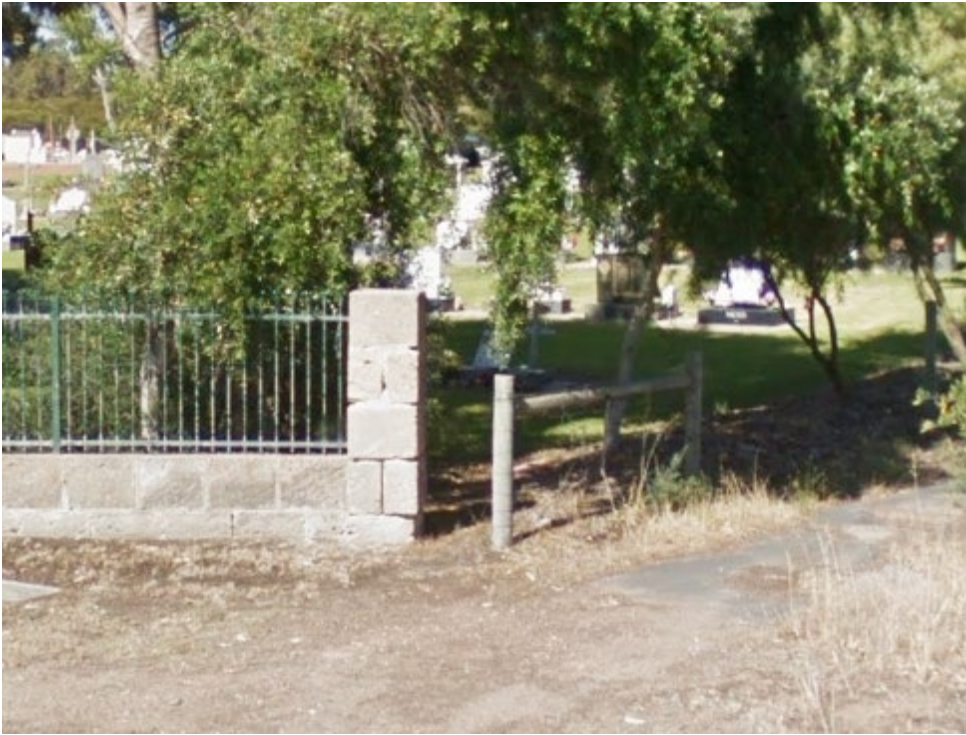
Other boundaries around the site are timber post and rail fences and timber and wire fences, which are in keeping with the immediate bushland setting of the cemetery. There are sections of the cemetery where the boundary treatments are in failing condition.

Figure 19 Post and rail fences

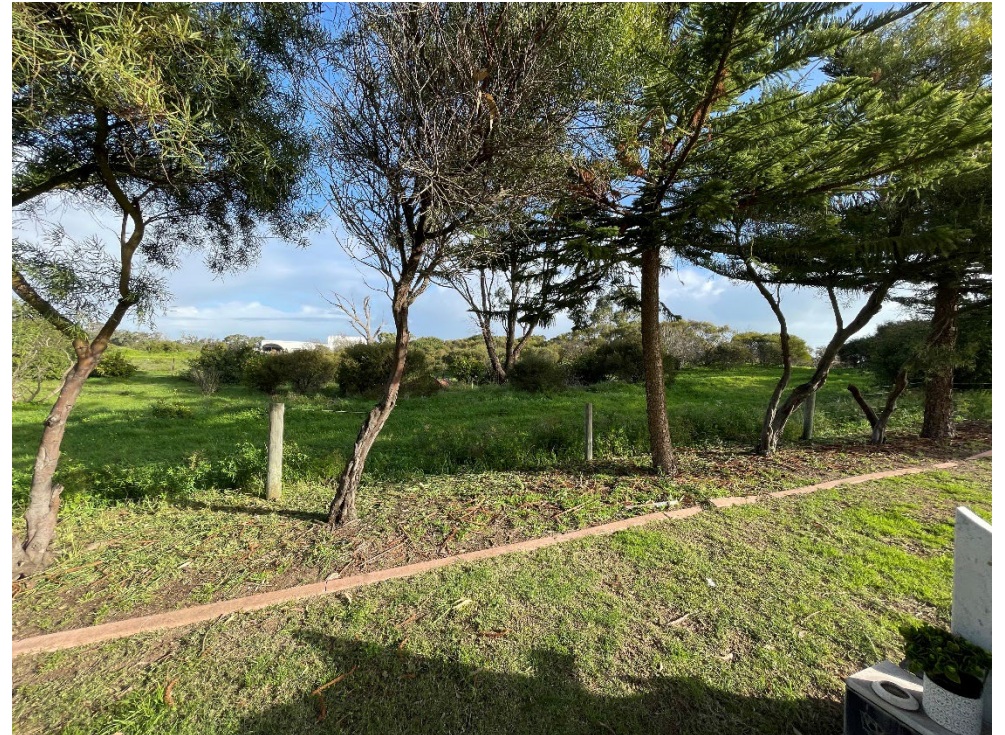
Figure 20 Wire boundary fence

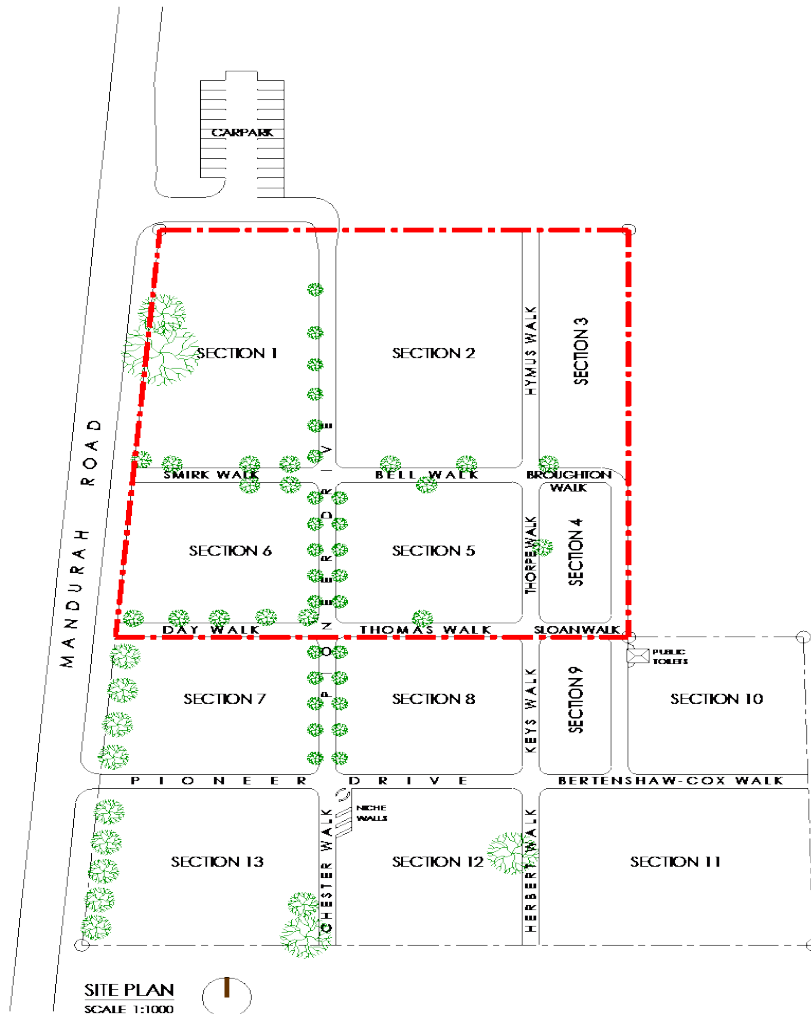
Figure 23 Site Plan

The cemetery is divided into a neat grid plan, with the earliest burials taking place in sections 1-6. The later sections are to the south of Day Walk, Thomas Walk and Sloan Walk. Burials have occurred in all sections apart from 9 and 10 with sections 8 and 11 only being half full.

The north-south and east-west pathways through this section of the cemetery are named after some of the early pioneer families including Day, Smirk, Thorpe, Bell and Hymus. All these families had houses nearby.

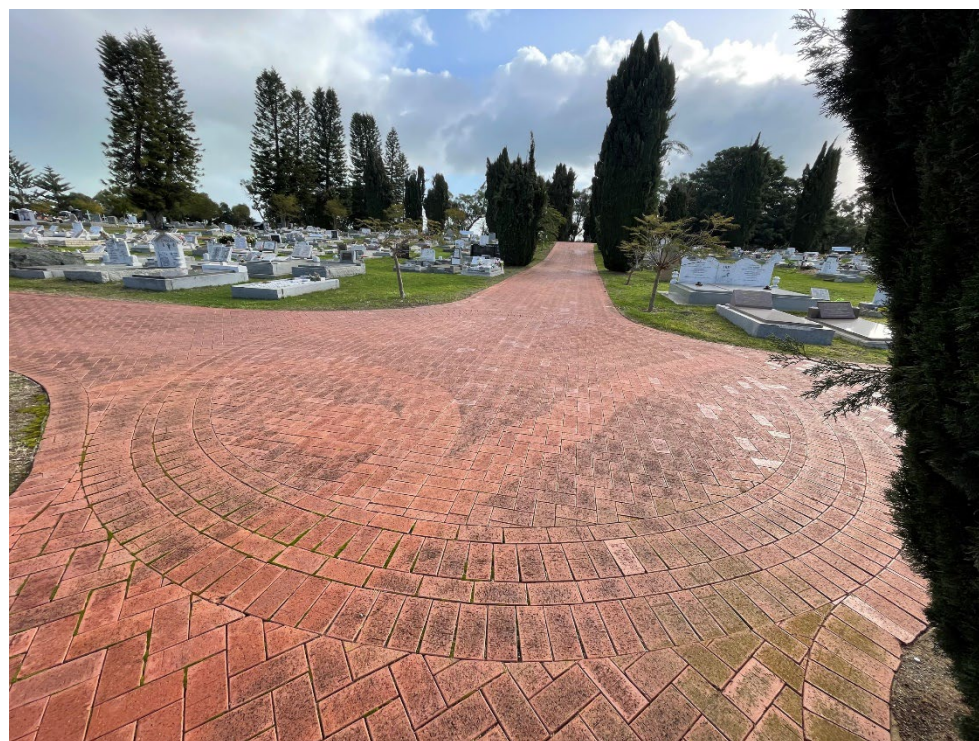
Figure 26 Various patters in the red brick paving

The pathways are of red brick paving arranged in a herringbone pattern, edged by the lot flat face of the pavers. Contrasting patterns mark the cross points of the paving. Additional wayfinding markers are inserted into the paving identifying the section and the plot numbers.

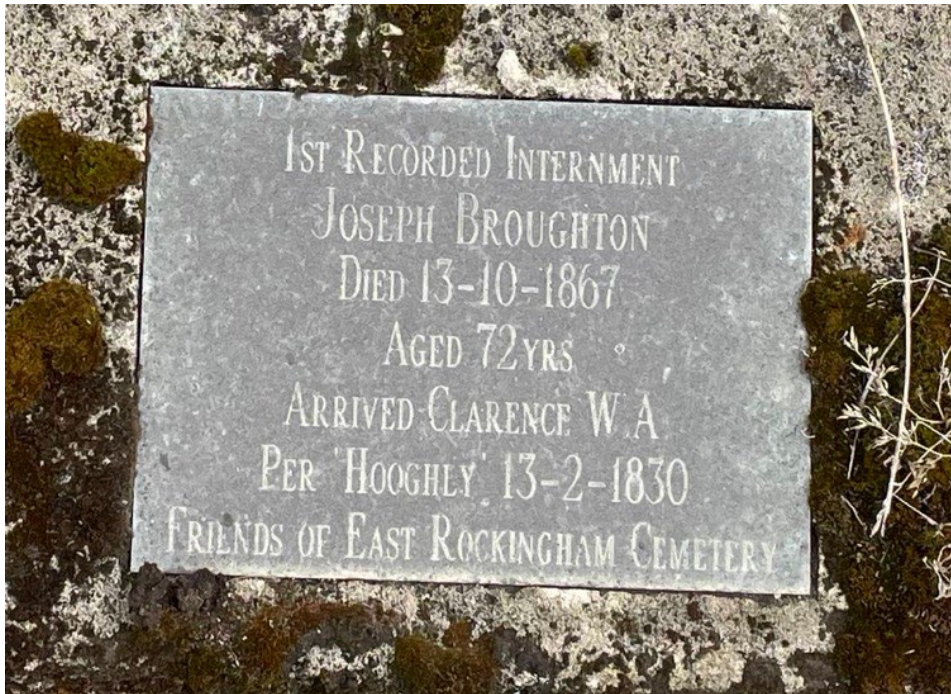
Joseph Broughton died on 13 October 1867 with his grave being one of the oldest in the cemetery located in the north west corner. The construction of the limestone wall along the western and north-western boundary disturbed the grave. As a result, the Friends of Rockingham Cemetery erected a simple limestone plinth with plaque commemorating Joseph Broughton.

Figure 29 Joseph Broughton Plaque

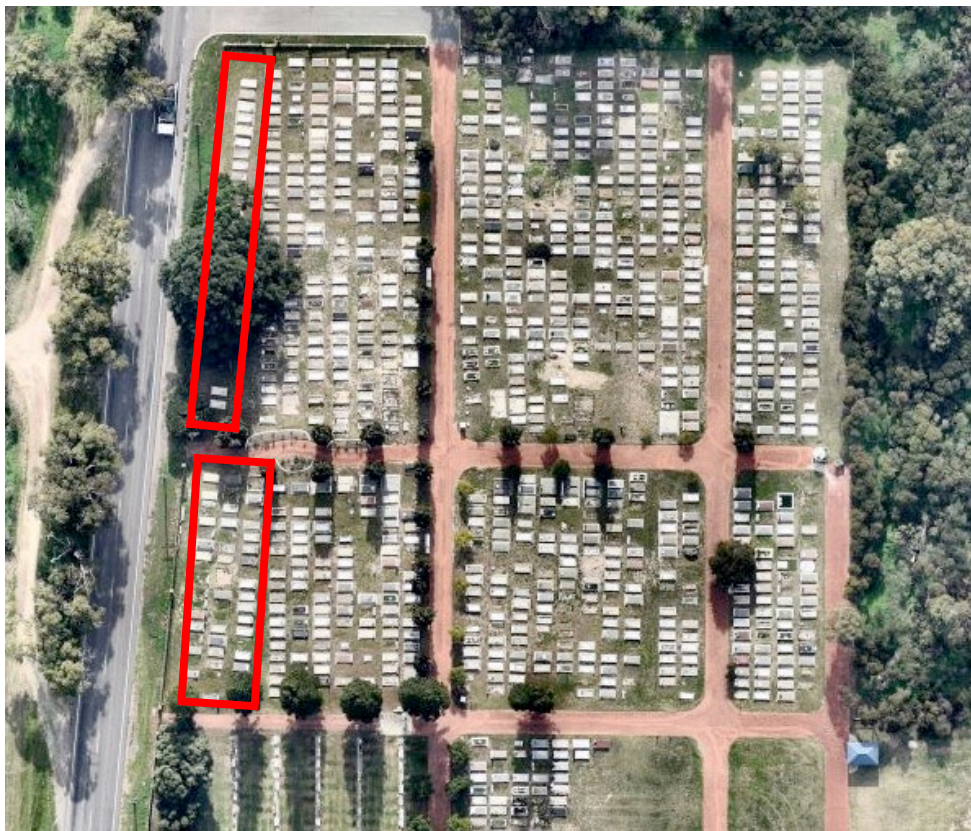
Aerial views clearly illustrate the formality of the arrangement of the early graves. The graves are laid out in regular rows, with the first three rows along the western edge being on an angle following the alignment of Mandurah Road.

Figure 35 Gravestones following the alignment of the road  
Courtesy Nearnmap, 2022

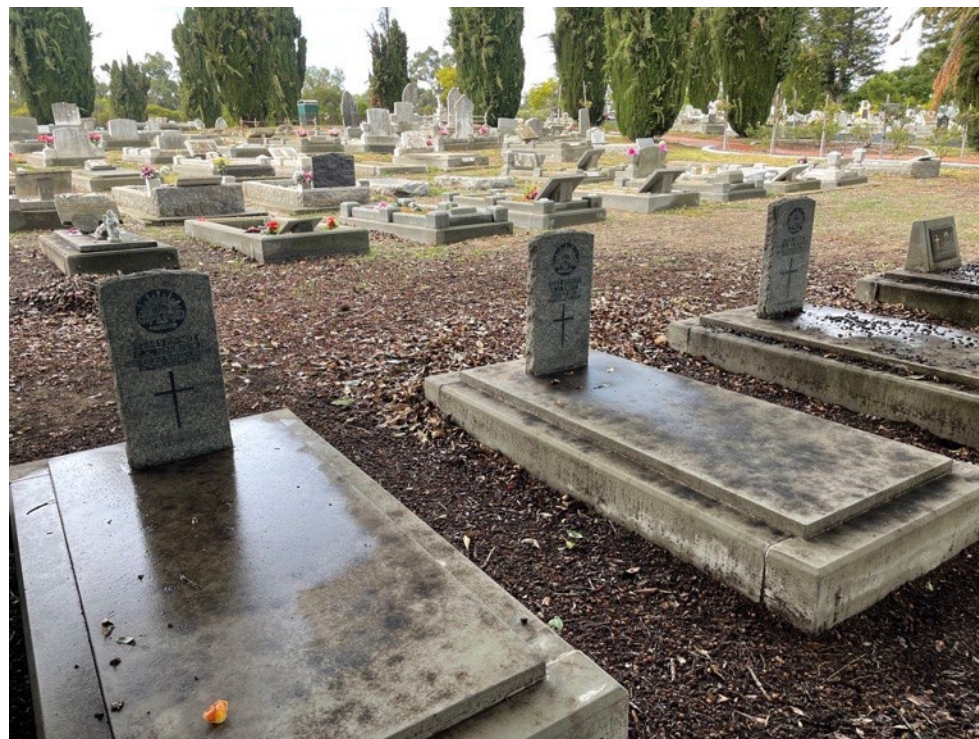
In the north west corner of section 6, there is a group of graves belonging to soldiers of the Australian Imperial Forces dating from 1918. The headstone

contains the name, rank, number and date of death as well as bearing the badge of the Australian Imperial Forces. The headstones are vertical roughly hewn granite slabs which sit on top of a granite slab grave. Three of the headstone are identical with a fourth grave bearing a plaque on a concrete headstone. The information contained on the fourth headstone is the same as the others.

Figure 36 Australian Imperial Forces Gravestones from 1918

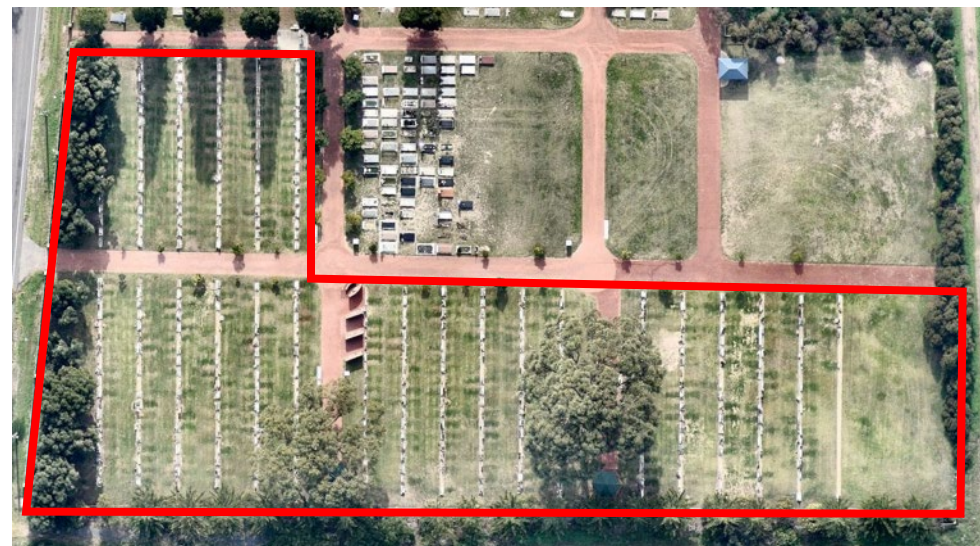
Sections 7, 11, 12 and 13 of the cemetery are regarded as being a lawn cemetery with rows of concrete beams extended in a north-south direction with the headstone memorials attached to the beams. The headstones face both east and west. Due to the provision of the concrete beams, there is a much more rigid appearance to the layout of the graves.

Figure 39 Lawn cemetery with concrete beams and headstones

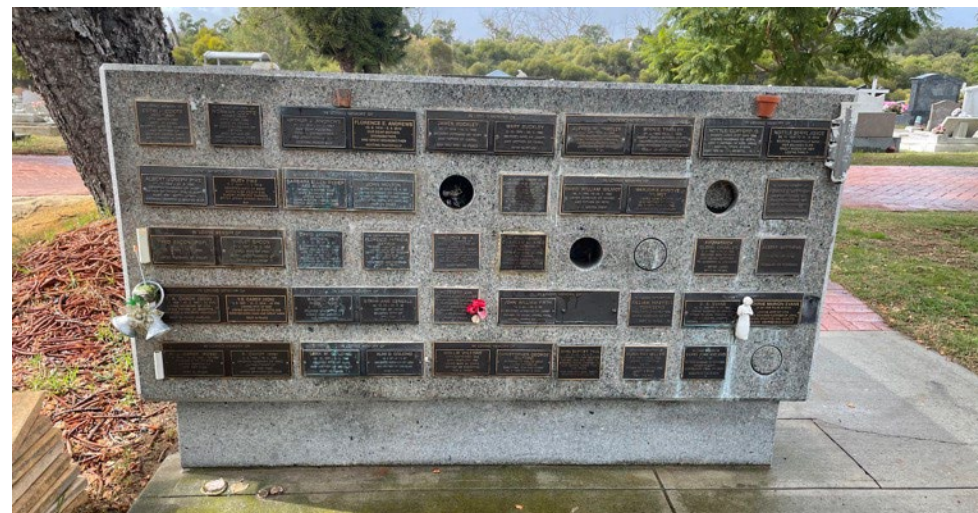
In addition to the headstones, there are three columbarium niche walls. The granite walls contain individual resting places for ashes which are then enclosed by a commemorative plaque. The columbarium niche walls are located in the north west corner of section 12, adjacent to Chester Walk.

Figure 42 Columbarium niche wall

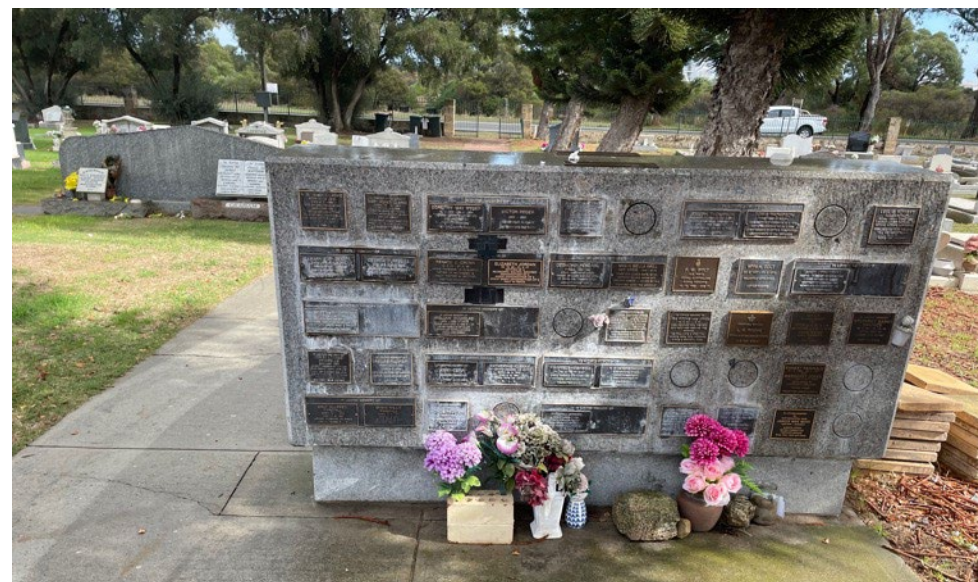
Figure 43 Columbarium niche wall

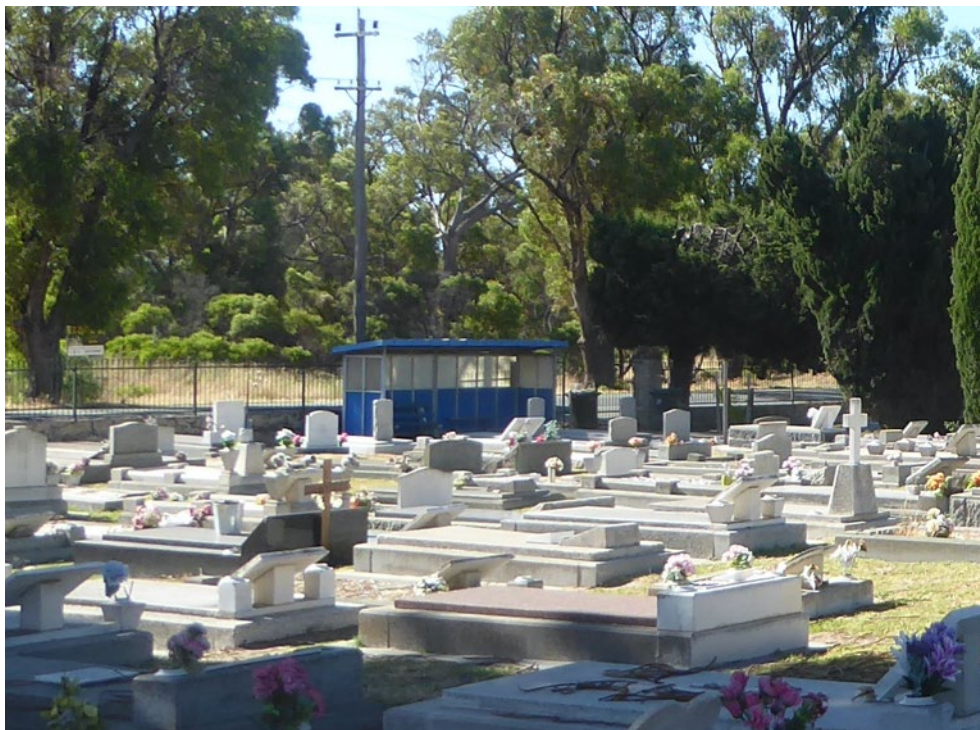
- A shelter constructed from metal frame with fibro cladding located along the western boundary to the south of Smirk Walk in section 6
- Water tank at the eastern end of Broughton Walk
- Toilets constructed at the eastern end of Sloan Walk
- Open sided timber gazebo at the southern end of Herbert Walk in section 11
- Open sided timber gazebo at the southern end of Chester Walk in section 12

Figure 44 Shelter in Section 6

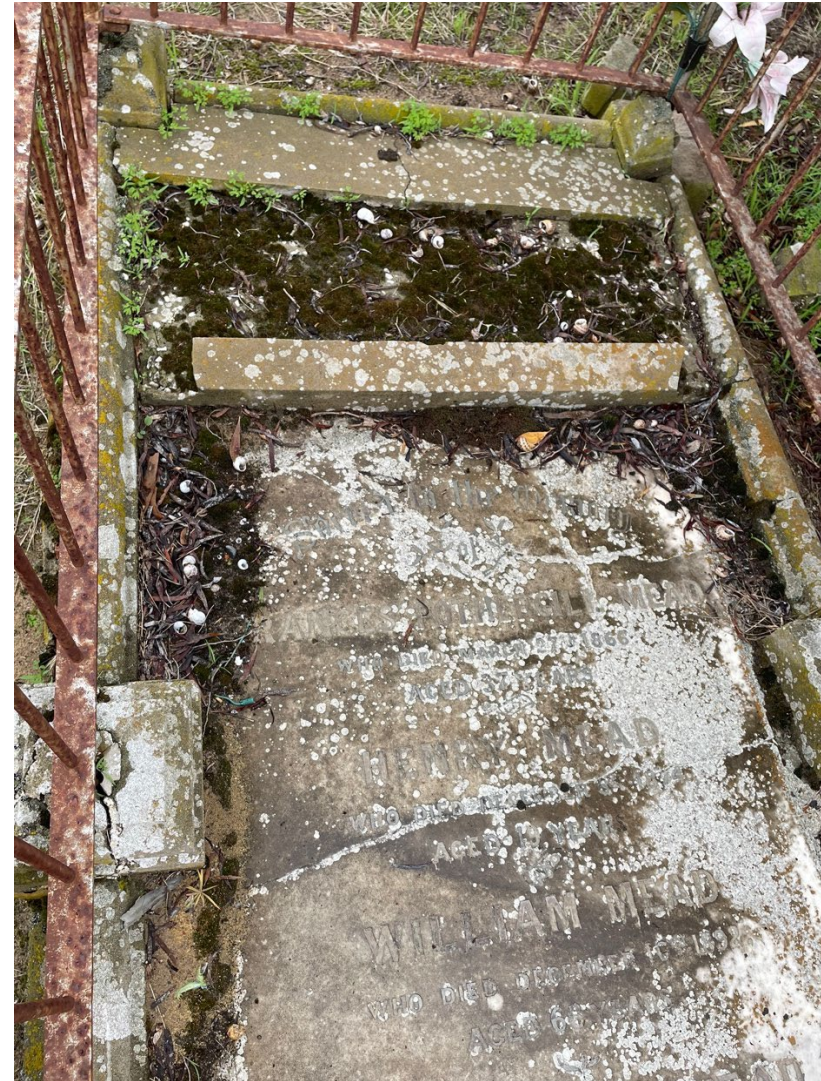
Stone ledgers (the top of the grave) have cracked in some instances, the kerbing/edging around the graves has been chipped and cracked and the stone topping so graves without ledgers has been lost.

Figure 49 Cracked ledger stone (note this headstone moved from Fremantle Skinner Street Cemetery).

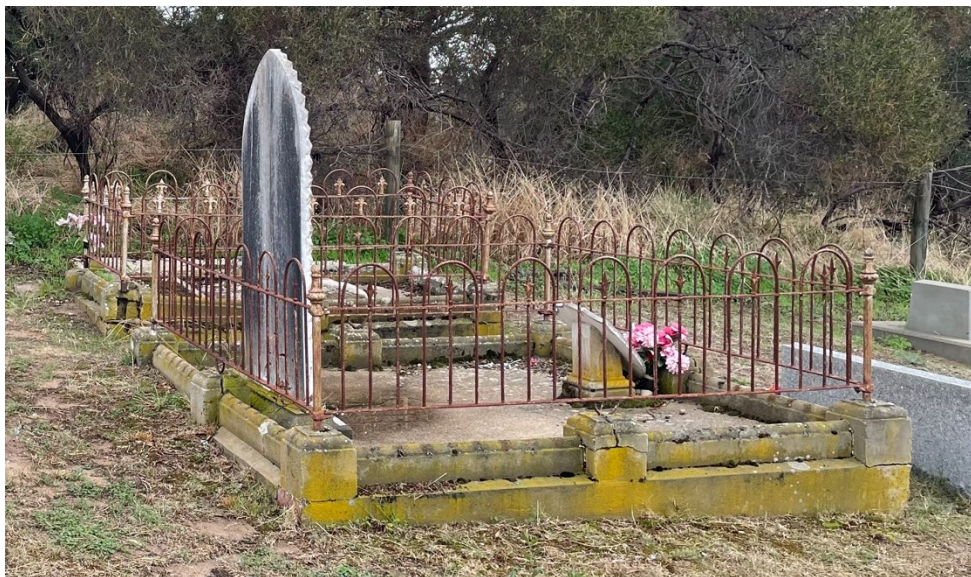
Figure 50 Cracked stone edging around the grave and rusted palisade fencing around the grave

The cast iron surrounds around many of the earlier graves are also beginning to show signs of deterioration. The metal is rusted and corroding with sections missing in place so there is no longer a complete surround to some of the graves.

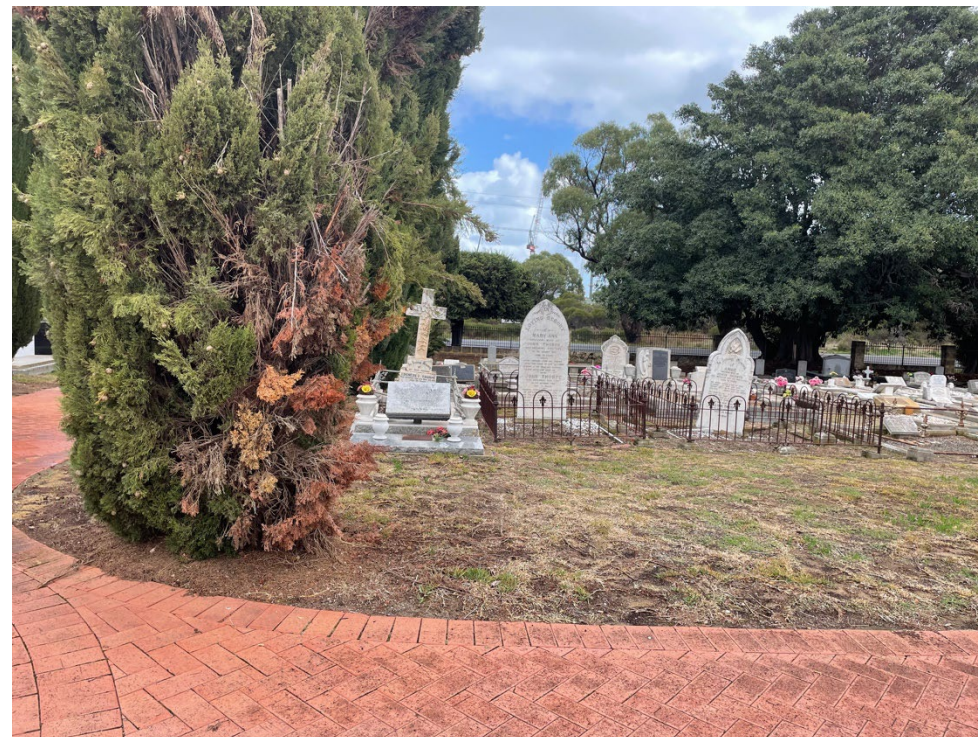
A number of the headstones and graves are suffering from subsidence and beginning to sink, creating a listing aesthetic to the grave. The reason for the subsidence should be investigated. Some of these stones including the Ebenezer Thorpe grave, are adjacent to trees where the root structure may be undermining the ground around the graves.

Figure 51 Graves suffering from subsidence adjacent to trees

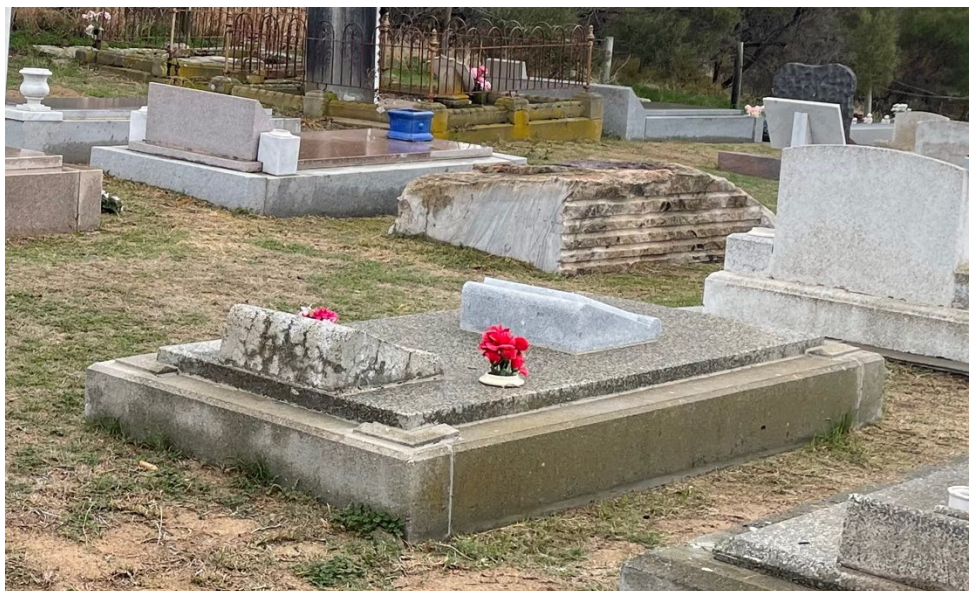
Lichen and moss growth is visible on some stones, particularly where the stone has started to delaminate and collect water.

Figure 52 Moss growth in cracks on headstones

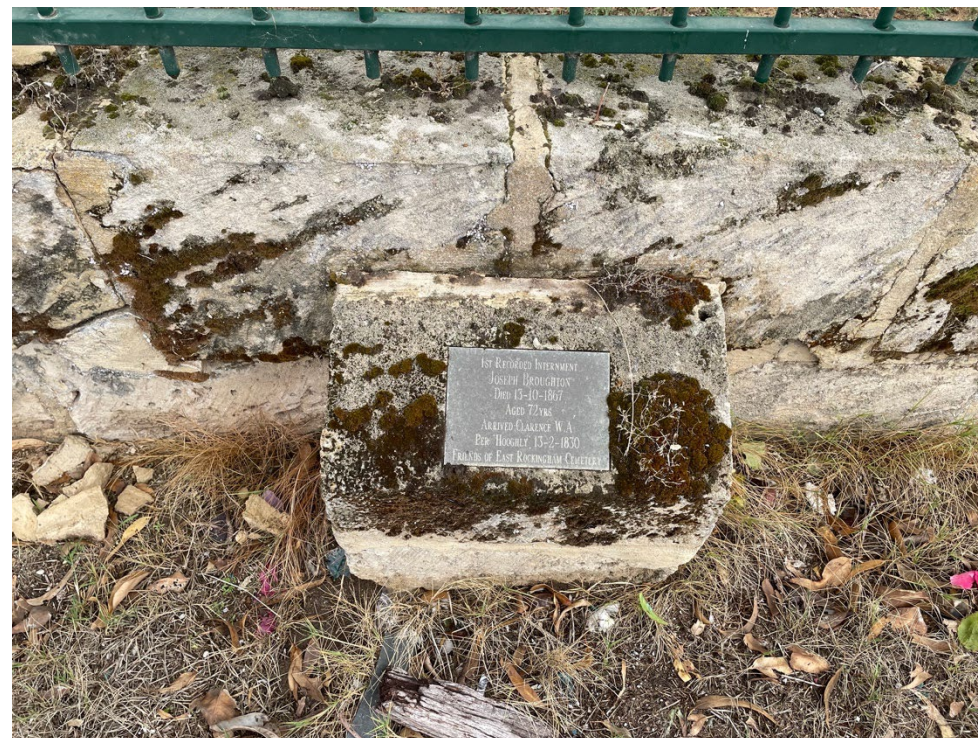
Figure 53 Moss growth in limestone

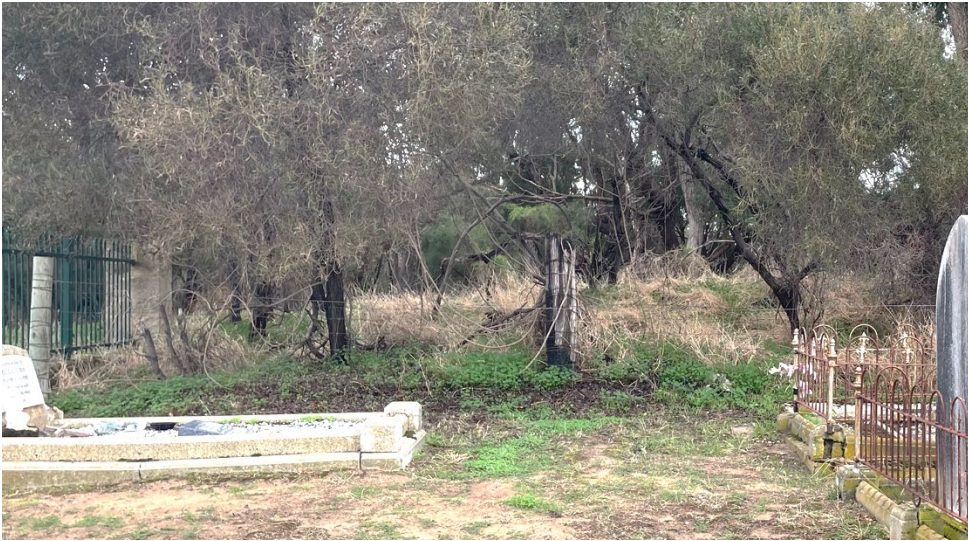
The limestone wall along the western boundary is in good condition. The timber and wire and timber and post fences to the other sides of the cemetery are in failing condition and need to be repaired. There is no need to erect a boundary fence of the same style all around the cemetery, a more rustic post and rail fence to the north, south and east boundaries is acceptable and in keeping with the more natural setting of the adjacent bushland.

Figure 54 Broken post and wire fence to northern boundary

As more industrial development occurs or if the cemetery is prone to vandalism a more secure type of fencing may need to be considered. As a public cemetery, and a cemetery where burials are still occurring, it is imperative that access is granted. Locked gates can cause a management issue but these may be necessary if conditions change.

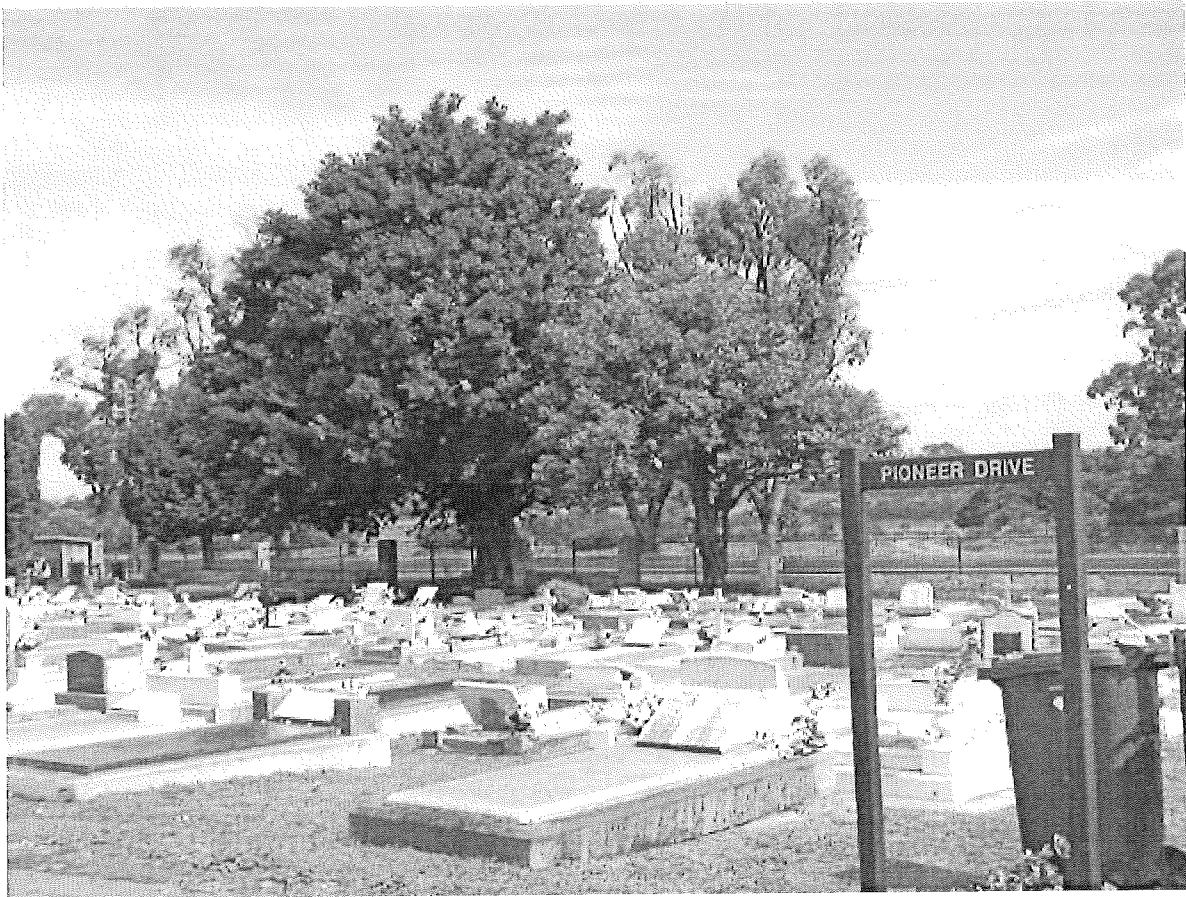
Plate 1 View of Section 1 looking south west. Note mature trees along boundary wall.

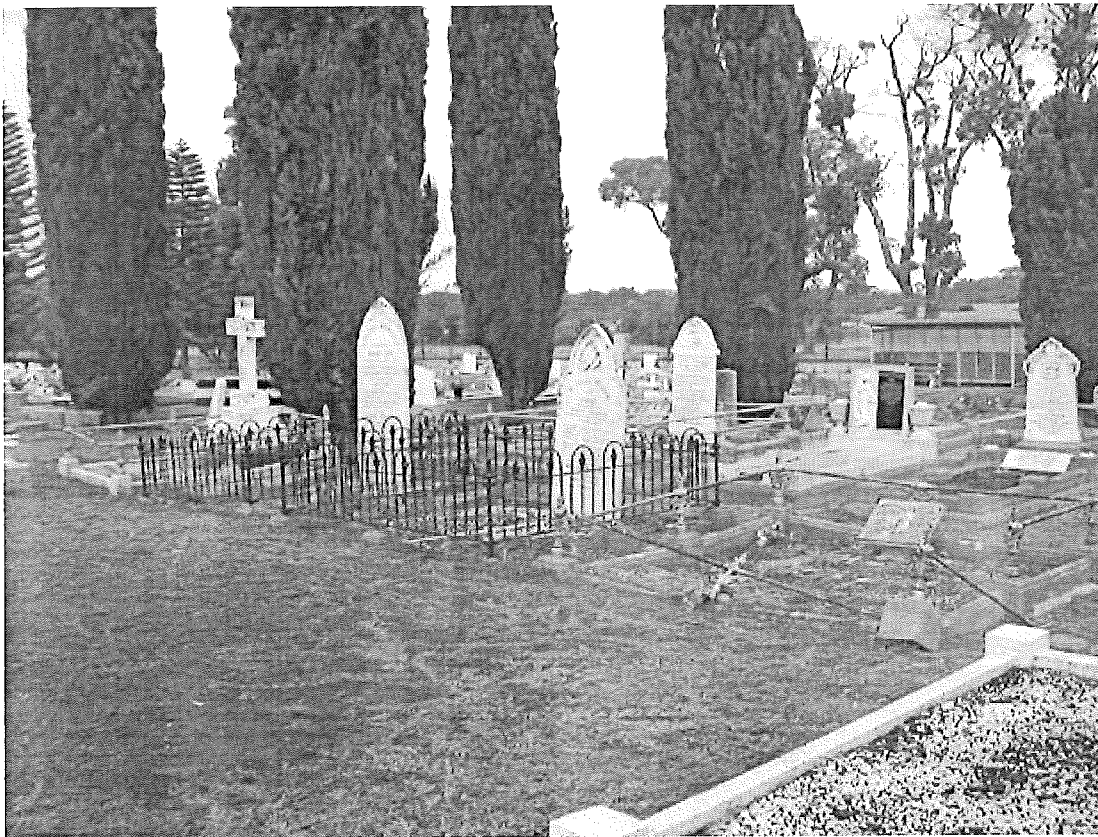
**Plate 3** View of Thorpe family plot represented by Ebenezer and Martha at extreme left, then Mary and John Thorpe, Annie Farmer and William Thorpe and double plot of Hanretty family.

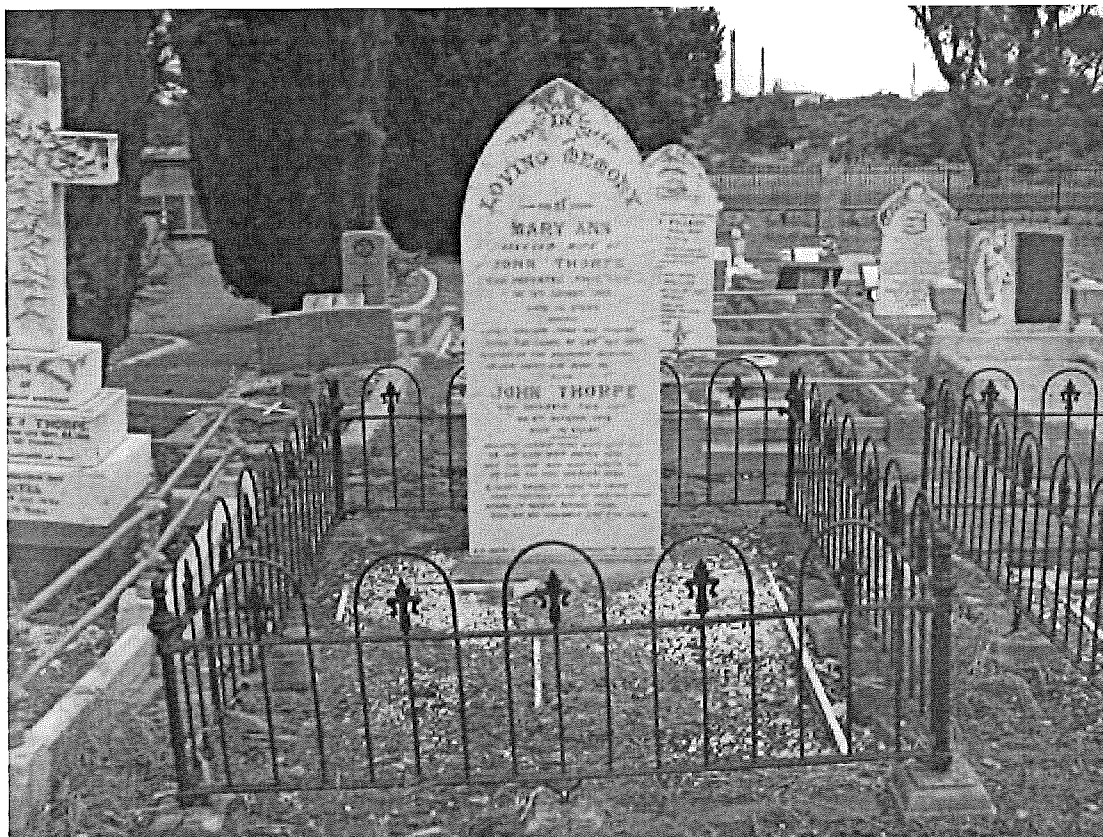
**Plate 4** Grave of Mary Ann and John Thorpe

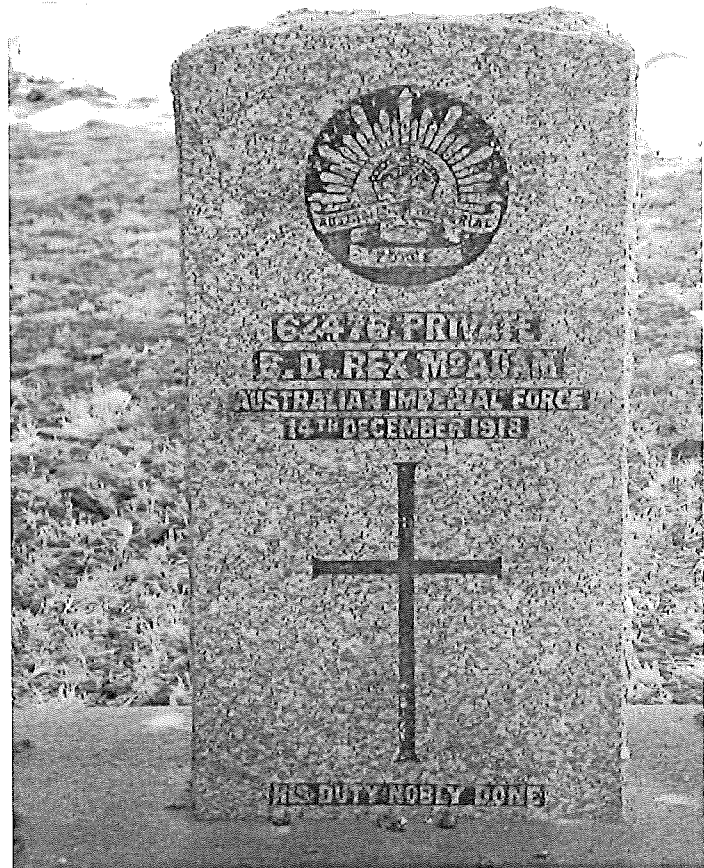
**Plate 6** Private McAdam's  
headstone displaying the style  
which can be seen in the seven  
A.I.F. burials

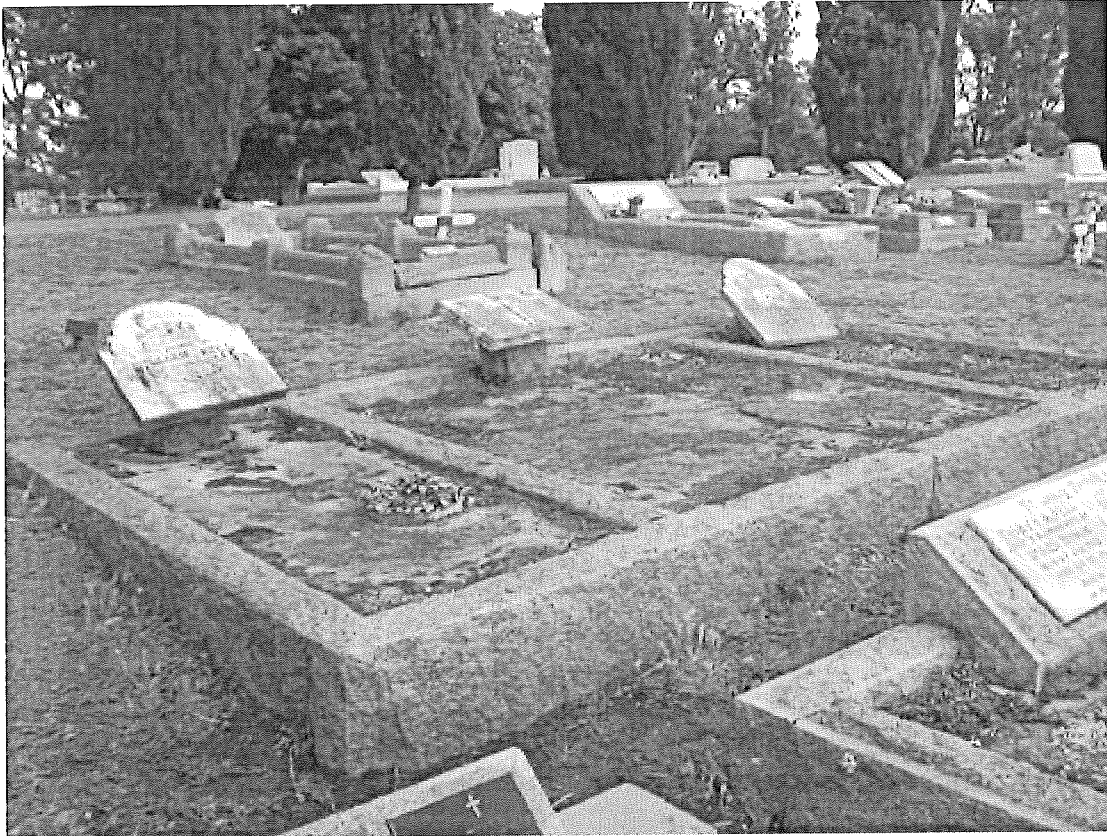
Plate 10 Bell Group: William, double plot of Jane and husband James and John Bell

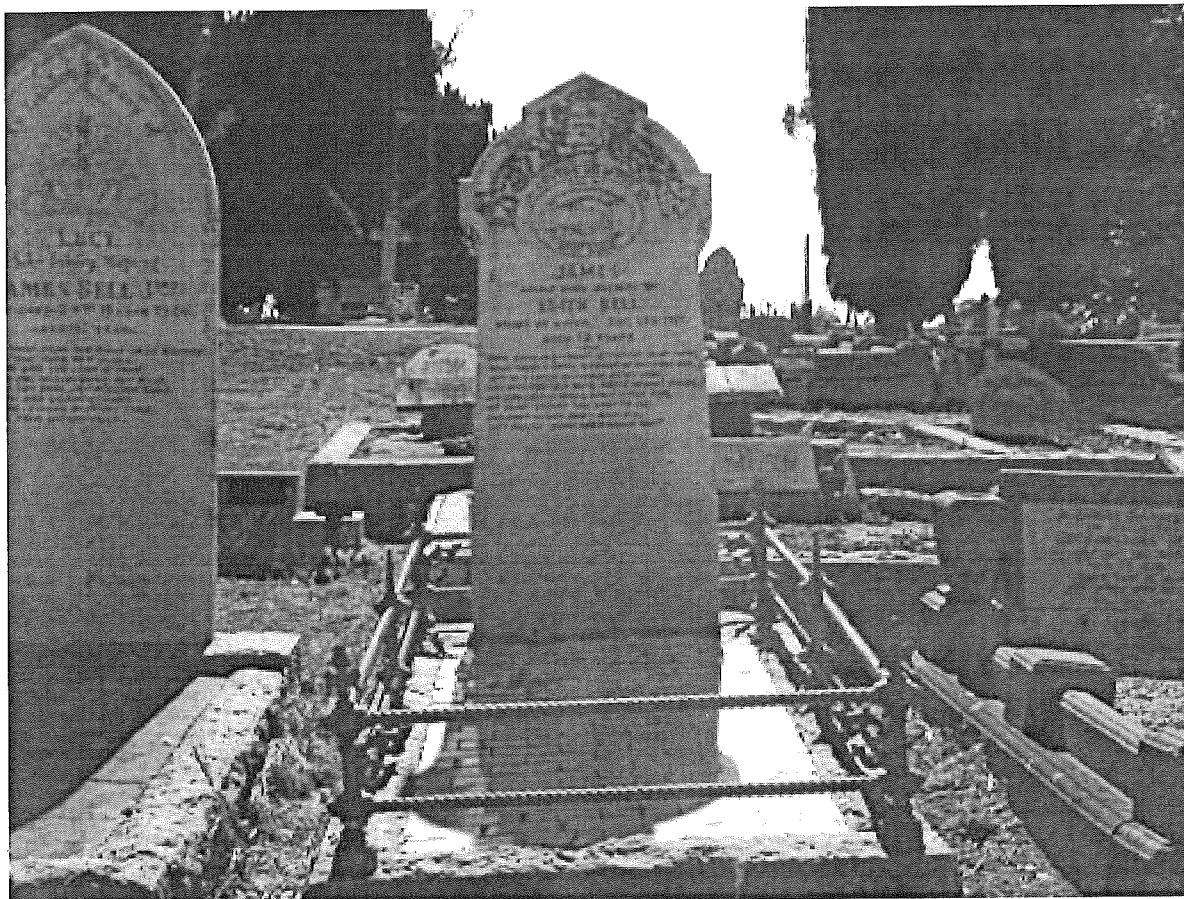
Plate 14 Graves of Lucy, James and Edith Bell

Plot 97 is occupied by Lucy Bell (nee Ramsay, died 24 March 1900). Lucy was the first wife of James Bell jnr. The grave is defined by a roughly dressed granite kerb covered with a concrete ledger. A arched, marble headstone sits on top of the ledger at the western end. It features a stylised bunch of flowers tied with a garland and carries the

inlaid inscription below. The edges of the arch have an engraved decorative motif. Both the grave and headstone are in good condition.

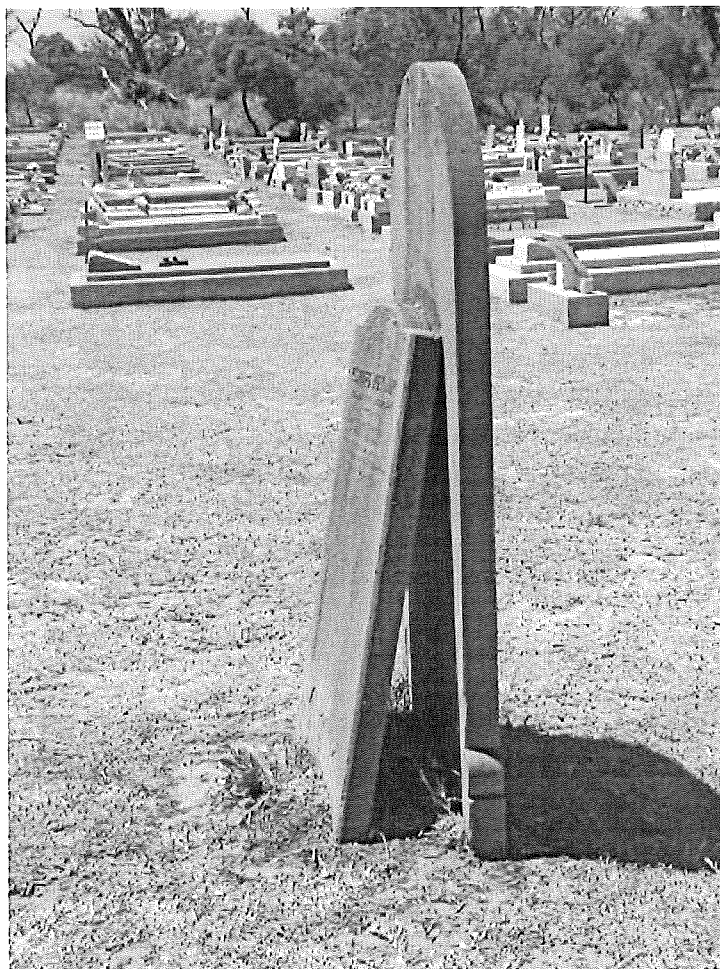
**Plate 16** Headstones for  
Edward Key snr and  
Edward key jnr

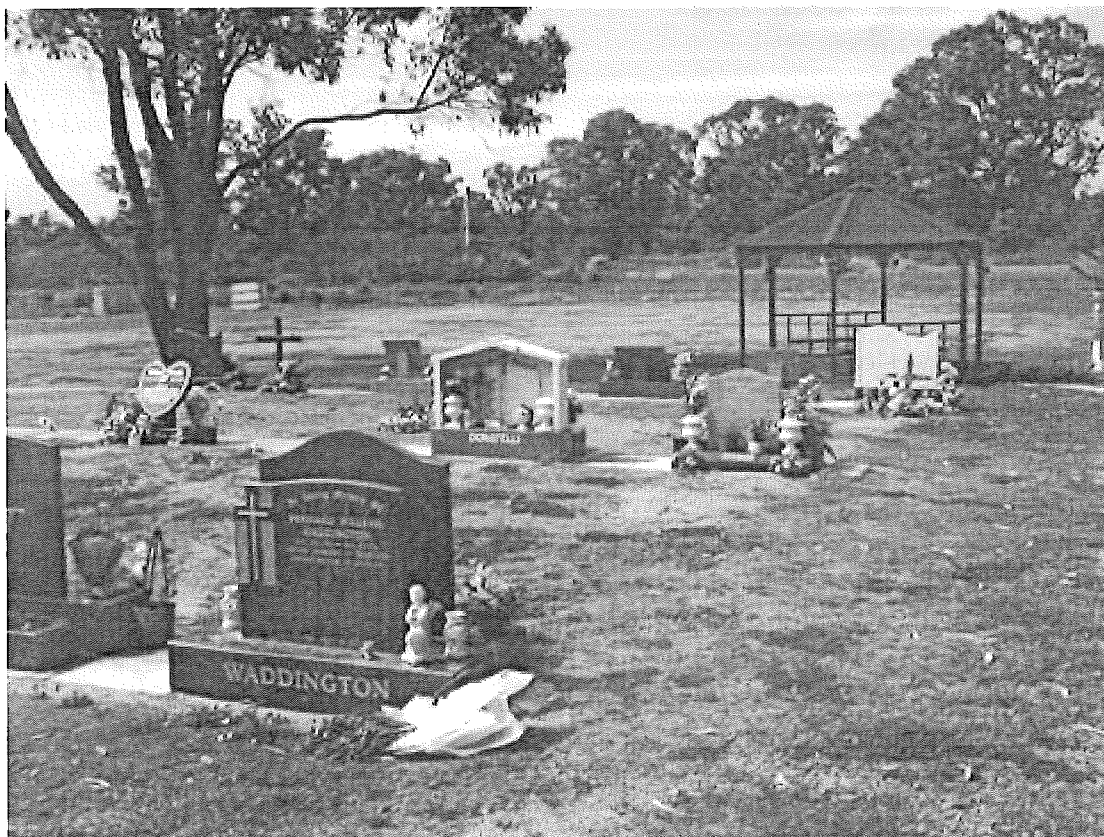
**Plate 22** View of Sections 11 and 10 looking north east. Note new gazebo which is located at the southern end of Herbert Walk.
