HOCKING HERITAGE + ARCHITECTURE

# East Rockingham Pioneer Cemetery Conservation Management Plan December 2022

## EXECUTIVE SUMMARY

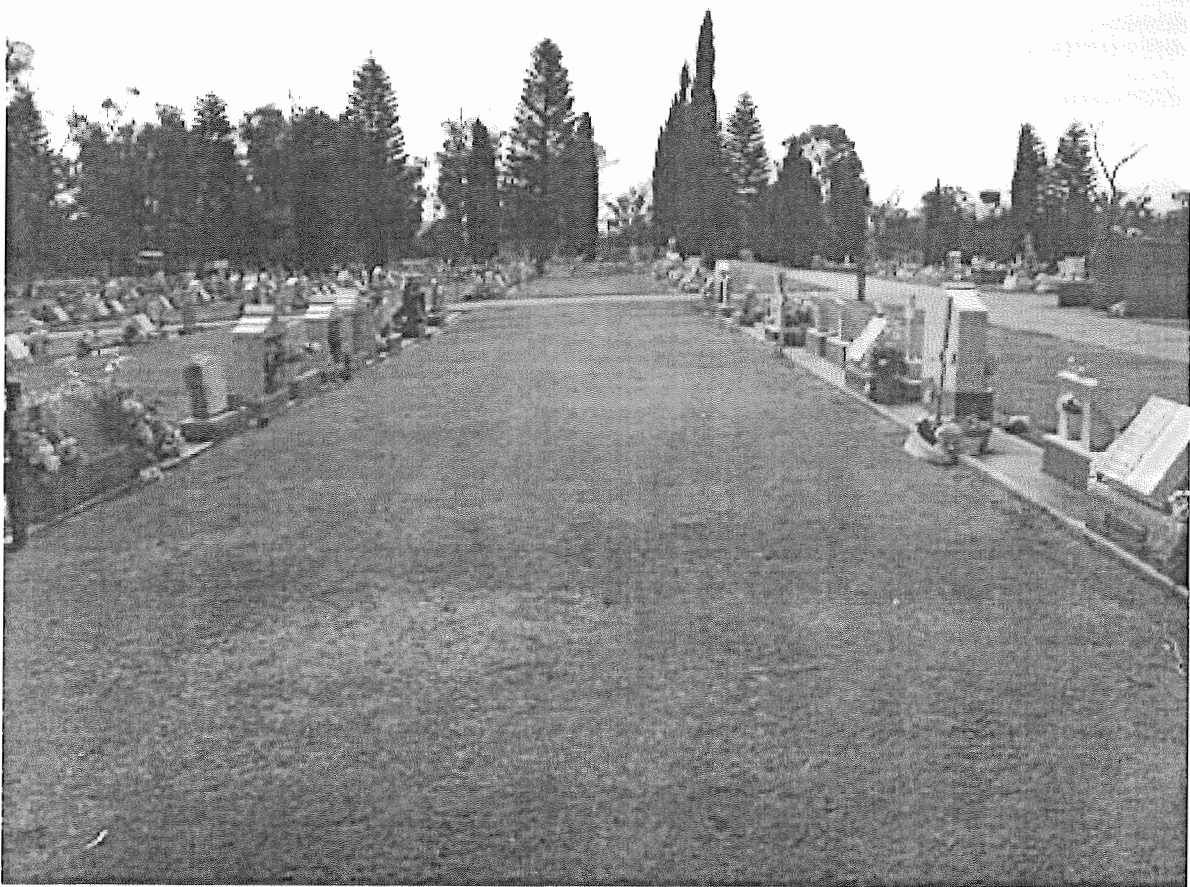
**Plate 23** Photo taken from the southern end of Section 13 looking north across Section 7 with Section 6 beyond the line of trees. To the right is Chester Walk and the two brick columbaria.
