Rockingham Road Board Offices (fmr)

Kent Street, Rockingham

Conservation Management Plan

January 2022

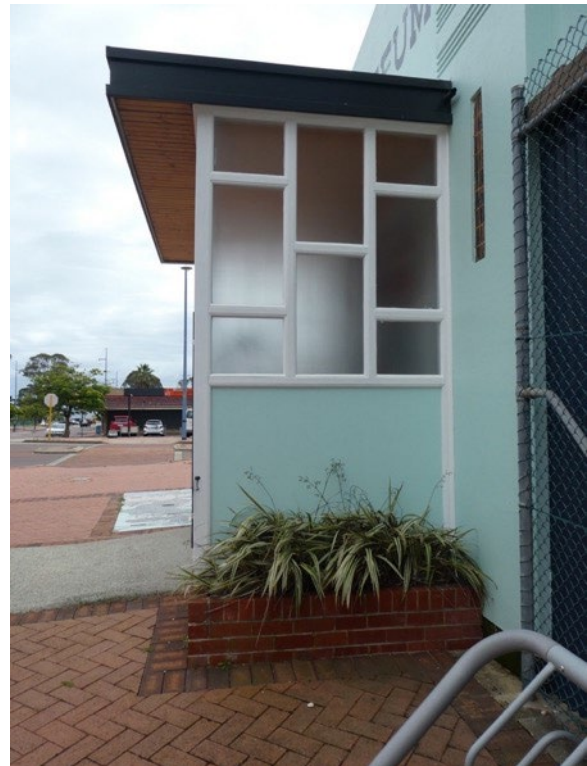
Figure 43: Outer porch

The main entrance to the building is from Flinders Lane through a two section porch entry including a timber framed open porch with fibre cement cladding and geometric windows. The canopy is flat with pine board lining, a replacement of the original Mini orb corrugated sheeting. The entry has been graded with cement and enclosed by metal palisade fencing style gates. This section of the entry is a later addition, constructed originally in the 1950s and replaced in 2012.

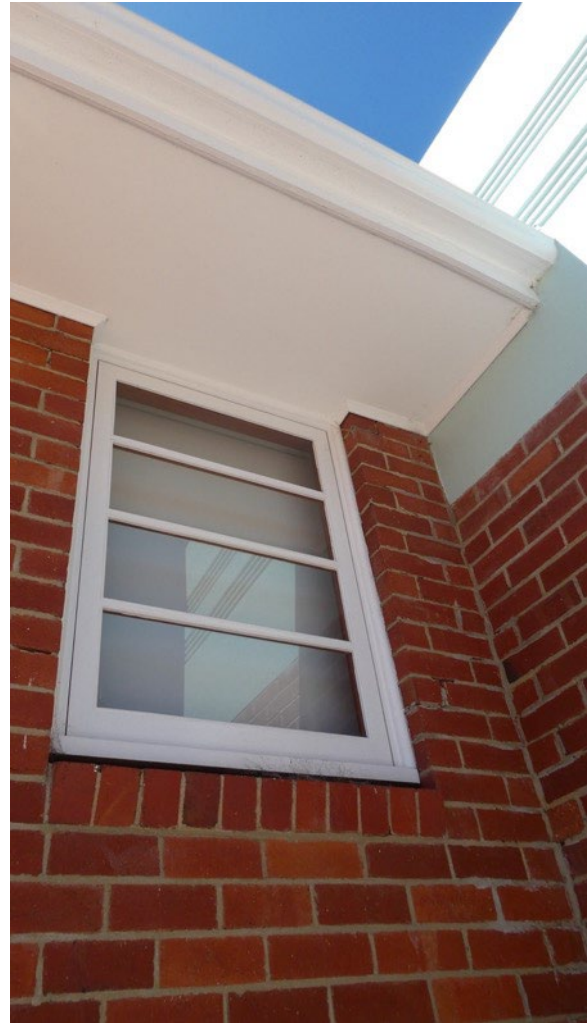
Figure 55: Replacement timber framed windows and lined eaves to the original section of the building

In 2012, the porch structure facing Flinders Lane was replaced and in the same year, the timber windows on the Kent Street elevation of the former Road Board building were replaced with windows of a similar design and materials. Although of the same design, these windows are fixed and cannot be opened. This prevents dust entering the building and better climate control for the collection.

The original section of the Old Rockingham Road Boards Office (fmr) building contains three groups of timber framed openings, all of which are located directly under the eaves. The central window is larger than the two flanking openings but all are of similar design incorporating horizontal glazing bars dividing the casements into a series of smaller panes. These fixed windows are replacements based on the original design. The window sills are of angled brick construction.

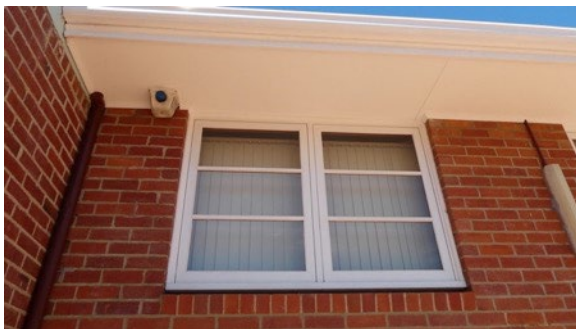
Figure 56: Replacement timber framed windows

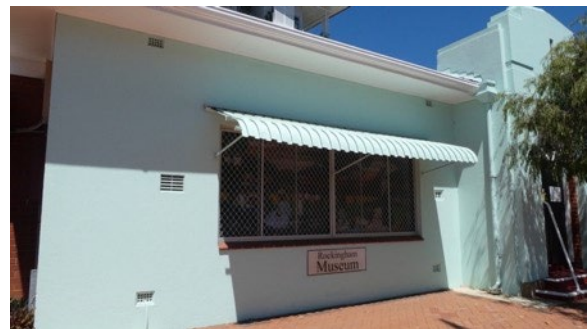
Figure 57: Former Council Chamber (second phase of construction) – altered openings and non-original rendered finish

The former Council Chambers section is brick construction which has been subsequently rendered and painted. The original timber framed sash windows have been removed being replaced by a wide window consisting of six aluminium framed openings with a non-original awning canopy above. The canopy dates from the 1970s when the Tourist Bureau occupied the former Council Chambers. The rendered finish obscures all evidence of the original openings.

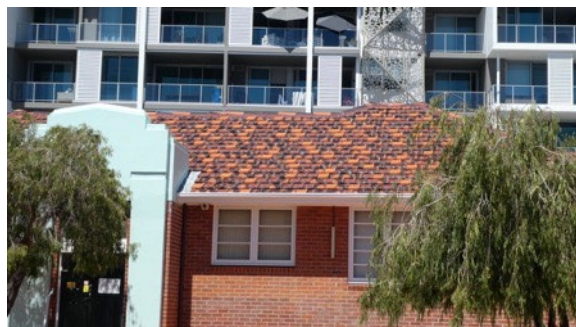
Figure 85: Replacement roof tiles

In 2013, the roof cladding of the former Road Board office was replaced with new Marseille tiles. The asbestos roof over the Link, former library and former hall were replaced with Colorbond.

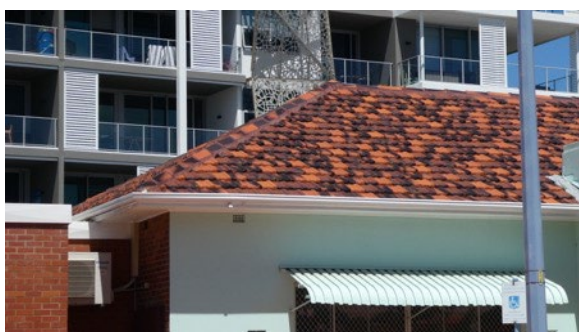
Figure 86: Replacement roof tiles
