# WOODBINE

(ALSO KNOWN AS BELL COTTAGE)

## CONSERVATION PLAN

City of Rockingham

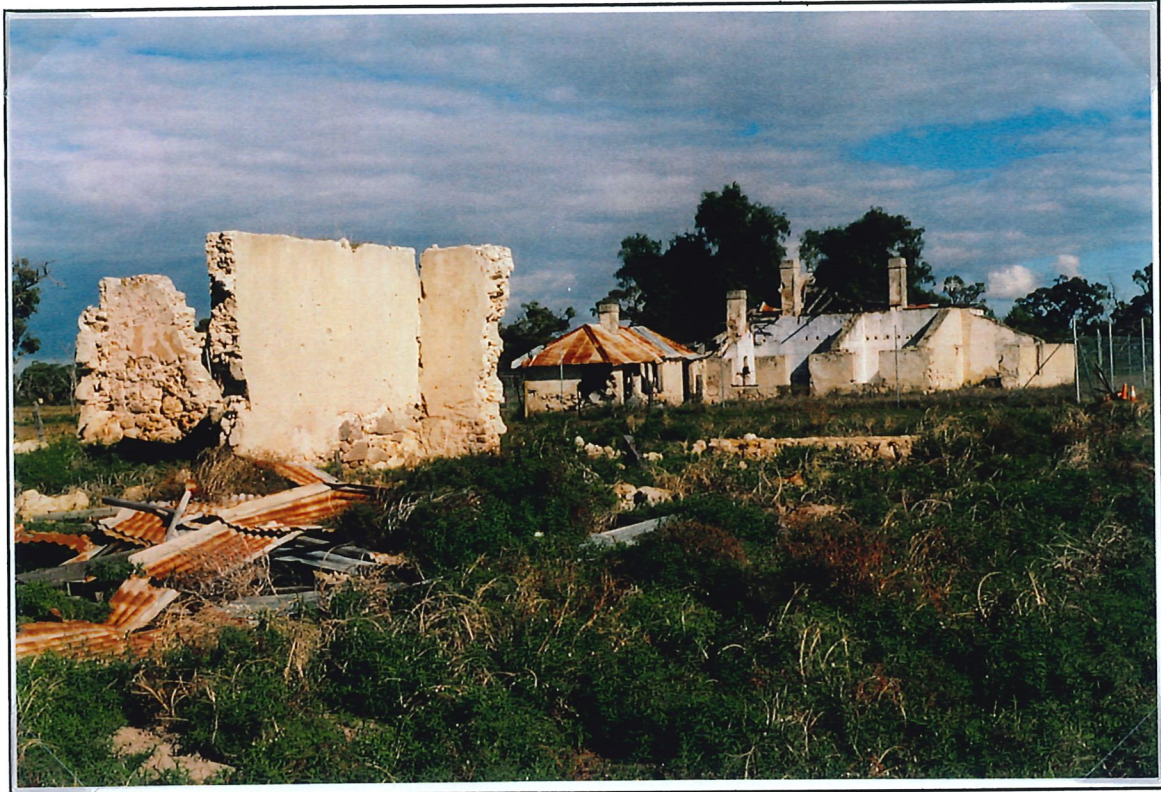
**Figure 3.18** View looking west with the barn ruin in the fore ground and cottage behind.

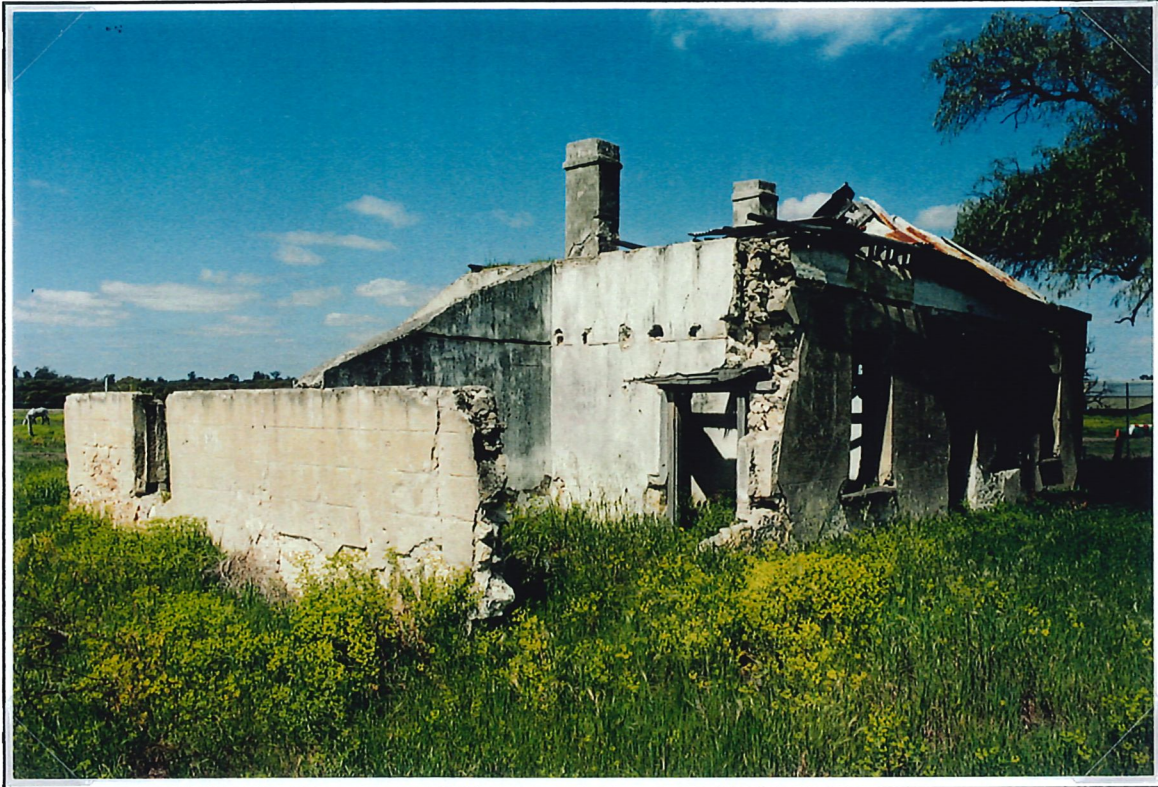
**Figure 3.22** View of the north and west facing elevations, looking south-east.

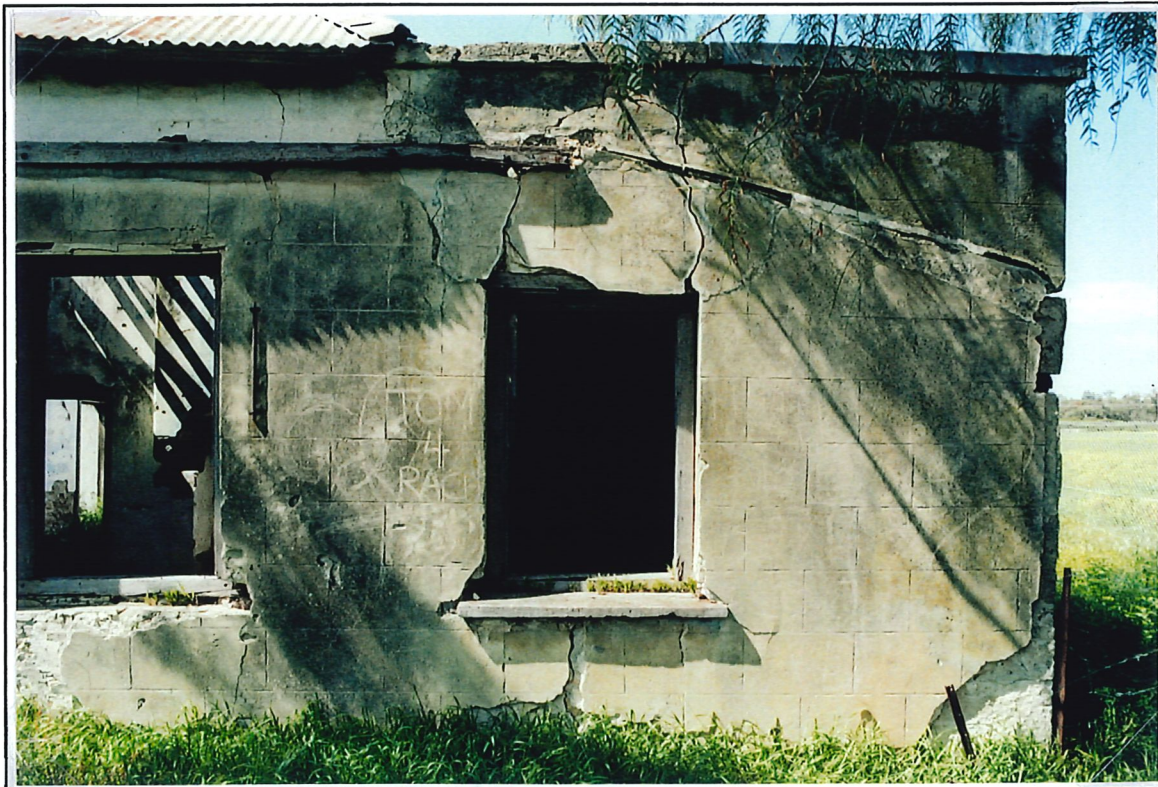
**Figure 3.23** Close-up of the parapeted southern end of the facade (west elevation).

The facade of the building conceals the line of the skillion on the south side of the main roof behind a parapet. A similar arrangement presumably existed on the northern side, but neither the parapeted facade wall nor the roof of that side remain. The top edge of the remaining parapet is level with the wall head of the largest rooms, the height of which measures approximately 3.6 metres from the ground. It was noted that the facade is leaning outwards by up to 100 mm at its highest point, the masonry having broken key with the return walls. Furthermore, fractures have occurred in the masonry directly over and below the south window in the facade, limiting support of the adjacent parapeted section of facade. It is likely that this section of wall will collapse in a similar manner as the northern end, unless urgent remedial action is taken. Other areas of masonry are also in danger of collapse, the main area of concern being the kitchen and store building, the masonry of which is rapidly deteriorating. In the main part of the cottage, only one section of wall has collapsed besides the northern part of the facade, being a short section of the back wall at the northern end.

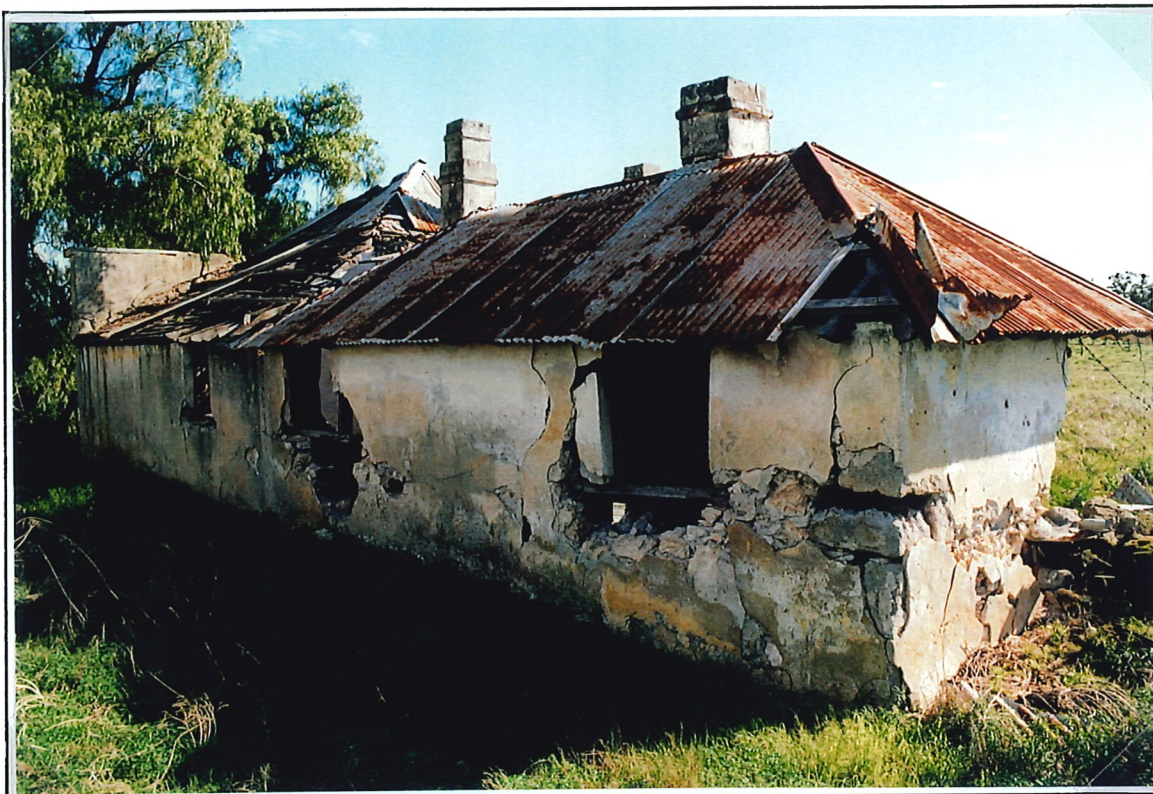
**Figure 3.24** View of the cottage from the south-east corner. The kitchen is in the foreground.

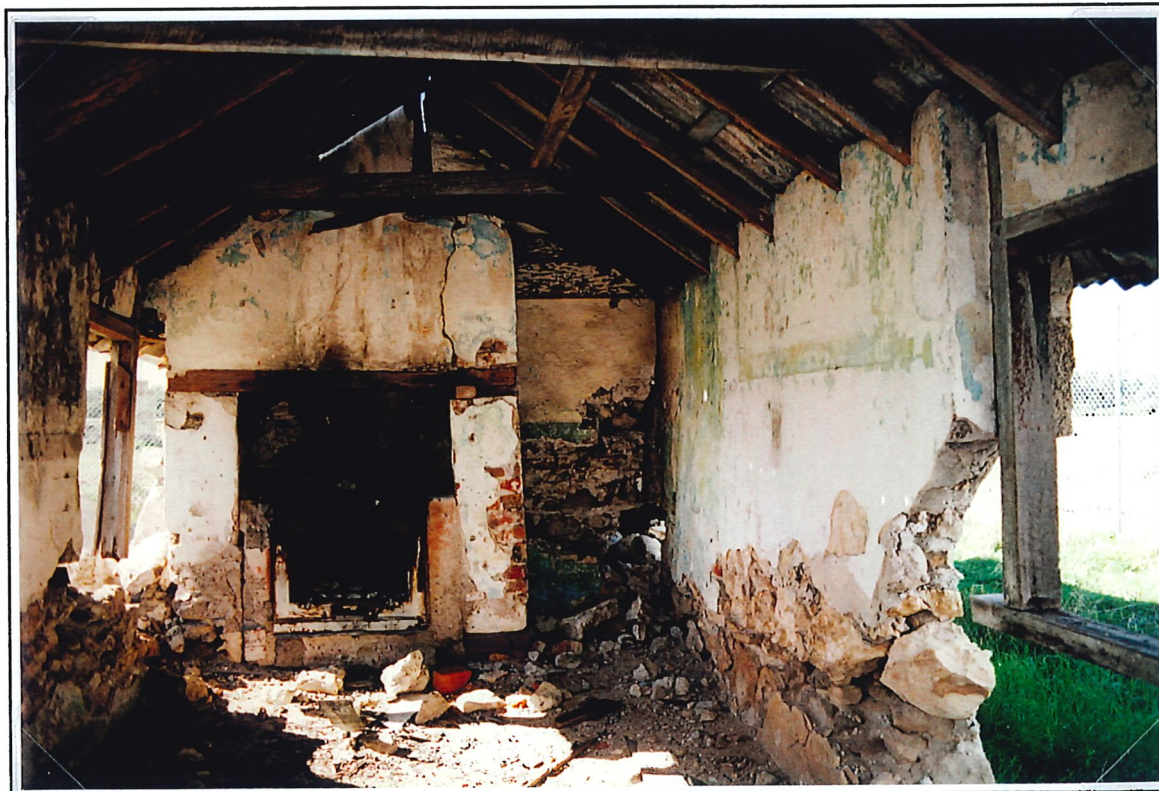
**Figure 3.25** Interior of the kitchen.

The house has four fireplaces, one in either of the largest front rooms, one in the main back room and one in the kitchen. The kitchen fireplace has the remains of an old cast iron fronted stove. Mantles and timber lintels over the fireplaces are missing.

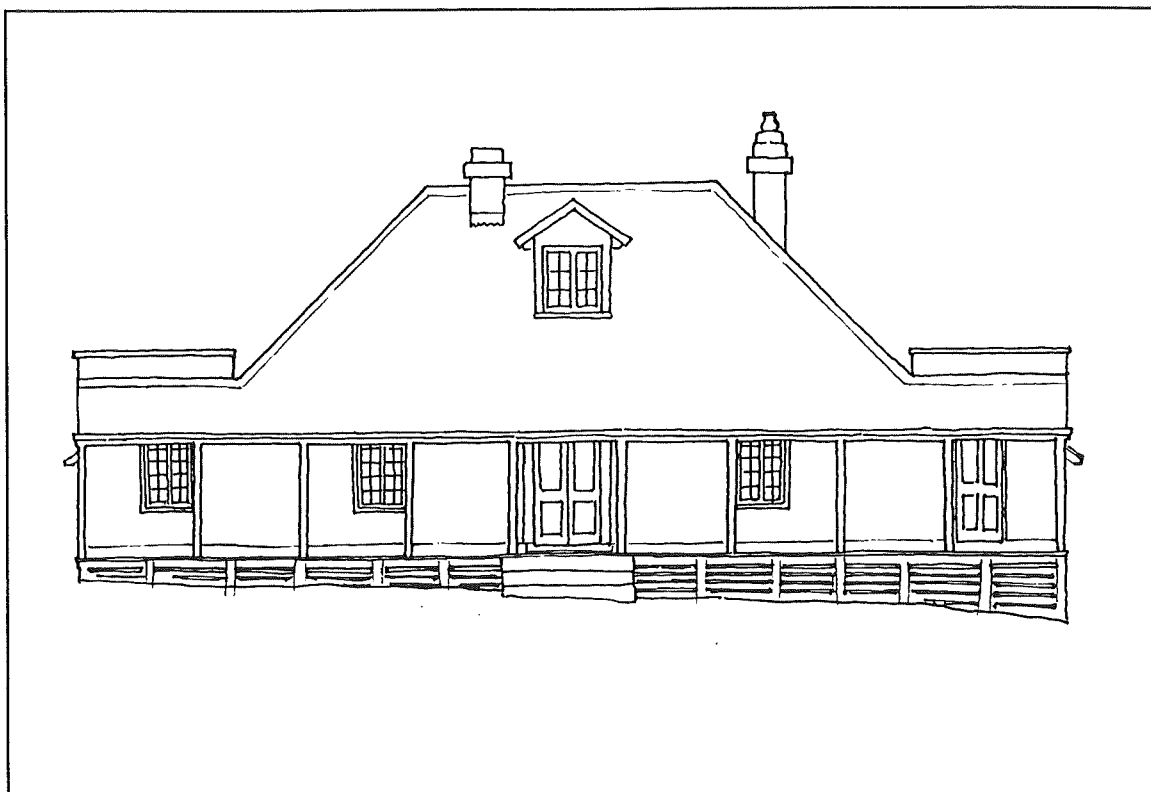
**Figure 4.3** Sketch of the facade of the Mahogany Inn.
