Report on
GEOTECHNICAL STUDY
PROPOSED MIXED-USE DEVELOPMENT
CORNER READ STREET & COUNCIL AVENUE
ROCKINGHAM

J1702030 002 R Rev2

24 August 2018

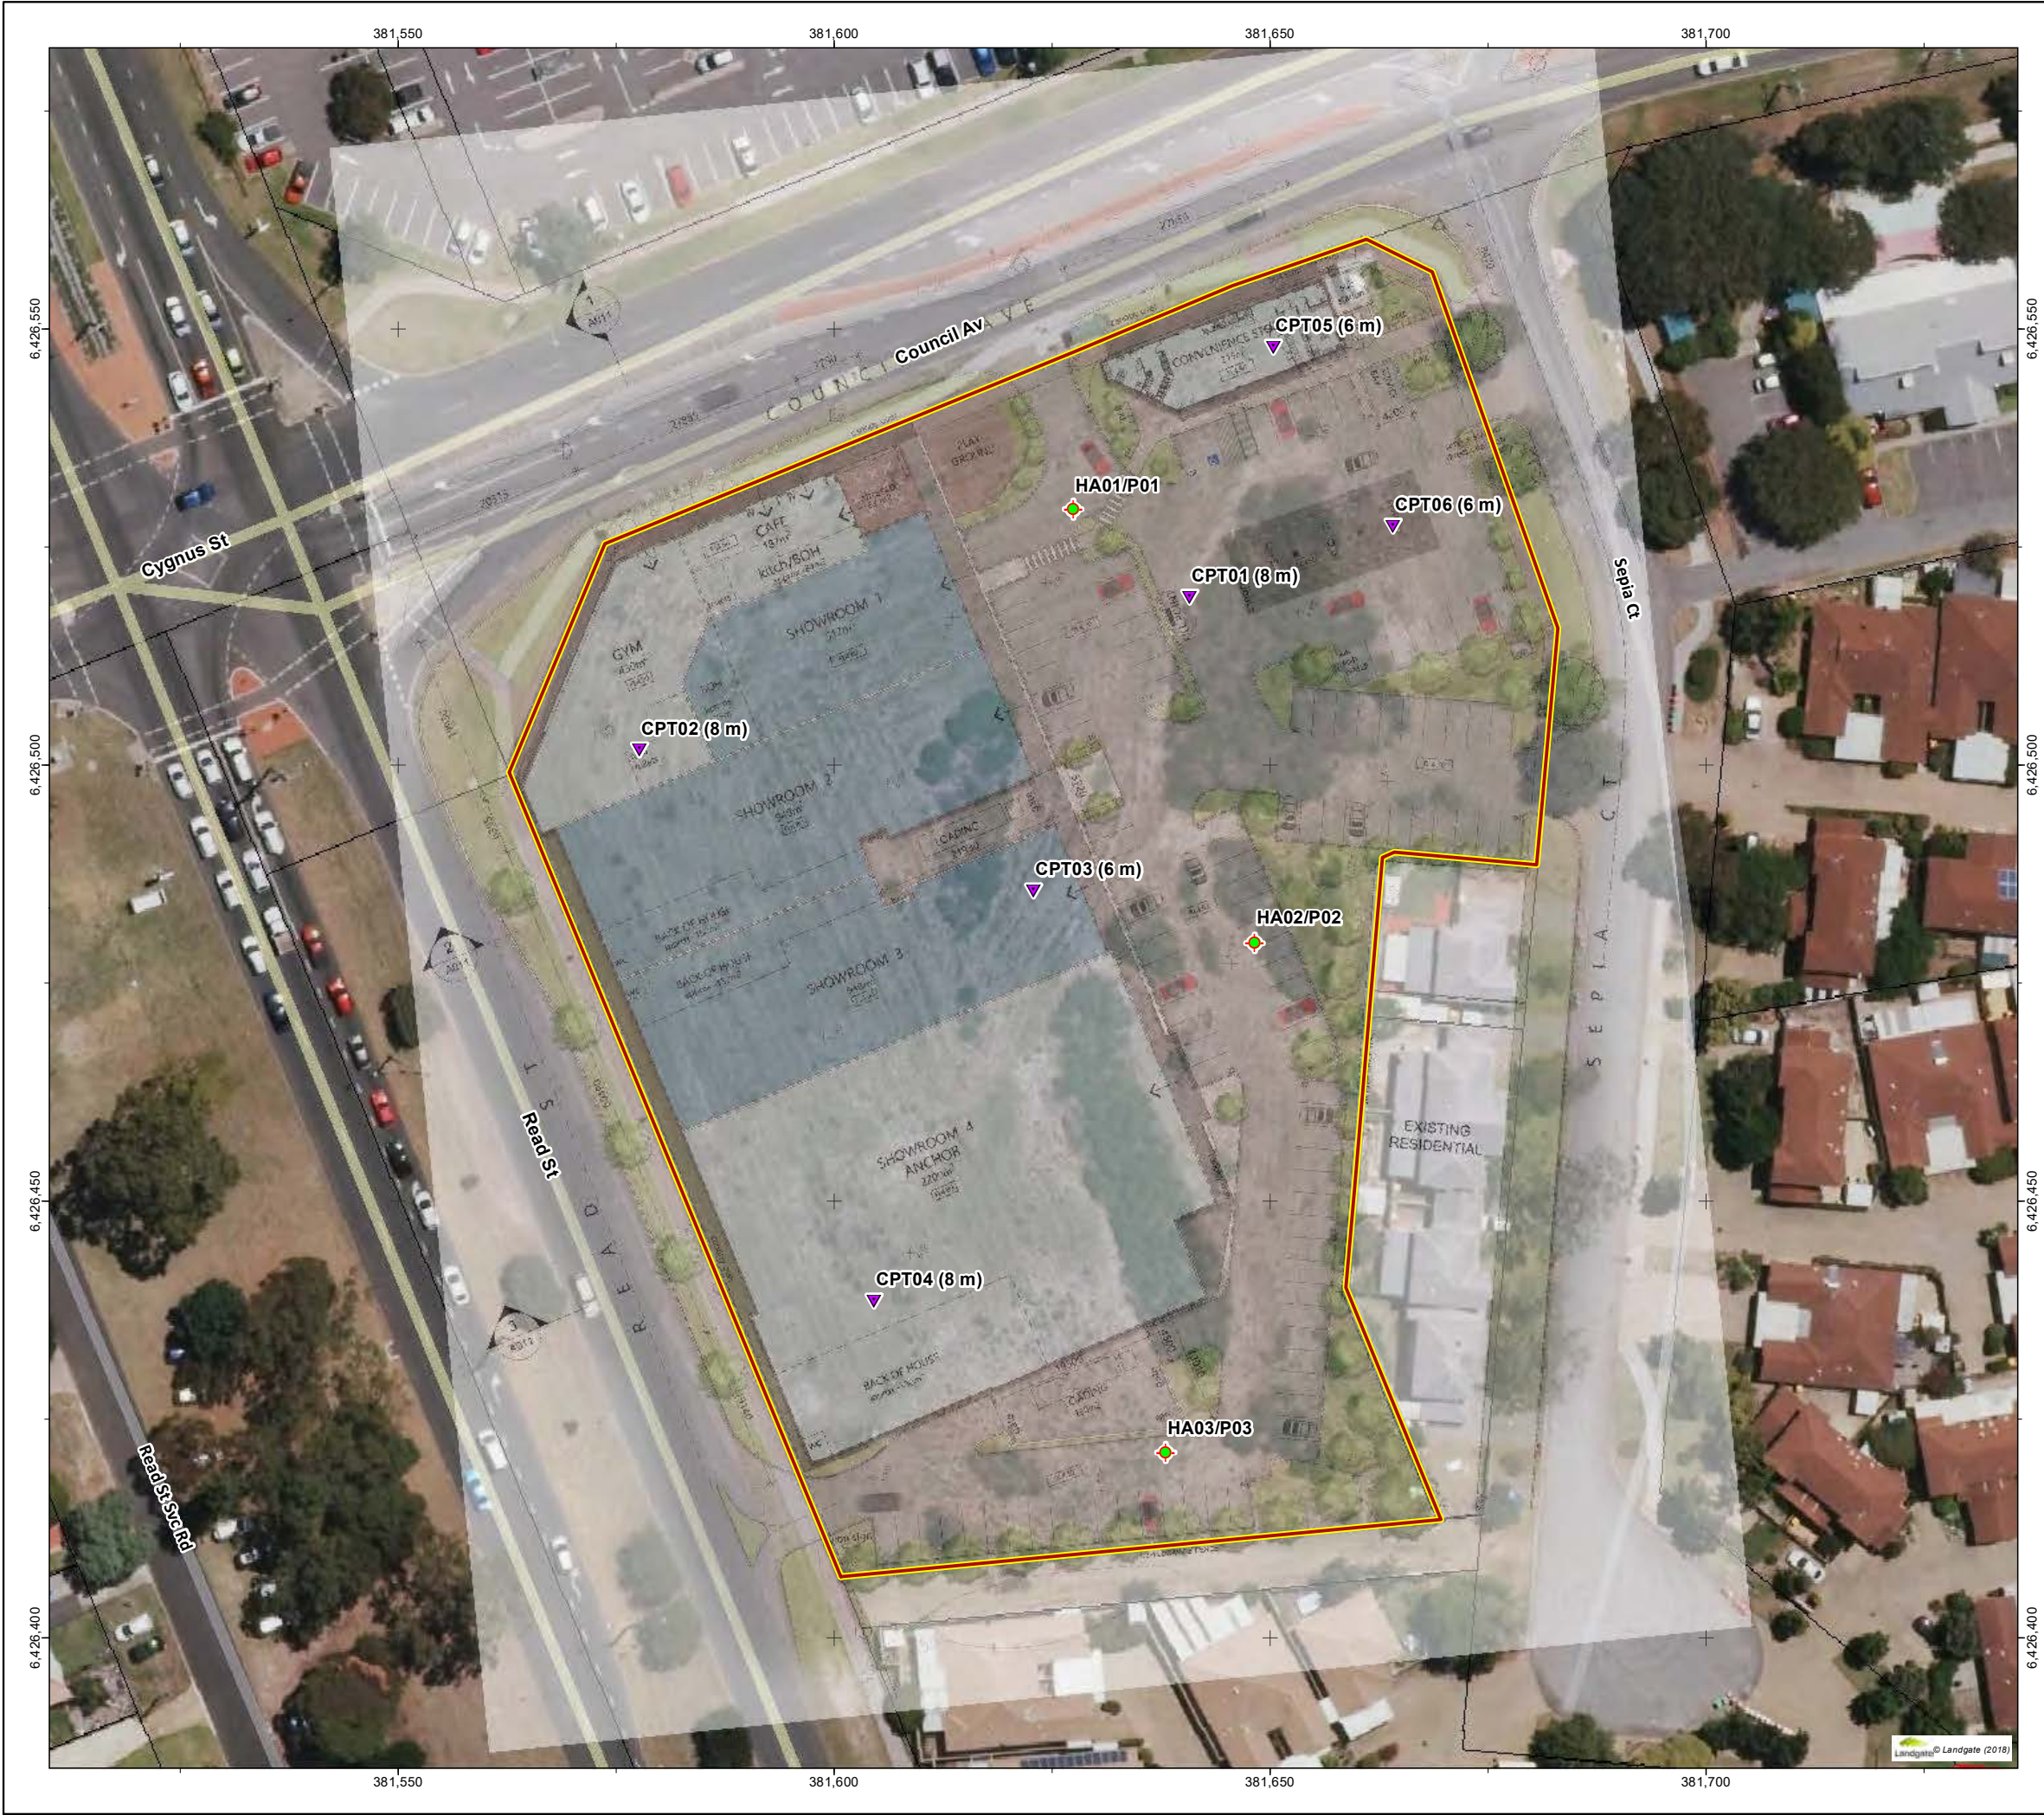
Figure 1: Site and Location Plan

The approximate test locations are shown on Figure 1, Site and Location Plan. Photographs of the site taken during the study are presented in Appendix A, Site Photographs.

This report presents the outcomes of Galt Geotechnics Pty Ltd's (Galt's) geotechnical study for the proposed mixed-use development at the corner of Read Street and Council Avenue, Rockingham (the "site"). The location of the site relative to the surrounding area is shown on Figure 1, Site and Location Plan.

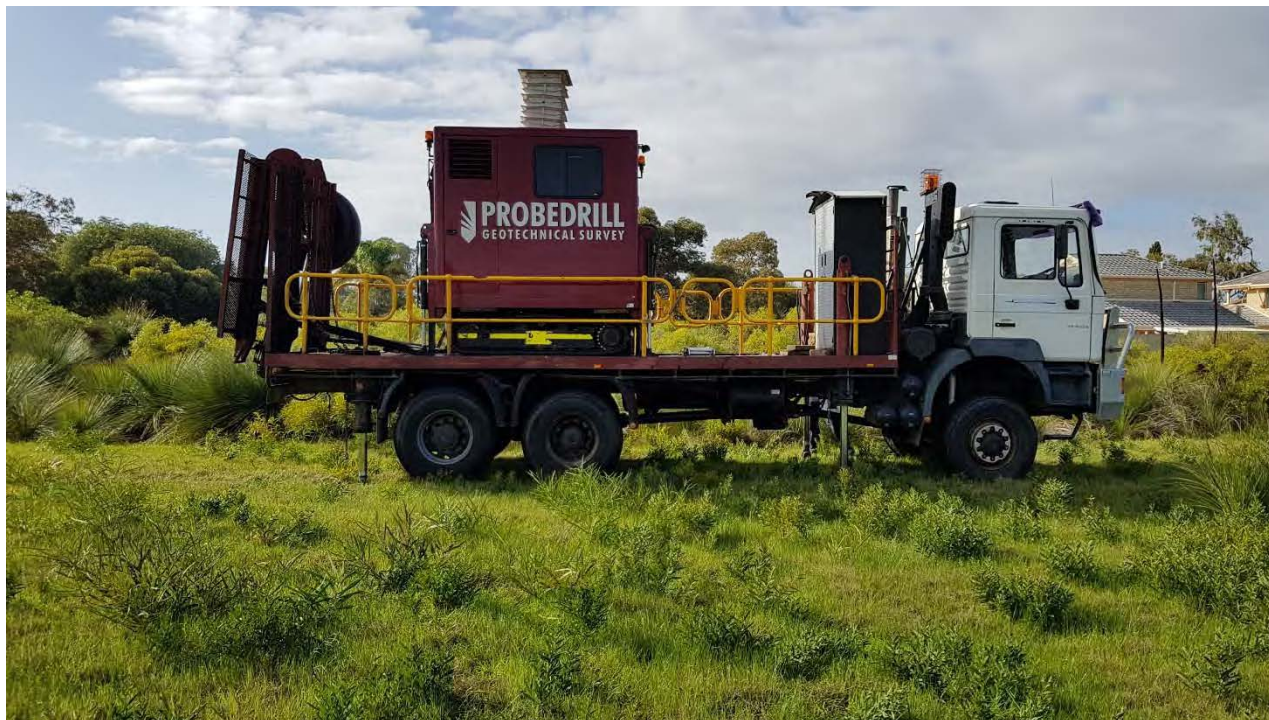
Photograph 1: CPT01 in progress

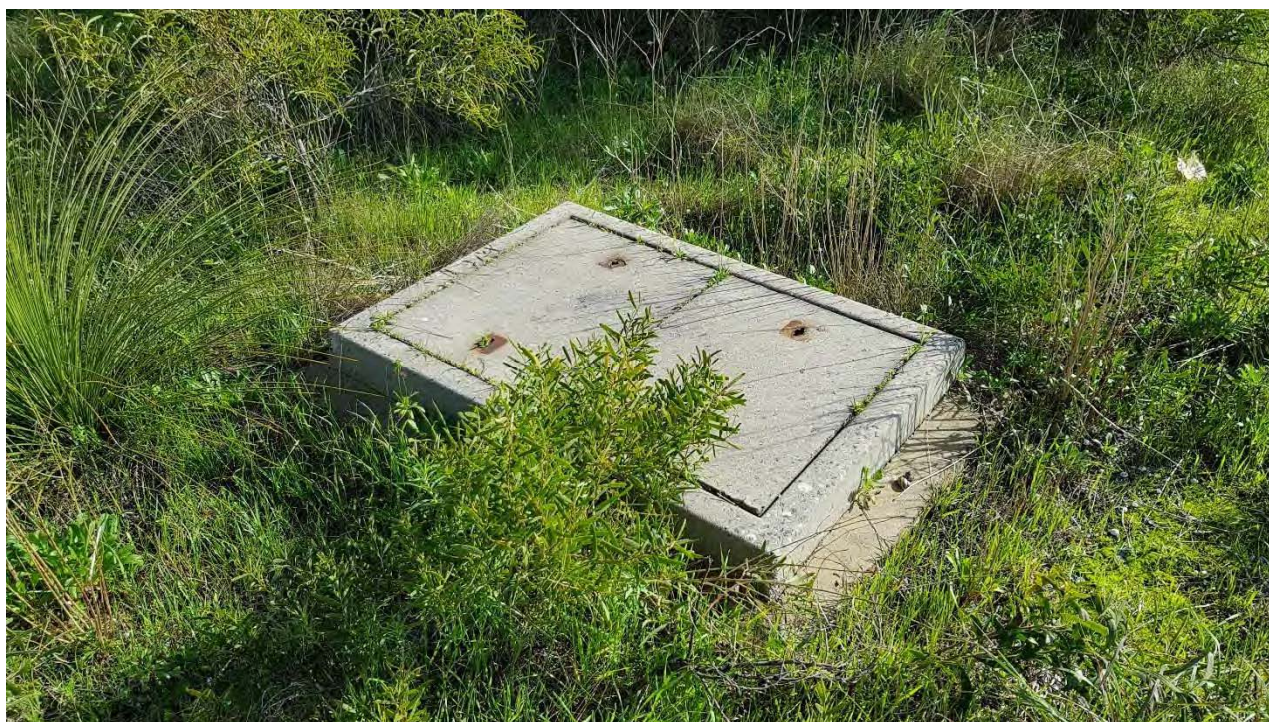
Photograph 2: Water Corporation sewer manhole in the centre of the site

A Water Corporation sewer manhole was observed in the centre of site. This is noted on DBYD information.

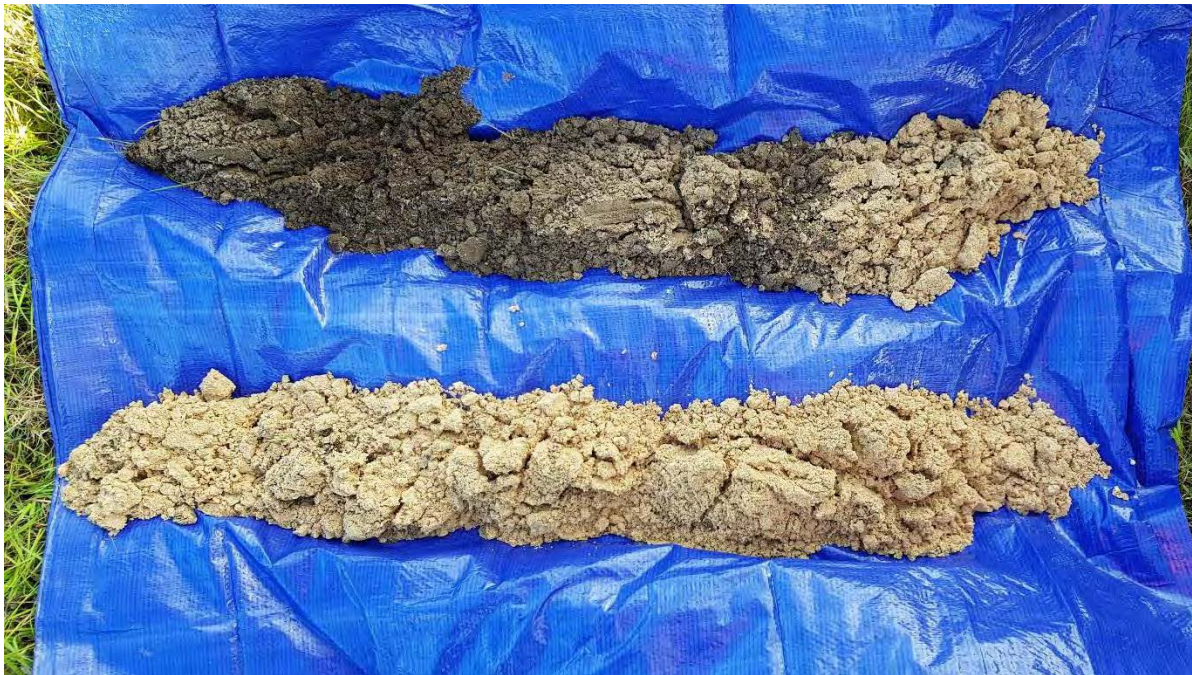
| Test Depth (m) | Stratigraphy |
|---|---|
| 0.0 – 2.0 | SAND (SP): fine to medium grained, sub-angular to sub-rounded, dark grey at surface becoming pale yellow to white below 0.6 m, trace organics top 0.2 m, trace fines, moist, medium dense to dense. |
| HA01 spoil | |

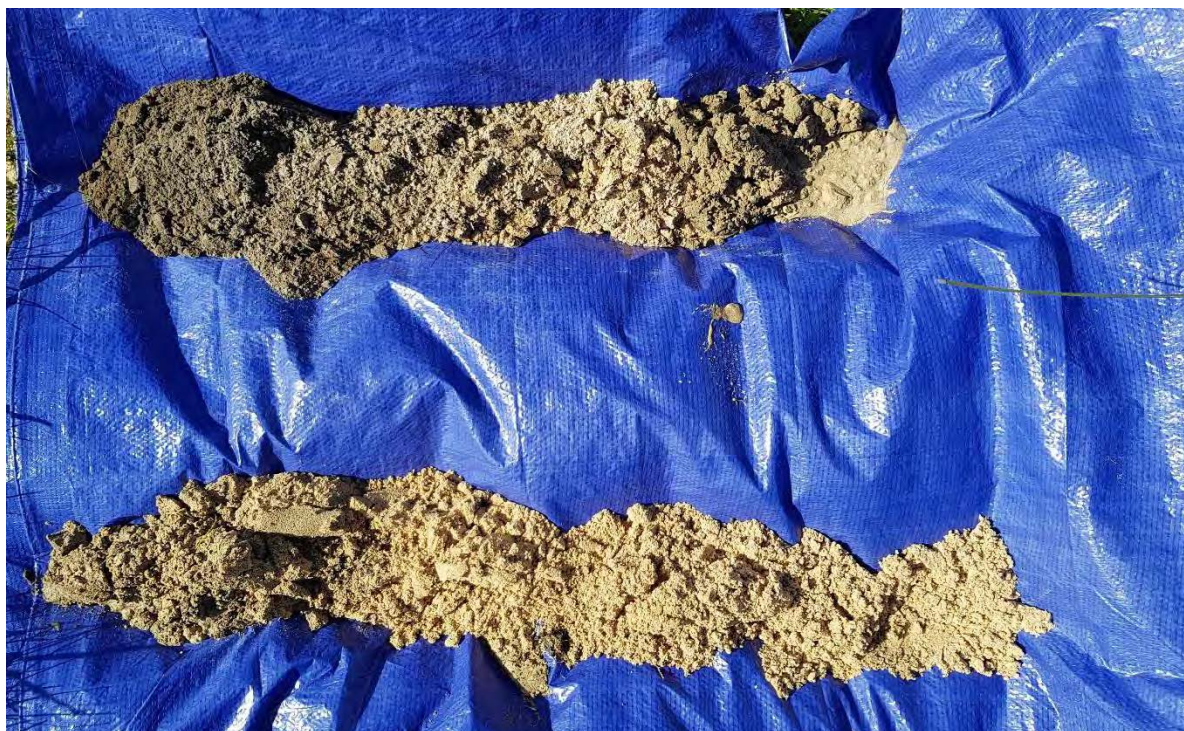
| Test Depth (m) | Stratigraphy |
|---|--|
| 0.0 – 2.0 | SAND (SP): fine to medium grained, sub-angular to sub-rounded, dark grey at surface becoming pale yellow to white below 0.3 m, trace organics top 0.2 m, trace fines, moist, medium dense. |

HA03 spoil

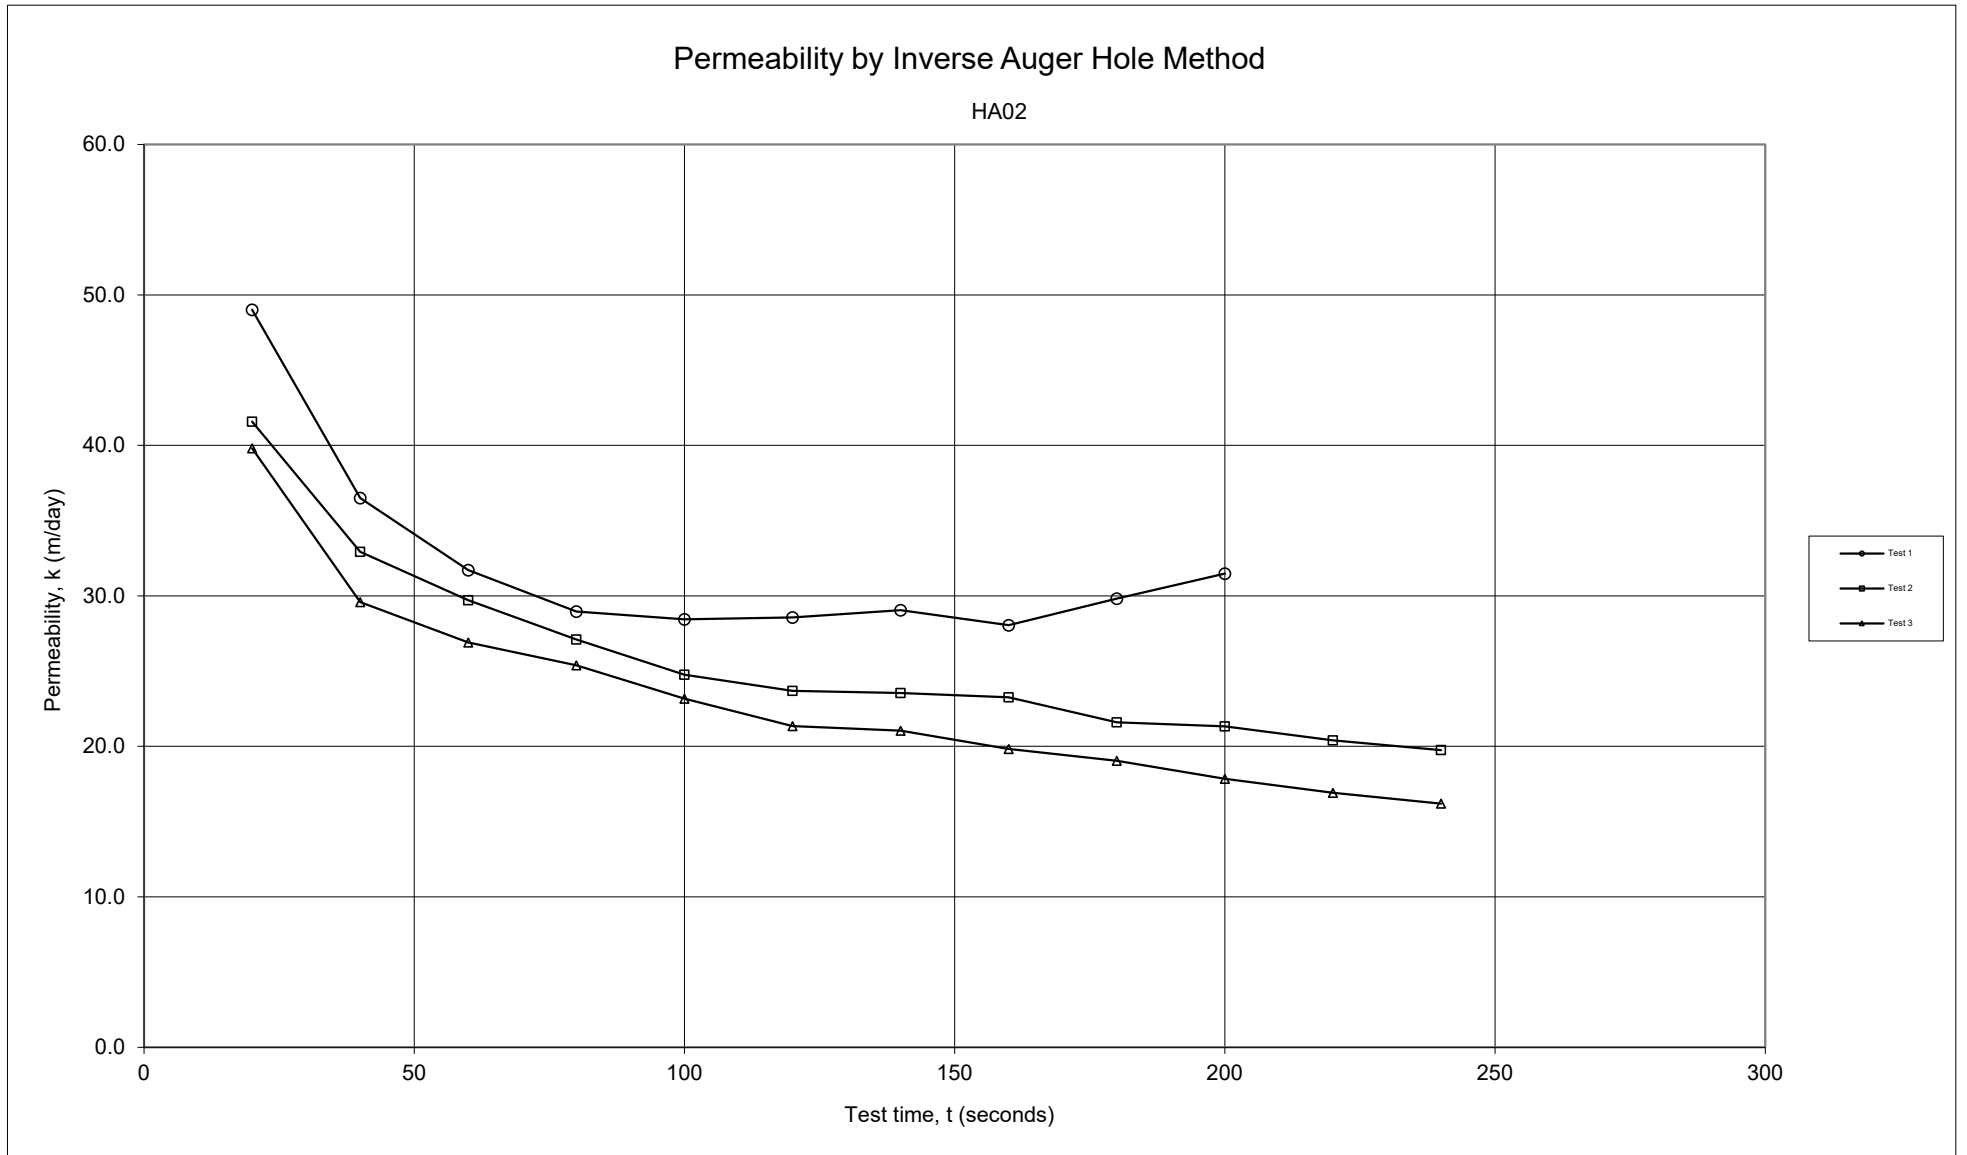
Permeability Calculation - Inverse Auger Hole Method

Infiltration tests were carried out using the 'inverse auger hole' method described by Cocks². The results of the infiltration testing are presented in Appendix E, Infiltration Test Results and are summarised in Table 2: Summary of Infiltration Test Results.

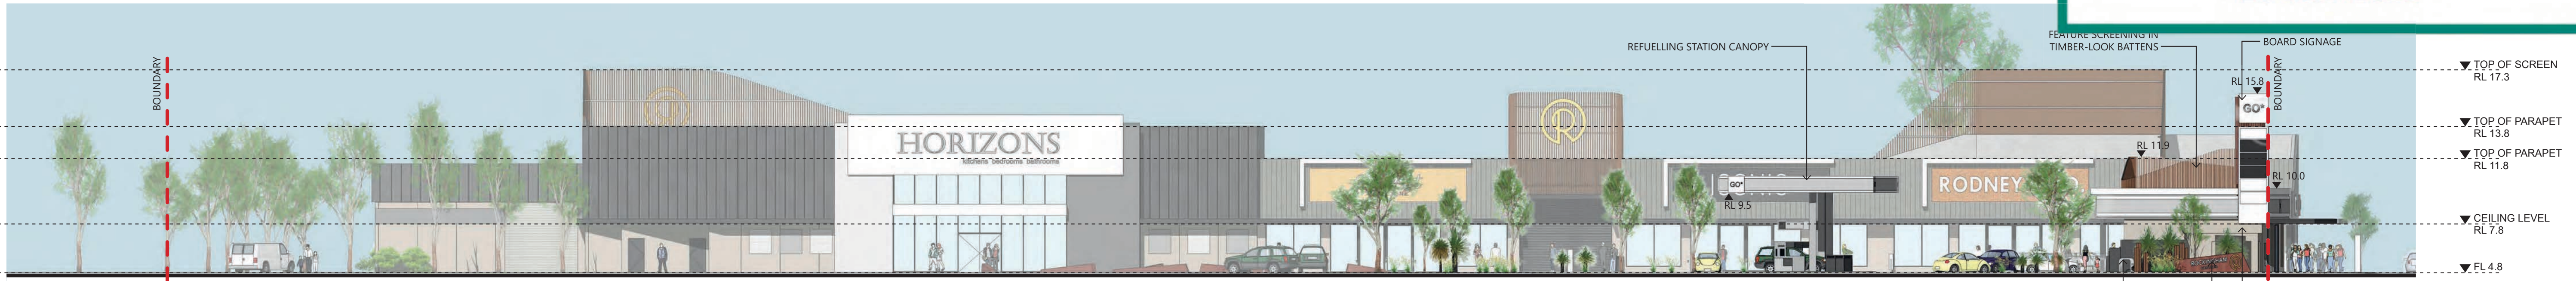
1 SEPIA CT ELEVATION

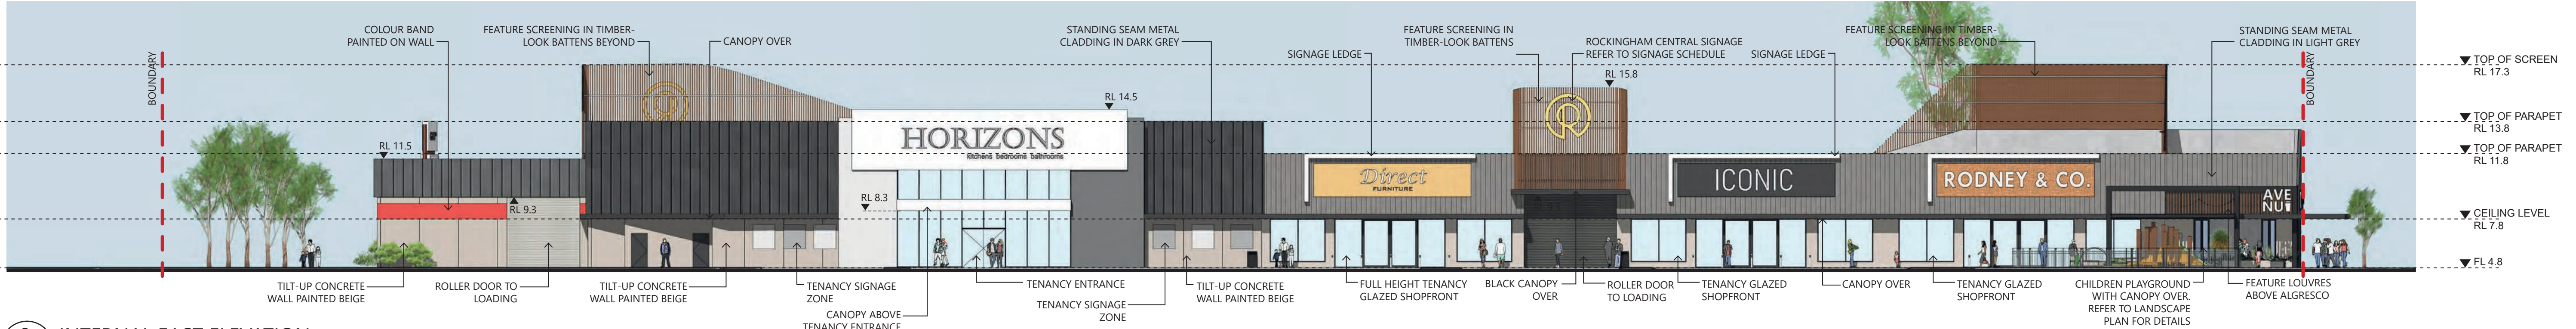
2 INTERNAL EAST ELEVATION
