ARCHITECTURAL ACOUSTICS

DAYTON PRIMARY SCHOOL - DD REPORT

PROJECT: Dayton PS - Acoustics DD Report **PROJ No:** 21-004

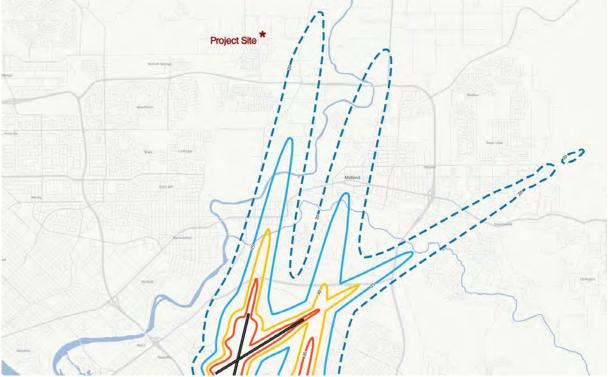
Image 01 - Perth Airport ANEF Contours with Proposed School Location

The proposed primary school location is located to the North of Perth Airport, however it can be seen in the below image that the proposed primary school location does not fall within the airport ANEF Contours:

Based on this information it is our view that aircraft noise intrusion is unlikely to be a concern. With typical primary school constructions aircraft noise will still be audible, however this should be below the recommended levels set out in the relevant Australian Standards.

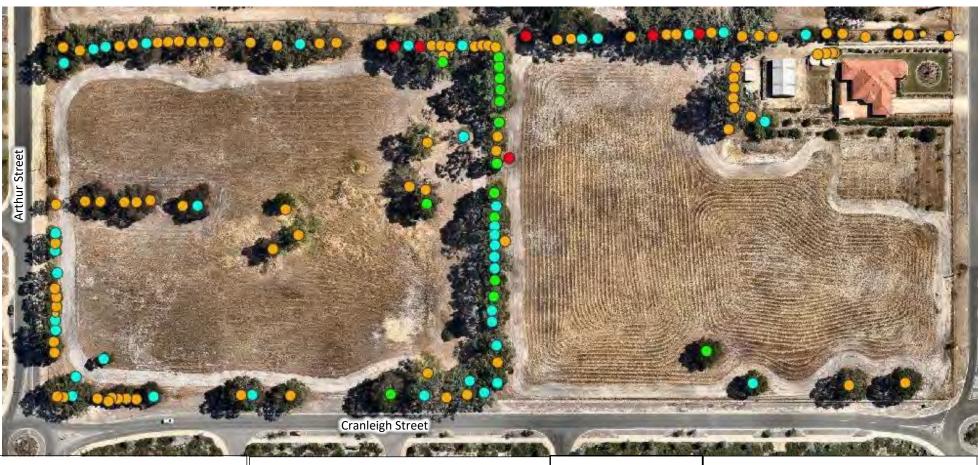
The aerial overleaf provides an overview of the Site with the retention value of each Tree overlaid and colour coded for ease of reference.

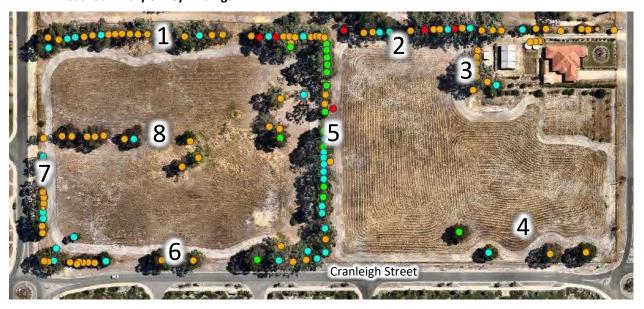
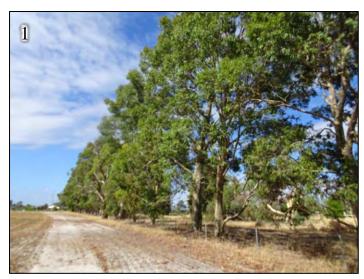
Long row of trees along the northern boundary planted as a windbreak.

Mix of species including some Flooded Gum (most of which look to be a cross with Northern River Red Gum) as well as some Ironbark.

Most currently show good health and structural form although some of the larger Trees in this area show evidence of a history of branch failures having occurred.

The Rose Gum and Northern River Red Gum and to a lesser extent the Bangalay are all considered to be higher risk species in terms of their propensity for branch failure so whilst physically large and in good condition they are not necessarily suited to school situations due to the risks that they can represent.

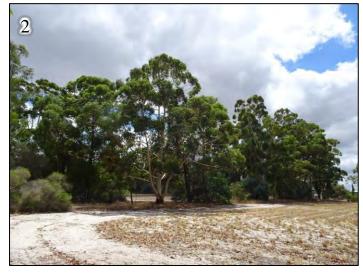
Long row of trees along the northern boundary planted as a windbreak.

Mix of species including some Flooded Gum (most of which look to be a cross with Northern River Red Gum) as well as some Ironbark, Rose Gum, Bangalay and others.

The Rose Gum and Northern River Red Gum and to a lesser extent the Bangalay are all considered to be higher risk species in terms of their propensity for branch failure so whilst physically large and in good condition they are not necessarily suited to school situations due to the risks that they can represent.

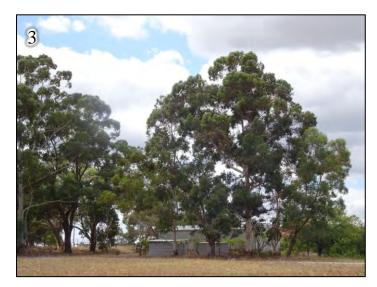
Short row of Trees; mostly Rose Gum.

Most currently show good health and structural form although some of the larger Trees in this area show evidence of a history of branch failures having occurred.

The Rose Gum are considered to be higher risk species in terms of their propensity for branch failure so whilst physically large and in good condition they are not necessarily suited to school situations due to the risks that they can represent.

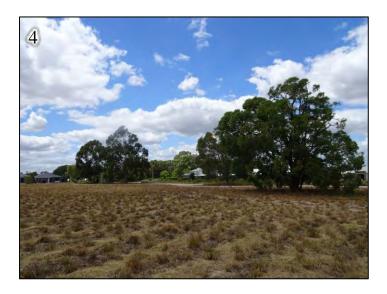
Four individual trees; 2 Rose Gum, a Marri and a Jarrah.

All currently show good health and structural form although both Rose Gum show evidence of a history of branch failures having occurred.

The Rose Gum are considered to be higher risk species in terms of their propensity for branch failure so whilst physically large and in good condition they are not necessarily suited to school situations due to the risks that they can represent.

The Marri may be ok to retain depending on the landscape around it (due to potential issues with the 'honky-nuts')

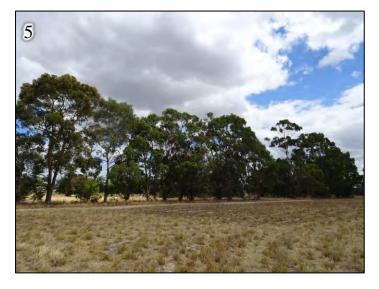
Row of large mature trees including some Spotted Gum and Rose Gum.

Most currently show good health and structural form although some of the larger Rose Gum in this area show evidence of a history of branch failures having occurred.

Conversely Spotted Gum although a physically large species are considered to have a comparatively low propensity for branch failure.

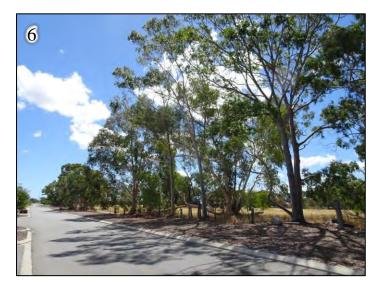
Row of large mature trees along the southern boundary and Cranleigh Street.

Mix of species but predominantly Lemon Scented Gum along with a few Flooded Gum.

Most currently show good health and structural form although some have been previously topped at some stage in the past so their structure looks likely to cause issues longer term and reduce their suitability for retention in the context of what's proposed.

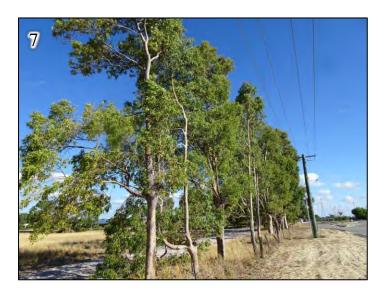
Row of mature trees along the western boundary and Arthur Street.

Predominantly Spotted Gum.

Most currently show good health although they all look to have been previously topped at some stage in the past so their structure looks likely to cause issues longer term and reduce their suitability for retention in the context of what's proposed depending on the proposed landscape around them and what 'targets' will be introduced into their fall zone area.

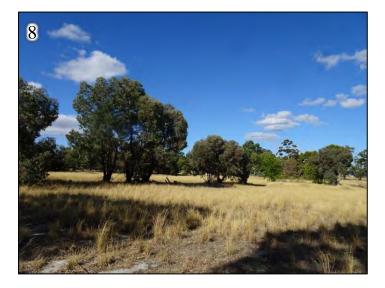
Row of mature trees through the middle of the Site.

Predominantly Ironbark.

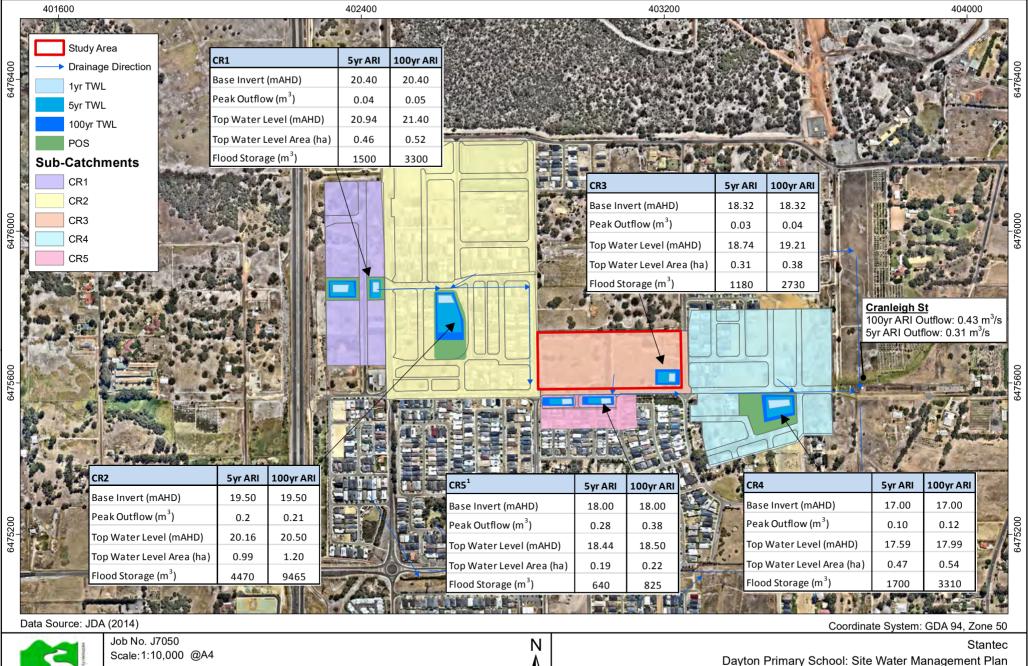
Figure 2: Catchment Plan from LWMS (JDA, 2014)

The proposed school site is catchment CR3 (see Figure 2). This catchment discharges southward to a series of swales immediately south of Cranleigh St. Currently there is no connection from the eastern most extent of the swales at Blundell St, through to the Malvern St Drain and the swales currently act as infiltration swales.

The proposed school layout is shown in Figure 5, with school buildings in the west and oval in the east. Rather than managing rainfall runoff using a single basin (as shown in the LWMS – Figure 2), it is proposed to use a combination of distributed underground storage / infiltration and swales to provide attenuation prior to discharge from the site.

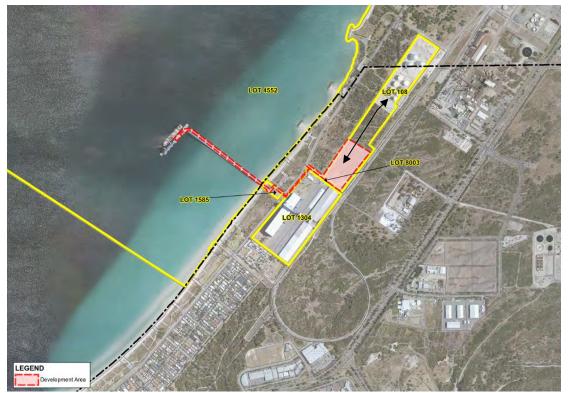
Figure 2. Aerial Photograph

The Development Area also comprises of Lots 1585 and 4552, which do not form part of this Joint Development Assessment Panel (JDAP) application. For clarity, the overall Development Area is identified below, in Figures 1 and 2, and is further explained below in the Proposal section of this report.

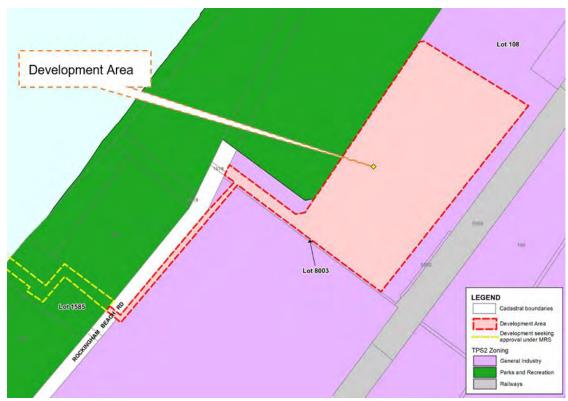
Figure 3. Extent of Development Seeing Approval under TPS2

While the MOJDAP is the determining authority for both Development Applications, this Responsible Authority Report (RAR) relates only to the CBH Fertiliser Expansion Project (Extent of Development Seeking Approval Under TPS2), being the development northeast of and under Rockingham Beach Road. This RAR assesses the proposal with regard to the City's TPS2.

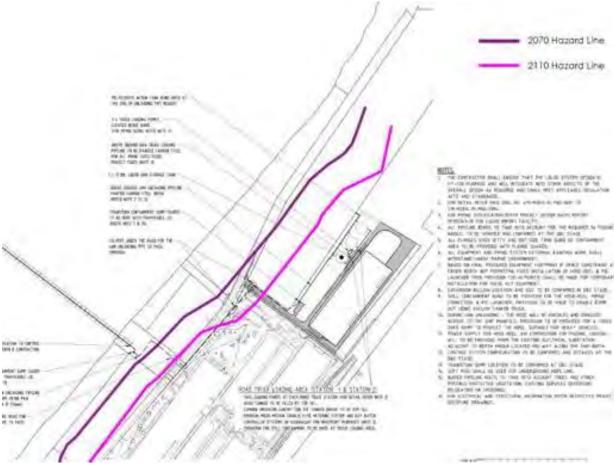
Figure 6. Coastal Erosion Overlay

An assessment of erosion vulnerability shows that the proposed development is within the coastal erosion hazard lines as modelled in the City's CHRMAP.

The proposed overall development has not appropriately addressed the threat of coastal erosion as identified by the City's CHRMAP. It is noted that pipeline is to be built on existing infrastructure, however, the works will only increase the value of the assets at risk. The new pipeline and vehicle access-way onto Rockingham Beach Road are also proposed as part of the development seeking approval under TPS2 (refer to Figures 1-4). The extent of the overall proposed development extends beyond the areas of existing approved infrastructure, and as such, the Development Approval process is an appropriate mechanism to ensure that the risk of future coastal hazards is suitably addressed prior to these development commencing.

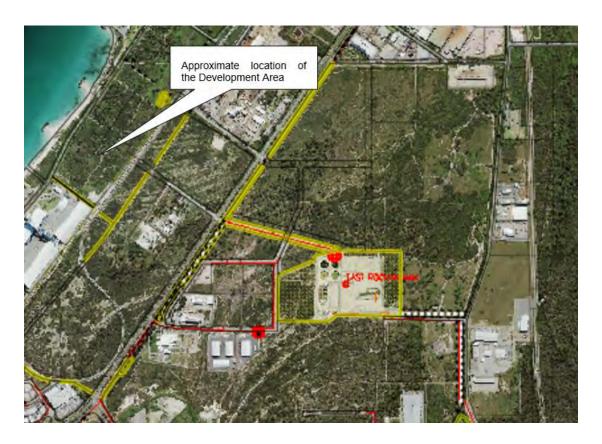
Figure 7. Existing Sewer Network (red line shows the location of any sewerage)

There are no reticulated sewerage networks in the area. As reticulated sewerage service is not available on Lot 108, a secondary treatment system with nutrient retention will be required for wastewater produced from staff facilities. The storage of potentially contaminated stormwater from bunded areas will be directed into a waste stabilisation (evaporation) pond. An application will need to be made to the City of Rockingham's Health Services for installation of the secondary treatment system and the evaporation pond as required by Health (Treatment of Sewerage and Disposal of Effluent and Liquid Waste) Regulations 1974.

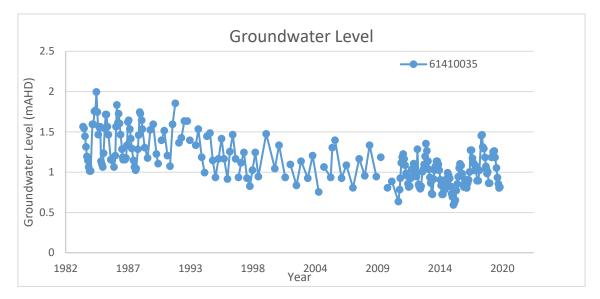
Plate 1: DWER Site Groundwater Levels

A search of the Water Information Reporting Database (DWER, 2020e) was undertaken and one DWER groundwater monitoring bore (ref: 61410035) were identified within approximately 900 m northeast to the site to have recent groundwater level information. The bore recorded groundwater levels since 1983 and the latest record was in March 2020. The groundwater level records are obtained from the database and plotted in Plate 1.

There is a generally decreasing trend in groundwater levels recorded in this bore.
