<b>1.</b>	<b>Introduction</b>	<b>1</b>
1.1	General	1
1.2	Site Location	1
1.3	Safety in Design	1
1.4	Verification Procedures	1
<b>2.</b>	<b>Project Overview</b>	<b>2</b>
<b>3.</b>	<b>Civil Services</b>	<b>3</b>
3.1	Objectives	3
3.2	Design Standards, Site Conditions and Constraints	3
3.3	Design Intent	7
3.4	Earthworks Estimates	10
3.5	Outstanding Information/Risk	11
	<b>Appendix A Safety In Design (SID)</b>	<b>12</b>
	<b>Appendix B Local Water Management Strategy – Figure 14</b>	<b>13</b>
	<b>Appendix C Existing Site and Services Information</b>	<b>14</b>
	<b>Appendix D Average Annual Maximum Groundwater Levels (AAMGLs)</b>	<b>15</b>
	<b>Appendix E Preliminary Civil Plans</b>	<b>16</b>

## **Proposed Dayton Primary School Masterplan**

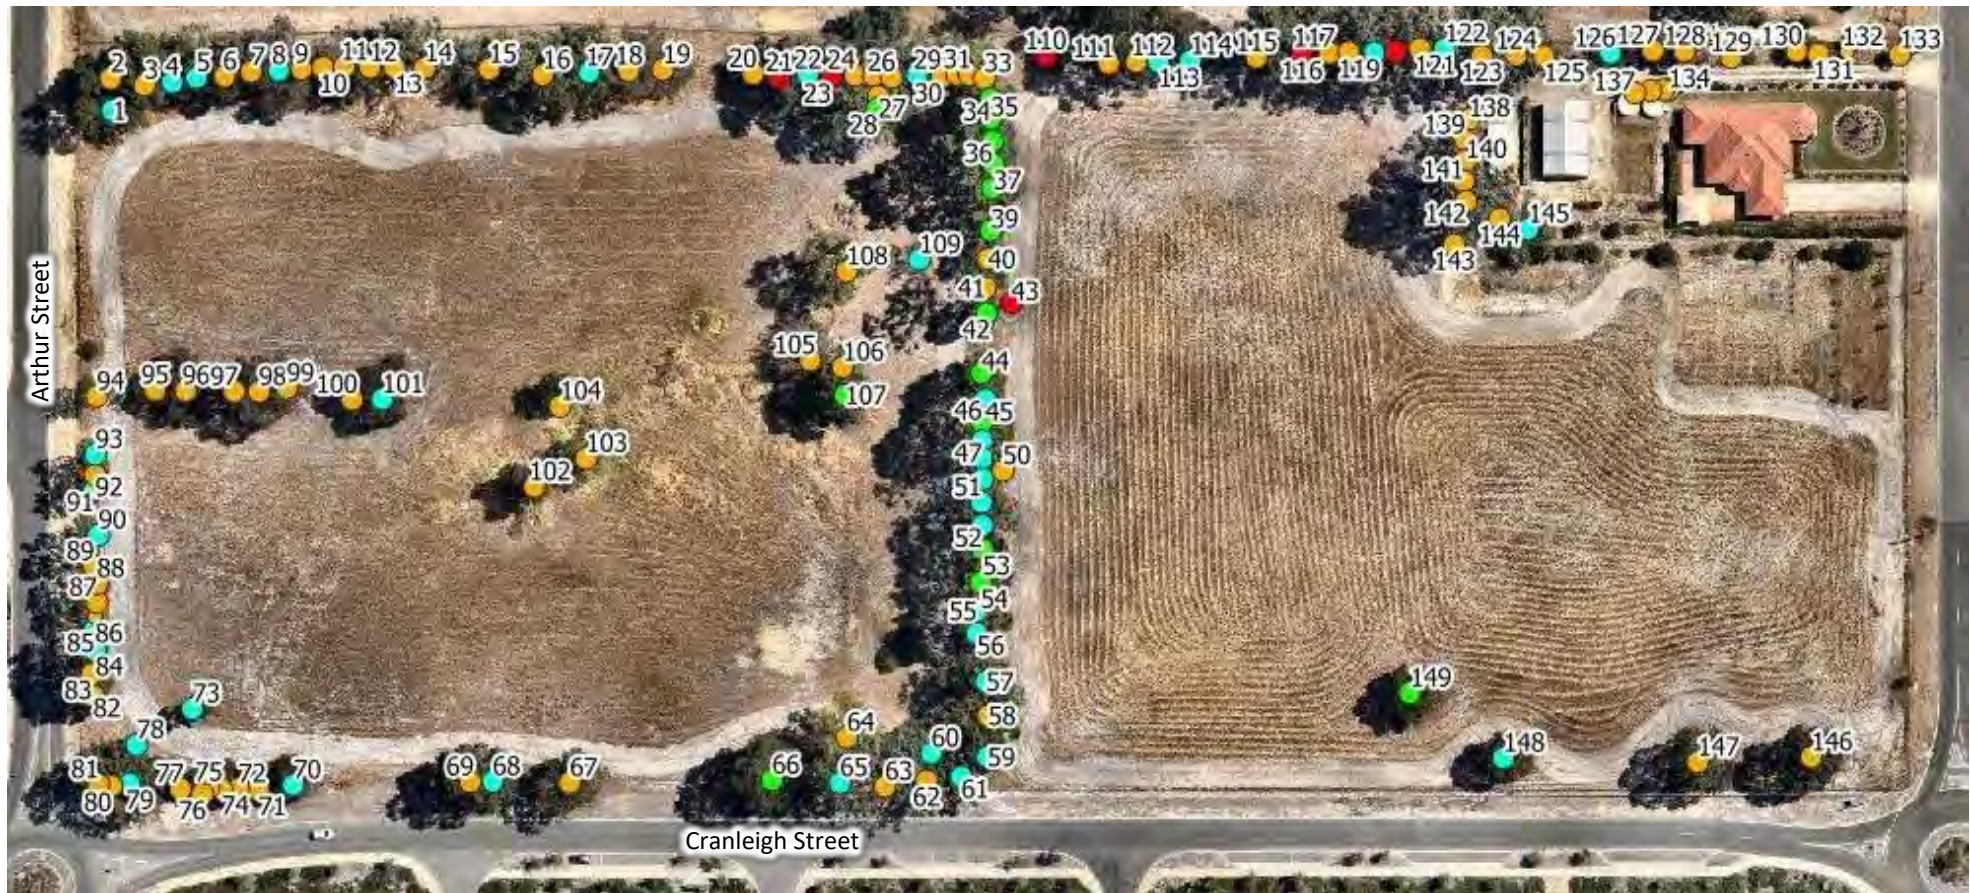
Attachment 1; Location Guide with Retention Value overlaid

<p><b>Key</b></p> <ul style="list-style-type: none"> <li><span style="color: green;">●</span> High Retention Value Tree</li> <li><span style="color: cyan;">●</span> Suitable Tree</li> <li><span style="color: yellow;">●</span> Unsuitable Tree</li> <li><span style="color: red;">●</span> Very Low Retention Value (remove)</li> </ul>	<p>Client; Four landscapes Studio Site; Dayton Primary School Drawn by; J Royal Revision; 0 Date; 12/02/2020 Aerial Source; Nearmap.com Scale; 1:1750</p>	 	<p><b>ARBOR logic</b></p> <p>PO Box 1025, Balcatta, WA 6914 Ph; (08) 9240 7555 info@arborlogic.com.au</p>
--	---	---	---

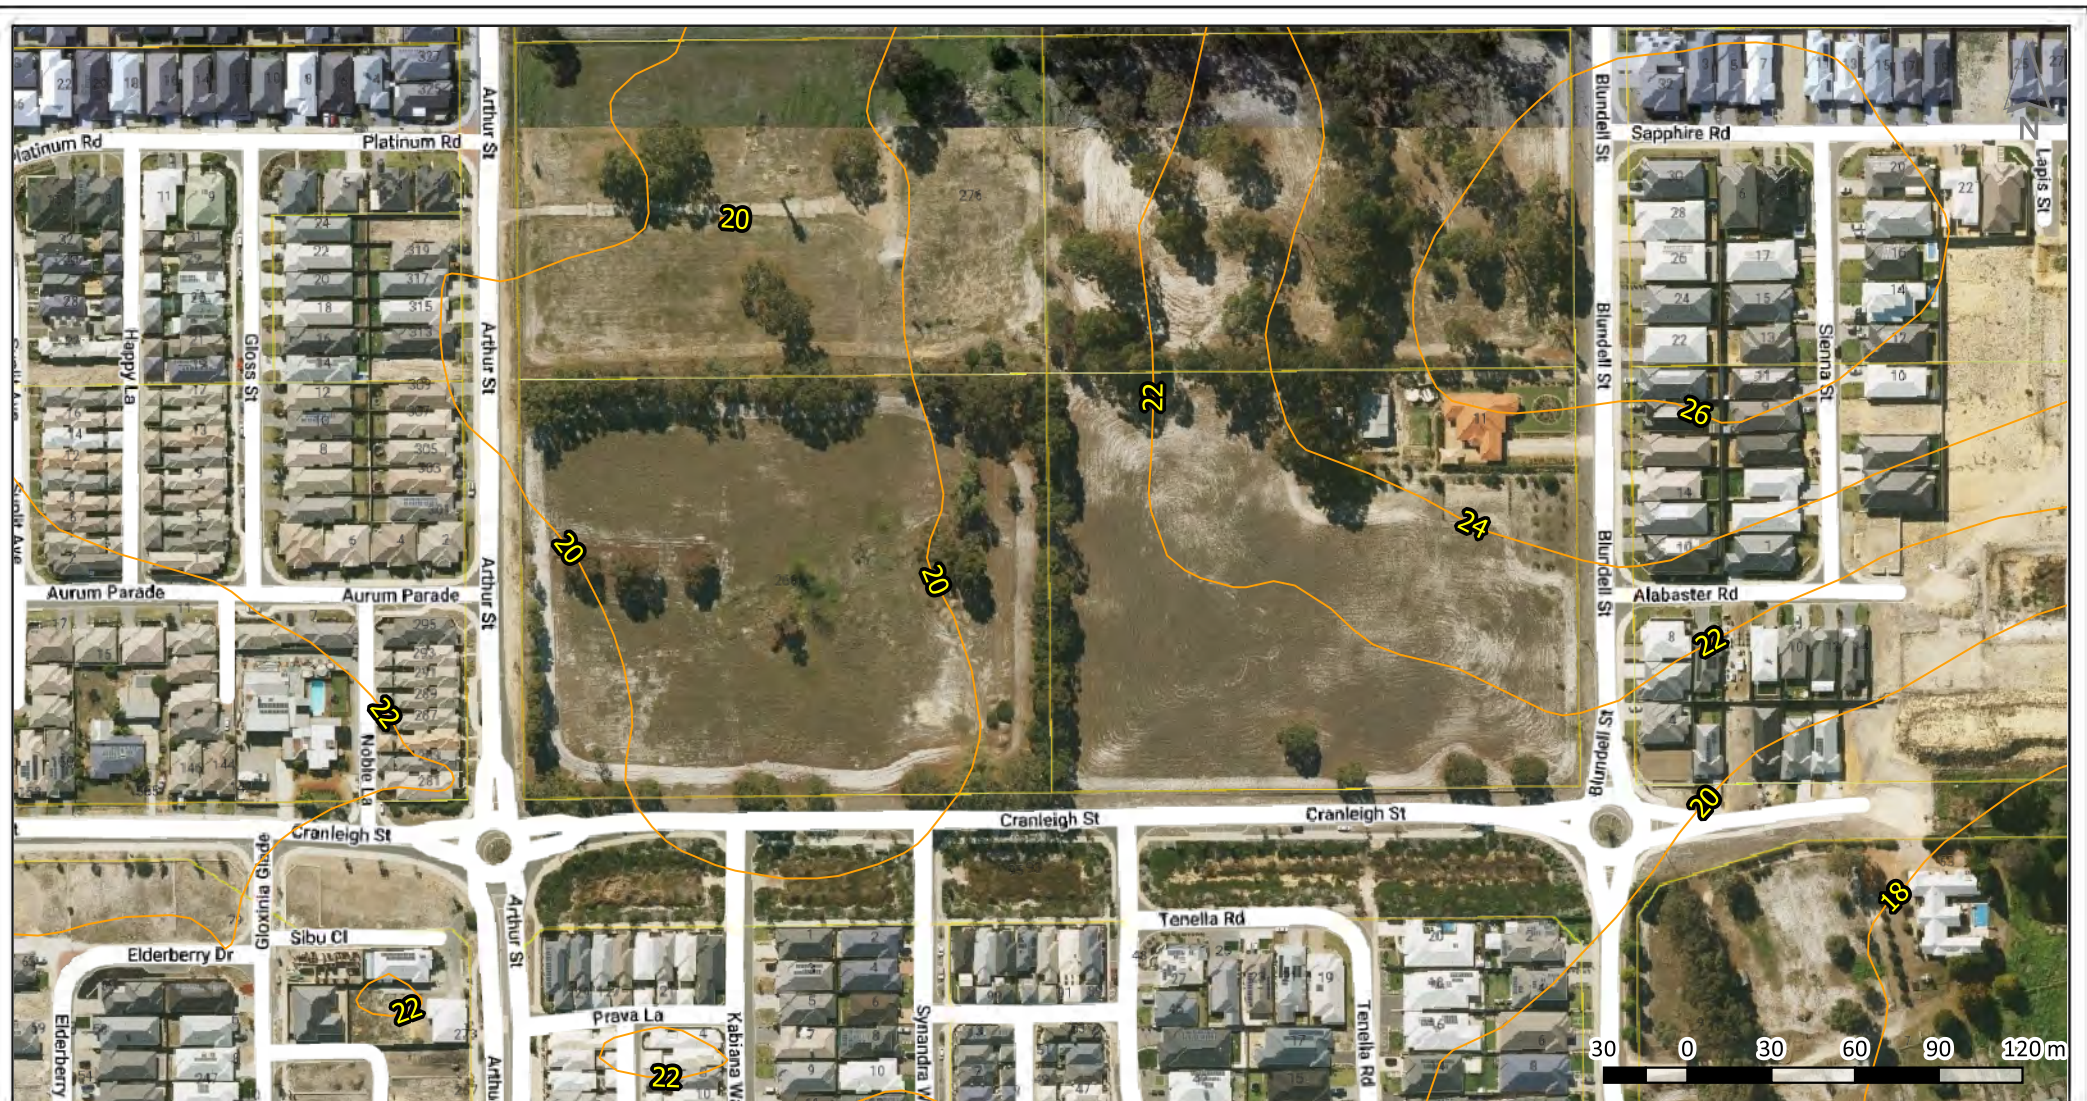
## Existing Conditions - Aerial Contours

Existing Aerial Contours

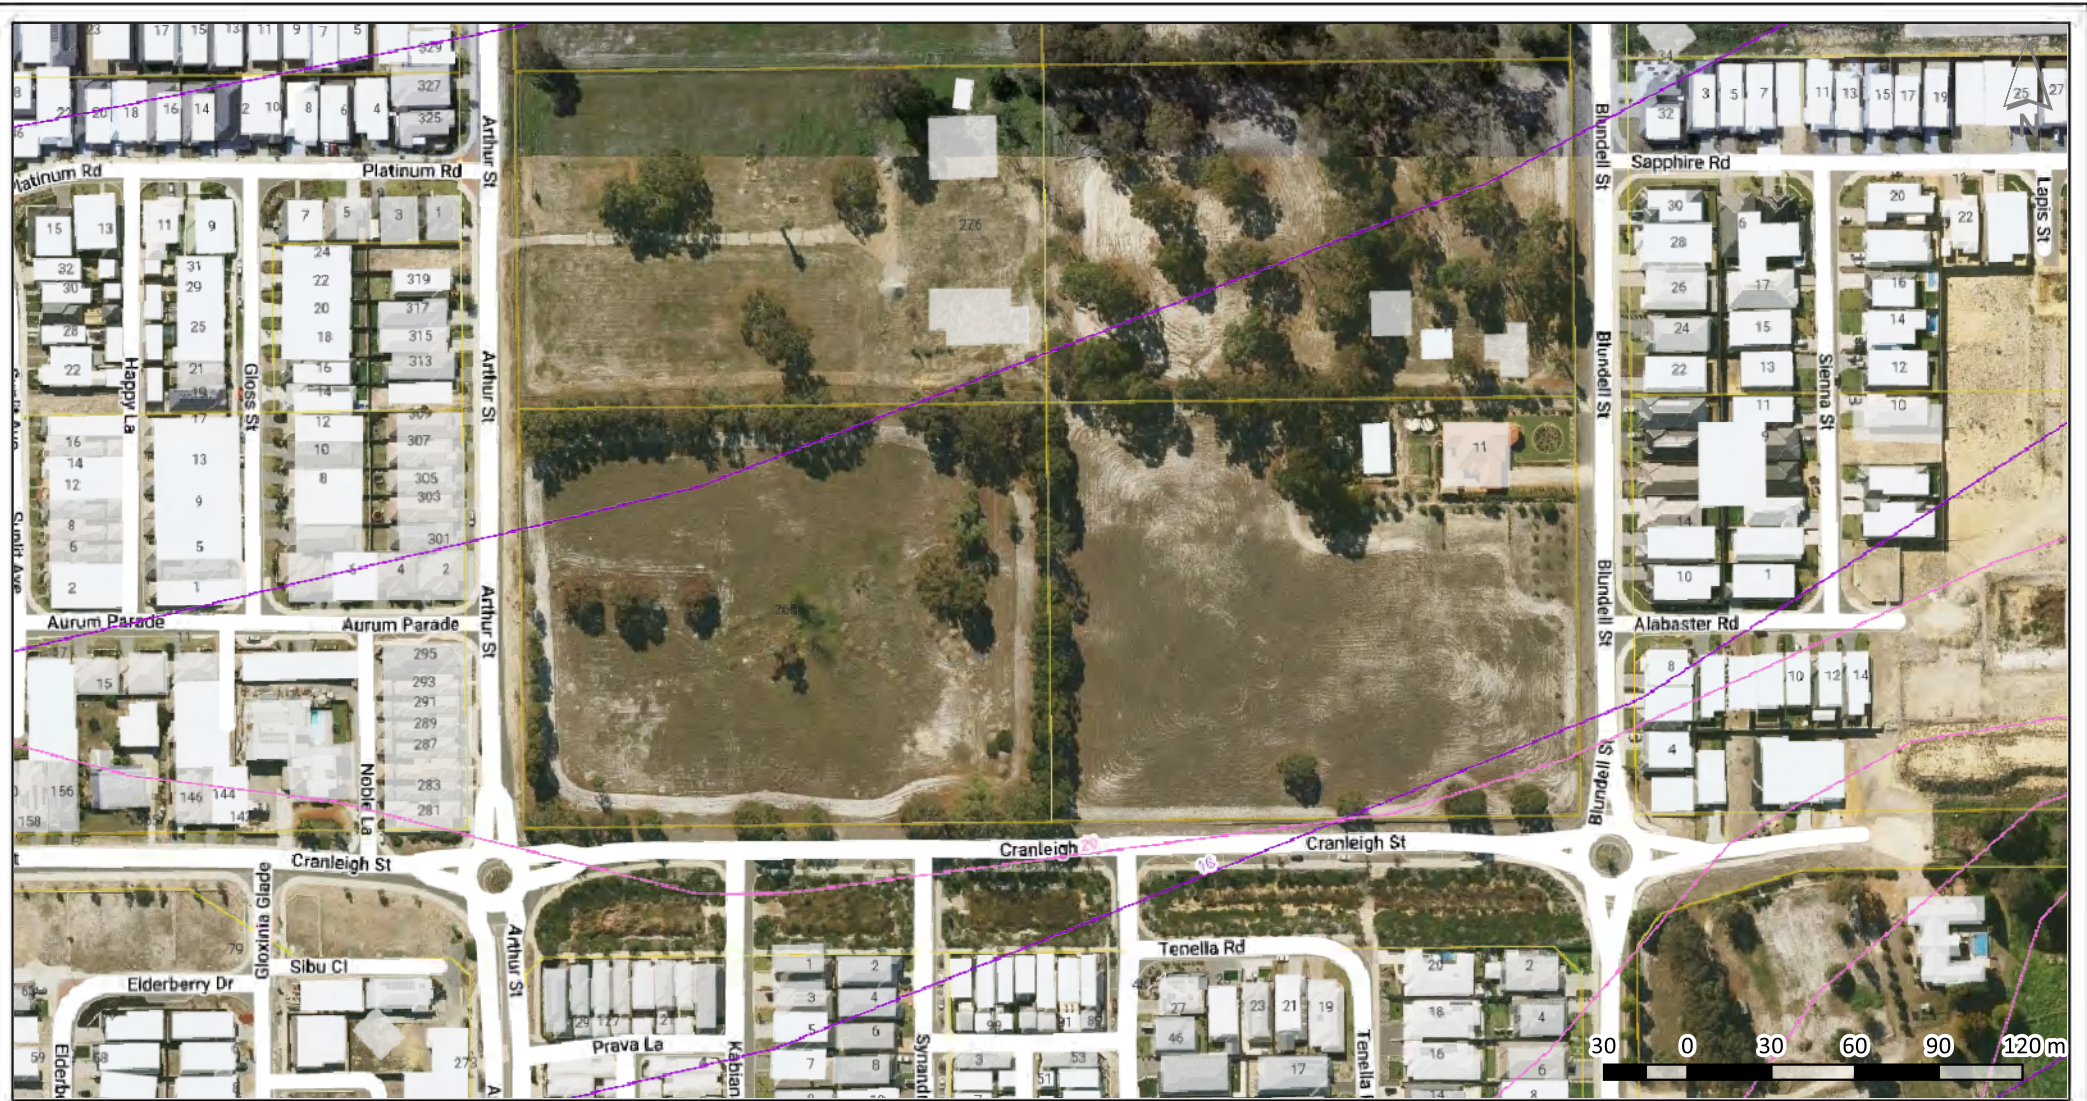
## Existing Conditions - Groundwater

Existing Groundwater Conditions (Minimum & Maximum)

The Geotechnical Report states groundwater was observed within the majority of test pit locations within the western half of the site (Lot 558), at depths of 1.75m to 2.8m, and notes investigations were undertaken when groundwater was likely near its low seasonal level.

Based on the above findings, groundwater will have an effect on the development, particularly on earthworks and drainage designs, including below ground infiltration storage structures, and also during excavations deeper than about 1m below existing ground levels in the lower areas of the site. Dewatering during excavation works and subsoil drainage systems may be required. The current preliminary earthworks and drainage designs have been updated, based on the AAMGL contours provided by JDA.

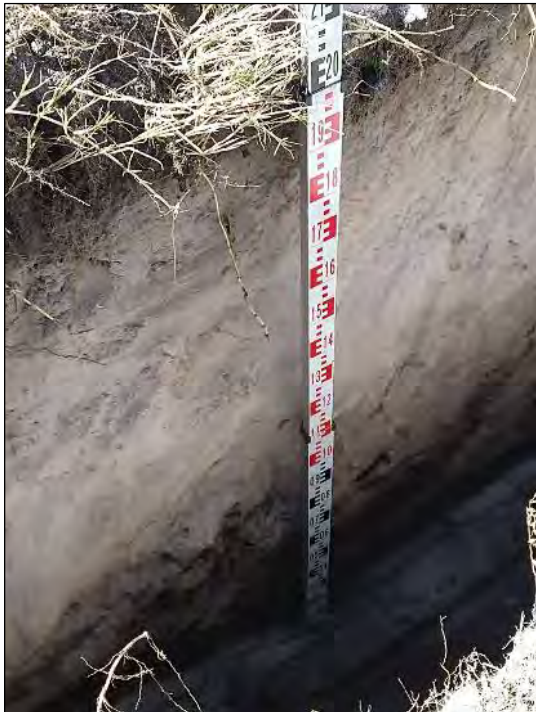
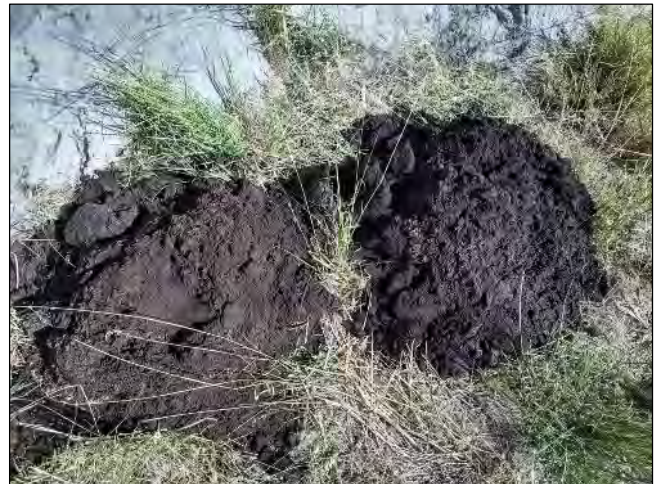
**PIT No:** 1  
**PROJECT No:** 201389.00  
**DATE:** 15/2/2021  
**SHEET 1 OF 1**

RL	Depth (m)	Description of Strata	Graphic Log	Sampling & In Situ Testing				Water	Dynamic Penetrometer Test (blows per 150mm)			
				Type	Depth	Sample	Results & Comments		5	10	15	20
22.0	0.25	FILL/SAND SP-SM: fine to medium grained, grey-brown, with silt, trace gravel (building materials) and rootlets, dry to moist.										
		SAND SP: fine to medium grained, grey, trace silt, moist, medium dense. Bassendean Sand.		D	0.5							
		- becoming dense from 0.75 m depth.		E	1.0							
21.3	1.3	CEMENTED Silty SAND SM (COFFEE ROCK): moderately cemented, dark brown, moist to wet.		E	1.5							
		- becoming well cemented from 1.9 m depth.		D	1.8							
20.2	2.1	Pit discontinued at 2.1m (Hard digging)		E	2.0

- Fine to medium grained, loose to medium dense, uncontrolled sandy fill (SP-SM), containing building materials and large pieces of concrete slabs, was encountered at two test locations (test pits 1 and 6 within the north-west and central east of Lot 558) to depths of 0.25m and 0.8m respectively

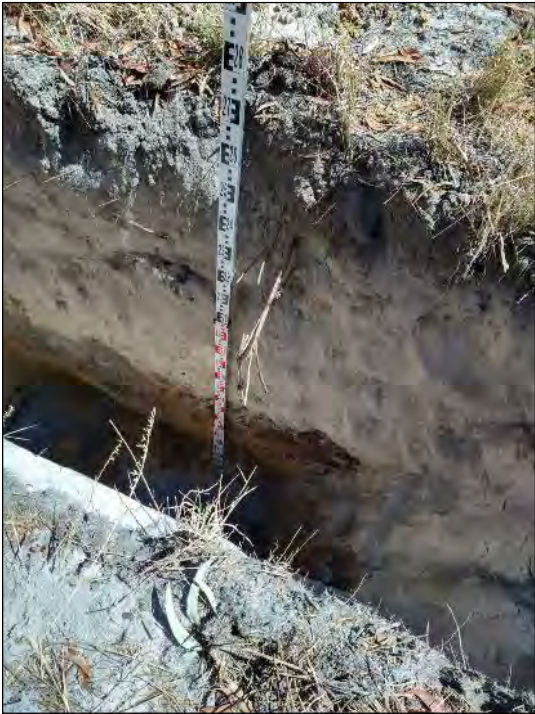
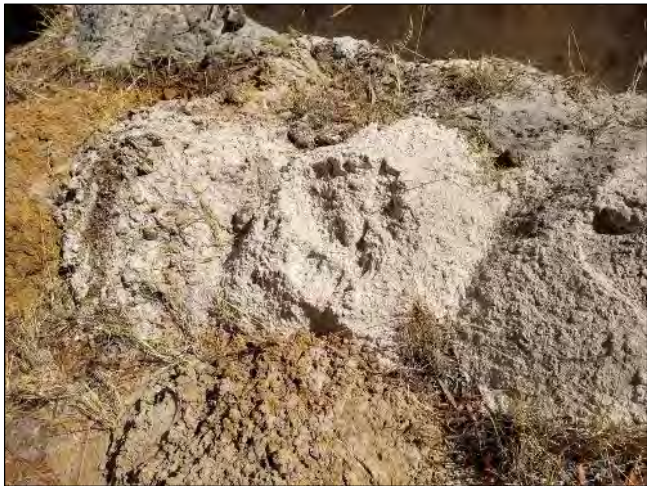
**PIT No:** 2  
**PROJECT No:** 201389.00  
**DATE:** 15/2/2021  
**SHEET 1 OF 1**

RL	Depth (m)	Description of Strata	Graphic Log	Sampling & In Situ Testing				Water	Dynamic Penetrometer Test (blows per 150mm)			
				Type	Depth	Sample	Results & Comments		5	10	15	20
22	0.17	TOPSOIL/SAND SP-SM: fine to medium grained, dark grey-brown, with silt, dry to moist.  SAND SP: fine to medium grained, light grey, trace silt and rootlets to 0.4 m depth, moist, loose. Bassendean Sand. - becoming medium dense to dense from 0.45 m depth.		D	0.1							
21	1.0			D	1.0							
20	1.25	CEMENTED Silty SAND SM (COFFEE ROCK): moderately cemented, dark brown, moist to wet.  - becoming weakly cemented, brown and with silt (SP-SM) from 1.6 m depth.  - becoming grey and wet from 2.0 m depth.										
19	2.3			D	2.3							
18	2.5	Pit discontinued at 2.5m (Collapsing conditions)

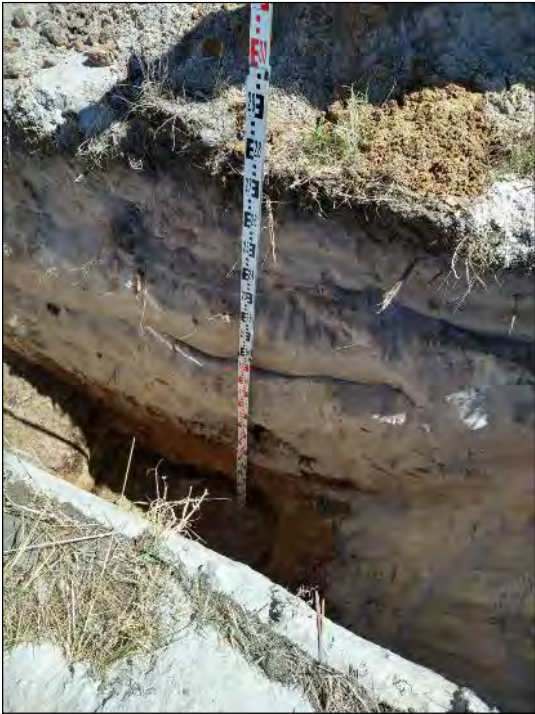
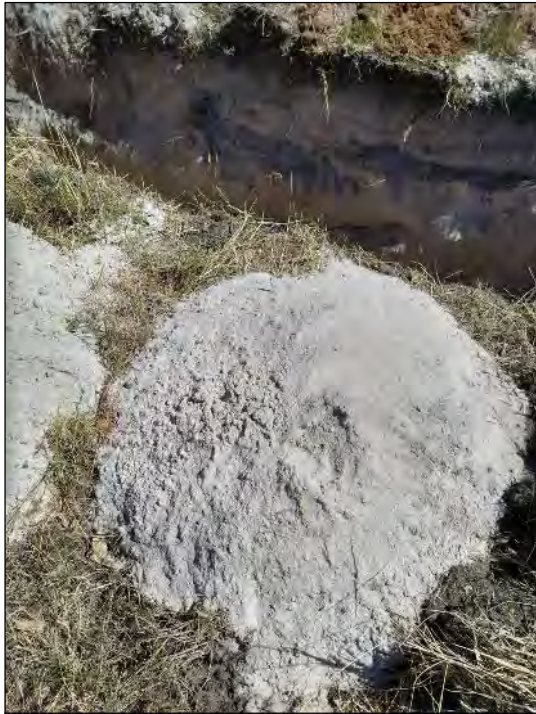
**PIT No:** 4  
**PROJECT No:** 201389.00  
**DATE:** 15/2/2021  
**SHEET 1 OF 1**

RL	Depth (m)	Description of Strata	Graphic Log	Sampling & In Situ Testing				Water	Dynamic Penetrometer Test (blows per 150mm)			
				Type	Depth	Sample	Results & Comments		5	10	15	20
22	0.1	TOPSOIL/SAND SP-SM: fine to medium grained, dark grey-brown, with silt, dry to moist. SAND SP: fine to medium grained, light grey, trace silt, moist, medium dense to dense. Bassendean Sand.		D	0.1							
21	1.0			D	1.0							
20	1.5	CEMENTED Silty SAND SM (COFFEE ROCK): very well cemented, dark brown, mottled brown, dry to moist.  - becoming moderately cemented, brown, mottled dark brown from 1.8 m depth.  - becoming weakly cemented, light grey-brown, with silt (SP-SM) from 2.1 m depth.										
19	2.0											
18	2.75	Pit discontinued at 2.75m (Collapsing conditions)

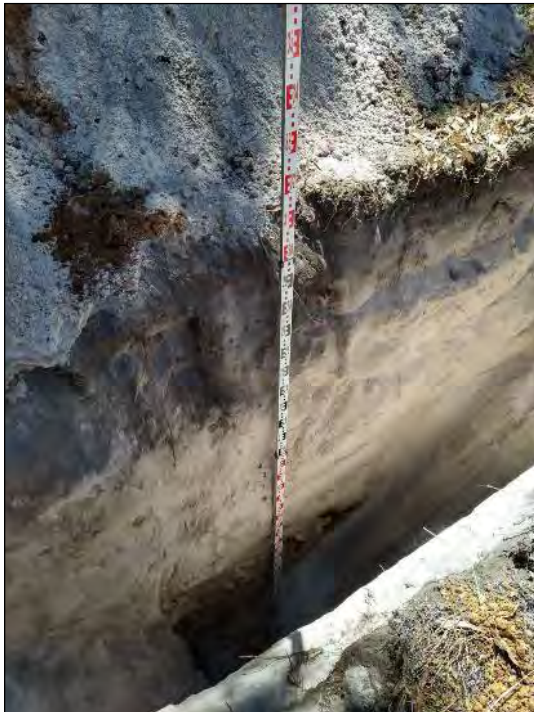
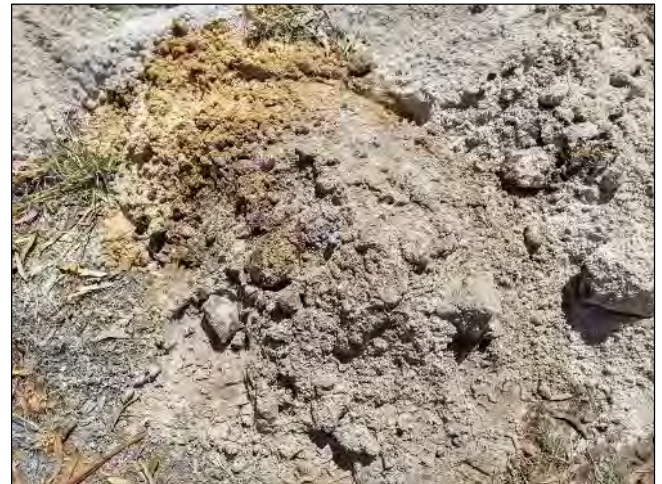
**PIT No:** 5  
**PROJECT No:** 201389.00  
**DATE:** 15/2/2021  
**SHEET 1 OF 1**

RL	Depth (m)	Description of Strata	Graphic Log	Sampling & In Situ Testing				Water	Dynamic Penetrometer Test (blows per 150mm)
				Type	Depth	Sample	Results & Comments		
22.0	0.1	TOPSOIL/SAND SP-SM: fine to medium grained, dark grey-brown, with silt, dry to moist. SAND SP: fine to medium grained, light grey, trace silt, moist, medium dense to dense. Bassendean Sand.		E	0.5				
21.0	1.0			E	1.0				
	1.5			E	1.5				
20.0	2.0	CEMENTED Silty SAND SM (COFFEE ROCK): moderately to well cemented, dark brown, moist to wet. - becoming brown, with silt (SP-SM) from 2.3 m depth.		E	2.0				
	2.5	- becoming wet from 2.7 m depth.		E	2.5				
19.0	2.9	Pit discontinued at 2.9m (Target)

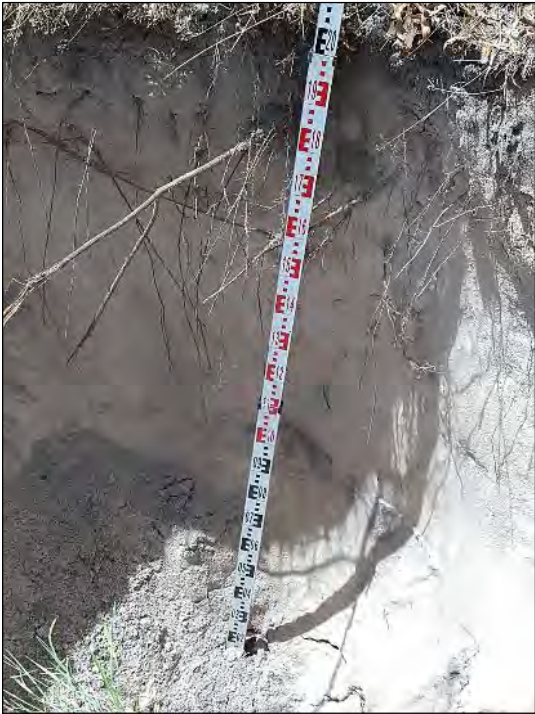
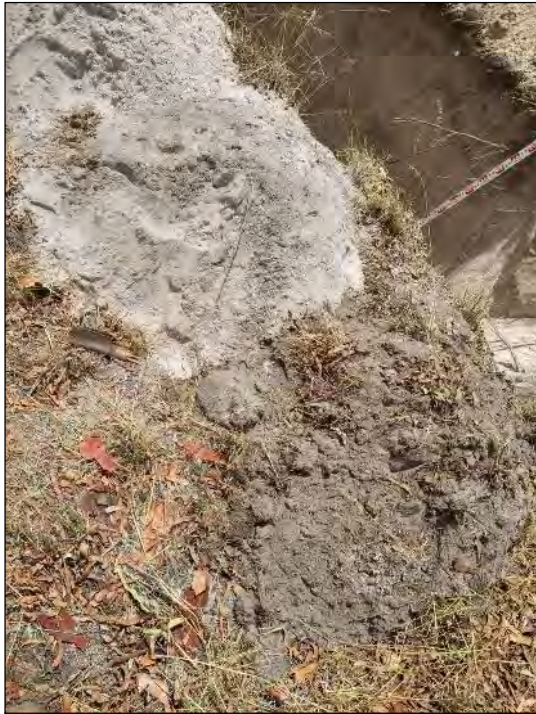
**PIT No:** 8  
**PROJECT No:** 201389.00  
**DATE:** 15/2/2021  
**SHEET 1 OF 1**

RL	Depth (m)	Description of Strata	Graphic Log	Sampling & In Situ Testing				Water	Dynamic Penetrometer Test (blows per 150mm)			
				Type	Depth	Sample	Results & Comments		5	10	15	20
22.0	0.1	TOPSOIL/SAND SP-SM: fine to medium grained, dark grey-brown, with silt, trace rootlets, dry to moist. SAND SP: fine to medium grained, light grey, trace silt, moist, loose. Bassendean Sand. - becoming medium dense from 0.45 m depth.		E	0.5							
21.0	1.0			E	1.0							
	1.5			E	1.5							
20.0	2.0	- becoming moist to wet from 1.8 m depth.		E	2.0							
	2.1	Clayey SAND SC: fine to medium grained, grey-brown, mottled orange-brown, low plasticity, wet. Guildford Formation.		E	2.5							
18.0	2.8	Pit discontinued at 2.8m (Collapsing conditions)

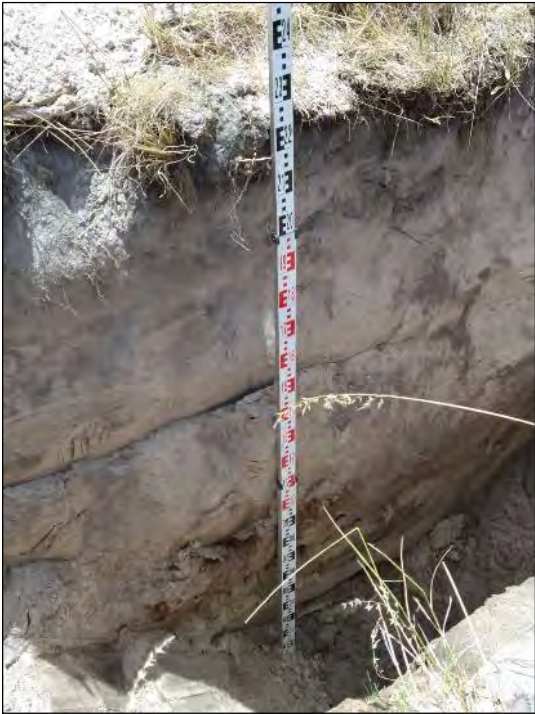
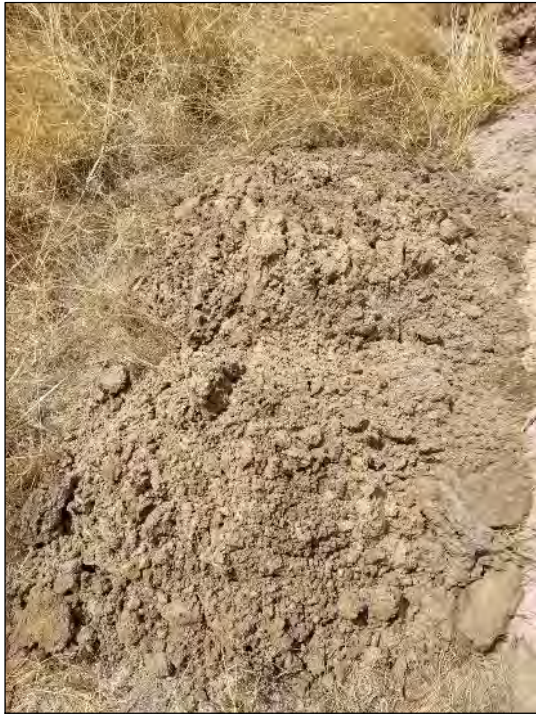
**PIT No:** 9  
**PROJECT No:** 201389.00  
**DATE:** 15/2/2021  
**SHEET 1 OF 1**

RL	Depth (m)	Description of Strata	Graphic Log	Sampling & In Situ Testing				Water	Dynamic Penetrometer Test (blows per 150mm)			
				Type	Depth	Sample	Results & Comments		5	10	15	20
22	0.2	TOPSOIL/SAND SP-SM: fine to medium grained, dark grey-brown, with silt, dry to moist.										
		SAND SP: fine to medium grained, light grey, trace silt, moist, loose. Bassendean Sand. - becoming medium dense from 0.3 m depth.										
20	1											
	1.5	CEMENTED Silty SAND SM (COFFEE ROCK): moderately cemented, brown, mottled dark brown, moist to wet.										
	1.8	- becoming weakly cemented from 1.6 m depth.										
20	2	Clayey SAND SC: fine to medium grained, grey mottled blue, low plasticity, wet, medium dense. Guildford Formation.		D	2.0		pp = 100					
	2.5	Pit discontinued at 2.5m (Collapsing conditions)

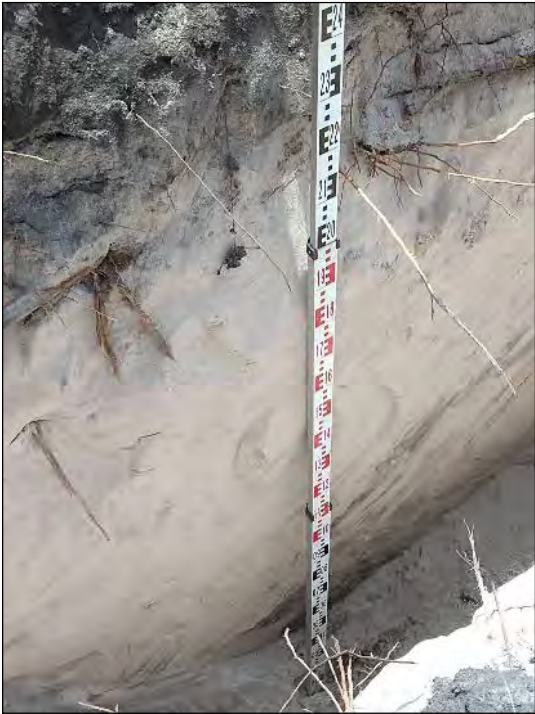
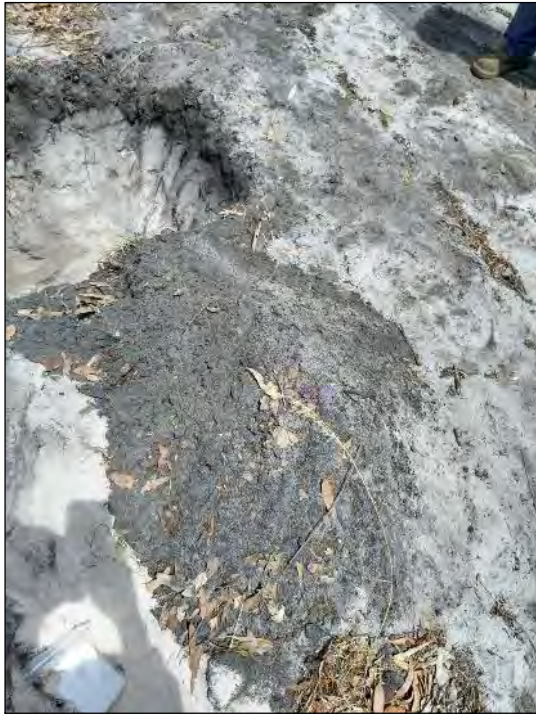
**PIT No:** 11  
**PROJECT No:** 201389.00  
**DATE:** 15/2/2021  
**SHEET 1 OF 1**

RL	Depth (m)	Description of Strata	Graphic Log	Sampling & In Situ Testing				Water	Dynamic Penetrometer Test (blows per 150mm)			
				Type	Depth	Sample	Results & Comments		5	10	15	20
22	0.17	TOPSOIL/SAND SP-SM: fine to medium grained, dark grey-brown, with silt, dry to moist.		D	0.1							
		SAND SP: fine to medium grained, light grey, trace silt, moist, loose. Bassendean Sand.		E	0.5							
		- becoming medium dense to dense from 0.45 m depth.		E	1.0							
				E	1.5							
				E	2.0							
24	2.4	CEMENTED Silty SAND SM (COFFEE ROCK): well cemented, dark brown, mottled brown, moist to wet.										
26	2.6	Pit discontinued at 2.6m (Hard digging)

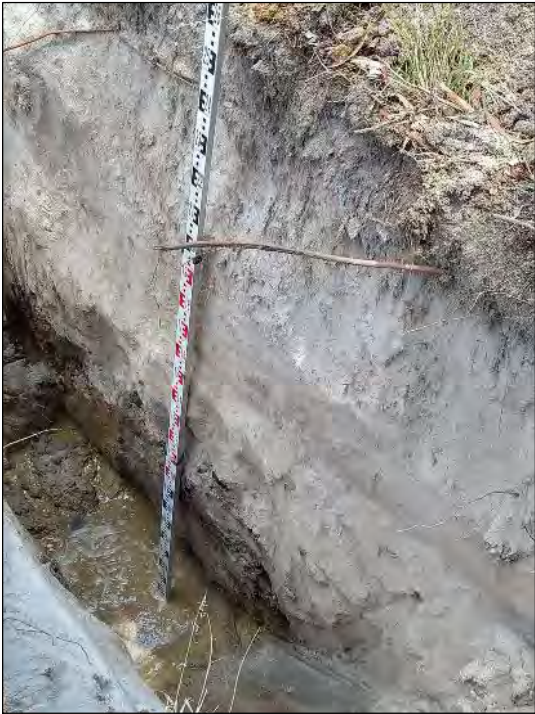
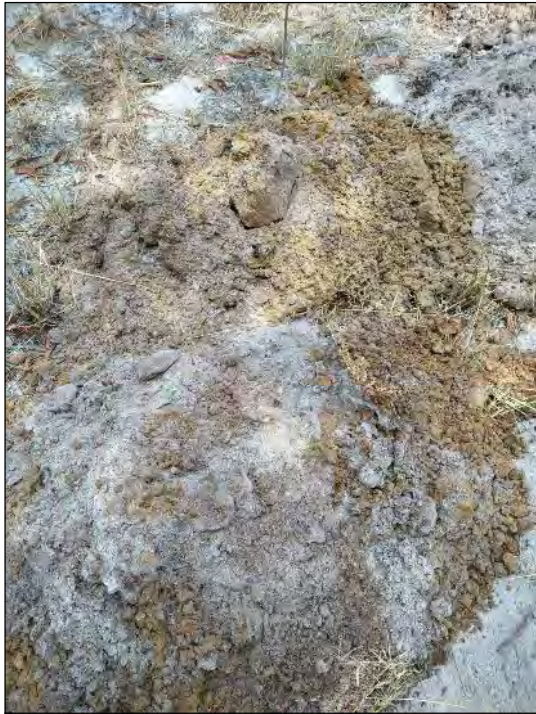
**PIT No:** 12  
**PROJECT No:** 201389.00  
**DATE:** 15/2/2021  
**SHEET 1 OF 1**

RL	Depth (m)	Description of Strata	Graphic Log	Sampling & In Situ Testing				Water	Dynamic Penetrometer Test (blows per 150mm)
				Type	Depth	Sample	Results & Comments		
22	0.2	TOPSOIL/SAND SP-SM: fine to medium grained, dark grey-brown, with silt, dry to moist.							
		SAND SP: fine to medium grained, light grey, trace silt, moist, loose. Bassendean Sand. - becoming medium dense to dense from 0.45 m depth.							
1	1.5	CEMENTED Silty SAND SM (COFFEE ROCK): moderately to well cemented, dark brown, moist to wet. - becoming brown, with silt (SP-SM) from 1.75 m depth. Possibly Guildford Formation.							
2	2.6	Pit discontinued at 2.6m (Collapsing conditions)

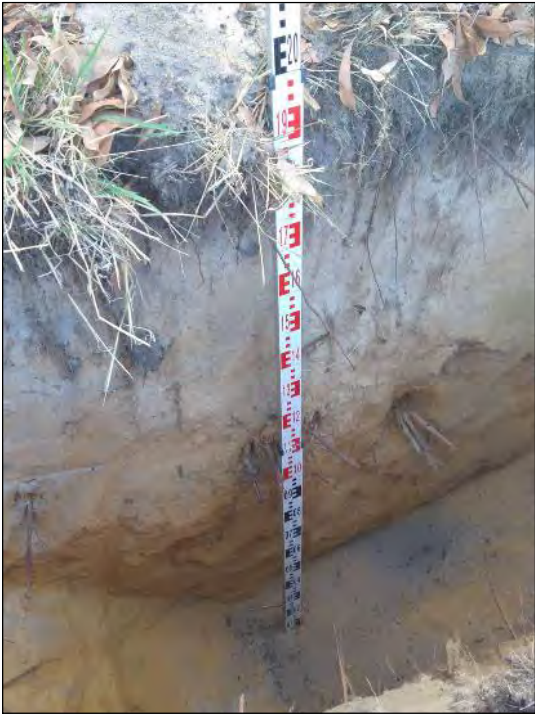
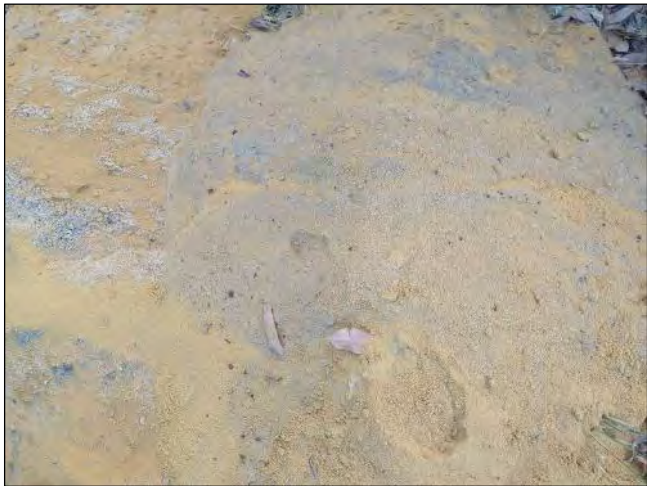
**PIT No:** 13  
**PROJECT No:** 201389.00  
**DATE:** 16/2/2021  
**SHEET 1 OF 1**

RL	Depth (m)	Description of Strata	Graphic Log	Sampling & In Situ Testing				Water	Dynamic Penetrometer Test (blows per 150mm)			
				Type	Depth	Sample	Results & Comments		5	10	15	20
24	0.16	<p>TOPSOIL/SAND SP-SM: fine to medium grained, dark grey-brown, with silt, dry to moist.</p> <p>SAND SP: fine to medium grained, light grey, trace silt, moist, medium dense. Bassendean Sand.</p> <p>- becoming yellow-brown from 0.7 m depth. Possibly Guildford Formation.</p> <p>- trace rootlets (10 mm - 20 mm in diameter) at 1.0 m depth.</p> <p>- trace rootlets (10 mm - 20 mm in diameter) at 1.2 m depth.</p>		D	1.0							
22	2.0	Pit discontinued at 2.0m (Target)

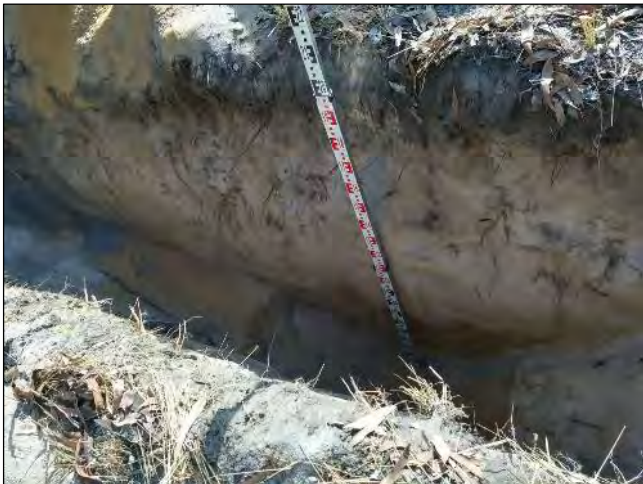
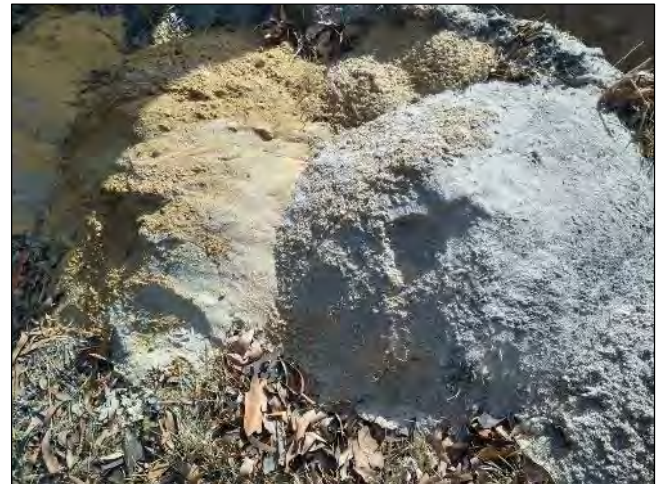
**PIT No:** 14  
**PROJECT No:** 201389.00  
**DATE:** 16/2/2021  
**SHEET 1 OF 1**

RL	Depth (m)	Description of Strata	Graphic Log	Sampling & In Situ Testing				Water	Dynamic Penetrometer Test (blows per 150mm)			
				Type	Depth	Sample	Results & Comments		5	10	15	20
	0.18	TOPSOIL/SAND SP-SM: fine to medium grained, dark grey-brown, with silt, dry to moist.										
		SAND SP: fine to medium grained, light grey, trace silt and trace rootlets to 0.9 m depth, moist, loose. Bassendean Sand.										
	1											
		- becoming yellow-brown, medium dense from 1.25 m depth. Possibly Guildford Formation.										
	2											
	2.0	Pit discontinued at 2.0m (Target)

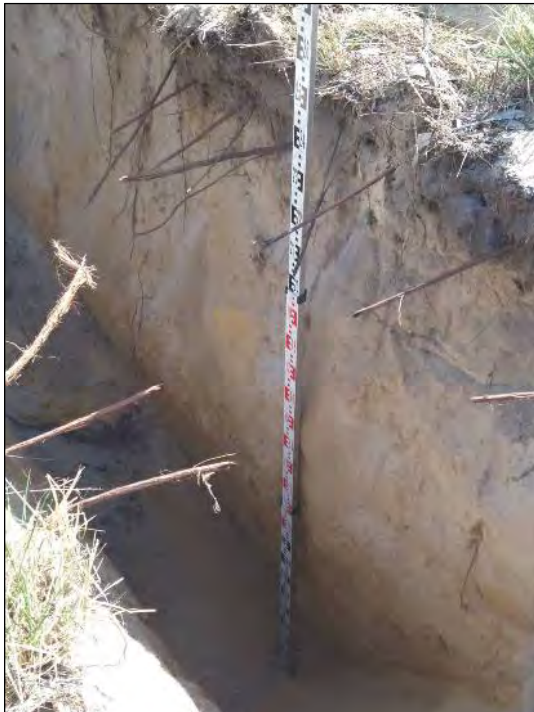
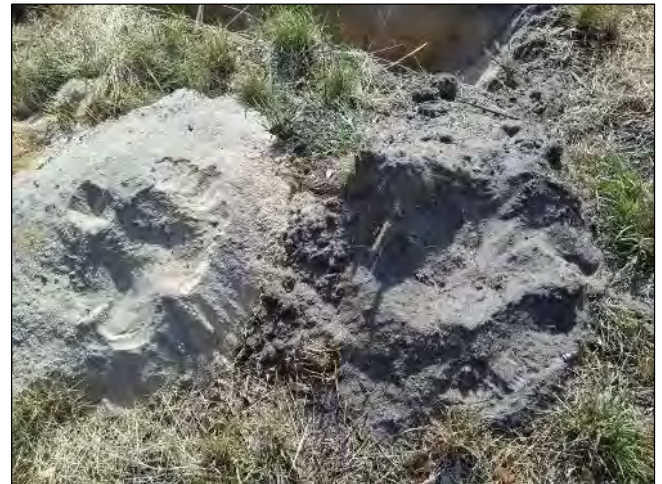
**PIT No:** 15  
**PROJECT No:** 201389.00  
**DATE:** 16/2/2021  
**SHEET 1 OF 1**

RL	Depth (m)	Description of Strata	Graphic Log	Sampling & In Situ Testing				Water	Dynamic Penetrometer Test (blows per 150mm)			
				Type	Depth	Sample	Results & Comments		5	10	15	20
	0.18	TOPSOIL/SAND SP-SM: fine to medium grained, dark grey-brown, with silt, dry to moist.		D	0.1							
		SAND SP: fine to medium grained, light grey, trace silt, moist, loose. Bassendean Sand.		E	0.5							
		- becoming yellow-brown from 0.65 m depth. Possibly Guildford Formation.		E	1.0							
		- becoming medium dense from 1.3 m depth.		E	1.5							
				E	2.0							
				E	2.5							
	2.9	Pit discontinued at 2.9m (Collapsing conditions)		E	2.9

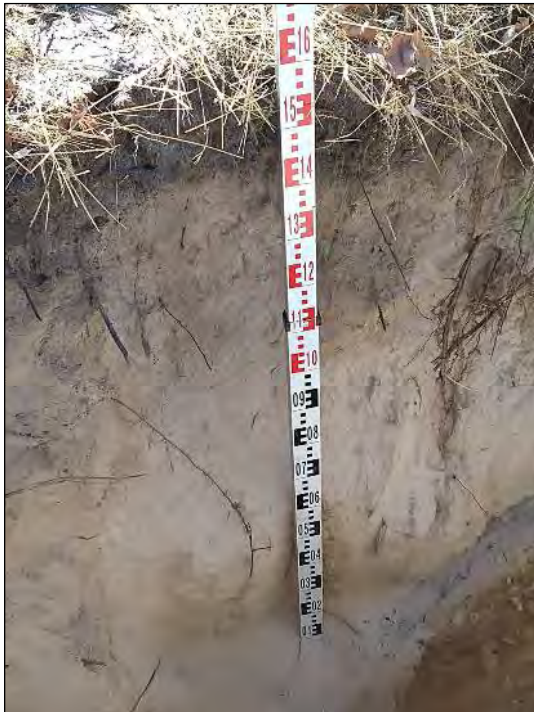
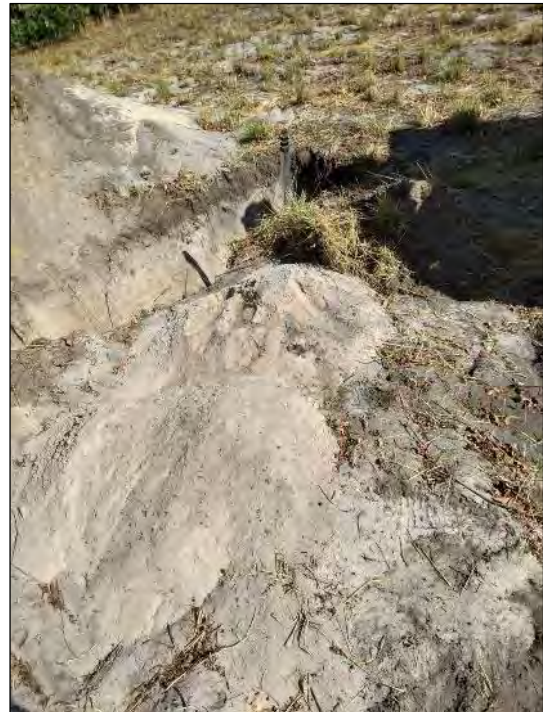
**PIT No:** 17  
**PROJECT No:** 201389.00  
**DATE:** 16/2/2021  
**SHEET 1 OF 1**

RL	Depth (m)	Description of Strata	Graphic Log	Sampling & In Situ Testing				Water	Dynamic Penetrometer Test (blows per 150mm)			
				Type	Depth	Sample	Results & Comments		5	10	15	20
	0.19	TOPSOIL/SAND SP-SM: fine to medium grained, dark grey-brown, with silt, dry to moist.										
		SAND SP: fine to medium grained, light grey, trace silt and rootlets to 0.6 m depth, moist, loose. Bassendean Sand.		D	0.5							
	1											
	1.5	- becoming yellow-brown from 1.4 m depth. Possibly Guildford Formation. - becoming medium dense from 1.5 m depth. Pit discontinued at 1.5m (Target)										
	2											
	20

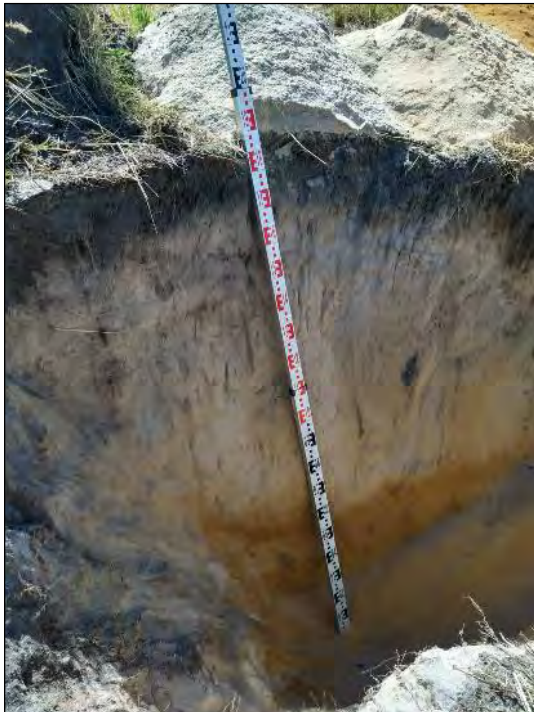
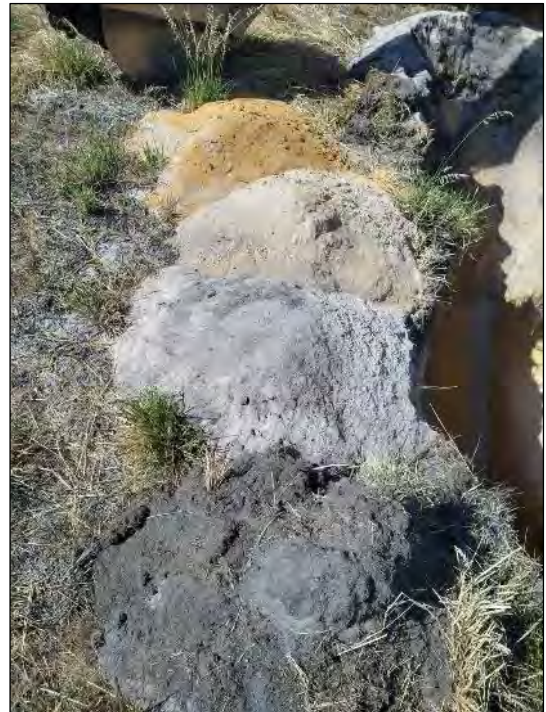
**PIT No:** 18  
**PROJECT No:** 201389.00  
**DATE:** 16/2/2021  
**SHEET 1 OF 1**

RL	Depth (m)	Description of Strata	Graphic Log	Sampling & In Situ Testing				Water	Dynamic Penetrometer Test (blows per 150mm)			
				Type	Depth	Sample	Results & Comments		5	10	15	20
23	0.18	TOPSOIL/SAND SP-SM: fine to medium grained, dark grey-brown, with silt, trace rootlets, dry to moist.		D	0.1							
22		SAND SP: fine to medium grained, light grey, trace silt and rootlets, moist, loose. Bassendean Sand.										
21		- becoming moist from 0.7 m depth.										
1		- becoming medium dense from 0.9 m depth.										
22		- becoming yellow-brown from 1.3 m depth. Possibly Guildford Formation.										
2	2.0	Pit discontinued at 2.0m (Target)

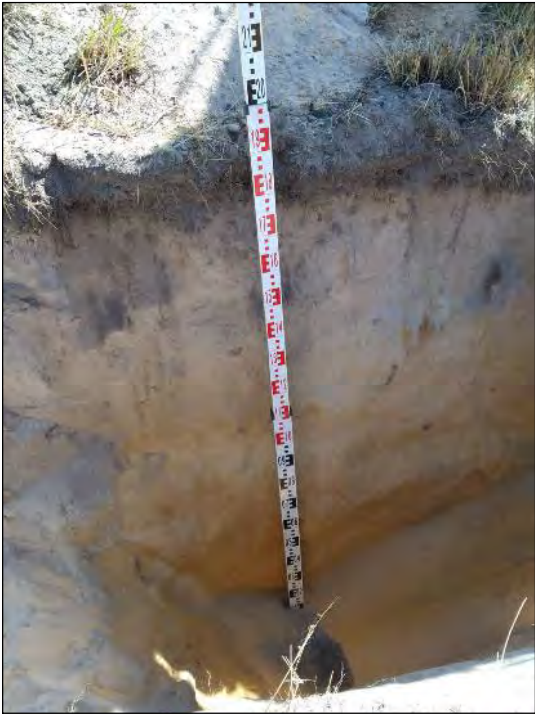
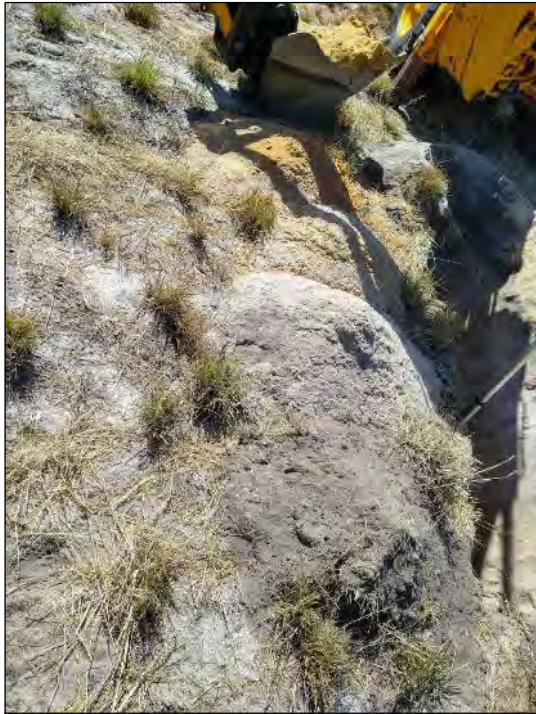
**PIT No:** 19  
**PROJECT No:** 201389.00  
**DATE:** 16/2/2021  
**SHEET 1 OF 2**

RL	Depth (m)	Description of Strata	Graphic Log	Sampling & In Situ Testing				Water	Dynamic Penetrometer Test (blows per 150mm)			
				Type	Depth	Sample	Results & Comments		5	10	15	20
0.16		TOPSOIL/SAND SP-SM: fine to medium grained, dark grey-brown, with silt, dry to moist.										
		SAND SP: fine to medium grained, light grey, trace silt, moist, loose. Bassendean Sand.										
1		- becoming loose to medium dense from 0.9 m depth.										
		- becoming yellow-brown from 1.1 m depth. Possibly Guildford Formation.										
2	2.0	- becoming medium dense from 2.4 m depth.		D	1.5							
		Pit discontinued at 2.0m (Target)

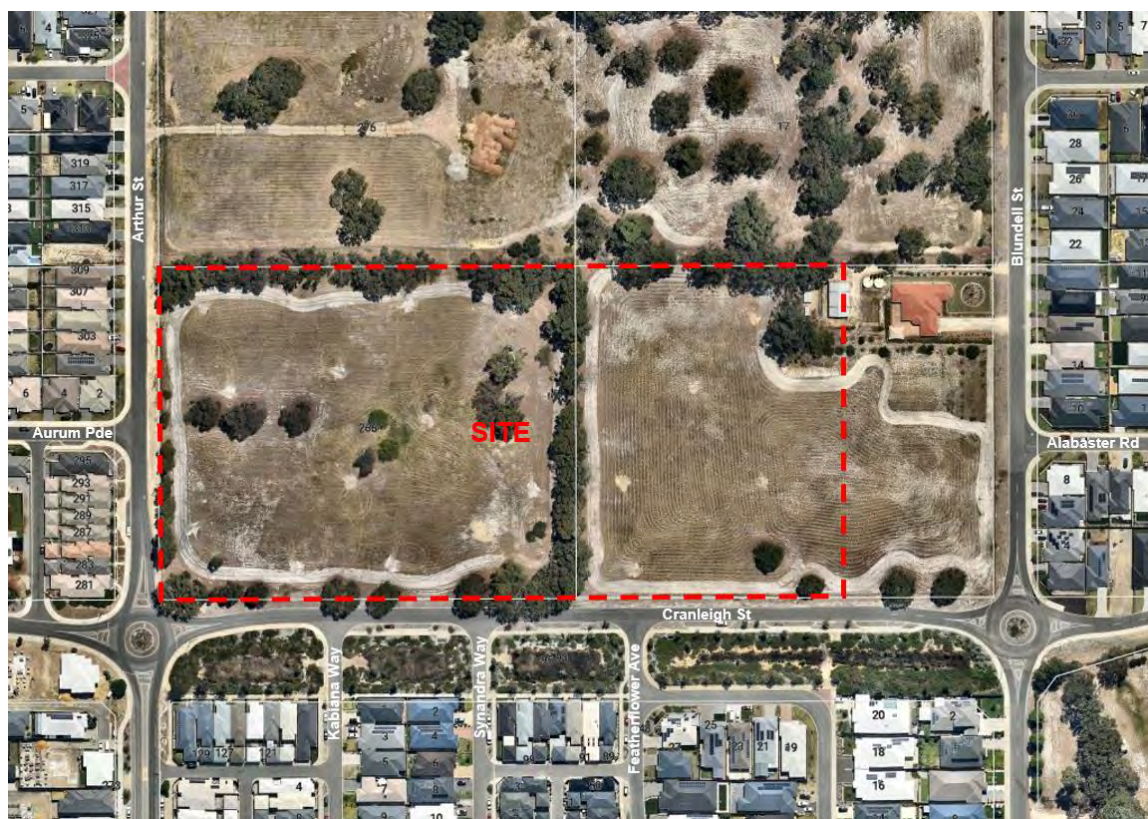
**Figure 3: Existing land uses**

The subject site and adjacent land to the north is currently rural land. Surrounding land uses to the south, west and east of the subject site are predominantly residential subdivision development, as can be seen in Figure 3.

The existing road network around the site is illustrated in Figure 3 and the existing MRWA functional road hierarchy in this area is illustrated in Figure 4.

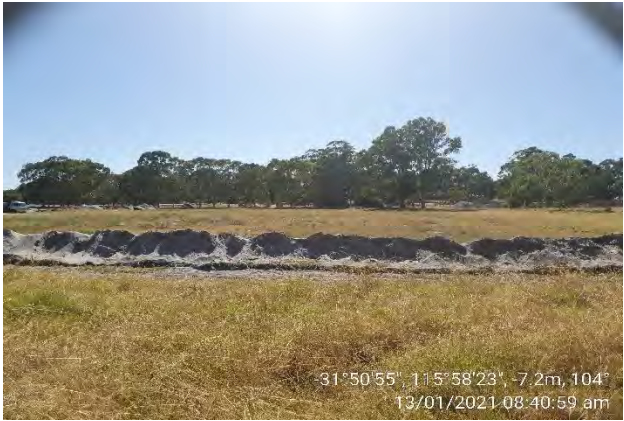
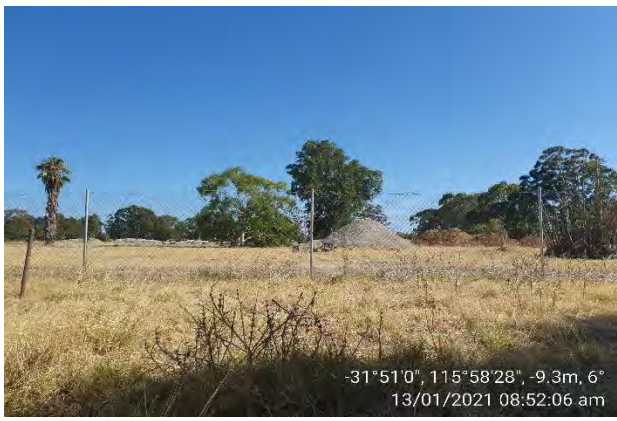
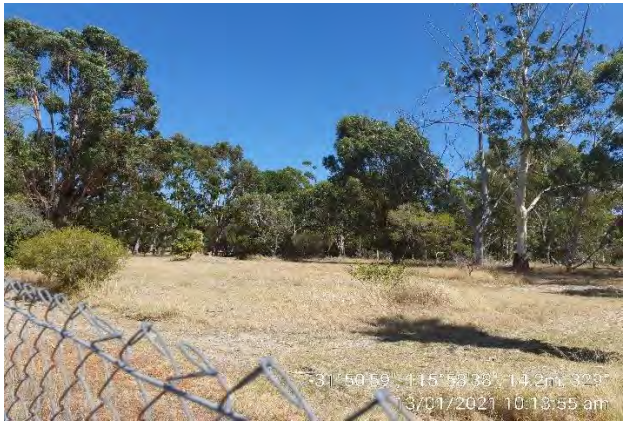
<div>Photo ID: 1</div> <div>Photo ID: 2</div>

VEGETATION AREA 1	
<b>AS 3959:2018 Vegetation Classification Applied:</b>	Class G Grassland
<b>Vegetation Types Present:</b>	Dense sown pasture G-25; Sown pasture G-26
<b>Description/Justification:</b>	Assessed as Grassland due to areas of grasses present in open areas. Currently in an unmanaged state and required to be classified in accordance with AS3959-2018. Foliage cover less than 10%.

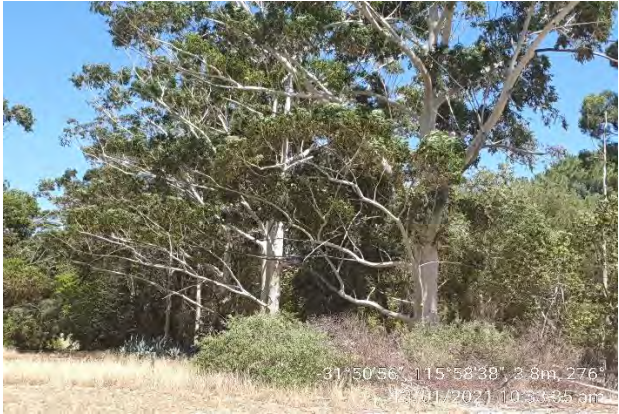
VEGETATION AREA 2	
<b>AS 3959:2018 Vegetation Classification Applied:</b>	Class A Forest
<b>Vegetation Types Present:</b>	Open forest A-03
<b>Description/Justification:</b>	<p>Mixed species of trees present inclusive of Eucalypts average heights of up to 20 metres. Understorey consists of unmanaged grasses, low shrub and low trees. Canopy coverage greater than 50%.</p> <p>NOTE: Zoom factor has been increased at Photo ID: 4 in order to obtain a suitable image. This is due to lack of access.</p>
