<b>1.</b>	<b>Introduction</b>	<b>1</b>
1.1	General	1
1.2	Site Location	1
1.3	Safety in Design	1
1.4	Verification Procedures	1
<b>2.</b>	<b>Project Overview</b>	<b>2</b>
<b>3.</b>	<b>Civil Services</b>	<b>3</b>
3.1	Objectives	3
3.2	Design Standards, Site Conditions and Constraints	3
3.3	Design Intent	7
3.4	Earthworks Estimates	10
3.5	Outstanding Information/Risk	11
	<b>Appendix A Safety In Design (SID)</b>	<b>12</b>
	<b>Appendix B Local Water Management Strategy – Figure 14</b>	<b>13</b>
	<b>Appendix C Existing Site and Services Information</b>	<b>14</b>
	<b>Appendix D Average Annual Maximum Groundwater Levels (AAMGLs)</b>	<b>15</b>
	<b>Appendix E Preliminary Civil Plans</b>	<b>16</b>

## **Proposed Dayton Primary School Masterplan**

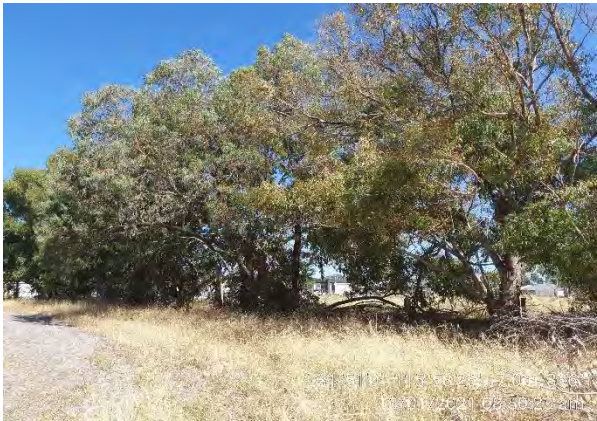
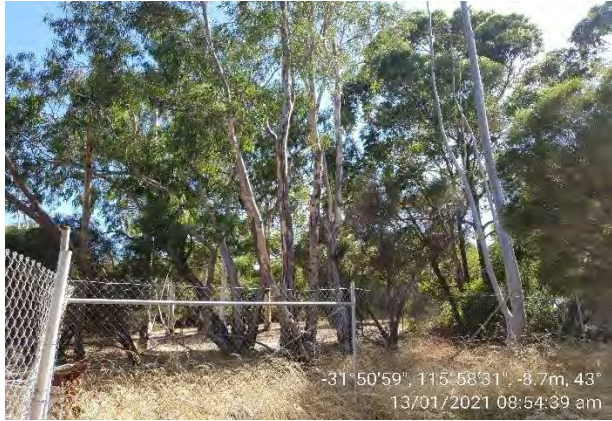
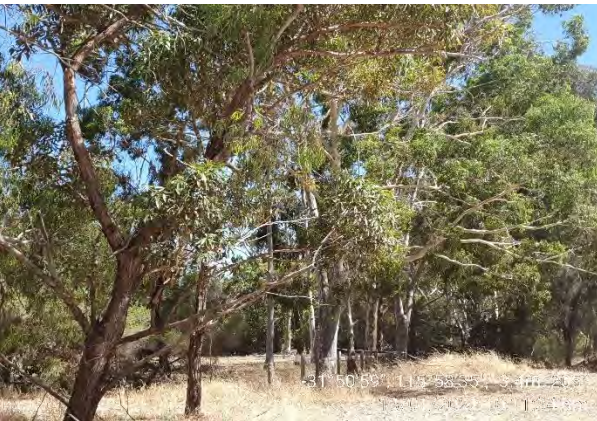
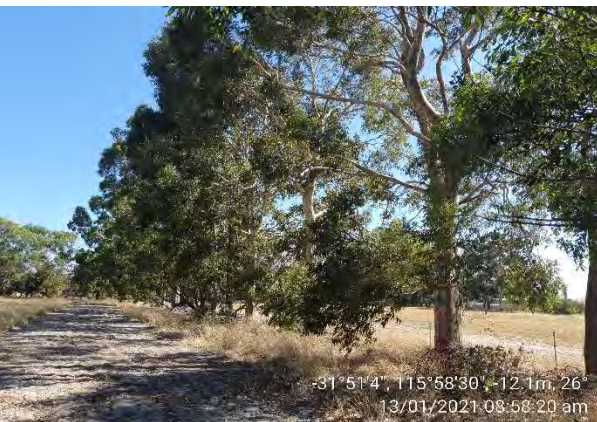
VEGETATION AREA 3	
AS 3959:2018 Vegetation Classification Applied:	Class B Woodland
Vegetation Types Present:	Woodland B-05
Description/Justification:	Mixed species of trees present inclusive of Eucalypts. Trees with average height of approximately 15-20 metres at maturity. Understorey consists of predominantly very low grasses and leaf litter. Canopy coverage approximately 30%. Occasional open areas between canopies.

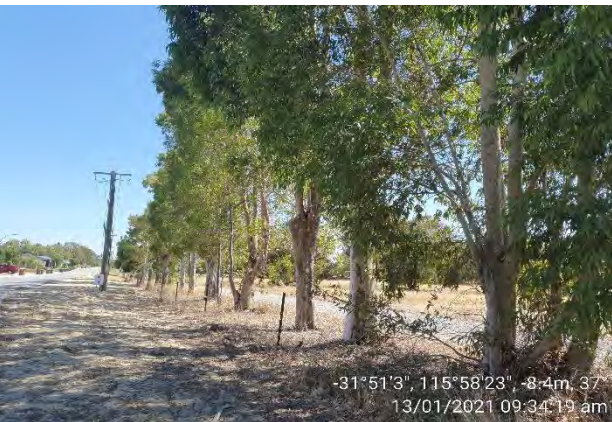
VEGETATION AREA 4	
<b>AS 3959:2018 Vegetation Classification Applied:</b>	Class G Grassland
<b>Vegetation Types Present:</b>	Sown pasture G-26
<b>Description/Justification:</b>	Assessed as Grassland due to areas of grasses present in open areas. Although grasses may appear to be in a managed state, there is the potential for these areas to become significantly unmanaged in future. As such this area has been classified as a precautionary measure with a worst-case scenario approach. Foliage cover less than 10%. NOTE: Remnants of Area 5 can be seen in the background of Photo ID: 12.

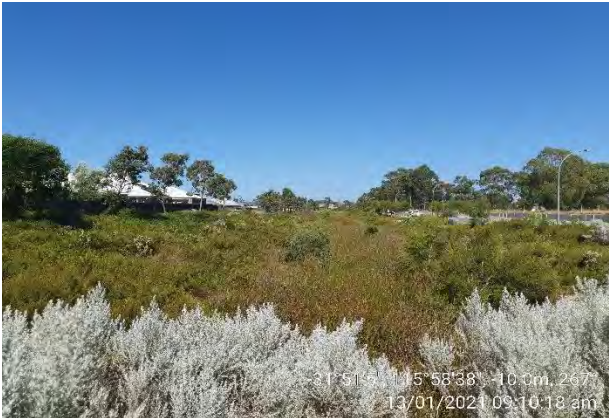
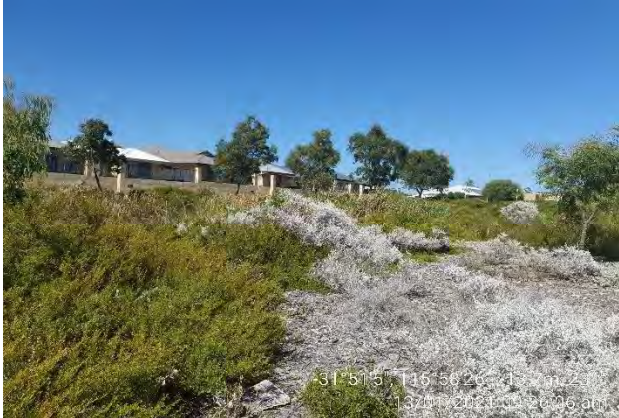
</div>	
Photo ID: 15	Photo ID: 16

VEGETATION AREA 6	
<b>AS 3959:2018 Vegetation Classification Applied:</b>	Class C Shrubland
<b>Vegetation Types Present:</b>	Closed heath C-10
<b>Description/Justification:</b>	Unmanaged shrub averaging less than 2 metres in height with mixed species composition.
<div>

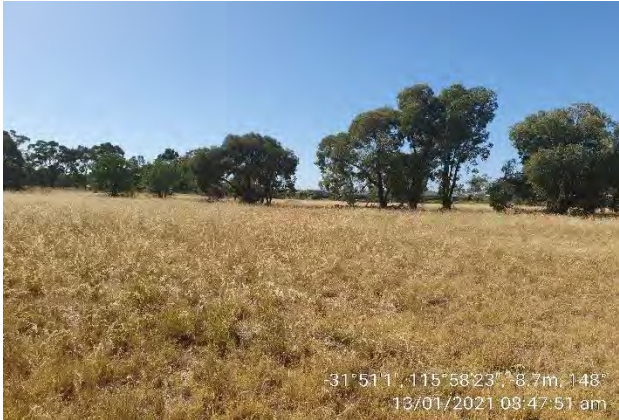
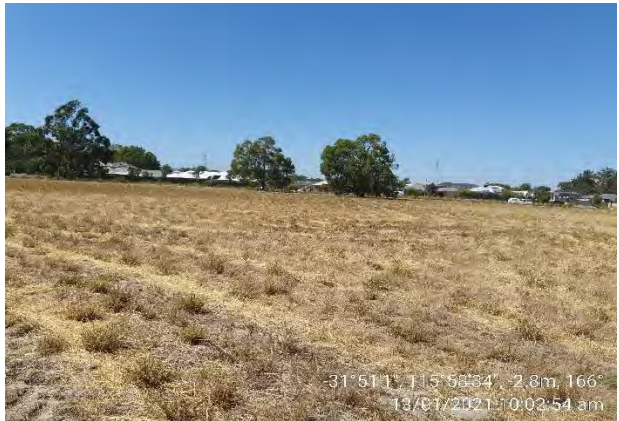
VEGETATION AREA 7	
<b>AS 3959:2018 Vegetation Classification Applied:</b>	Class G Grassland
<b>Vegetation Types Present:</b>	Sown pasture G-26
<b>Description/Justification:</b>	Assessed as Grassland due to areas of grasses present in open areas. Although grasses may appear to be in a managed state, there is the potential for these areas to become significantly unmanaged in future. As such this area has been classified as a precautionary measure with a worst-case scenario approach. Foliage cover less than 10%.

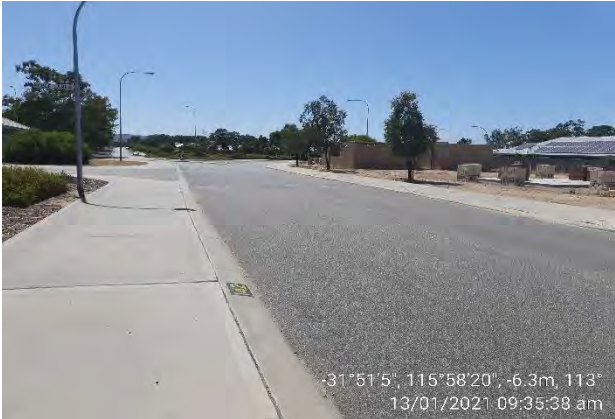
Photo ID: 27

VEGETATION AREA 8	
<b>AS 3959:2018 Vegetation Classification Applied:</b>	Excluded as per Section 2.2.3.2 (f) Low Threat Vegetation
<b>Vegetation Types Present:</b>	Low Threat Vegetation
<b>Description/Justification:</b>	A combination of an established and developing residential areas. Grasses maintained to less than 50mm in height. Footpaths, hardstand areas and street scapes/verges cleared of unmanaged vegetation.

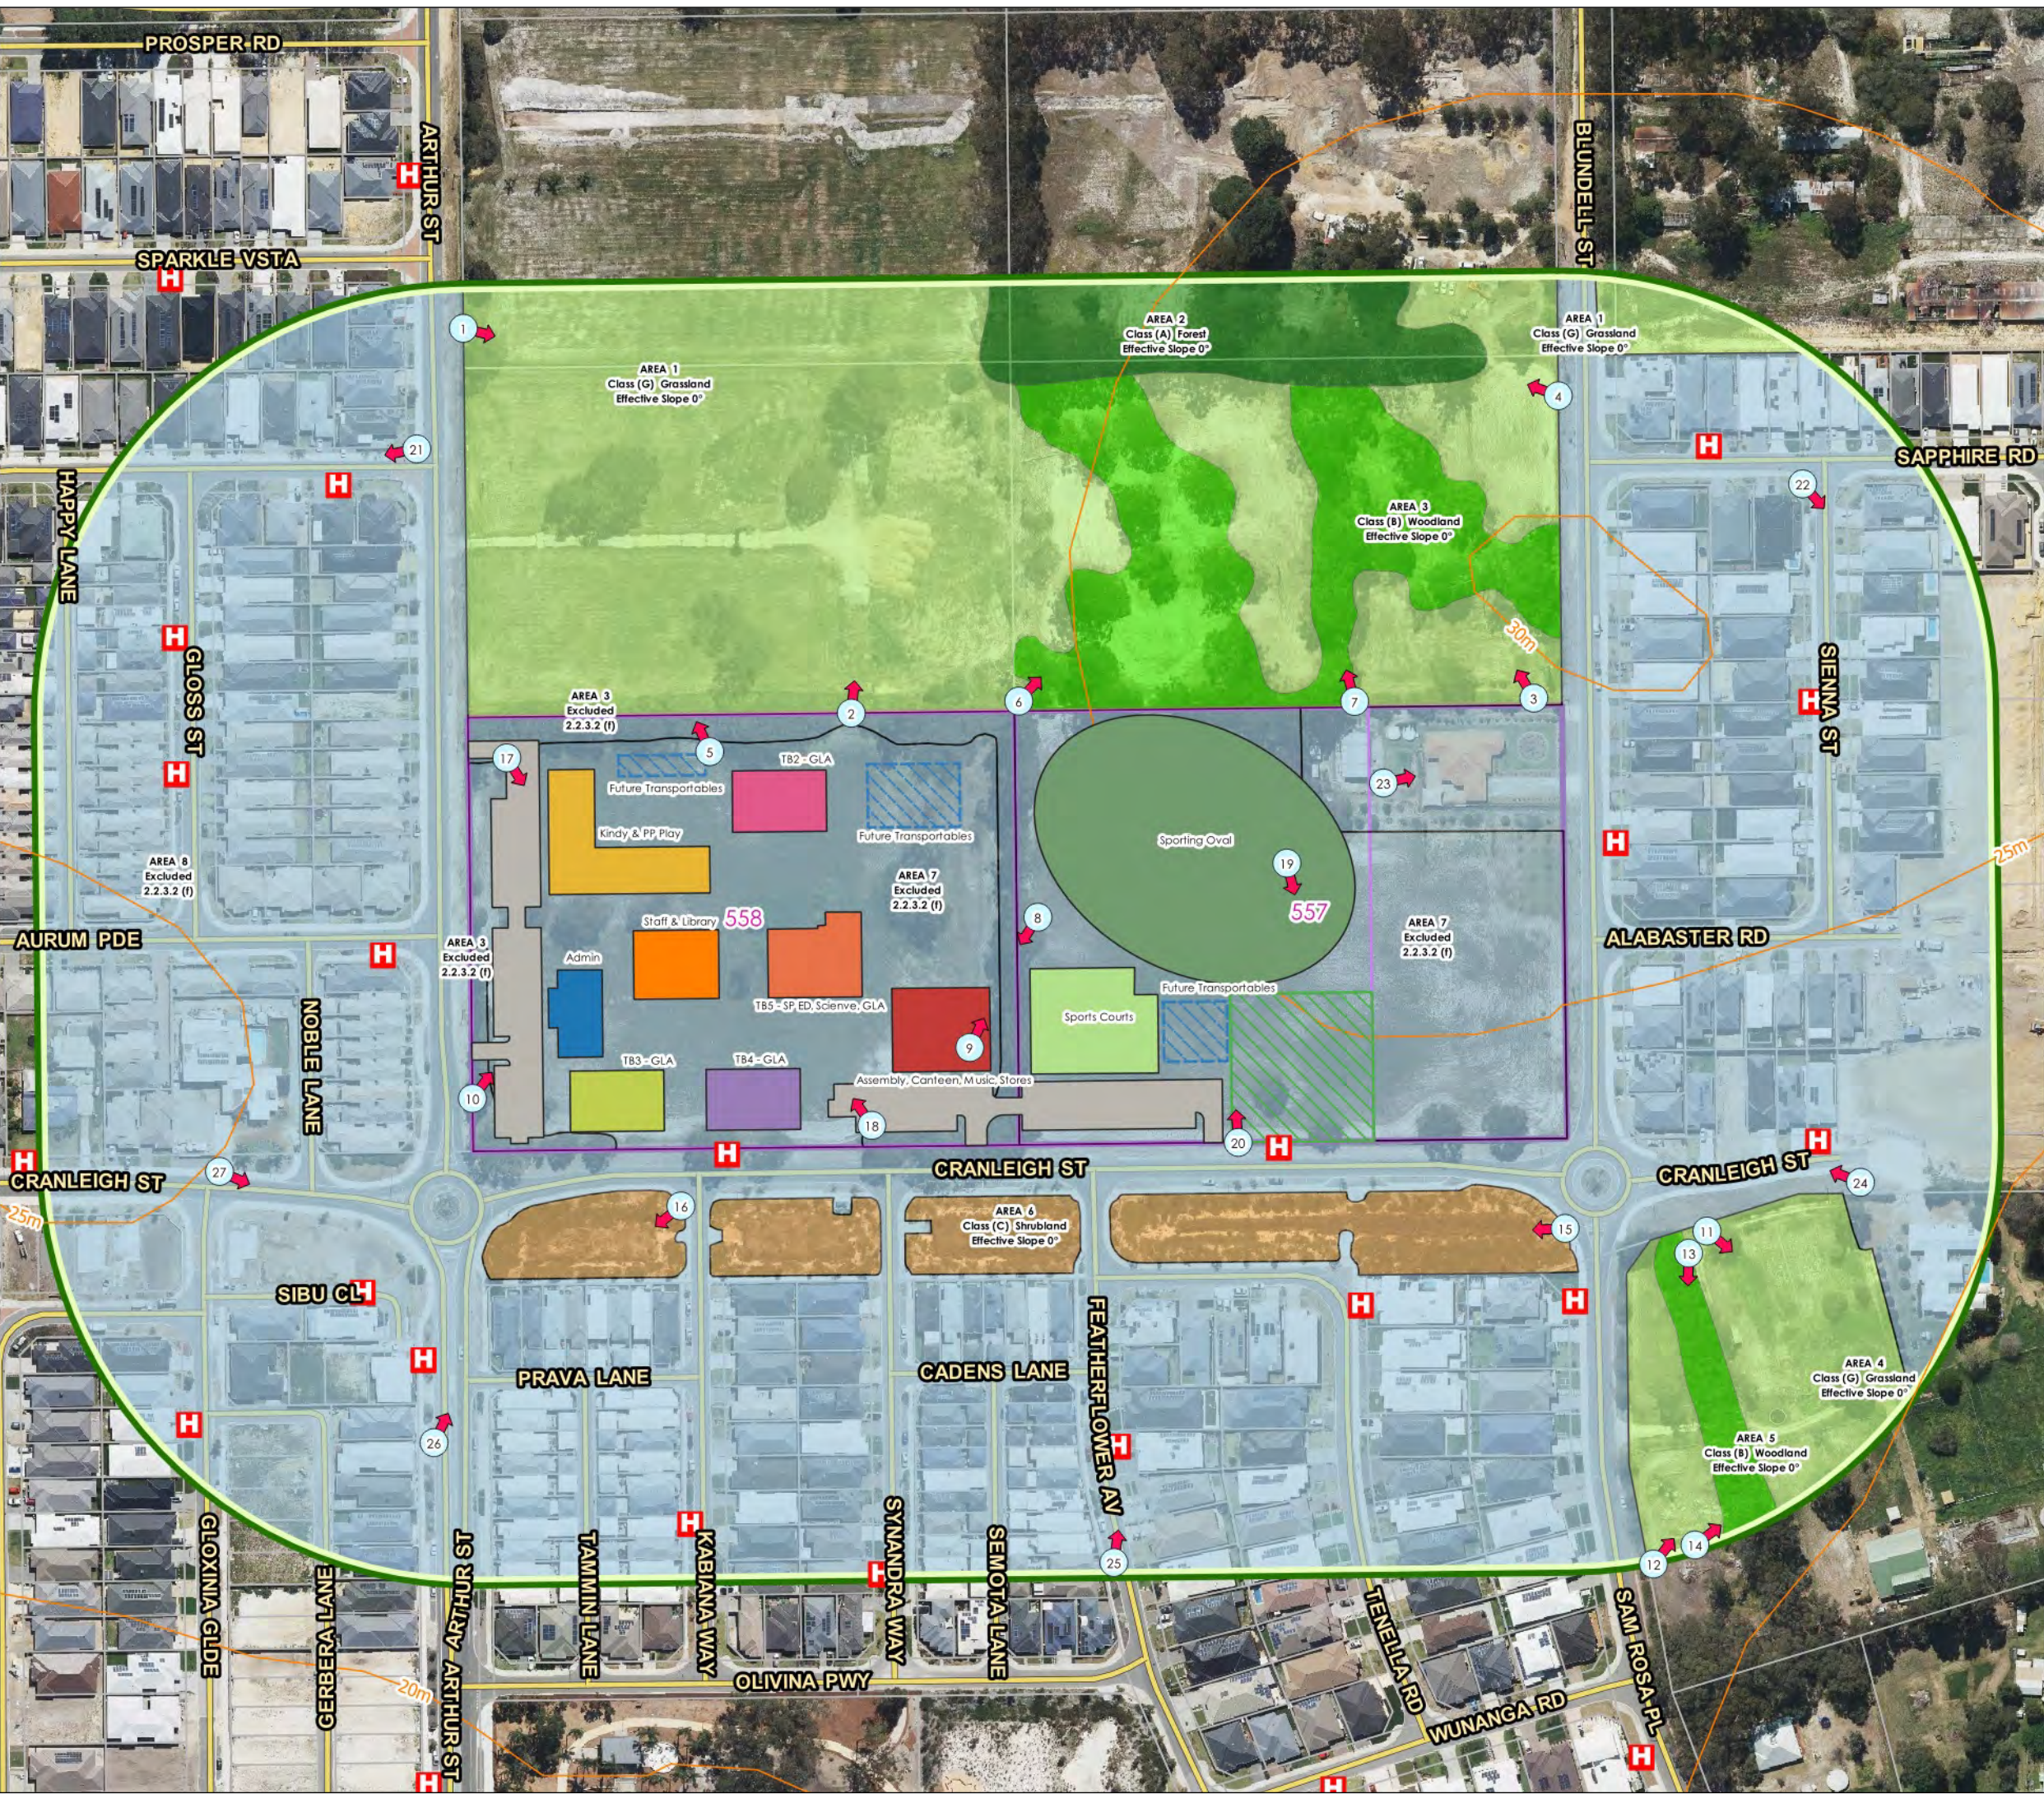
Figure 3.2  
**Vegetation Classification & Topography Map - (Post-Development)**

MINIMUM SEPARATION DISTANCES REQUIRED TO RETAIN INDICATIVE, MAXIMUM, ACCEPTABLE BAL RATING – POST DEVELOPMENT				
Vegetation Area	Vegetation Classification	Effective Slope (degrees)	Maximum Acceptable BAL Rating	Required Separation Distances (metres)
1	Class G Grassland	0	BAL-29	8
2	Class A Forest	0		21
3	Class B Woodland	0		14
*3	Excluded AS3959:2018 2.2.3.2 (f)	0		N/A
4	Class G Grassland	0		8
5	Class B Woodland	5		14
6	Class C Shrubland	0		9
7	Class G Grassland	0		8
*7	Excluded AS3959:2018 2.2.3.2 (f)	0		N/A
8	Excluded AS3959:2018 2.2.3.2 (f)	0		N/A
Note <sup>1</sup> : *3 and *7 indicates vegetation subject to changes post development of this site, with the area/s being reclassified to 'Excluded' AS3959-2018 (f)'. This is the result of the implementation of Asset Protection Zones around the proposed structures and landscaping within the development site. The development site is to be maintained to a low bushfire threat state in perpetuity in accordance with Schedule 1: Standards for Asset Protection Zones as stipulated in the Guidelines for Planning in Bushfire Prone Areas, AS3959-2018 s2.2.3.2 requirements and the City of Swan Fire Hazard Reduction Notice (Firebreak Notice).

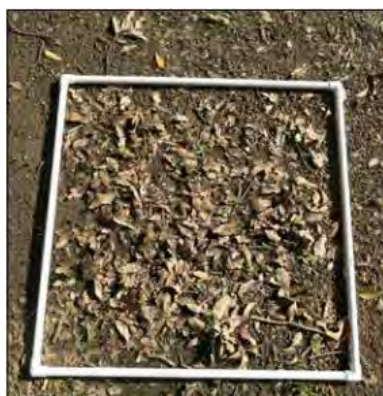
Example: Fine fuel load of 2 t/ha

**Fine Fuel Load:** combustible dead vegetation matter less than 6 mm in thickness reduced to and maintained at an average of two tonnes per hectare (example below).
