**SUBURB:** Cooloongup

**PAW Code No.** C1    Map F4

Connects Killarney Place to Don Cuthbertson Reserve.

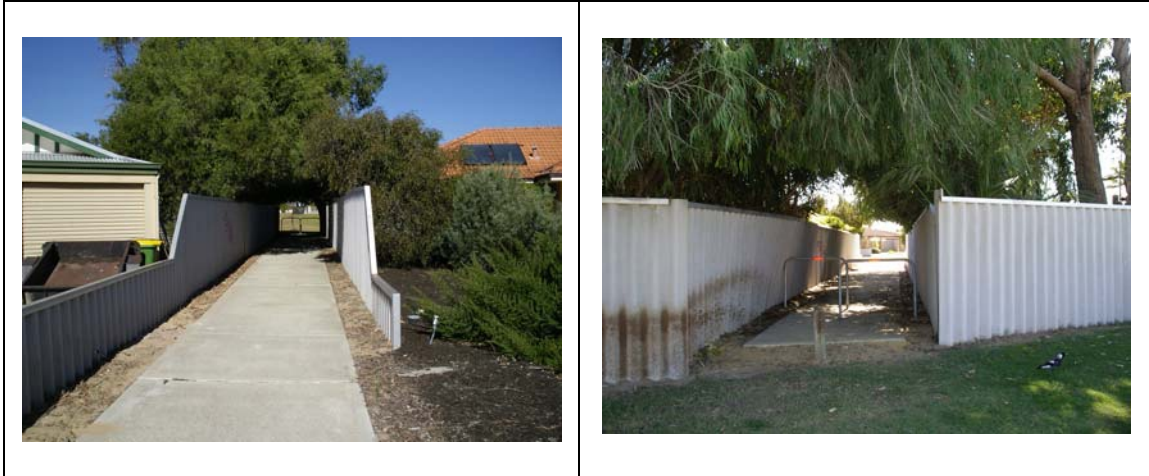
PAW reserve approx. 3m wide and 32m long. Straight, short and flat with bollards at park end only.

Fair to good. Small amount of graffiti, and nuts/berries/leaves over path.

High Super six in good condition.

Concrete approx. 1.9m wide.

Small amount overhanging side fences – recently pruned.

The path in the PAW needs sweeping to remove the leaves, nuts and berries.

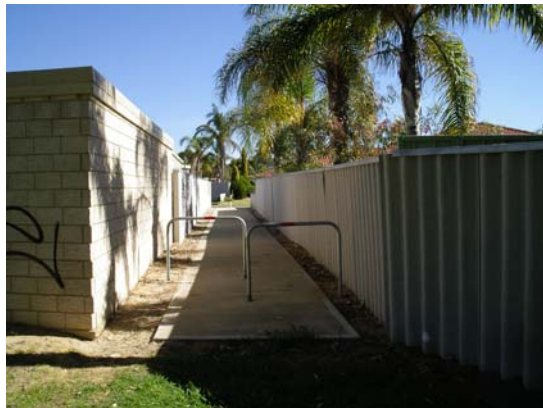
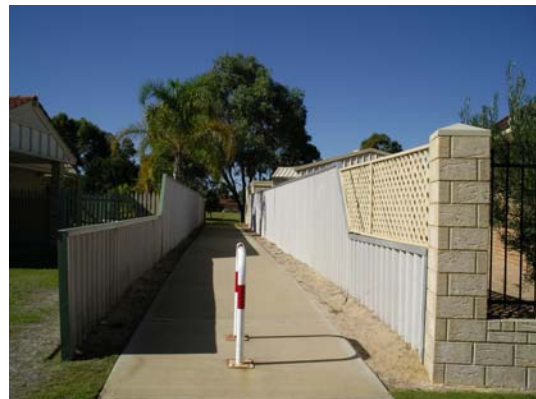
**PAW Code No.** C2    Map F3, F4

PAW reserve approx. 3m wide and 35m long. Straight, short and flat with bollards at both ends.

Good. Small amount of leaves over path.

High Super six and masonry wall in good condition.

Concrete approx. 1.9m wide.

Small amount overhanging side fences.

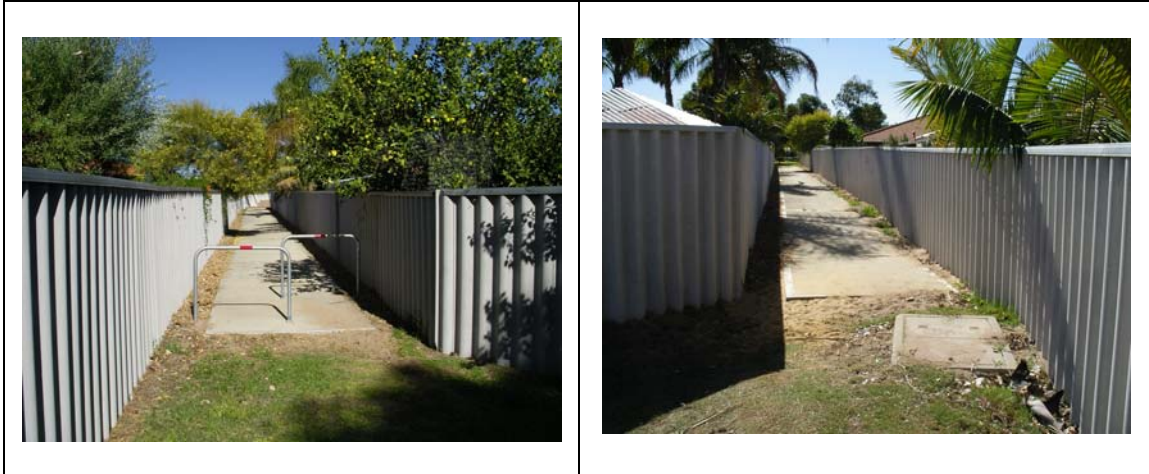
**PAW Code No.** C4    Map F4

PAW reserve approx. 3m wide and 50m long. Straight and flat with bollards at northern end only.

Fair to good. Small amount of graffiti, some weeds, leaves and sand over path.

Concrete approx. 1.9m wide. Paving stops abruptly at both ends.

Some overhanging side fences.

The overhanging vegetation, especially the spiky palm tree, requires pruning. The concrete paving in the PAW should be extended further out into each park (see photo previous page on right).

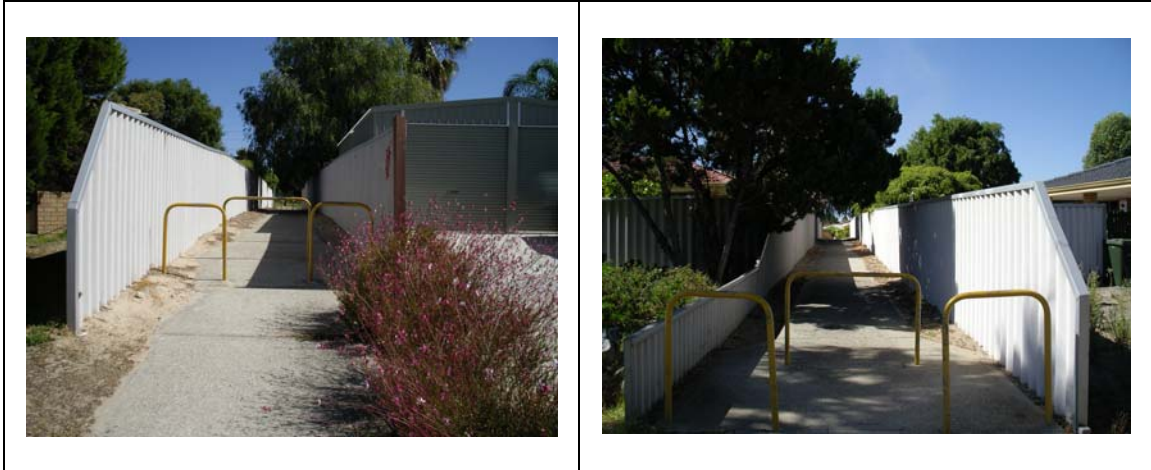
**PAW Code No.** C7 Map E4

PAW reserve approx. 3m wide and 54m long. Straight, slight hump towards the middle, and bollards at both ends.

Fair. Small amount of graffiti, rubbish (bones & dirty nappies), leaves, sand over path.

Concrete approx. 1.8m wide.

Peppermint tree and conifer overhanging side fence.

The overhanging vegetation requires cutting back.

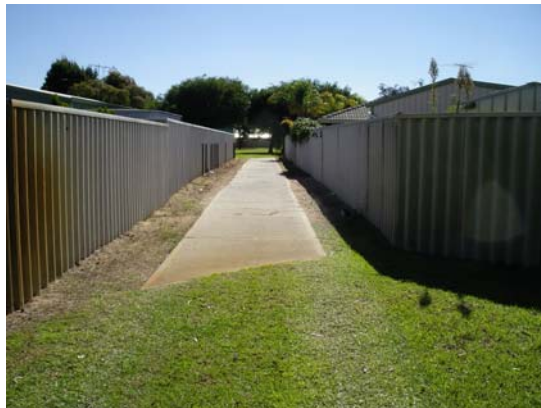
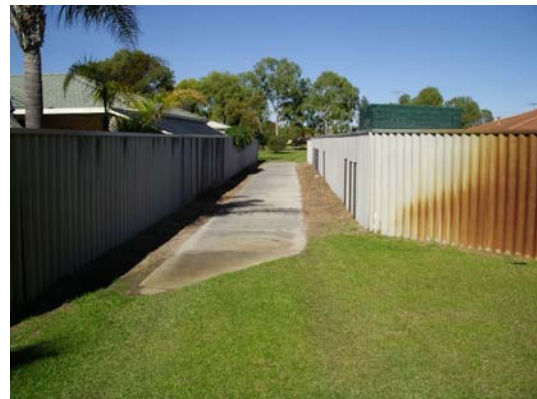
**PAW Code No.** C8    **Map** F4

PAW reserve approx. 4m wide and 40m long. Straight and flat with no bollards.

Fair. Some leaves, rubbish and broken glass.

High Super six in varying condition.

Concrete approx. 1.9m wide.

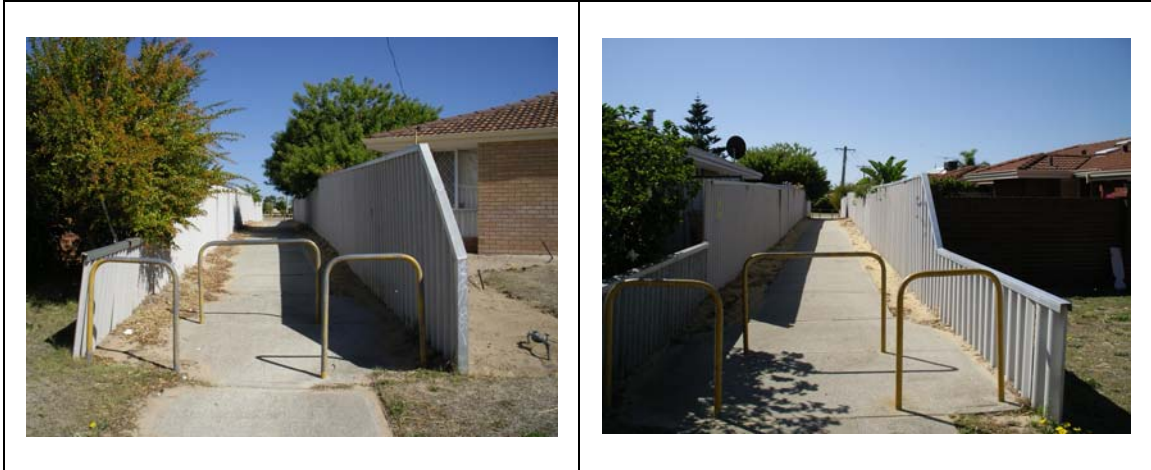
**PAW Code No.** C10    Map E4

PAW reserve approx. 3m wide and 52m long. Straight, slight hump towards the middle, and bollards at both ends.

Fair. Graffiti, rubbish, sand over path.

High Super six in fair to good condition.

Pepper tree overhanging side fence.

The overhanging vegetation requires cutting back.

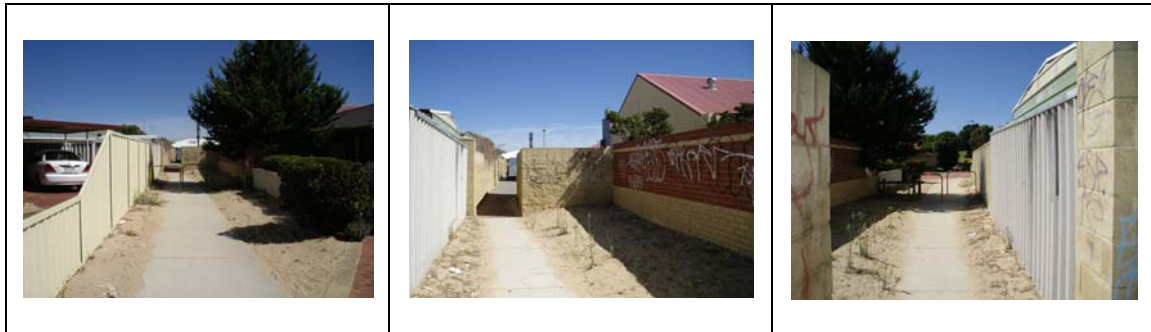
**PAW Code No.** C11      Map E4

PAW reserve approx. 4m wide and 27m long. Straight, flat.

Poor. Large quantity of graffiti, sand over path, rubbish, leaves, broken glass.

This PAW is not part of a comprehensive pedestrian/cycle network, and there are nearby alternative, parallel routes provided in the form of public streets (Elanora Drive and Waterloo Road). The PAW is in poor condition, but does, however, provide convenience benefits for Redbud Mews residents.

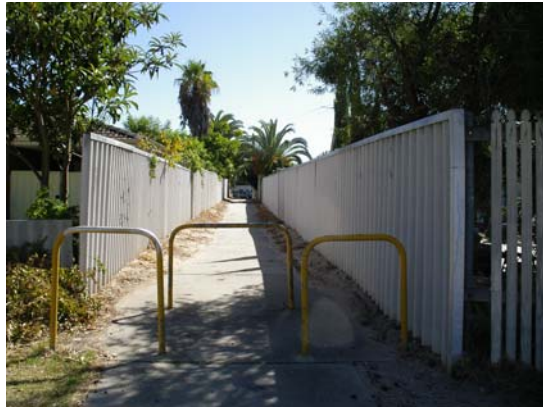
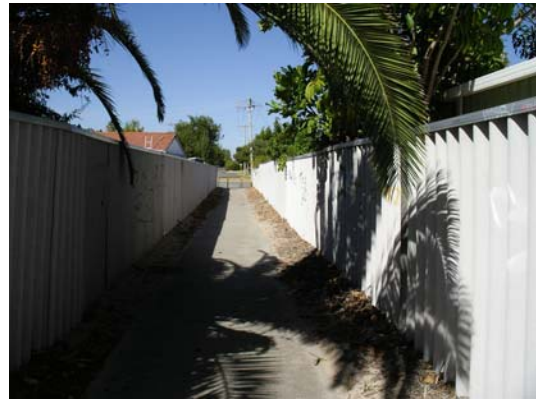
PAW reserve approx. 3m wide and 56m long. Straight, flat with bollards at both ends.

Fair. Graffiti, high sand margins, sand over path, rubbish, leaves, weeds, broken glass.

The path needs to be replaced and widened.

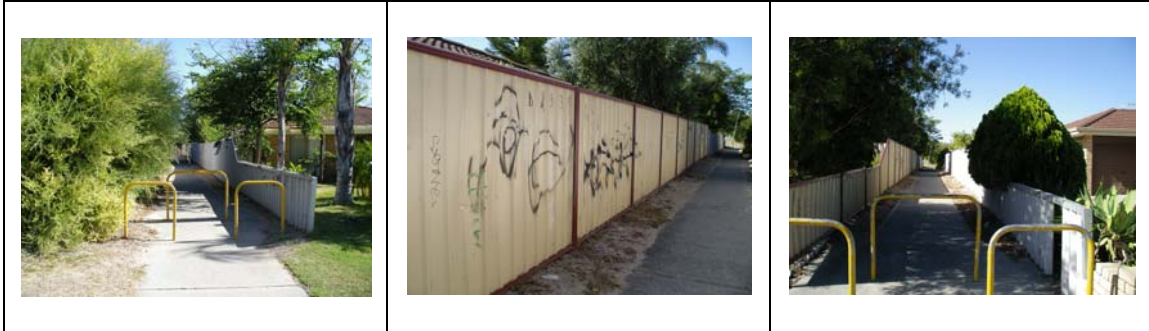
PAW reserve approx. 3m wide and 67m long. Straight and flat with bollards at both ends.

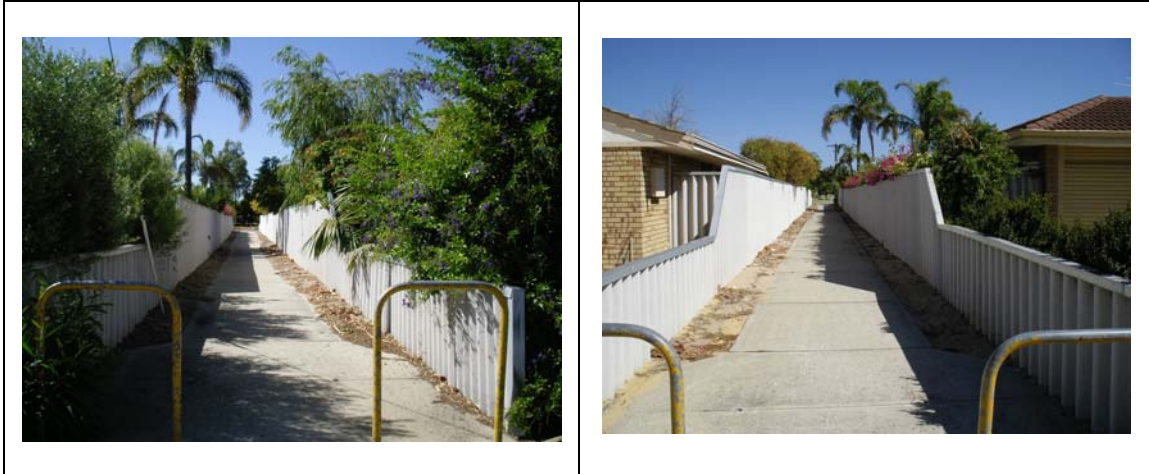
PAW reserve approx. 3m wide and 60m long. Straight, flat, bollards at both ends.

Fair. Graffiti, high sand margins, sand over path, rubbish, leaves, broken glass.

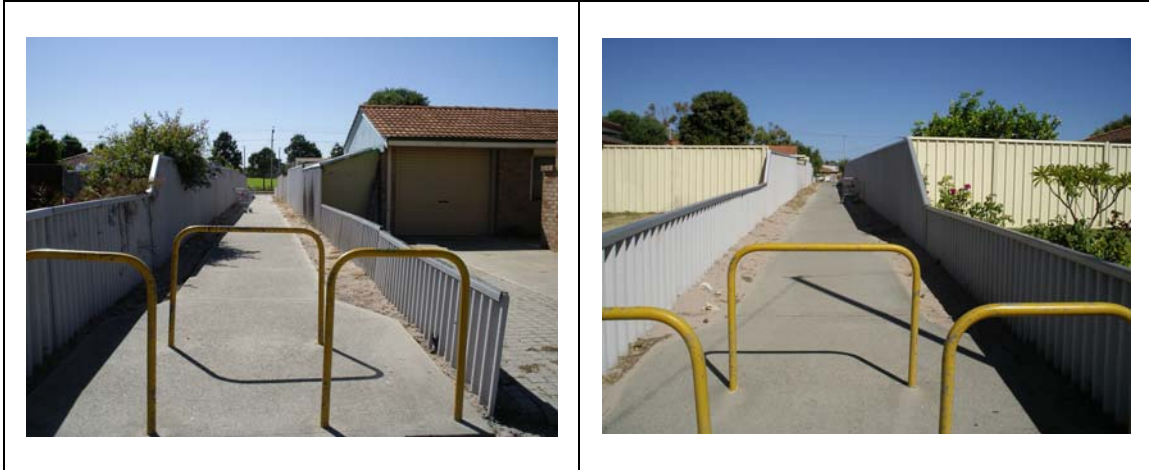
PAW reserve approx. 3m wide and 60m long. Straight, slight hump towards the middle, and bollards at both ends.

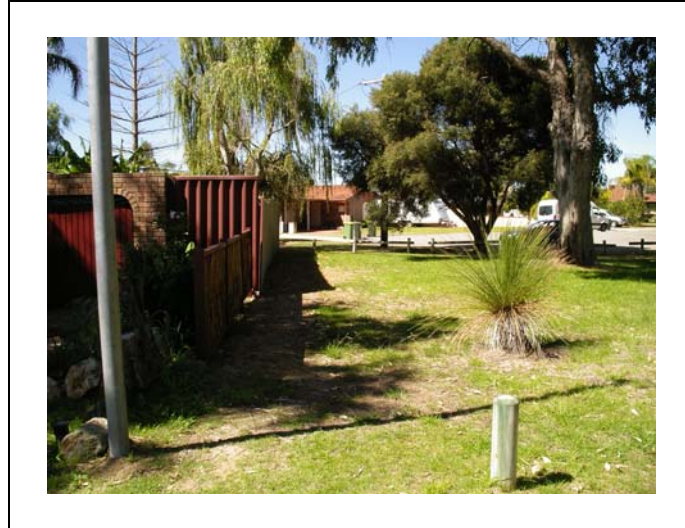
PAW reserve approx. 3m wide and 23m long. Straight, flat with no path. Sits within a park (Solquest Reserve).

Sand and grass. No constructed path. No worn track.

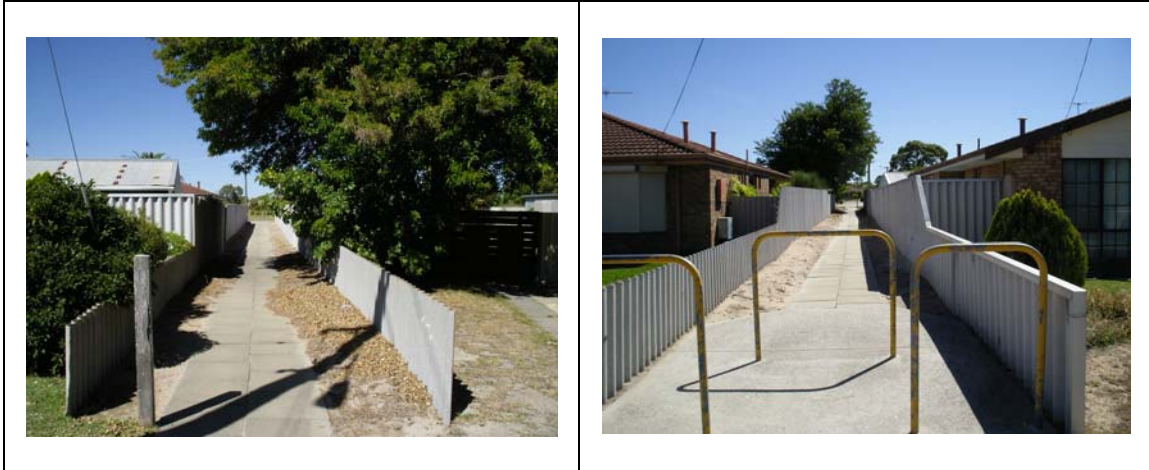
PAW reserve approx. 3m wide and 55m long. Straight, flat rising slightly at the northern end, with bollards at south end only.

Poor. Graffiti, high sand margins, sand over path, empty bottles, rubbish, leaves, broken glass.

The path needs to be replaced and widened. The overhanging vegetation needs to be cut back.

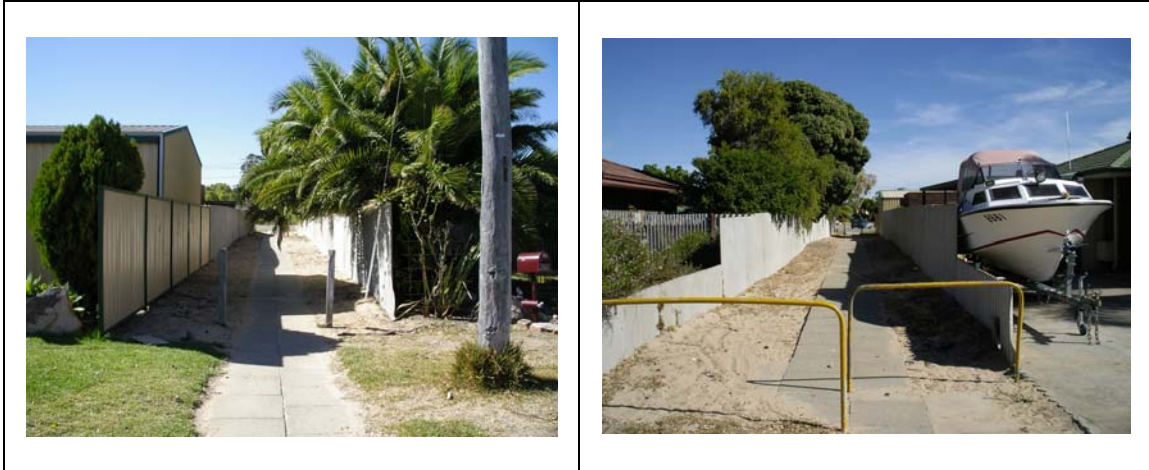
PAW reserve approx. 4m wide and 47m long. Straight, undulating. Bollards at each end.

Poor. Graffiti, high sand margins, sand over path, rubbish, tree branches, lots of broken glass.

High Super six and steel panels in fair condition.

The path needs to be replaced and widened. The overhanging vegetation requires cutting back.

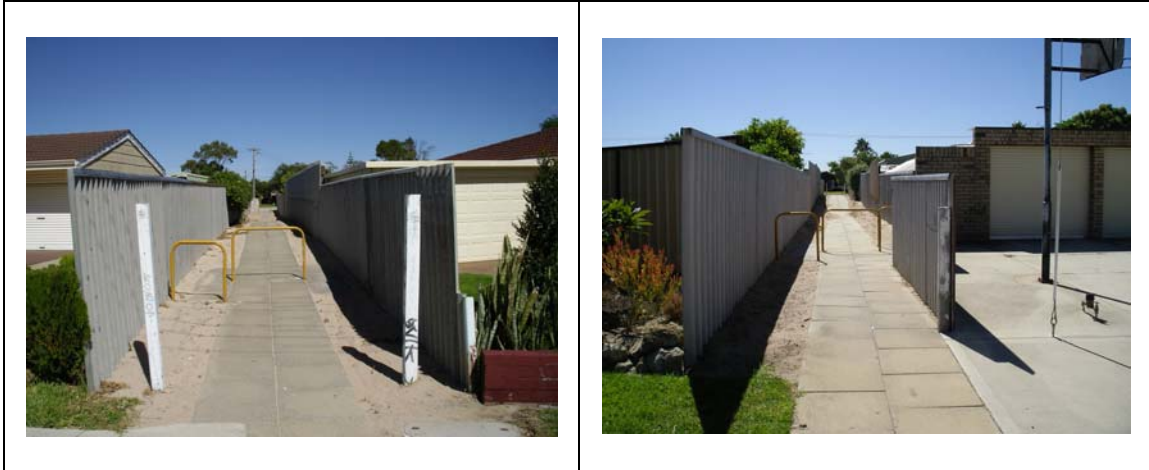
PAW reserve approx. 3m wide and 57m long. Straight, undulating with bollards at both ends.

Poor. Graffiti, high sand margins, sand over path, weeds, rubbish, leaves, broken glass.

High Super six varying in condition from poor to good.

The path needs to be replaced and widened.

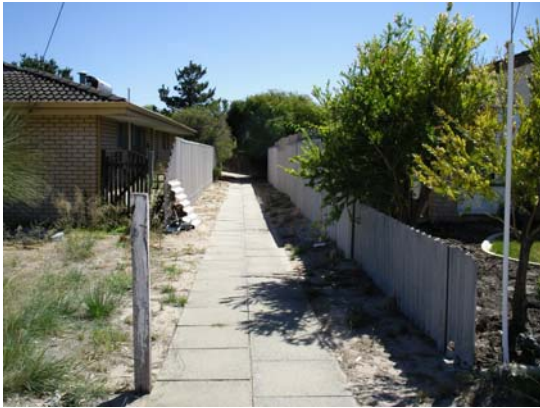
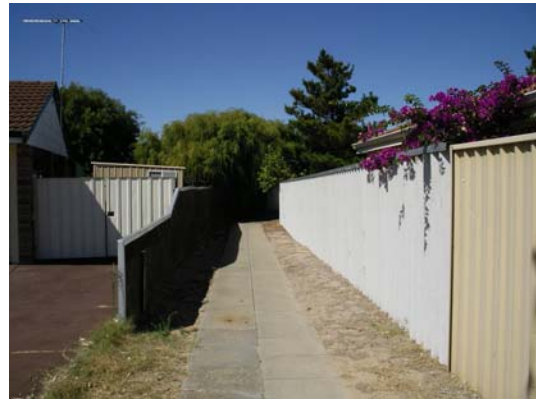
PAW reserve approx. 3m wide and 55m long. This PAW has a bend half-way, and is almost flat.

Very poor. Graffiti, leaves, rubbish, broken glass.

High Super six varying in condition from poor to good.

The path needs to be replaced and widened. The overhanging vegetation needs cutting back.

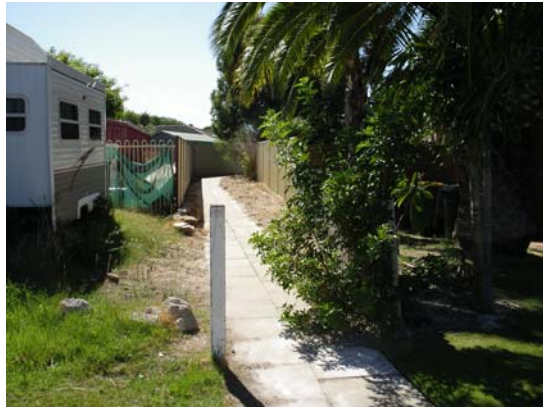
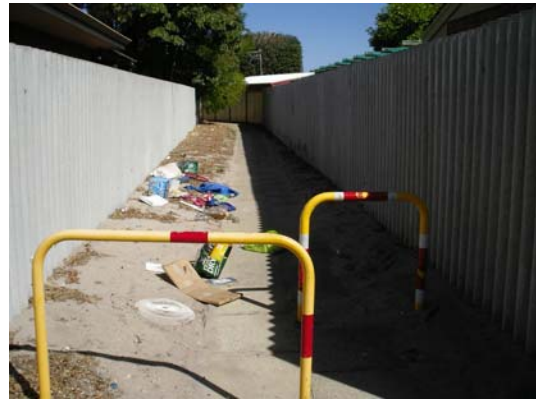
PAW reserve approx. 3m wide and 62m long. Flat, with a bend half-way. One timber margin bollard at west end. Steel bollards at east end.

Very poor. Considerable graffiti and rubbish, weeds, broken glass and sand over path.

Concrete slabs two wide (approx. 1.2m). Narrow, broken, uneven.

If the PAW is retained, the path needs to be replaced and widened. The overhanging vegetation needs to be cut back.

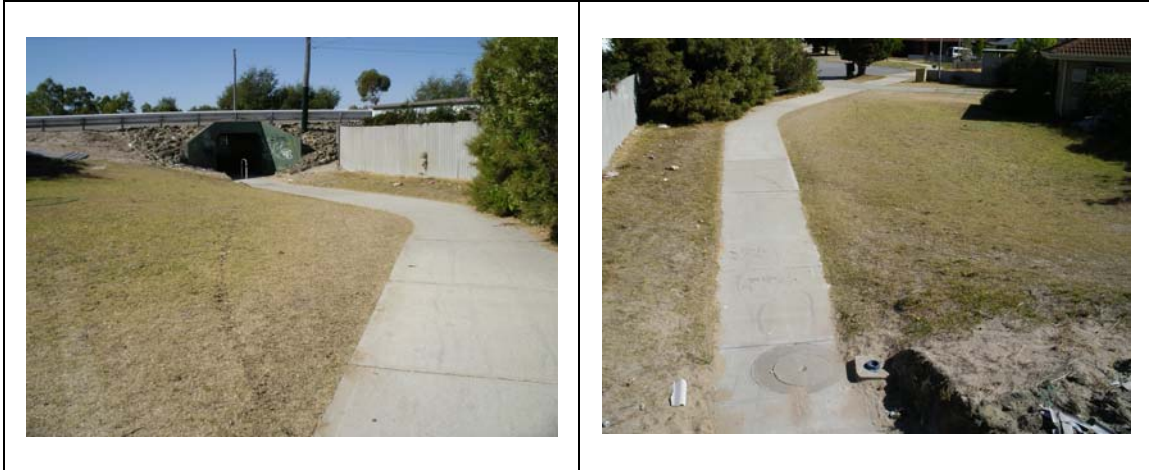
PAW reserve is triangular-shaped – approx. 18m at its longest, 10m at its widest. It contains a path that slopes down to an underpass beneath Willmott Drive. Only part of the path is actually located within the Reserve.

Super six ranging in condition from very poor to fair. Some panels smashed.

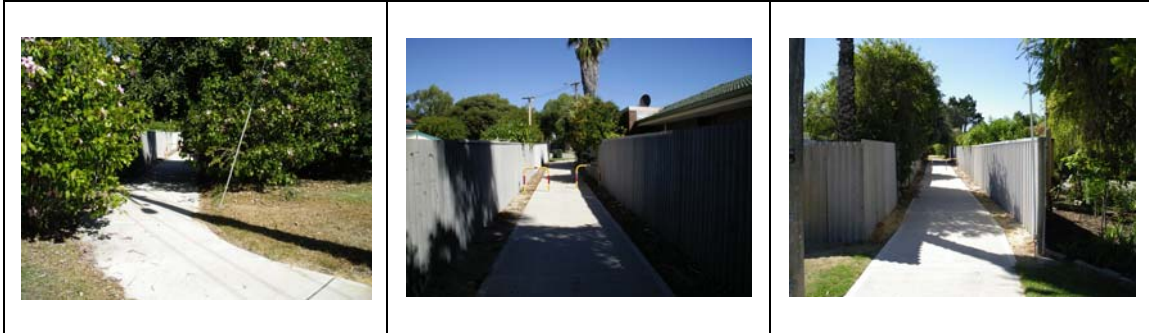
PAW reserve approx. 3m wide and 38m long. Straight, flat with bollards at mid-point.

Concrete about 1.9m wide, in good condition.

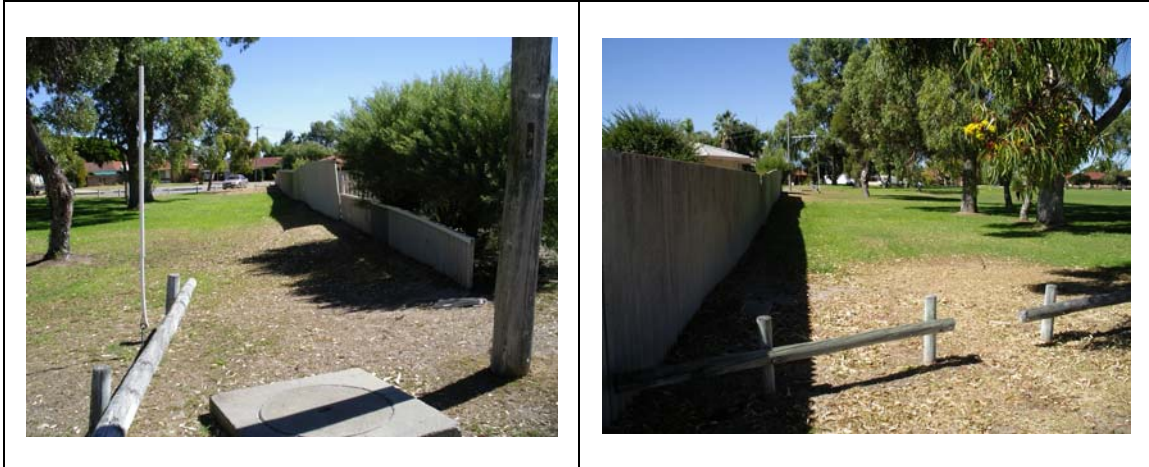
PAW reserve approx. 3m wide and 40m long. Straight, flat with no path. Sits within a park (Solquest Reserve).

Sand and grass. No constructed path. No worn path.

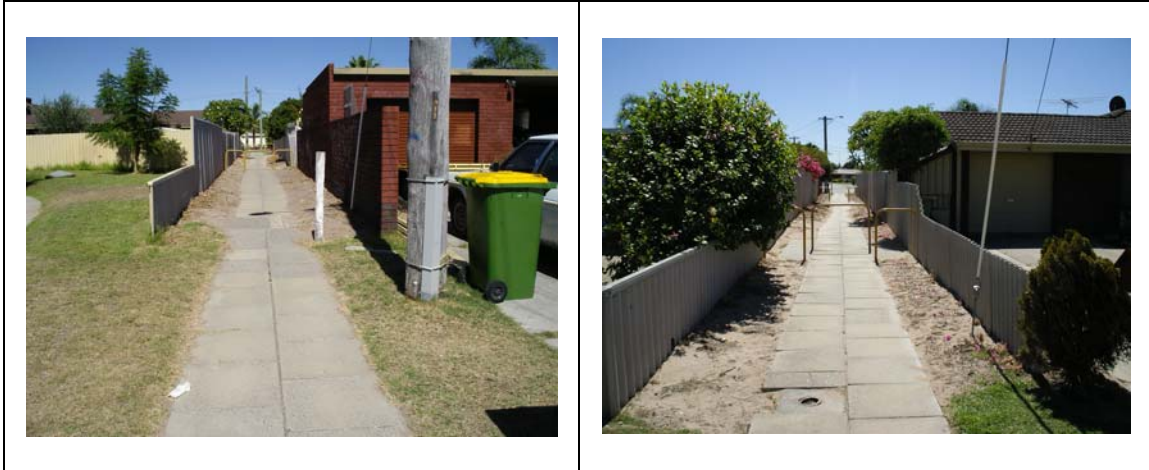
PAW reserve approx. 3m wide and 46m long. Straight, flat with bollards at south end and in middle.

Poor. Lots of graffiti, sand over path, rubbish, leaves, broken glass.

High Super six in fair condition. One section of brick wall in good condition.

The path needs to be replaced and widened.

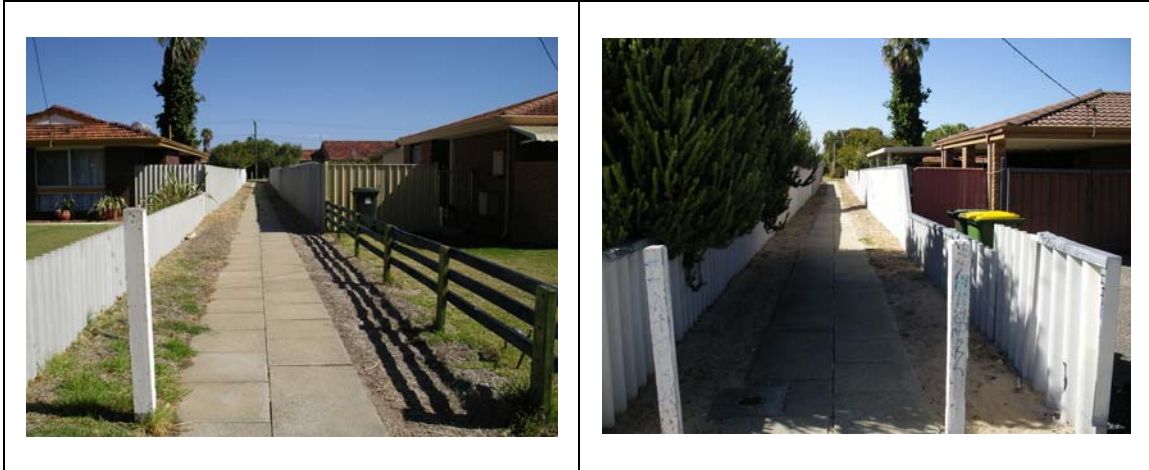
PAW reserve approx. 3m wide and 70m long. Straight, slightly undulating with timber margin bollards.

High Super six in fair condition. One section of low super six and one section of low timber ranch-style fencing.

Concrete slabs two wide (approx. 1.2m). Narrow, cracked, uneven.

The path needs to be replaced and widened.

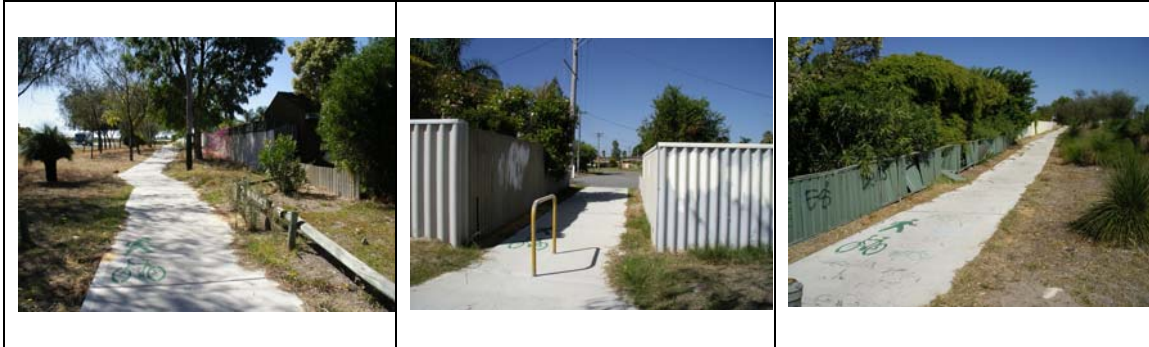
PAW reserve is "T"-shaped. The top of the "T" is approx. 188m long and 3m wide. The base of the "T" is approx. 11m long and 3m wide. The terrain is undulating, and the path is mostly straight but has a winding alignment in parts. The main path of this PAW forms a section of the dual use path that runs alongside Rae Road.

Mostly high super six. A section of low steel panel fencing at the PAW's eastern end is badly damaged.

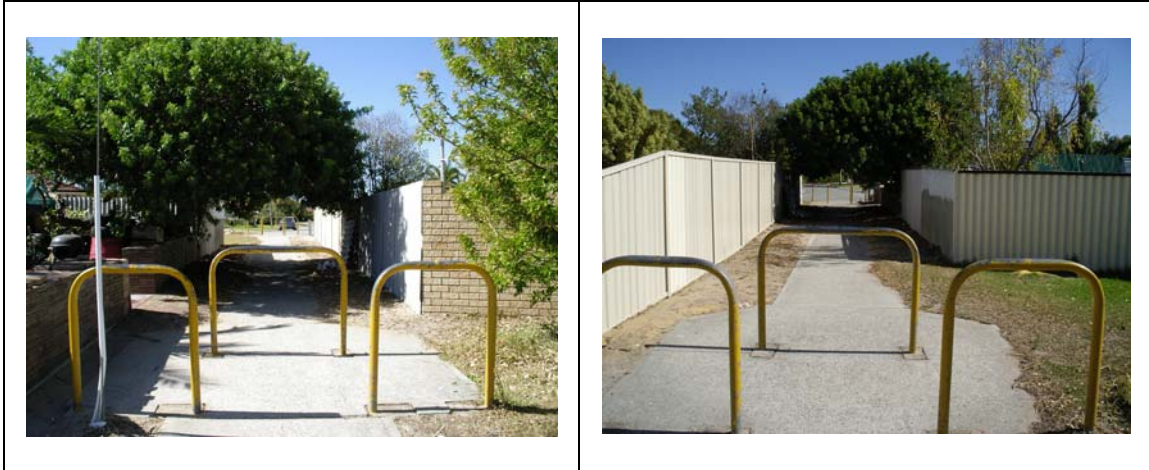
PAW reserve approx. 4m wide and 25m long. Straight, flat with bollards at both ends.

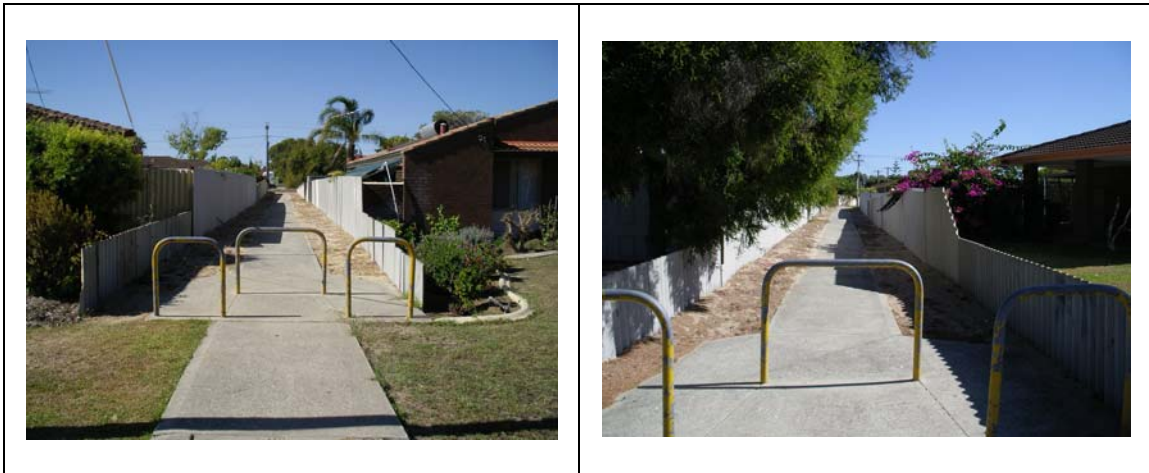
PAW reserve approx. 4m wide and 68m long. Straight & flat with bollards at both ends.

Fair. Graffiti, rubbish, broken glass, sand over path.

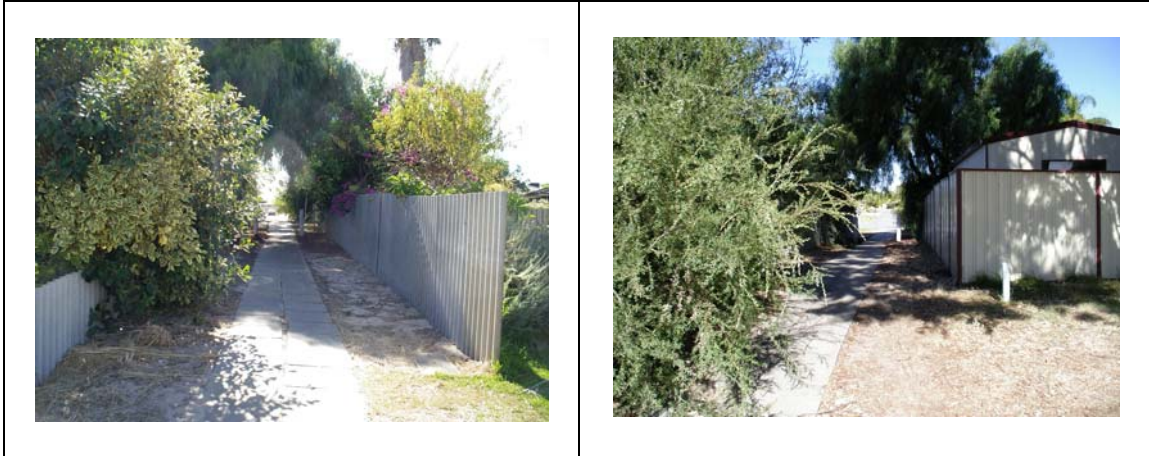
PAW reserve approx. 4m wide and 28m long. Straight, slight slope up to Rydal Court end. Margin bollards at midway point.

Poor. Graffiti, sand over path, rubbish, sticks, branches, leaves, broken glass.

The path needs to be replaced and widened. The intruding vegetation needs cutting back.

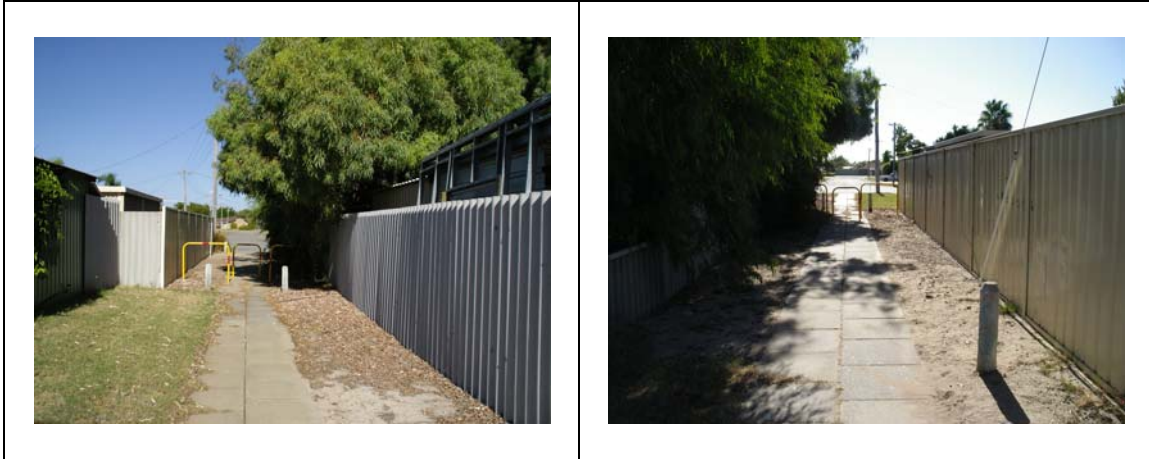
PAW reserve approx. 4m wide and 28m long. Straight & flat. Bollards at midway point.

The path needs to be replaced and widened. The overhanging vegetation needs cutting back.

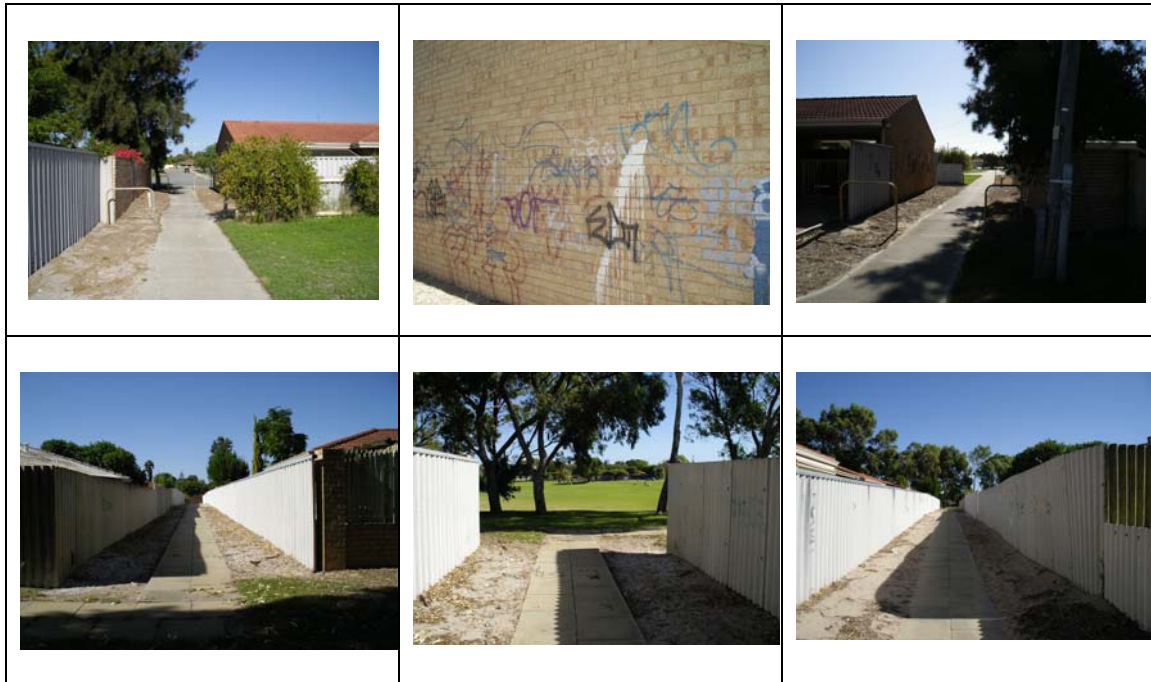
PAW reserve is "T"-shaped. The top of the "T" is approx. 4m wide and 28m long and connects the two culs-de-sac. The base of the "T" is approx 4m wide and 77m long. There is a slight slope in the long section.

- Short section is concrete approx. 1.4m wide.
- Long section is concrete slabs x two wide (approx. 1.2m). Narrow, uneven and cracked.

The short section of the PAW should be retained. The long section appears unnecessary for local access. It is also long, unlit and in poor condition. It also abuts the aged care facility, and perhaps represents a security issue for the residents. It could be closed without any significant detriment to the local pedestrian/cycle network.

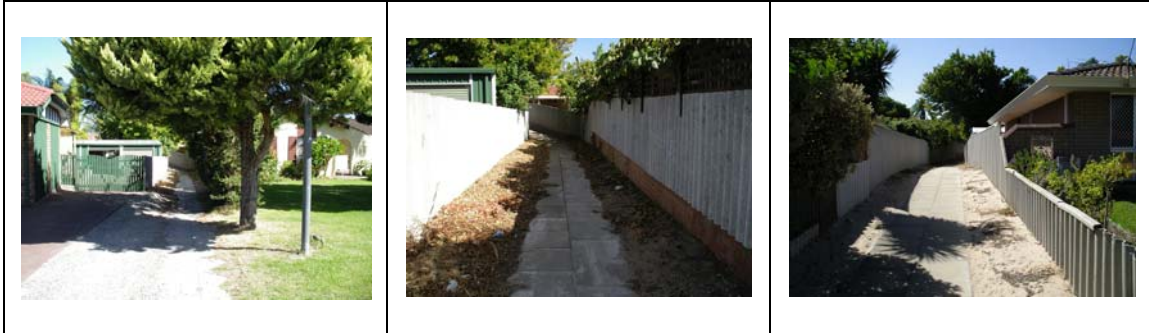
PAW reserve is approx. 3m wide and 68m long. Undulating, with a bend half-way.

Very poor. Graffiti, high sand margins, sand and blue metal over path, empty bottles, rubbish, leaves, pruned branches, bottles and broken glass.

High Super six in poor to fair condition.

Concrete slabs two wide (approx. 1.2m). Narrow, broken, uneven.

If the PAW is retained, the path needs to be replaced and widened. The overhanging vegetation needs to be cut back. The PAW needs cleaning up.

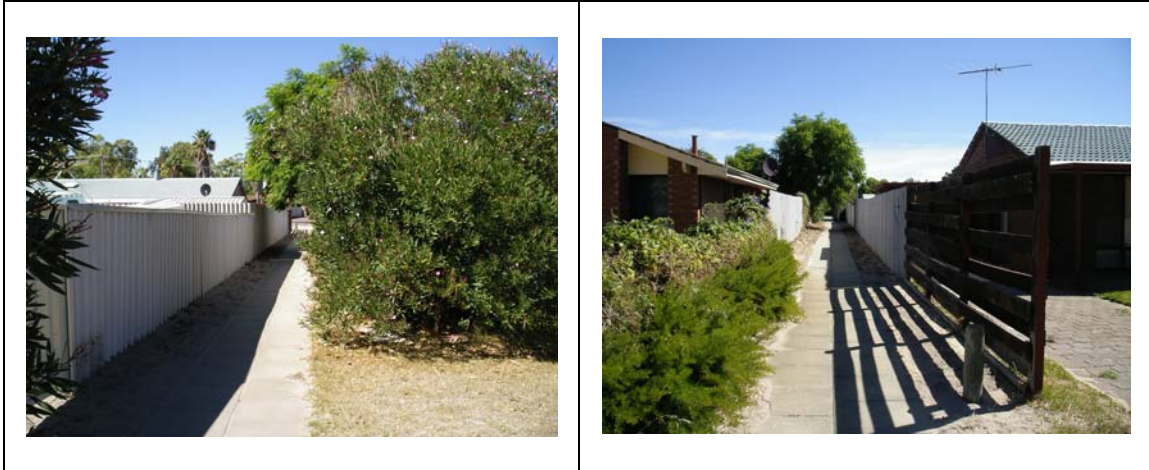
PAW reserve approx. 3m wide and 50m long. Straight, flat. The entry from the Nerrima Court end is via an oblique path across the verge.

Poor. Graffiti, sand over path, rubbish, leaves, broken glass.

The path needs to be replaced and widened. The overhanging vegetation requires cutting back.

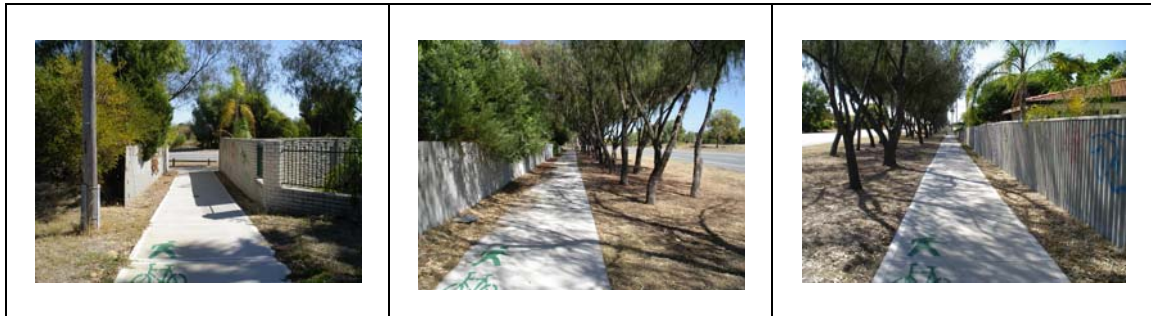
PAW reserve is "T"-shaped. The top of the "T" is approx. 3m wide and 146m long, and functions essentially as the dual use path running alongside Rae Road. The base of the "T" connecting to Peron Close is approx. 3m wide and 12m long. The terrain is flat.

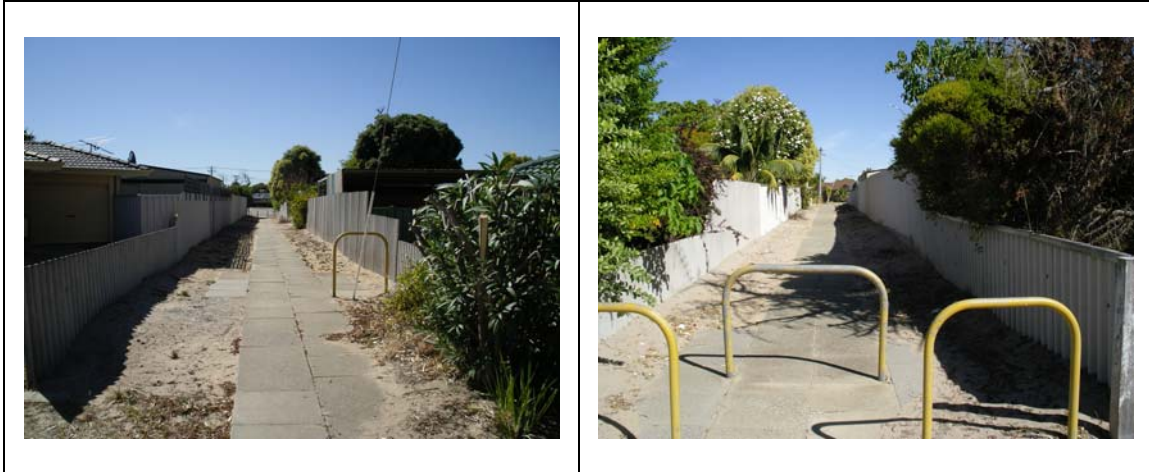
PAW reserve approx. 4m wide and 64m long. Straight, gently sloping, long. Two bollards missing at southern end.

Poor. Graffiti, high sand margins, sand over path, rubbish, leaves, weeds, broken glass.

The path needs to be replaced and widened. The missing bollards should be replaced.

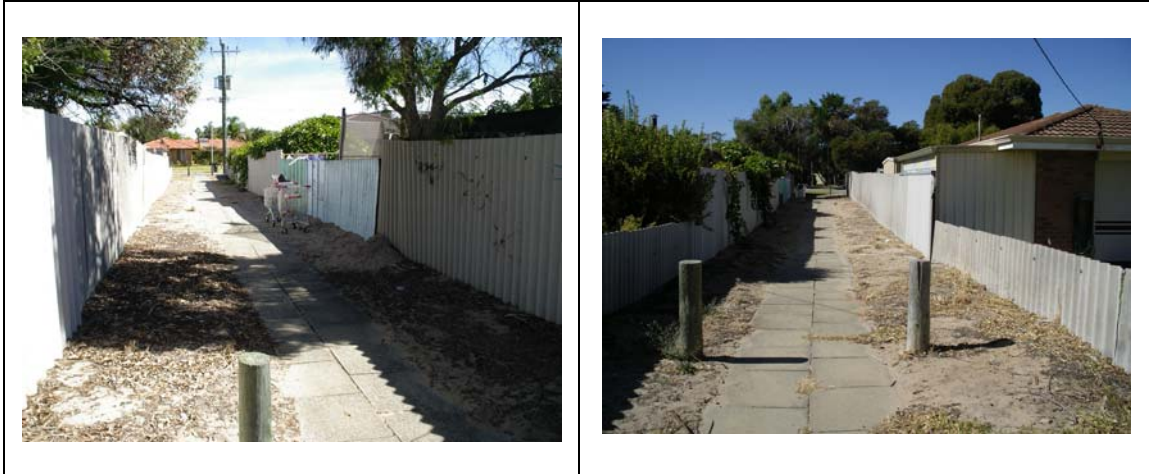
PAW reserve approx. 4m wide and 40m long. Straight, undulating, with margin bollards.

Super six and old tin fences in very poor to fair condition.

The path needs to be replaced and widened.

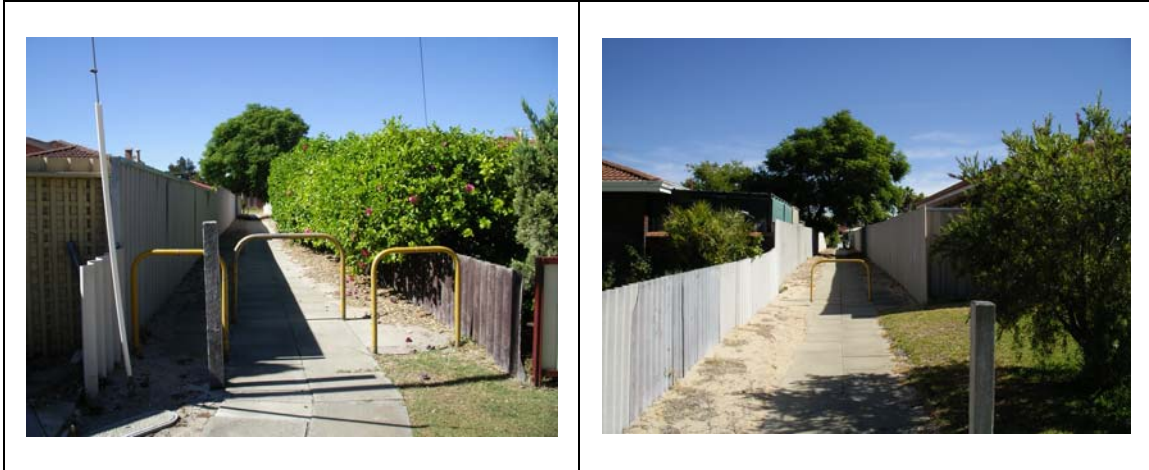
PAW reserve approx. 3m wide and 70m long. Straight, long, slightly undulating. Bollards at both ends. Bollard at Jindarra Court end knocked to a 45 degree angle.

Poor. Graffiti, high sand margins and sand over path, rubbish, leaves, broken glass, dog faeces.

The path needs to be replaced and widened. Overhanging vegetation requires cutting back. The bent bollard requires repairing.

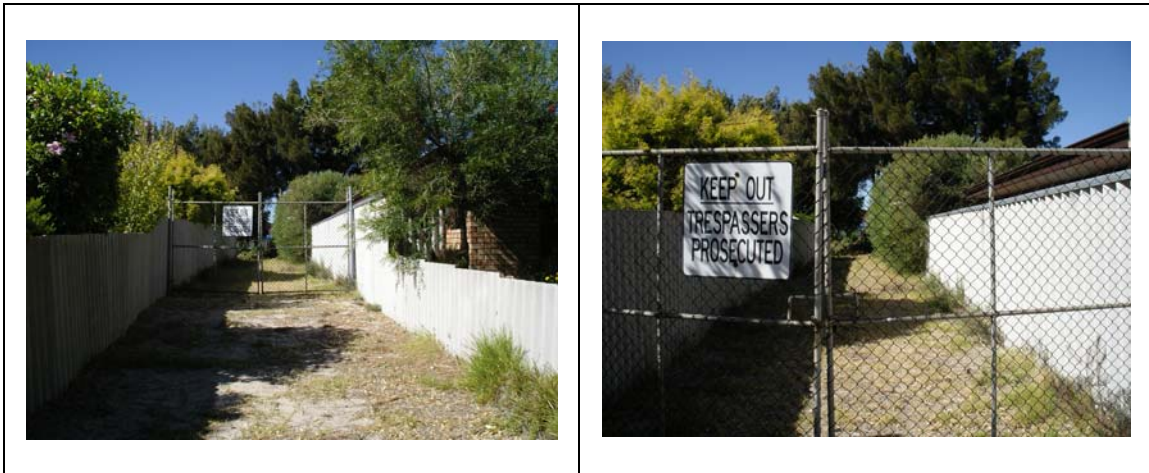
PAW reserve approx. 4m wide and 37m long. No constructed path, gated off.

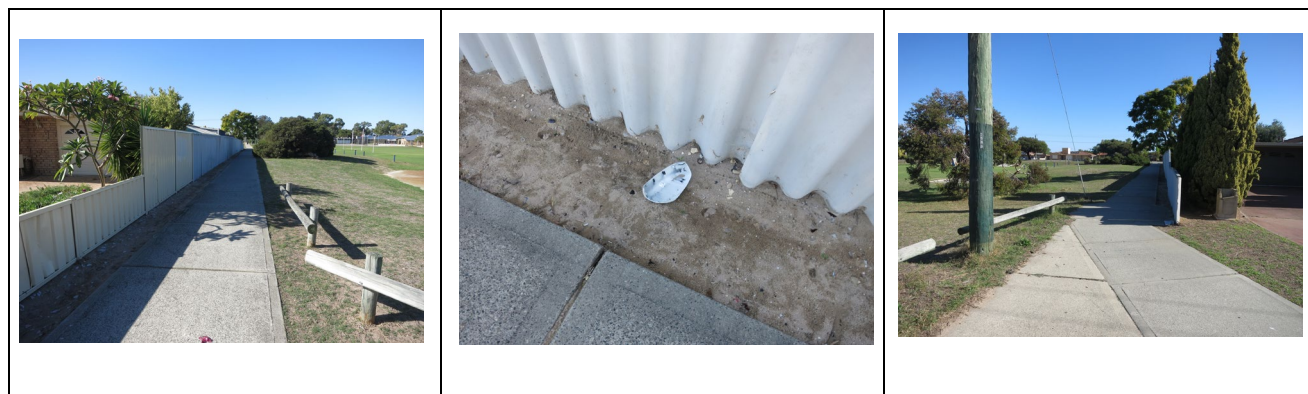
PAW reserve approximately 3m wide and 68m long. Straight and flat. No bollards. Fenced on northern side by residential development and open to school ovals on the southern side.

Concrete pathway one slab wide. Good condition.

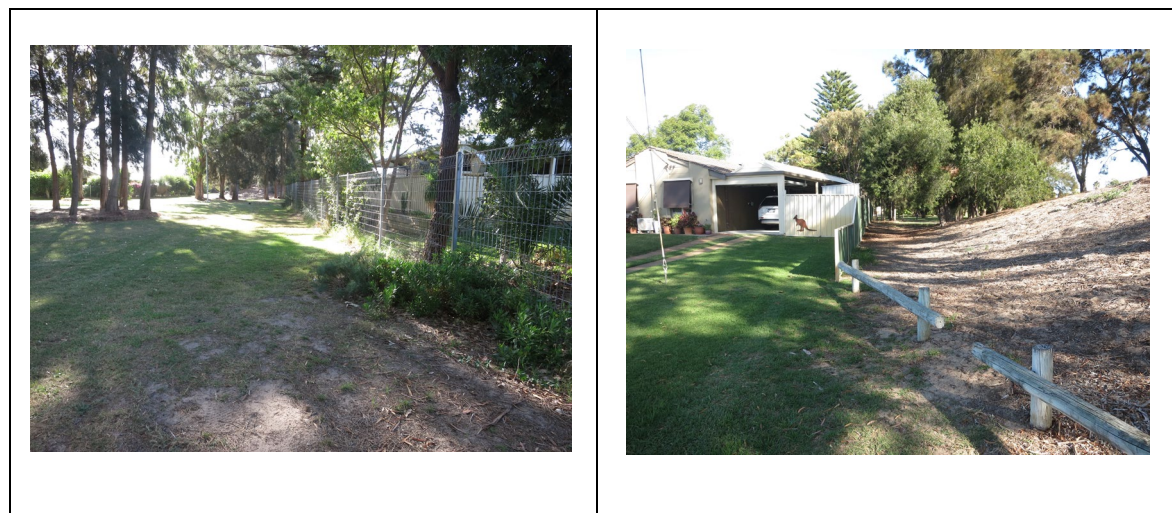
PAW reserve is approximately 3m wide and 240m long. Uneven surface. PAW runs parallel with Lynda Crescent before turning at a 45 degree angle to meet with Lynda Crescent. Low wooden post fence located at the northern entry.
