Infrastructure Servicing Report

16 mcdonald road, baldivis infrastructure servicing report Project No. 15-046

Pritchard Francis has been engaged by Defence Housing Australia (DHA) to undertake an Infrastructure Services Report to support the Structure Plan submission for residential development at a portion of Lot 16 McDonald Road, Baldivis.

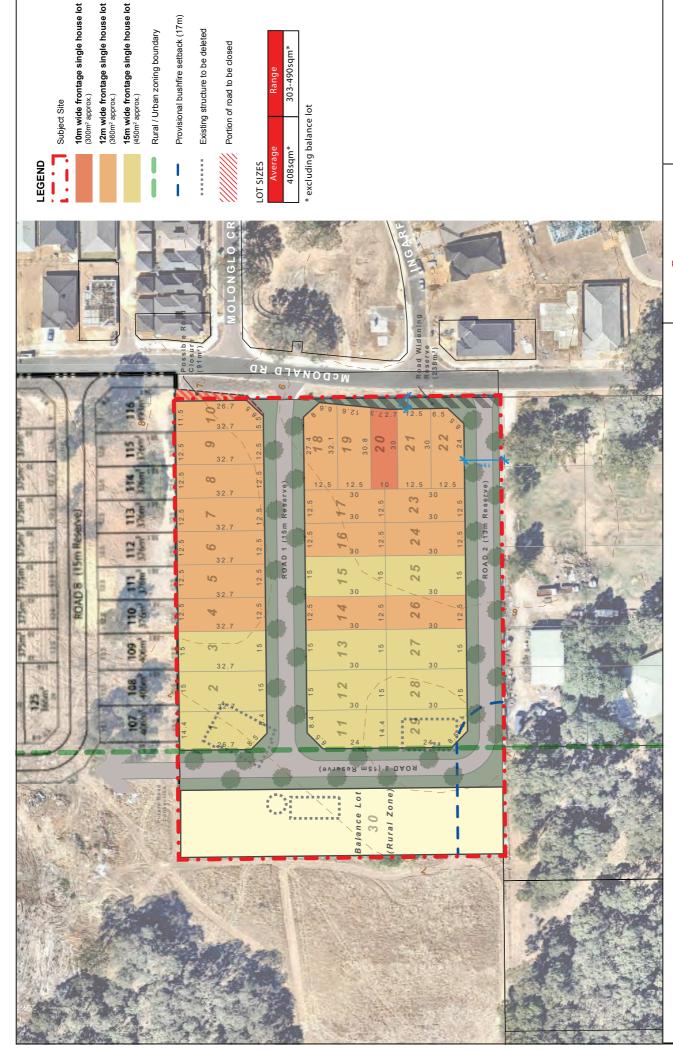
appendix one: preliminary site layout

This report outlines existing site conditions, adjacent services and likely development constraints. This report is based on the preliminary site layout contained within Appendix One.

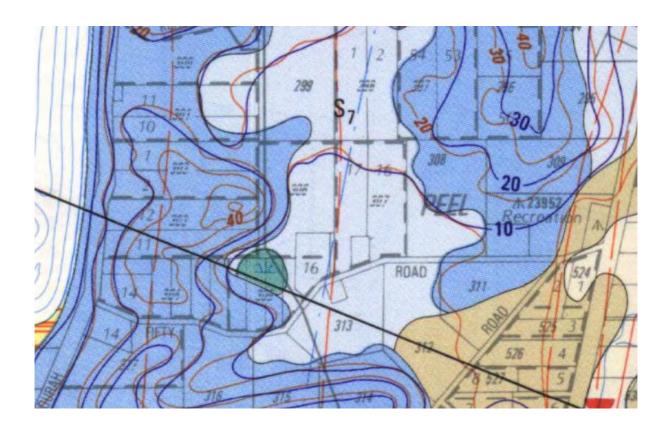
appendix two: geological mapping

The Perth sheet of the 1:50,000 scale Environmental Geology series maps (included in Appendix Two), indicates the site as having soil profiles as follows:

SAND (s7) – derived from Tamala Limestone is pale yellowish brown, medium to course grained, sub-angular quartz, trace of feldspar, moderately sorted, of residual origin. Few limitations, some settlement under foundations can be expected, some ability to attenuate pollutants due to small clay content, usually considerable depth to water table due to topography.

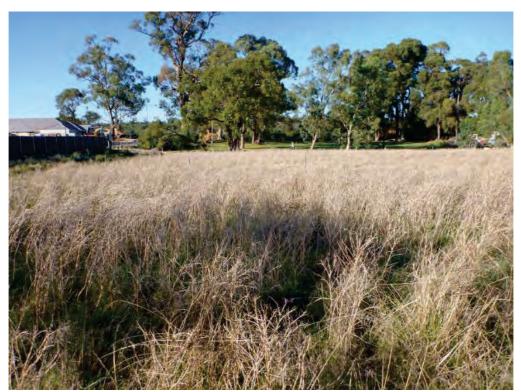
Photograph 1: At TP05 facing south, facing towards a former market garden

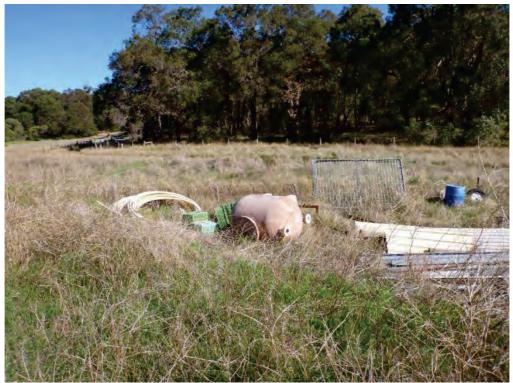
Photograph 4: At TP04 facing west, note the higher elevation at TP04 compared to the western land

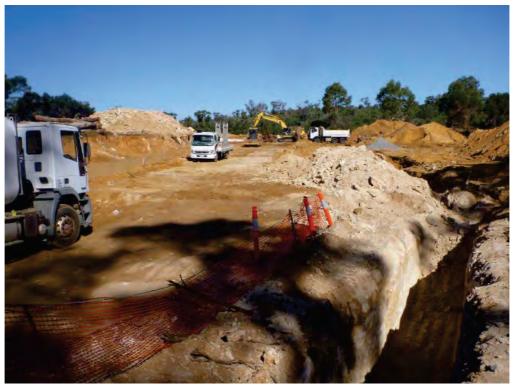
Photograph 6: Current development located nearby the site at the corner of McDonald Road and Fifty Road.

Note the presence of shallow massive limestone
