# Lots 1006 and 1007 Baldivis Road, Baldivis

## Engineering Services Report

Project No: 15-292

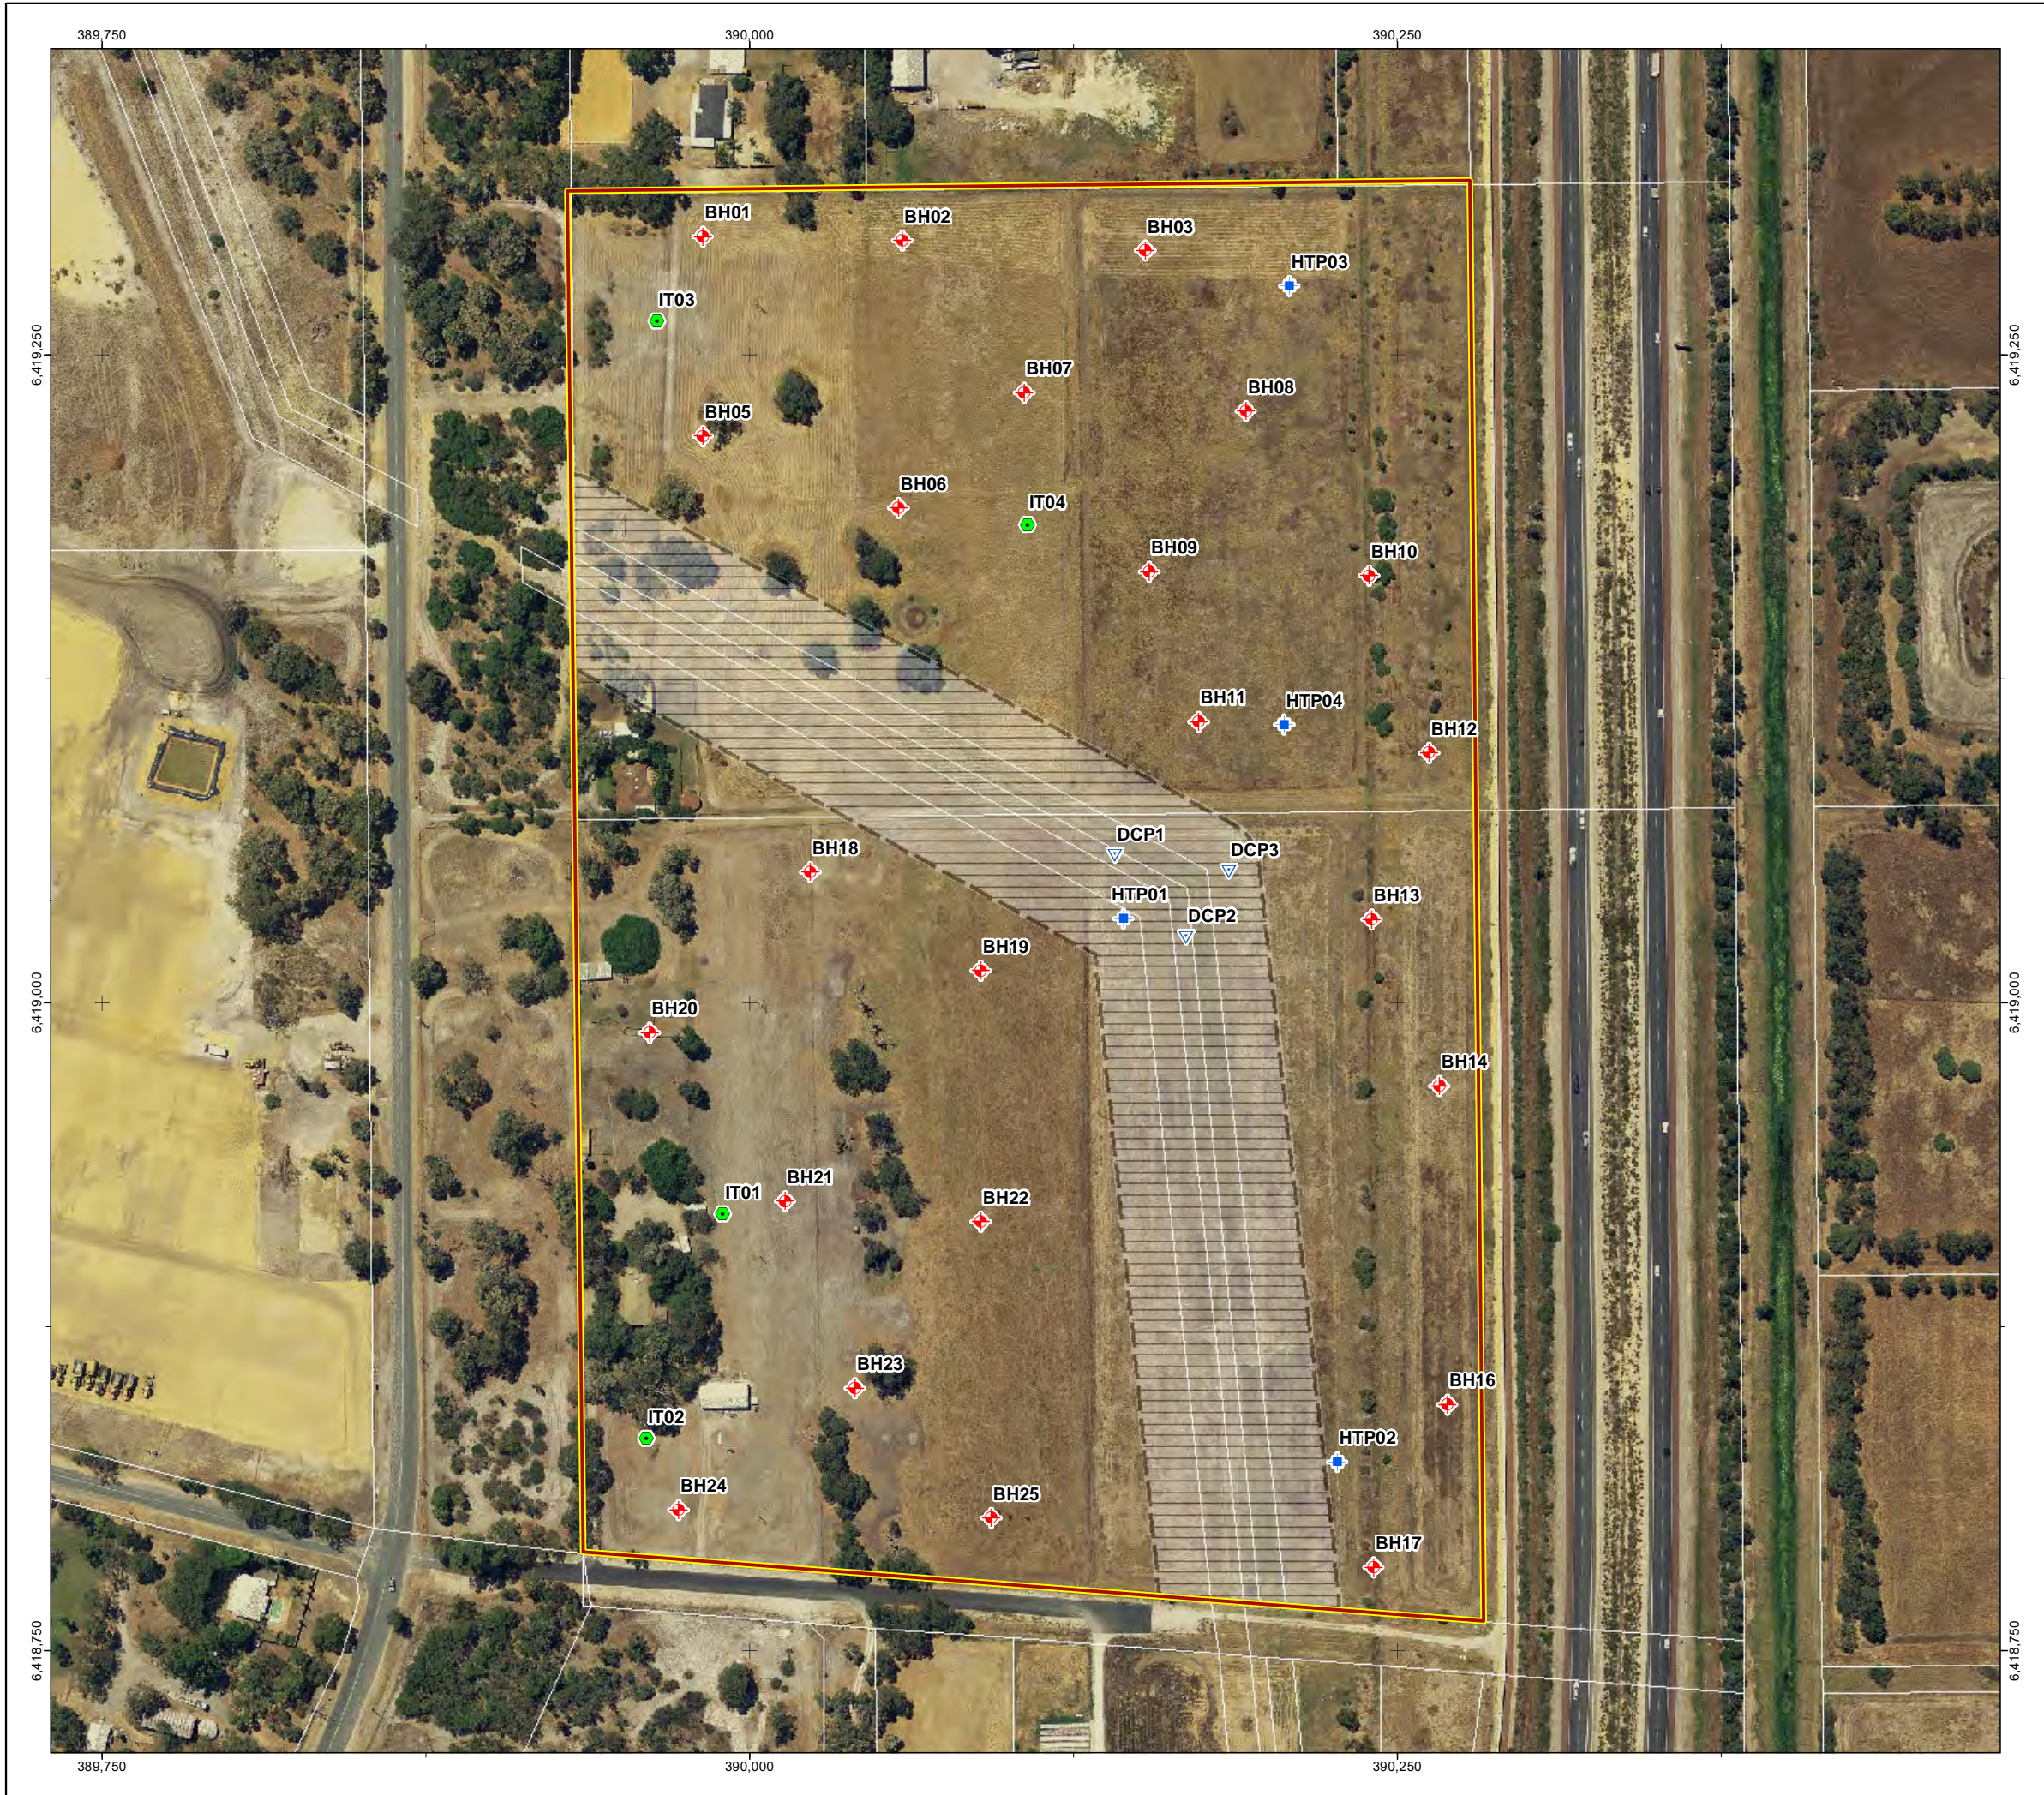
CLIENT	ABN GROUP		
PROJECT	PROPOSED RESIDENTIAL SUBDIVISION		
LOCATION	939 & 993 BALDIVIS ROAD BALDIVIS		
TITLE	SITE & LOCATION PLAN		
Job No	J1501236	Fig No	FIGURE 1
		Rev	A

- Site Boundary
- Buffer Zone
- Borehole
- Dynamic Cone Penetration
- Hand Excavation
- Infiltration Test

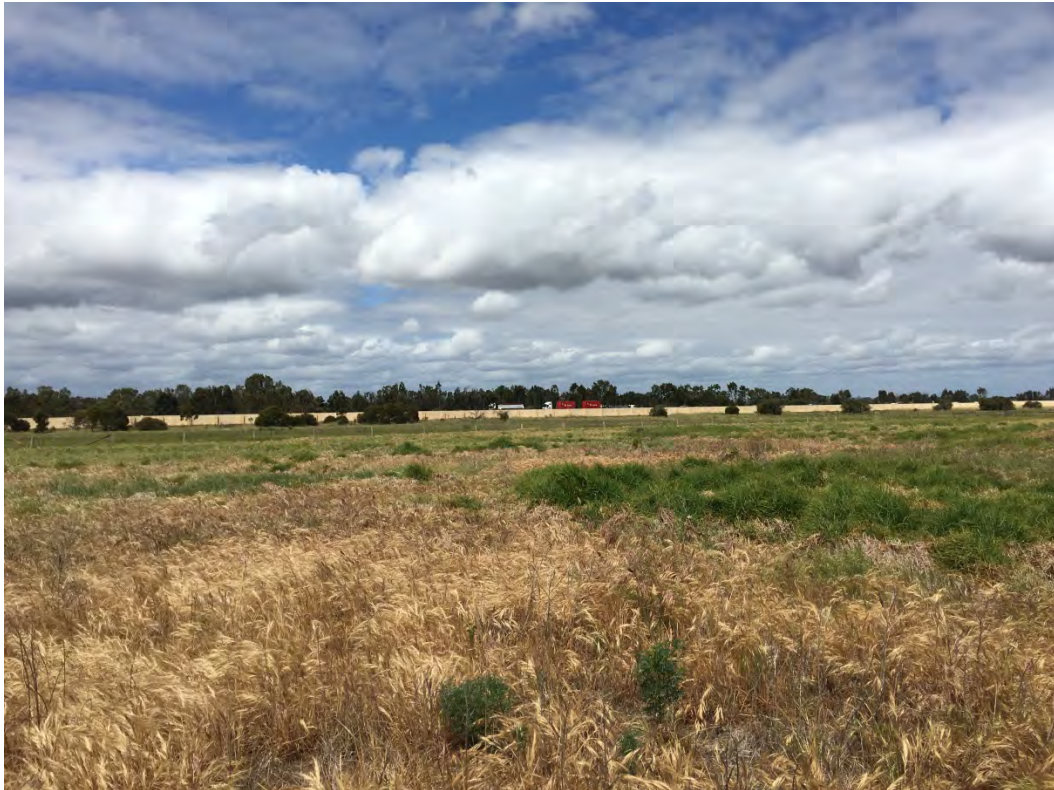
**Photograph 1: Typical surface cover across the site. Western portion of site looking east.**

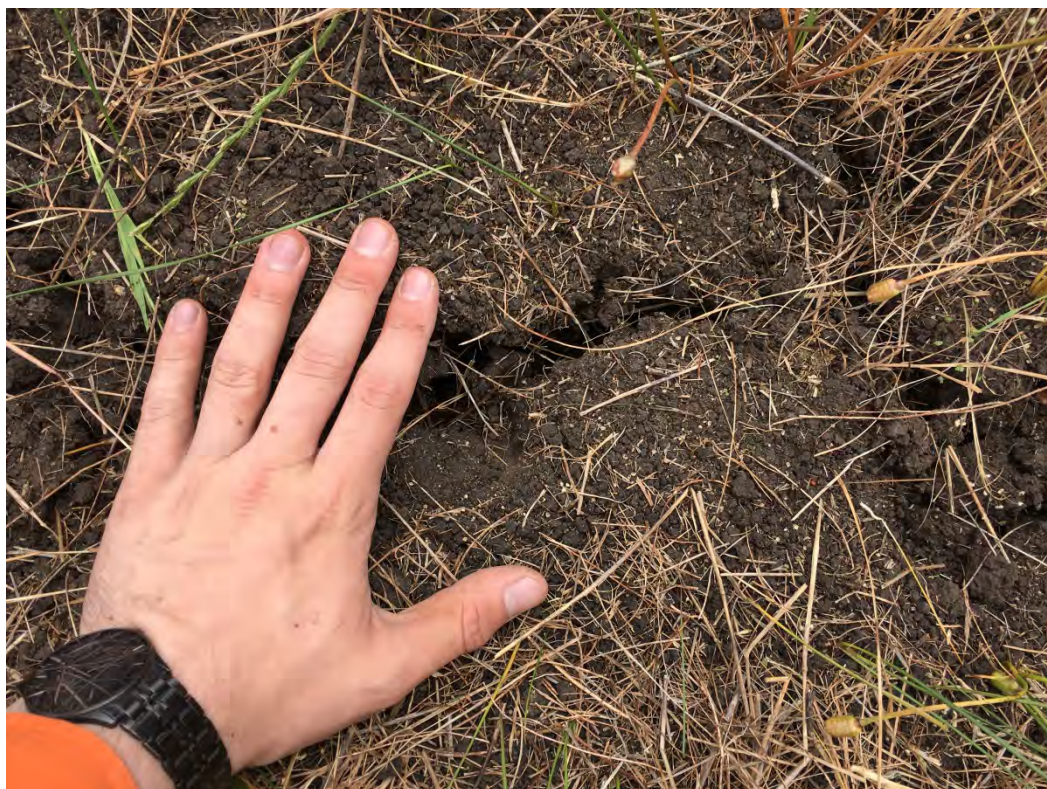
Photograph 3: Shrinkage cracks in Organic Clay material in east of site

The Organic CLAY present in the eastern portion of the site typically has a stiff upper crust (top 0.1 m to 0.2 m), which becomes very soft to firm below. Large shrinkage cracks were also observed at the surface where the organic clay is present.

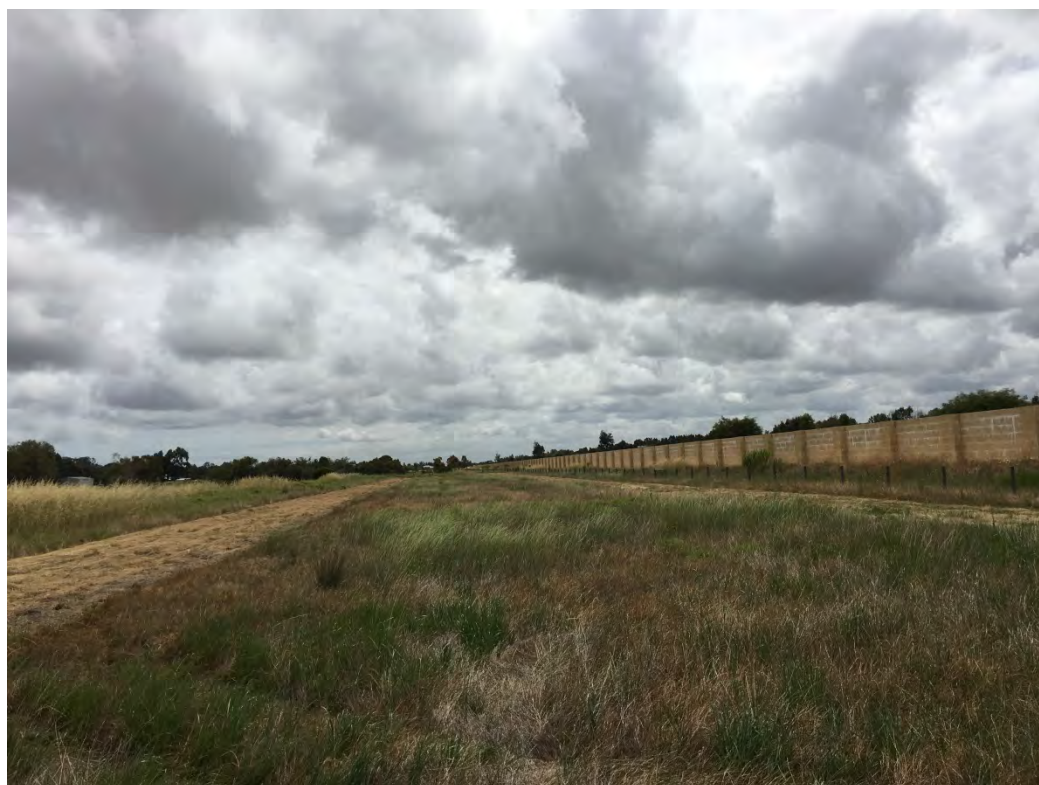
Photograph 4: Drain in east of the site, looking north
