LOCAL WATER MANAGEMENT STRATEGY

WEST KARNUP - LOT 805 LSP ADDENDUM Project Number EP14-047

DOC NAME	WEST KARNUP - LO	WEST KARNUP - LOT 805 LSP LOCAL WATER MANAGEMENT STRATEGY ADDENDUM							
DOC NO.	EP14-047(06)006C	RLE							
REVISION	DATE	AUTHOR		REVIEWER					
1	March 2015	Rachel Evans	RLE	Dave Coremans	DPC				
1	Draft for issue to the	Draft for issue to the project team							
^	April 2015 Rachel Evans RLE Dave Coremans DPC								
Α	For issue to DoW an	d CoR							
	February 2016	Rachel Evans	RLE	Dave Coremans	DPC				
В	For issue to DoW an	d CoR							
	June 2017	June 2017 Rachel Evans RLE Dave Coremans DPC							
C	For issue to DoW an	d CoR

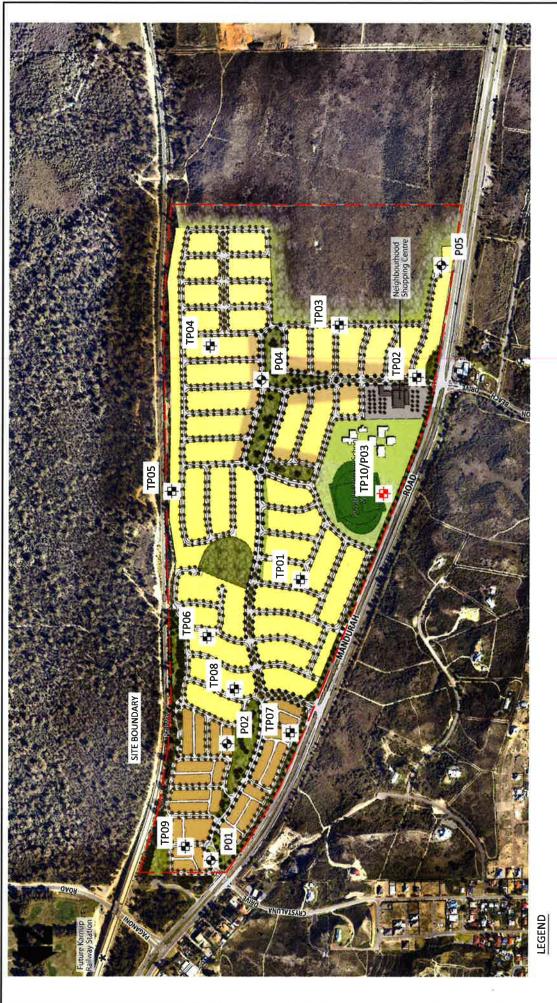
TP01 - TEST PIT LOCATION

4 P01 - PERMEABILITY TEST LOCATION
