# City of Rockingham

## EPBC 2011/5971 - Annual Compliance Report 2022 Extension of Mundijong Road

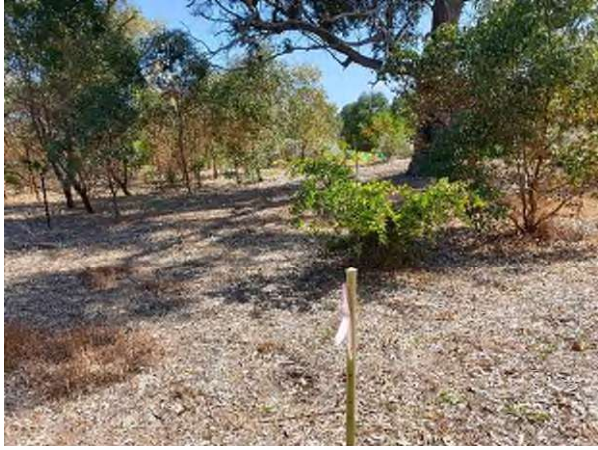
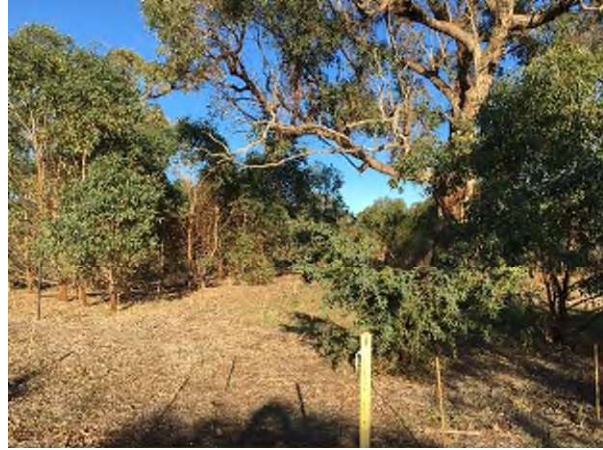
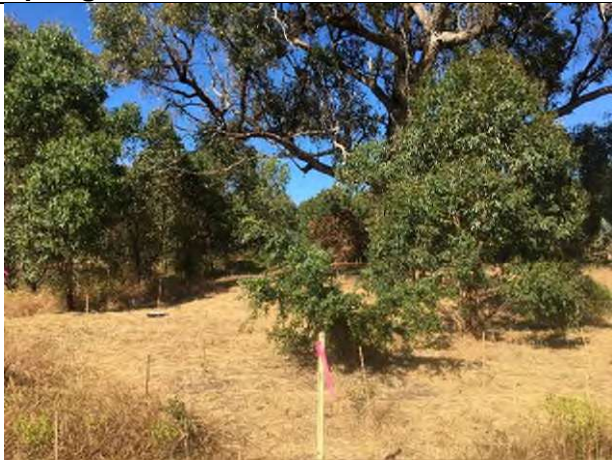
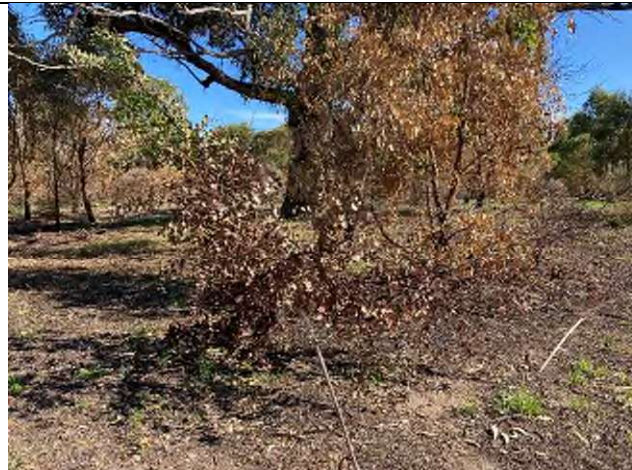
**Table 8: Revegetation monitoring – Quadrat 2 Dixon Road Conservation Precinct**

**Spring 2020**

**Autumn 2021**

**Spring 2021**

**Autumn 2022**

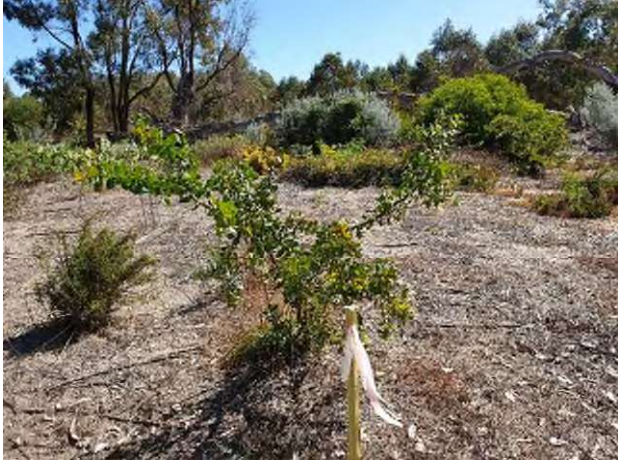
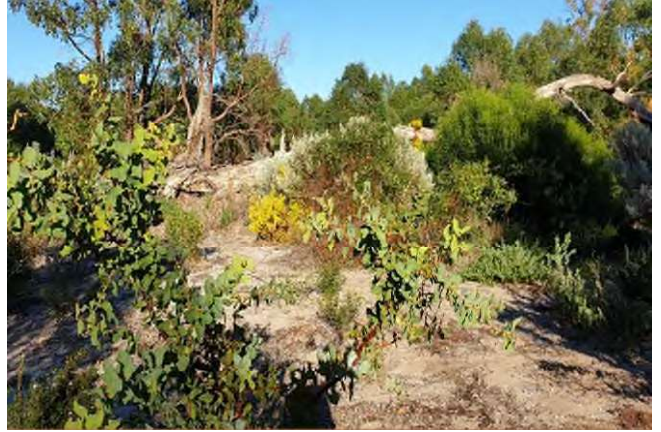
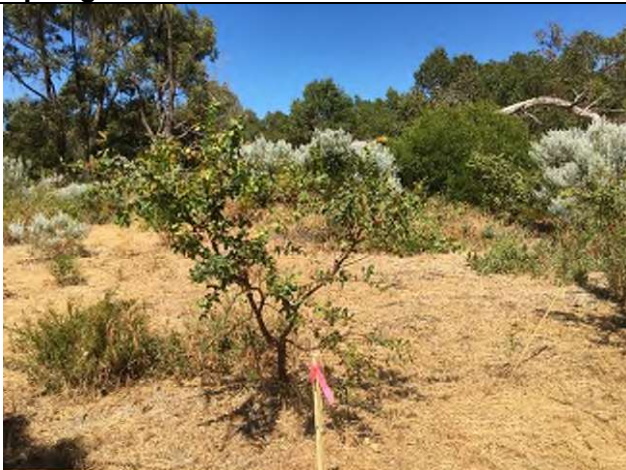
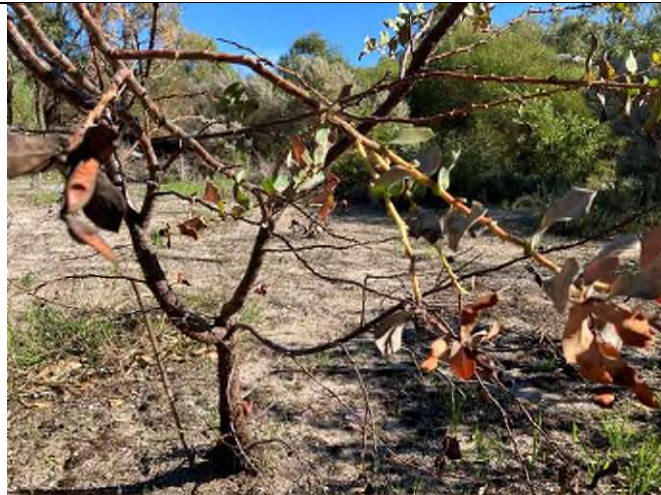
**Table 9: Revegetation monitoring – Quadrat 3 Dixon Road Conservation Precinct**

**Spring 2020**

**Autumn 2021**

**Spring 2021**

**Autumn 2022**

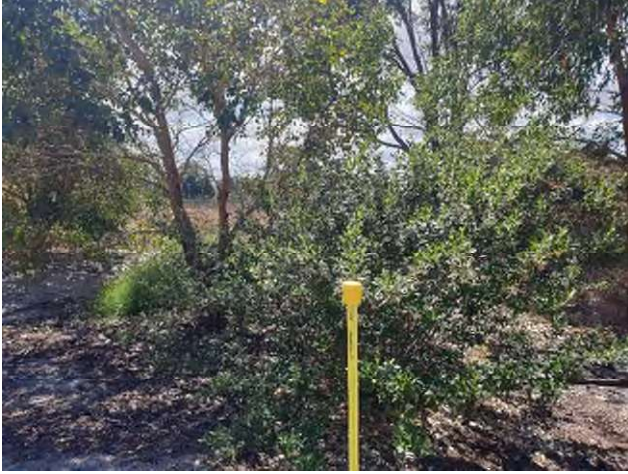
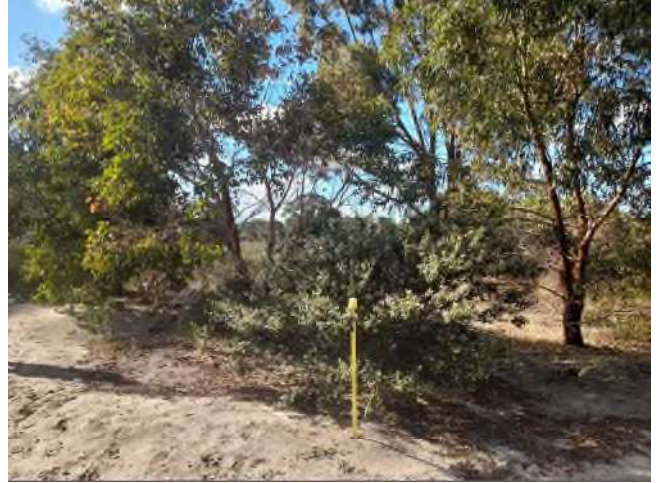
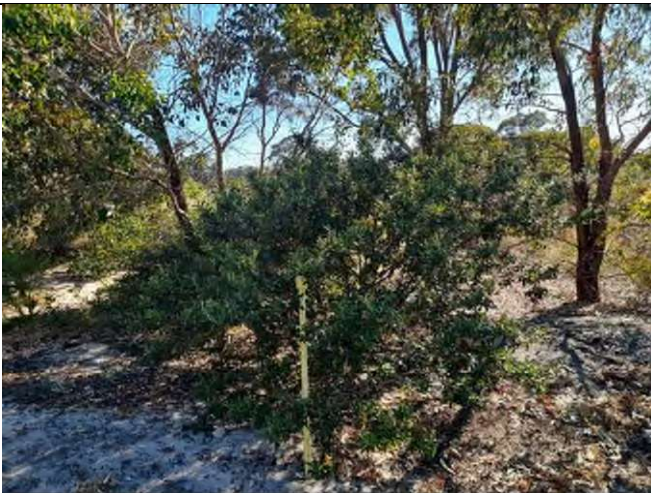
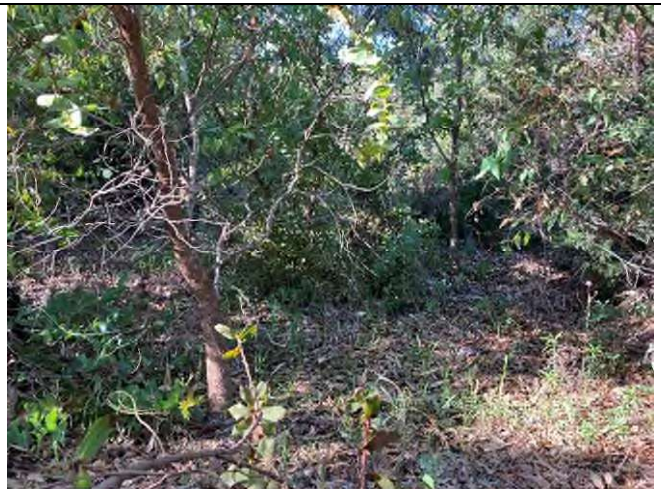
**Table 10: Revegetation monitoring – Quadrat 1 Trenant Park Wetland**

**Spring 2020**

**Autumn 2021**

**Spring 2021**

**Autumn 2022**

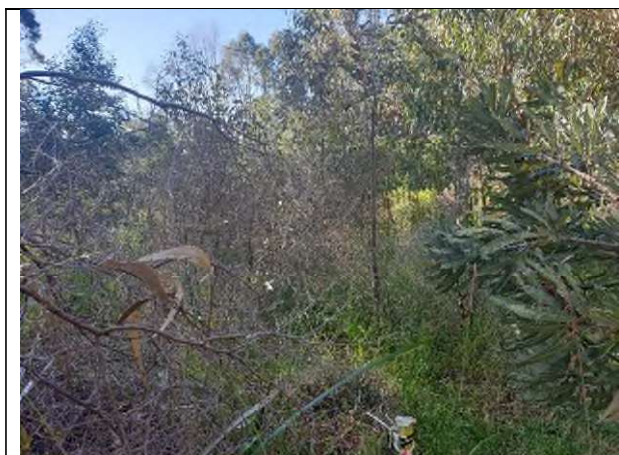
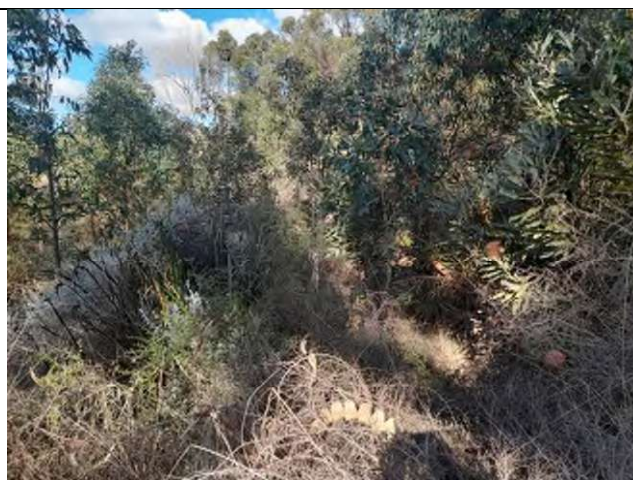
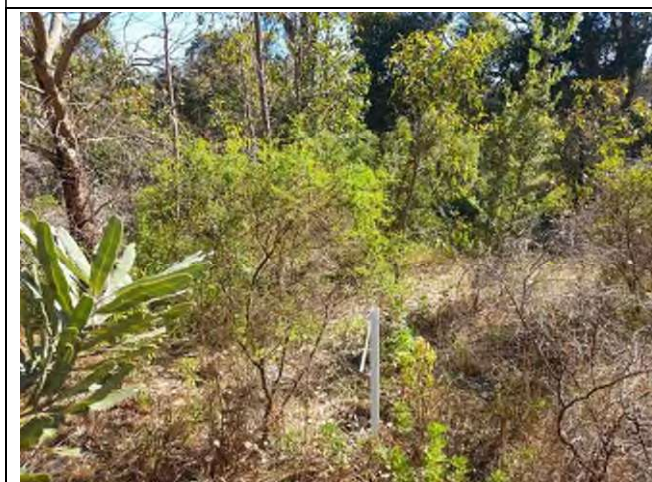
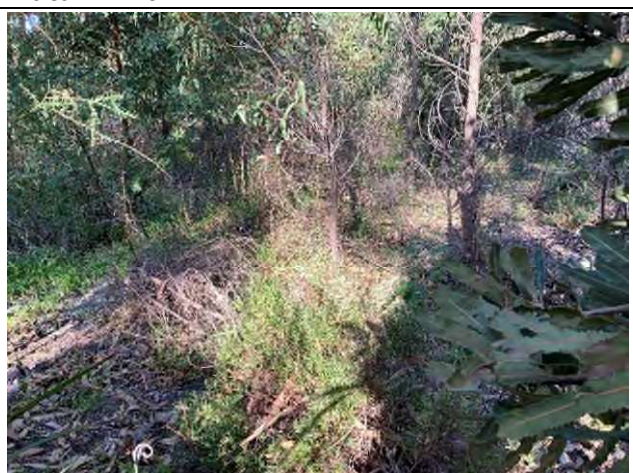
**Table 11: Revegetation monitoring – Quadrat 2 Trenant Park Wetland**

**Spring 2020**

**Autumn 2021**

**Spring 2021**

**Autumn 2022**

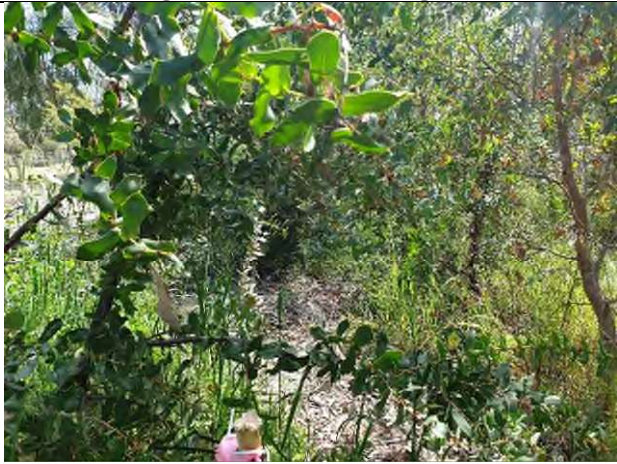
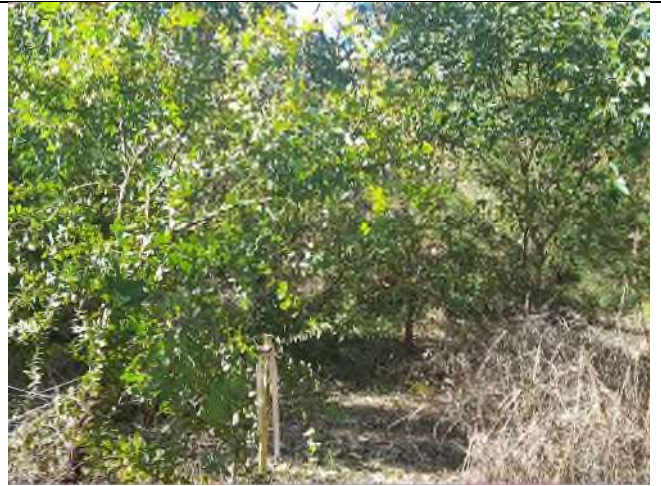
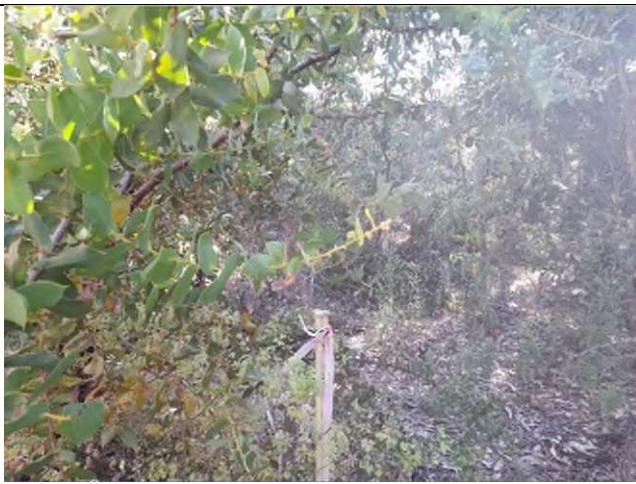
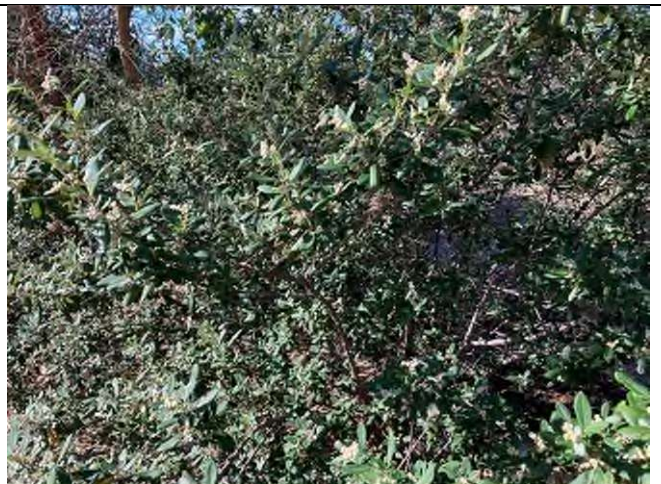
**Table 12: Revegetation monitoring – Quadrat 3 Trenant Park Wetland**

**Spring 2020**

**Autumn 2021**

**Spring 2021**

**Autumn 2022**

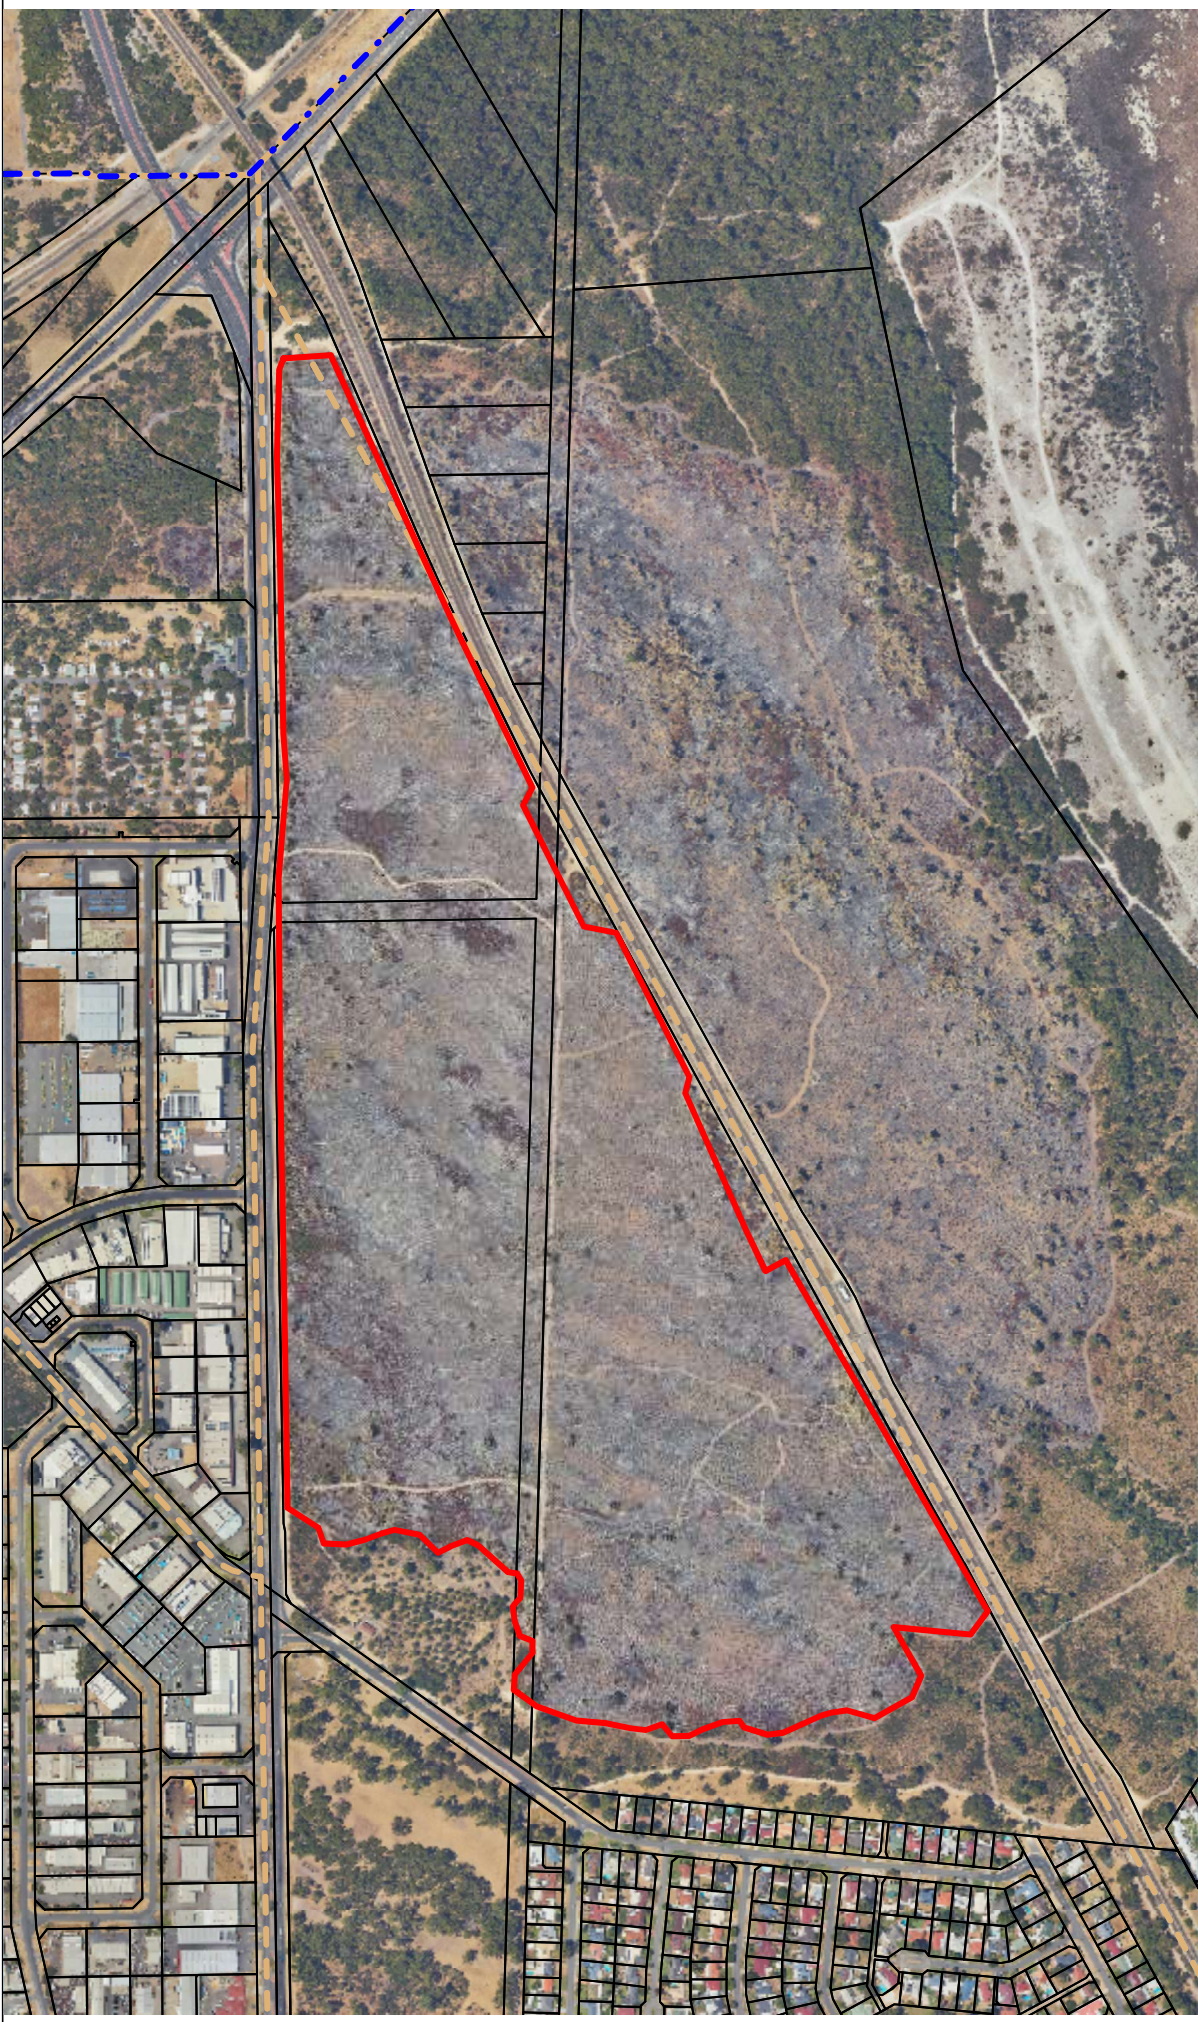
**Appendix 1**  
**February 2022 fire scar map**  
**Dixon Road Conservation**  
**Precinct**

An extensive fire impacted the majority of Dixon Road Conservation Precinct (DRCP) during February 2022. The fire is believed to have been arson with an ignition point in the east of the reserve. A map of the fire scar is included in the report in Appendix 1. The revegetation site in the northwest of the reserve was not significantly impacted. A small number of plants were lost on the eastern side, but most of the area remained unaffected.

Weed regrowth following the fire at DRCP detailed in Section 5.1 will be spot sprayed to limit reestablishment. Quotes are being sought to treat the weeds across the entirety of the fire scar area. Timing is projected to be August 2022 for the first treatment, with a follow up in late spring 2022.

A section of fencing at DRCP was damaged during the February fire. Contractors replaced 20 burnt pine posts and rejoined cut wires.
