City of Rockingham

EPBC 2011/5971 - Annual Compliance Report 2023 Extension of Mundijong Road

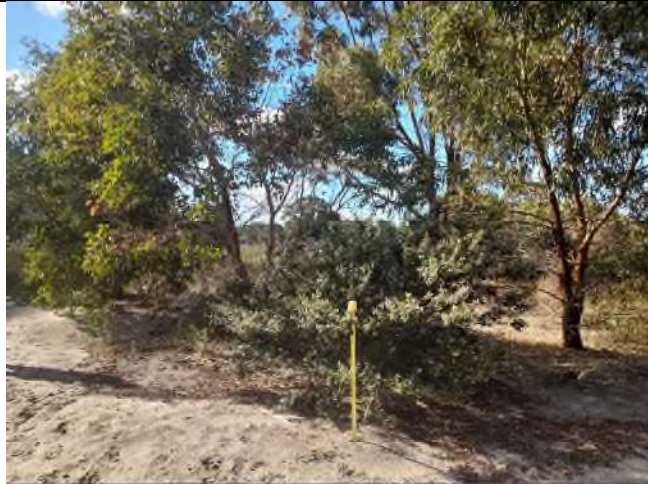
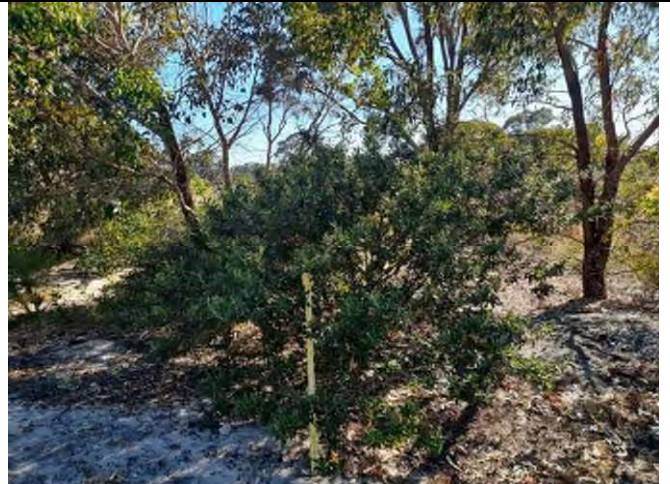
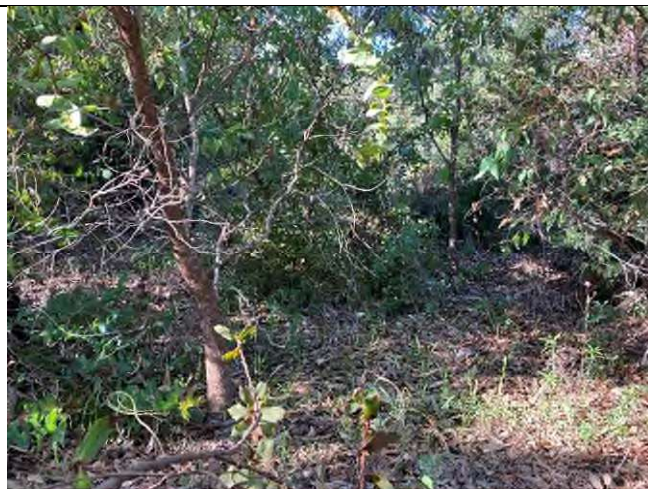
Table 10: Revegetation monitoring – Quadrat 1 Trenant Park Wetland

As of autumn 2023, coverage of native species at DRCP was an average of 29%, down 24% from spring 2021. At TPW, native coverage in autumn 2023 was 60%, down from the 67% coverage measured in spring 2021. This was in part due to the very hot and dry mid to late summer over 2022/2023.

Weed density at DRCP was low at an average of 11.5% across the monitoring quadrats. At TPW, the average weed density was 43%. Much of this was a large presence of *Fumaria capreolata*.
