SUBURB: Rockingham

Code No. F1R

Connects Chalwell Street (head of cul-de-sac) to Esplanade

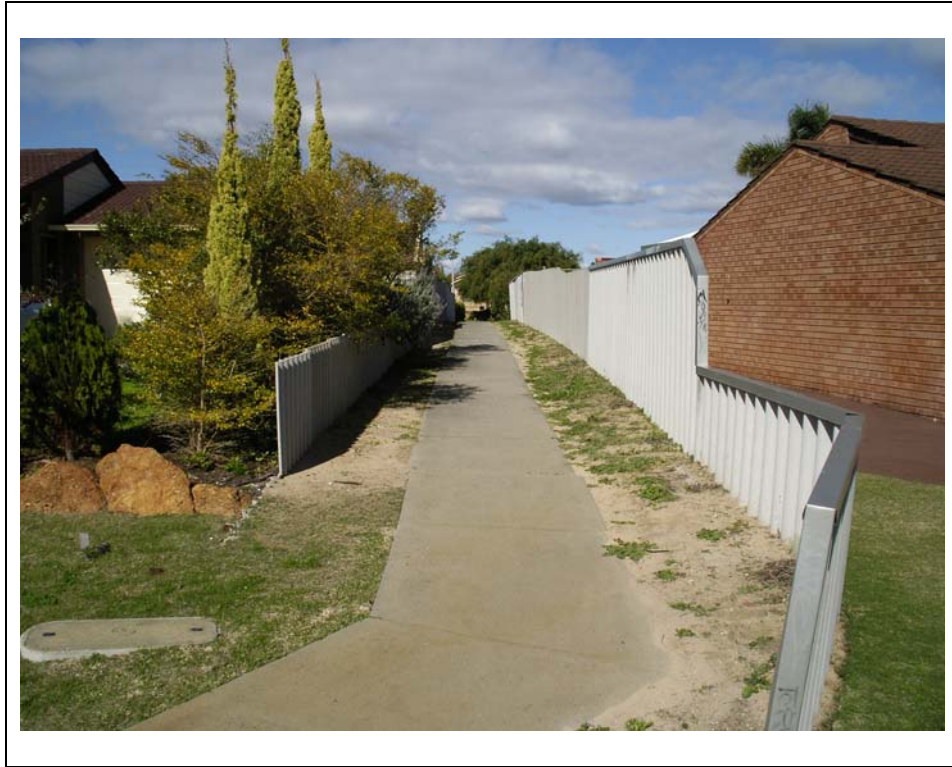
Code No. F13WK Map D6

Accessway approx. 3m wide and 50m long. Straight, slightly undulating.

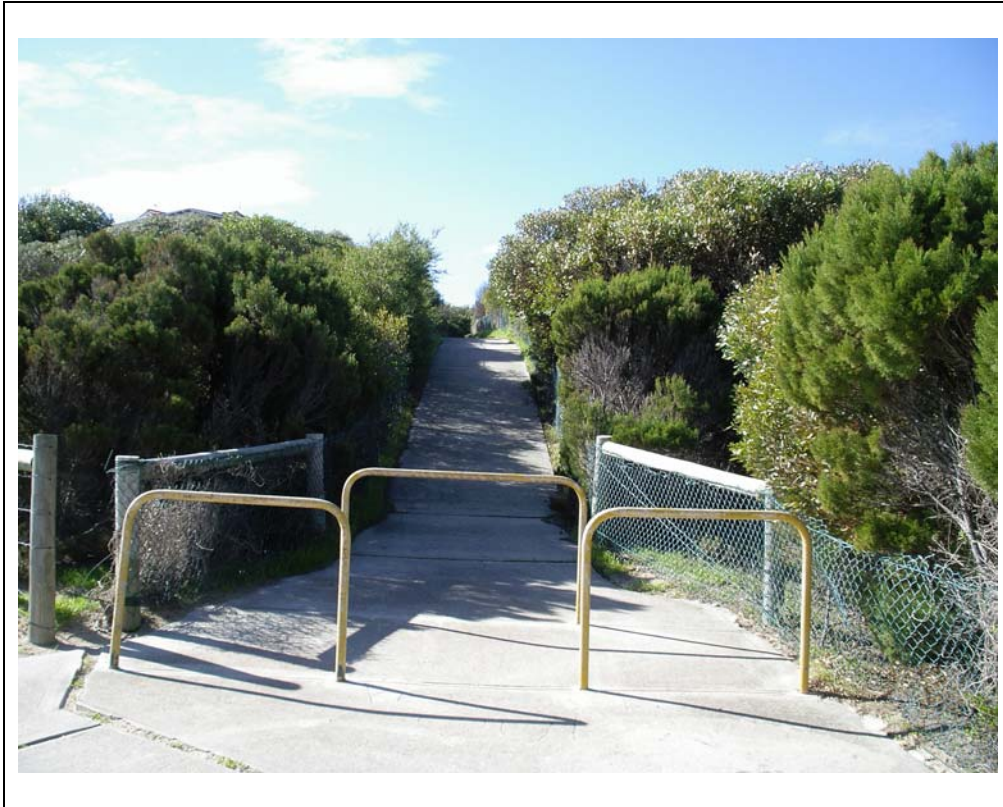
Code No. F14SB Map D6

Accessway approx. 4m wide and 70m long. Narrow, undulating, very steep in parts, winding path, bend half way. Bollards at both ends.

Whilst not essential to the local pedestrian/cycle network, this accessway appears to be operating satisfactorily, and is in fair condition. It could be retained.

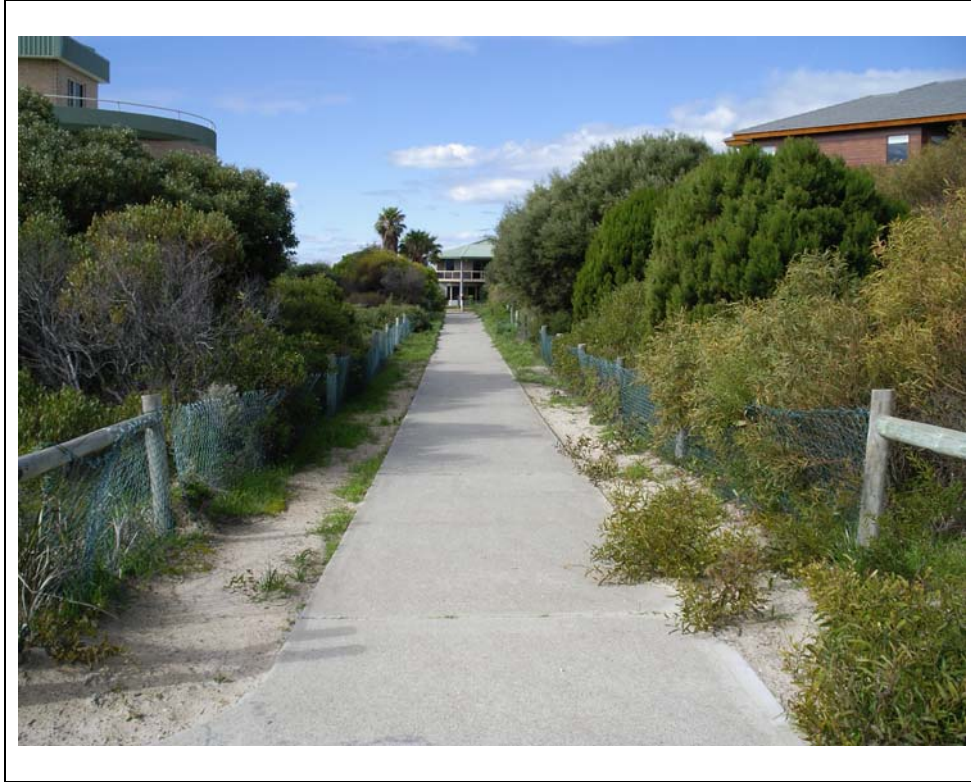
Code No. F15W **Map** E7

Accessway approx. 4m wide and 60m long. Straight, undulating, with single bollard at cul-de-sac end.

Whilst not essential to the local pedestrian/cycle network, this accessway appears to be operating satisfactorily, and is in fair condition. It could be retained.

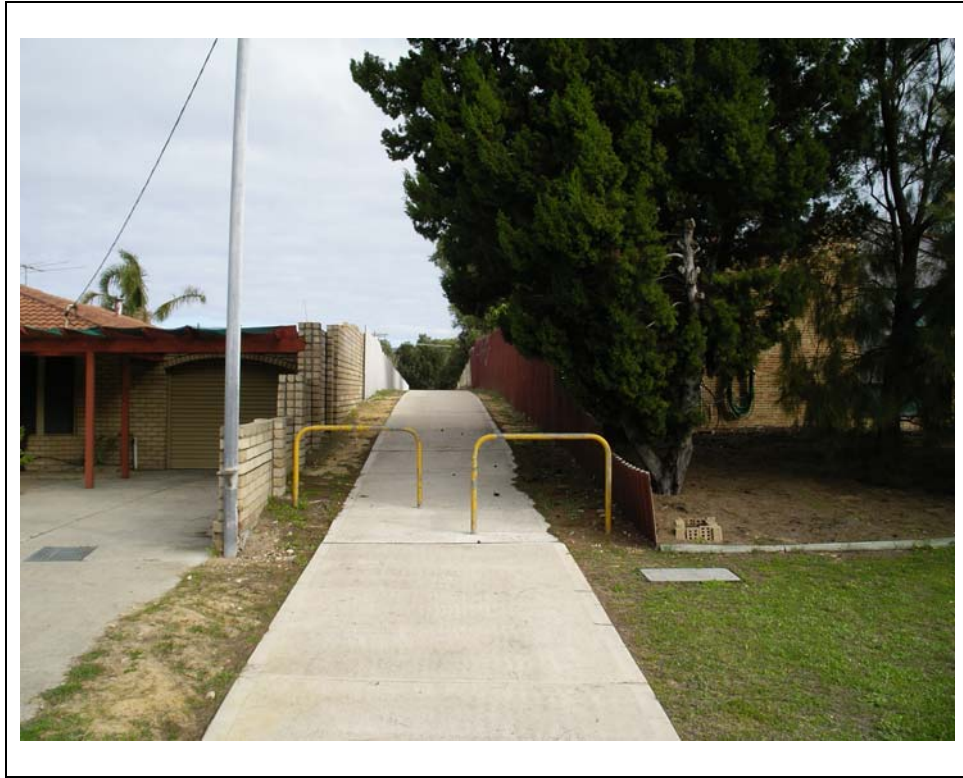
Code No. F16W **Map** E7

Accessway approx. 4m wide and 80m long. Straight, undulating. Bollards at both ends.

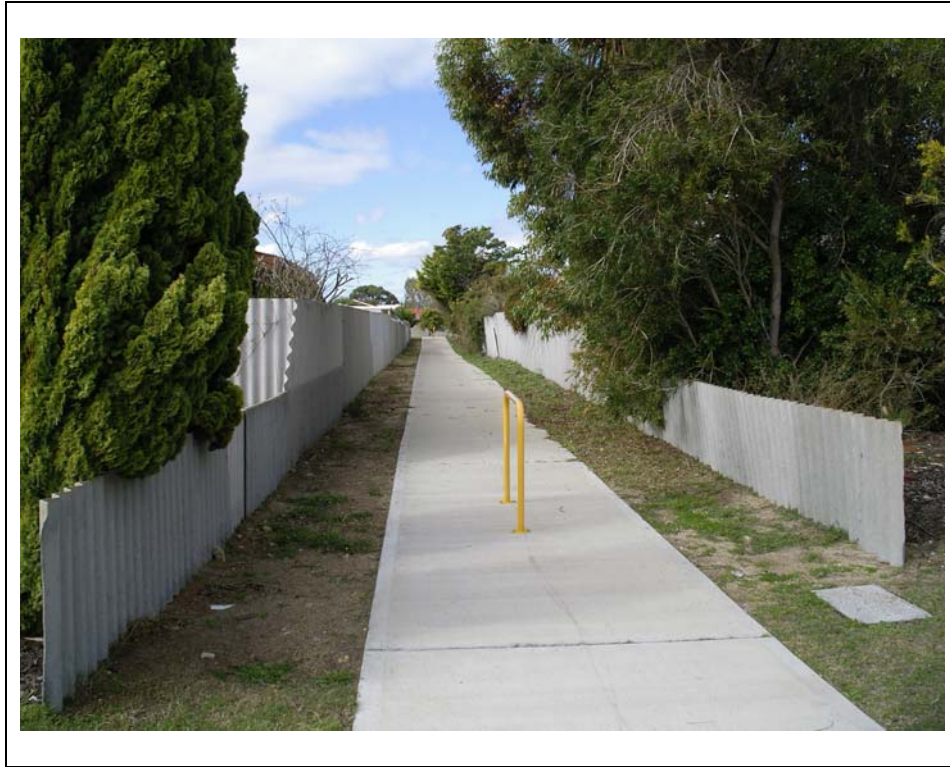
Code No. F17W **Map** E7

Accessway approx. 4m wide and 75m long. Straight, undulating. Bollards at both ends.

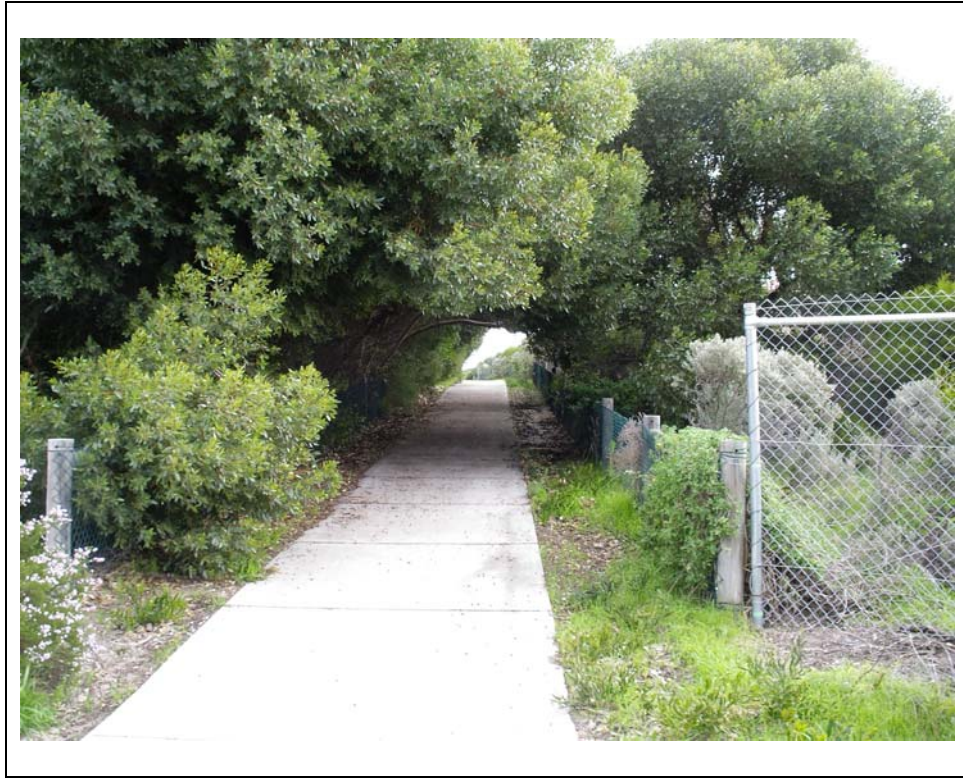
Code No. F18W **Map** E7

Accessway approx. 4m wide and 80m long. Undulating and sloping, bend half-way, winding path.

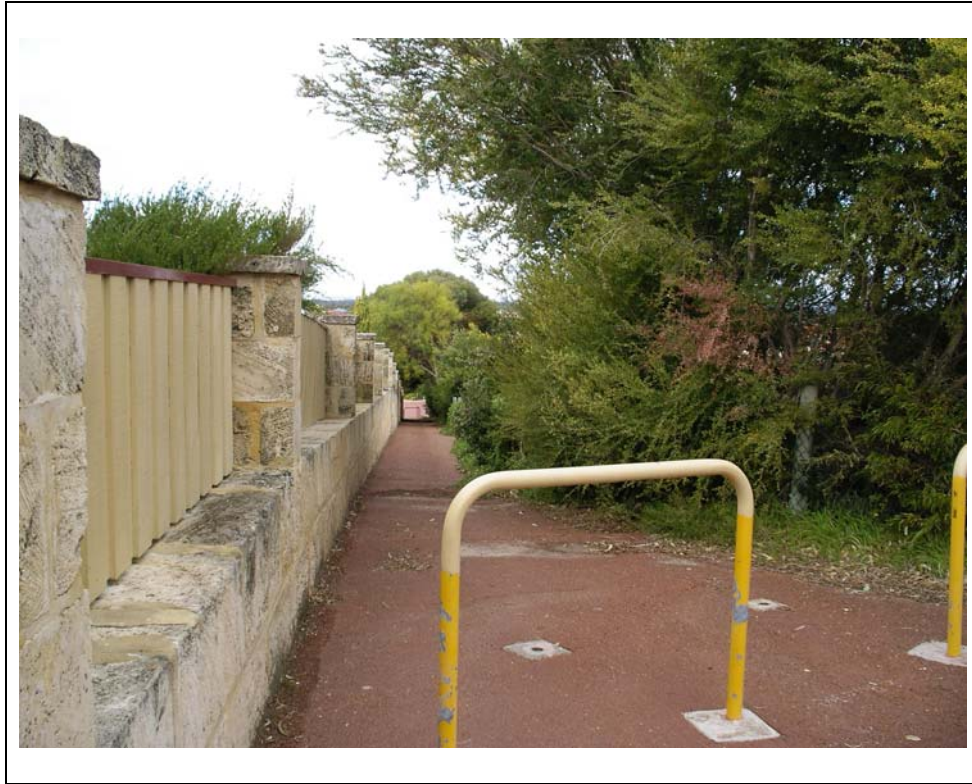
Code No. F19PK **Map** E8

Accessway approx. 4.5m wide and 70m long. Straight, steeply sloping in parts, with bollards at both ends.

Whilst not essential to the local pedestrian/cycle network, this accessway appears to be operating satisfactorily, and is in fair condition. It could be retained, although there is a genuine PAW (PK198) located nearby and parallel.

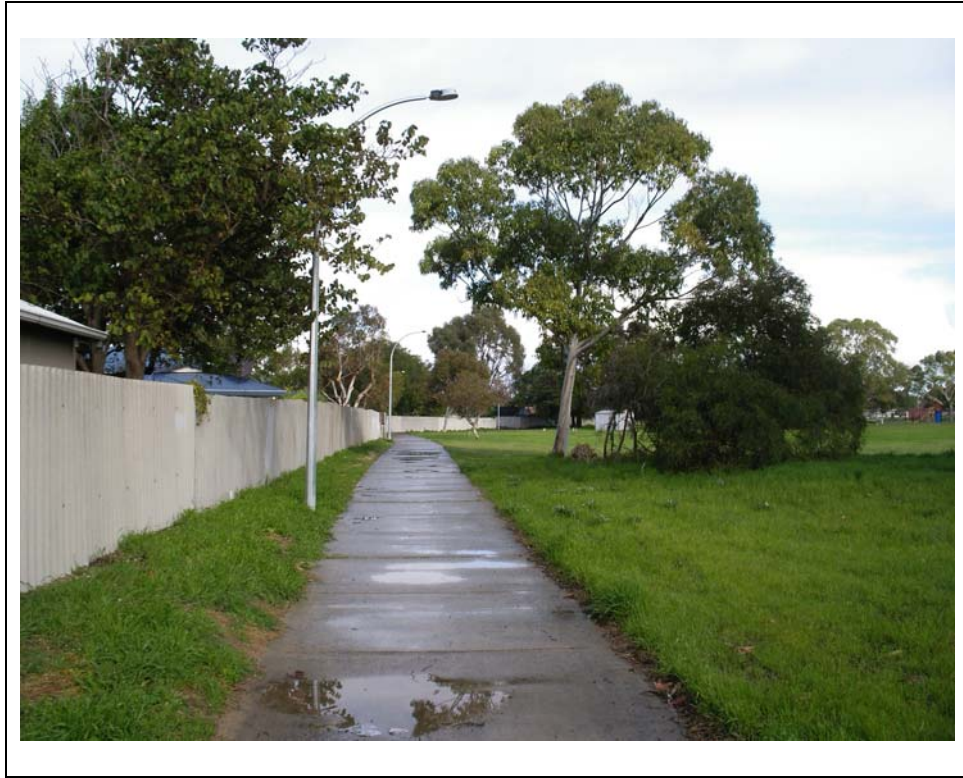
Code No. F21H Map E3

Accessway approx. 5.5m wide and 160m long in total. "T"-shaped with bend in main length. Flat, but sloping down to an underpass at the eastern end. No bollards.

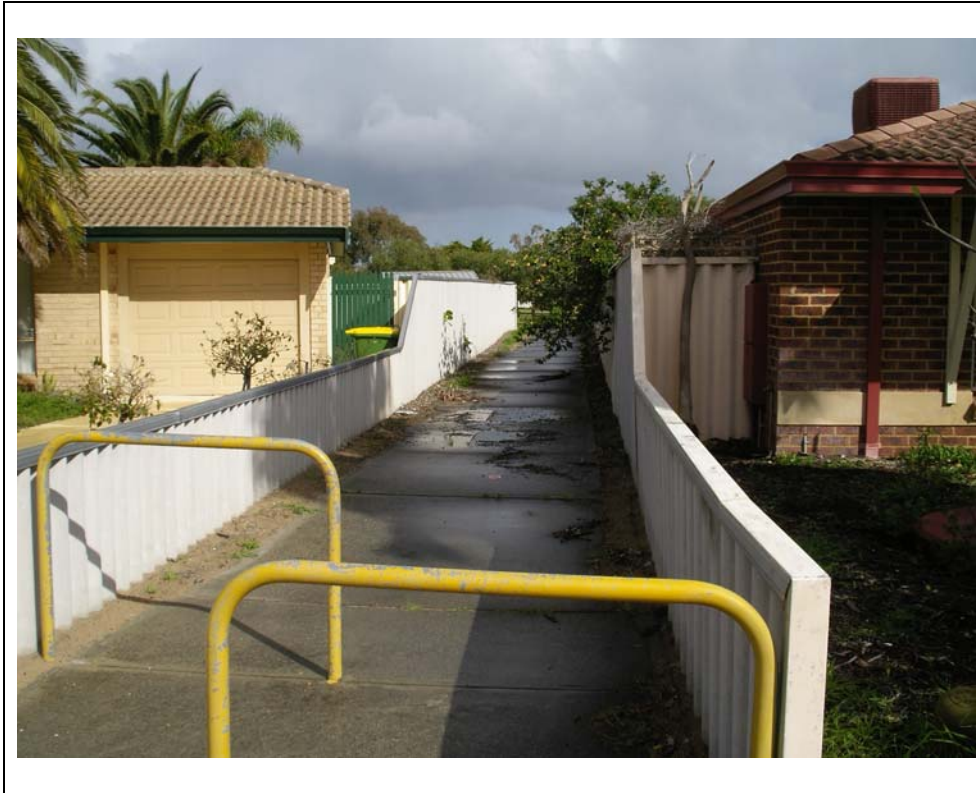
Code No. F22C **Map** E4

Accessway approx. 3m wide and 35m long. Straight, flat, with bollards at cul-de-sac end only.

Whilst not essential to the local pedestrian/cycle network, this accessway appears to be operating satisfactorily, and is in fair condition. It could be retained, although there are other access points to the park nearby.

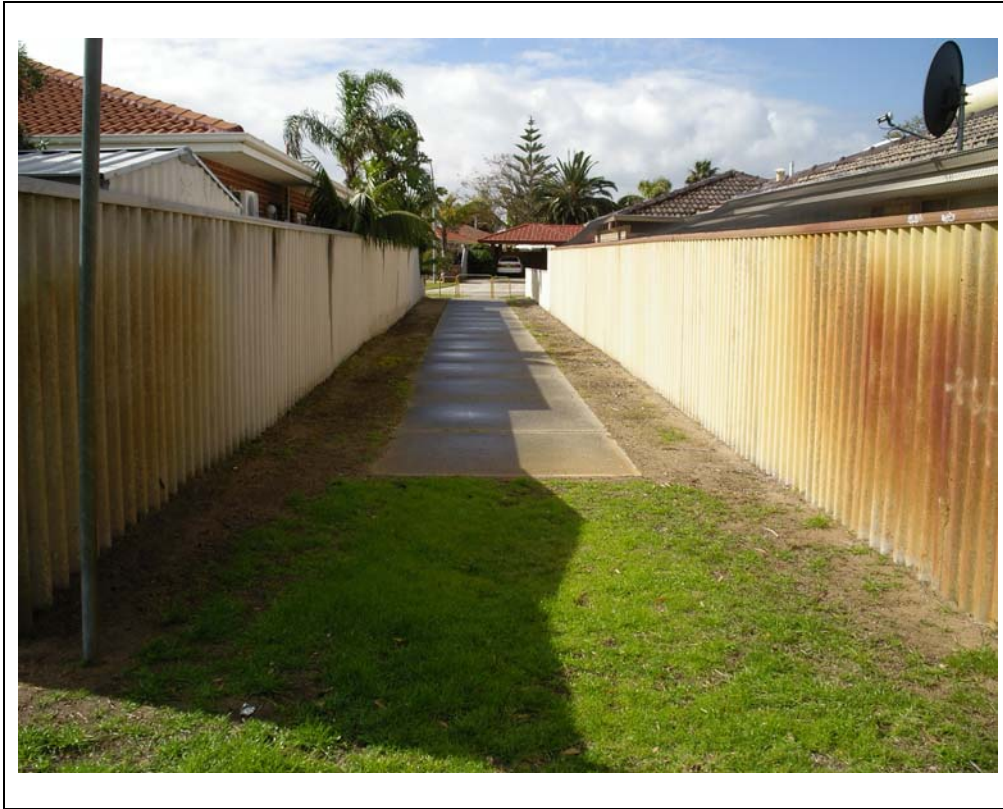
Code No. F24C **Map** F4

Accessway approx. 4m wide and 36m long. Straight, flat, with bollards at cul-de-sac end only.

Whilst not essential to the local pedestrian/cycle network, this accessway appears to be operating satisfactorily, and is in fair condition. The road pattern in the area is very convoluted, and this accessway assists pedestrians and cyclists by providing a short-cut to the park and other destinations to the north. There seems to be no reason to remove the accessway at present.

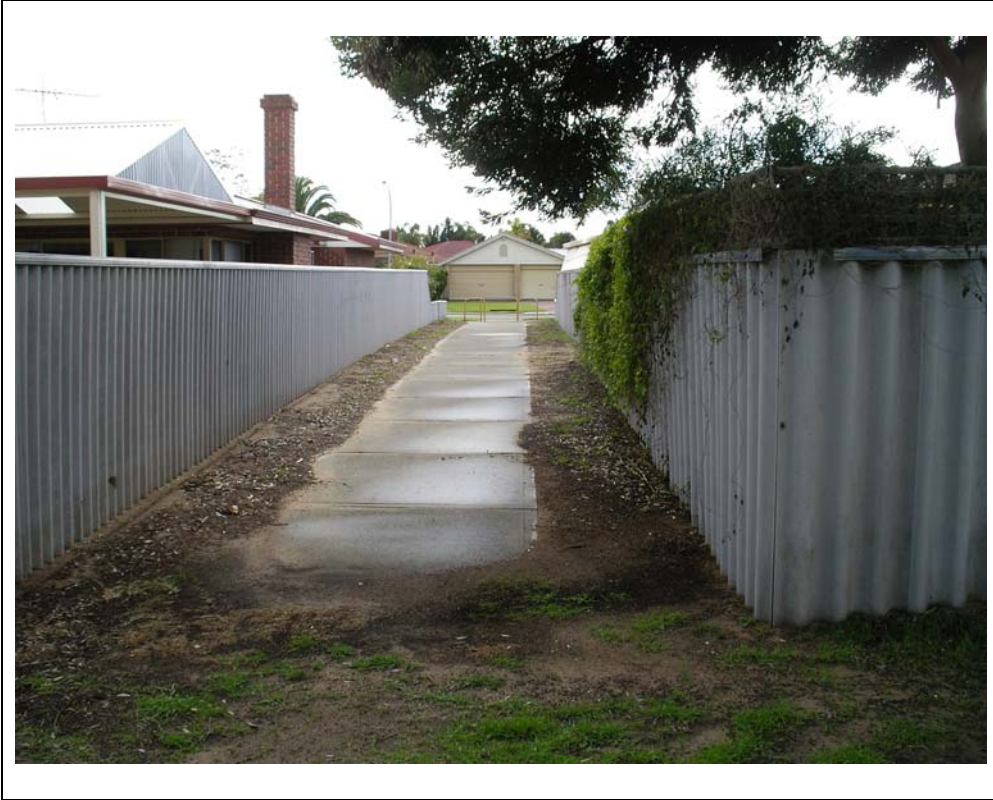
Code No. F25C **Map** F4

Accessway approx. 4m wide and 30m long. Straight, gently undulating, with bollards at cul-de-sac end only.

Whilst not essential to the local pedestrian/cycle network, this accessway appears to be operating satisfactorily, and is in fair to good condition. The road pattern in the area is very convoluted, and this accessway assists pedestrians and cyclists by providing a short-cut to the park and other destinations to the south. This accessway is apparently owned by the Water Corporation.

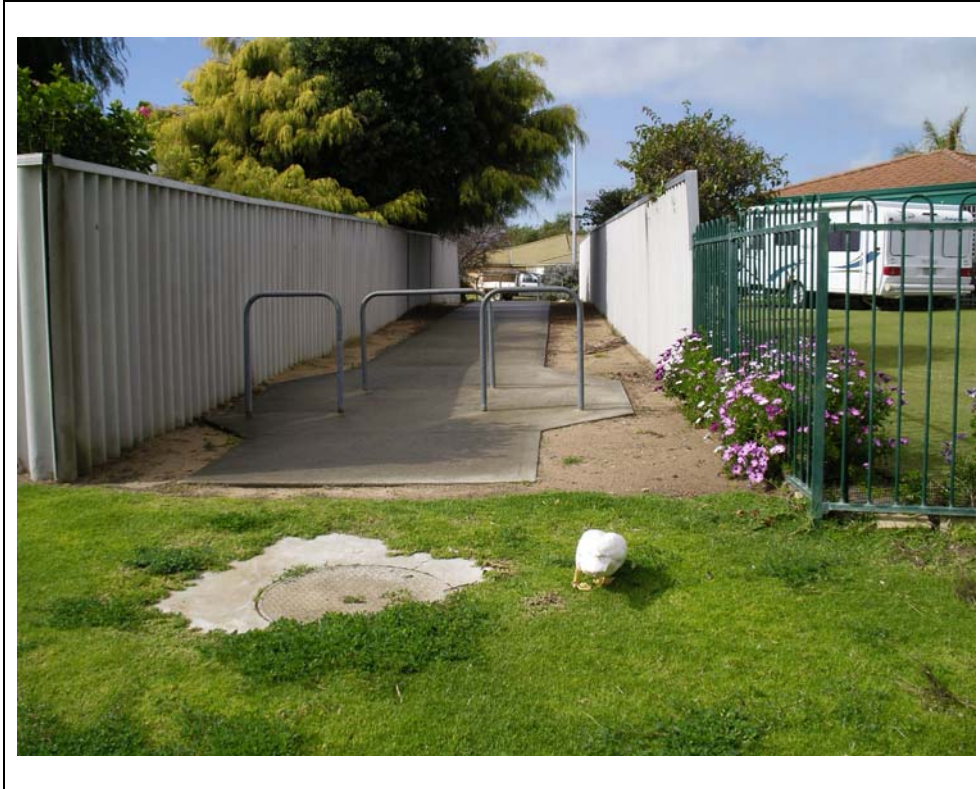
Code No. F26C **Map** F4

Accessway approx. 4m wide and 25m long. Straight, undulating, with bollards at both ends.

Whilst not essential to the local pedestrian/cycle network, this accessway appears to be operating satisfactorily, and is in fair to good condition. The road pattern in the area is very convoluted, and this accessway has local importance in that it assists pedestrians and cyclists living to the south and east of it by providing direct access to the park and other destinations to the north.

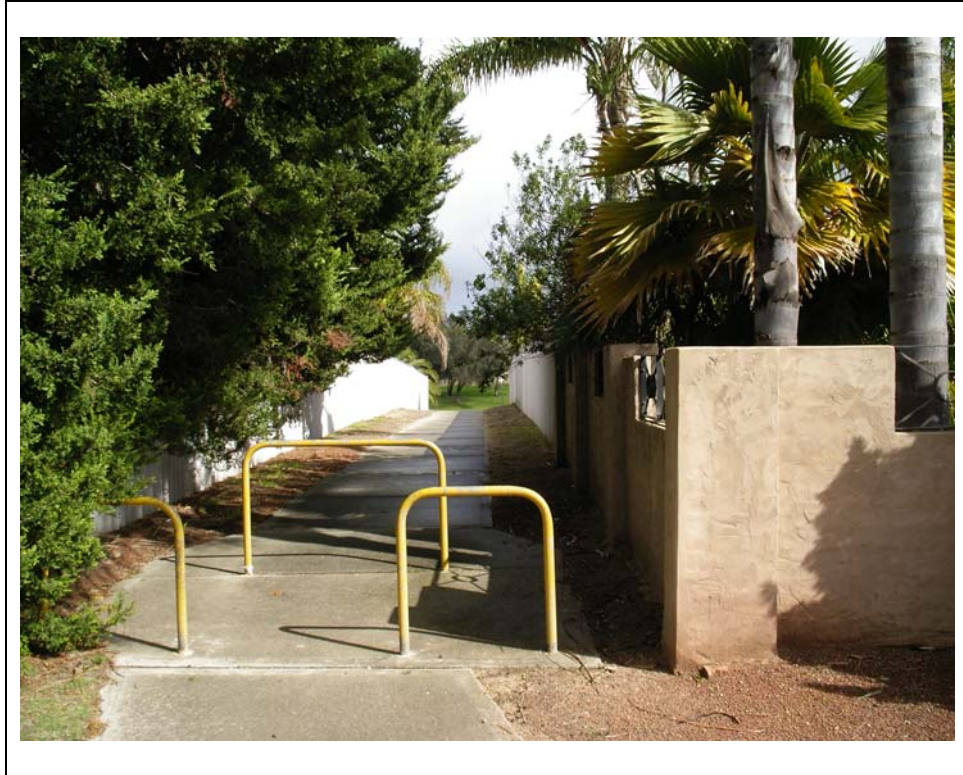
Code No. F27C **Map** F4

Accessway approx. 4m wide and 42m long. Straight, slightly undulating, with bollards at cul-de-sac end only.

Whilst not essential to the local pedestrian/cycle network, this accessway appears to be operating satisfactorily, and is in fair condition. The road pattern in the area is very convoluted, and this accessway has local importance in that it assists pedestrians and cyclists living to the east of it by providing direct access to the park and other destinations to the north. There seems to be no reason to remove the accessway at present.

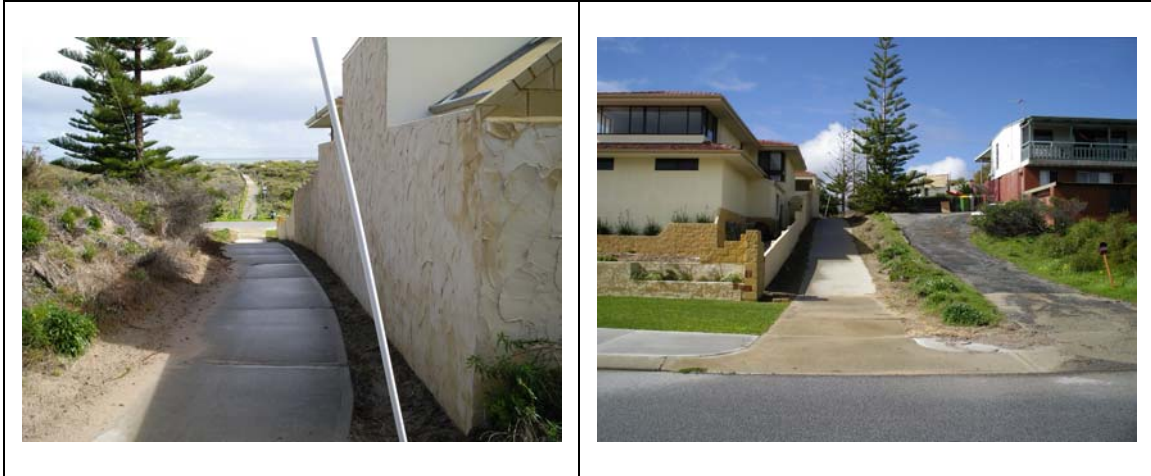
Accessway is straight with a curved entry from the cul-de-sac, and slopes down steeply in parts from east to west. Approx. 4m wide and 40m long. Single bollard at east end only.

Bight Reefs Road does, however, provide a convenient, nearby alternative access route, so this accessway could not be considered essential. It is in fair to good condition, however, and is being used, and should preferably be retained if there are no problems associated with its continued existence.

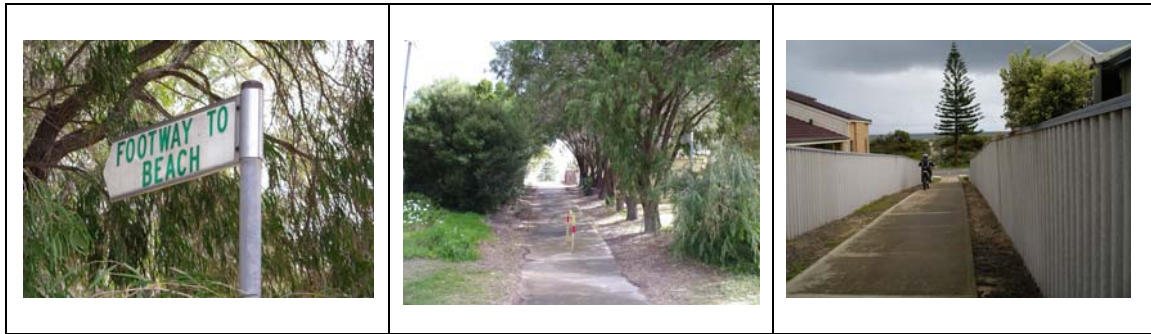
Accessway is straight with a pronounced humped profile. Steeply sloping in parts. Approx. 4m wide and 82m long. Bollards at both ends.

Used by locals to access the beach. A sign at its eastern end encourages pedestrian use. On the day of inspection a motor cyclist was observed using the accessway.

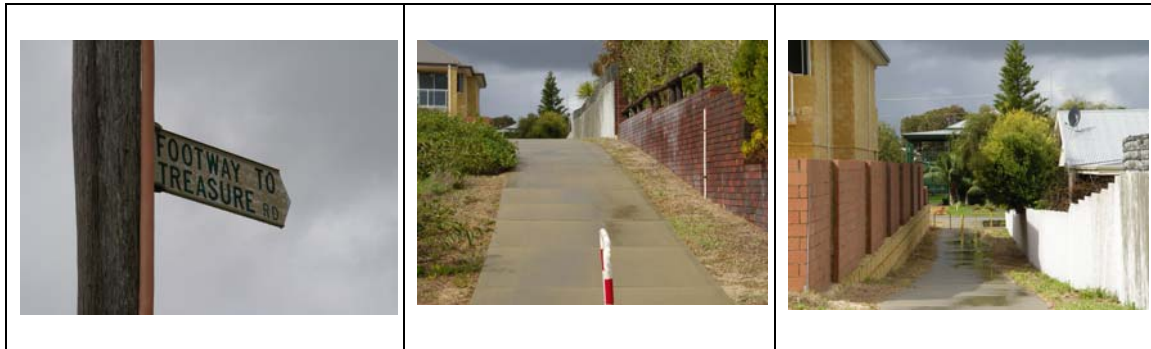
Accessway is straight with a pronounced humped profile. Steeply sloping in parts. Approx. 4m wide and 92m long. Bollards at both ends.

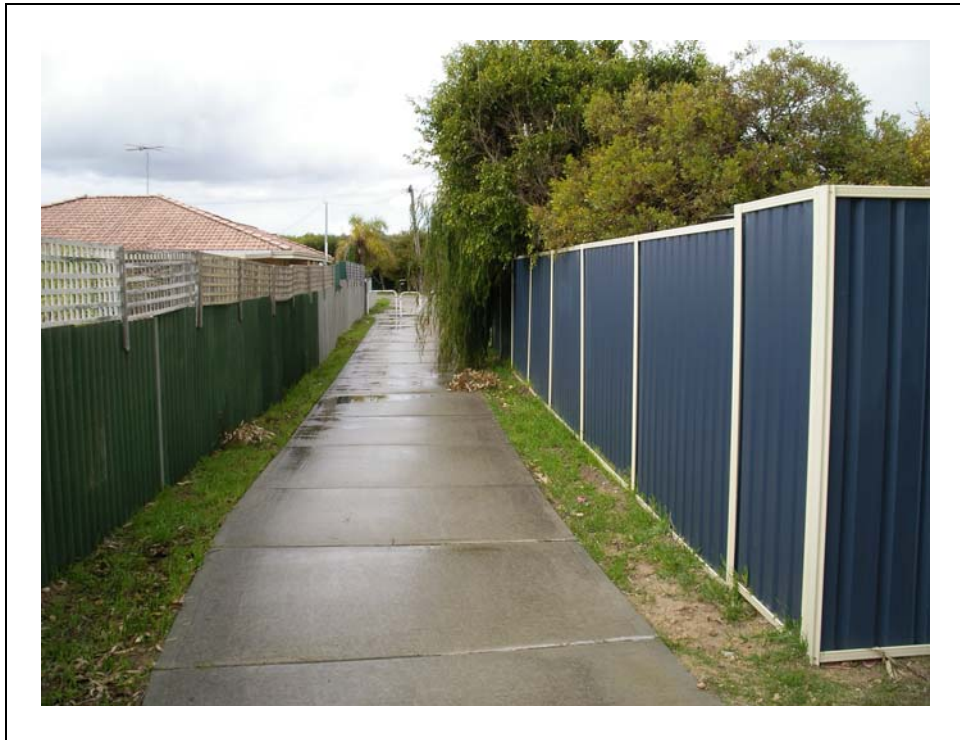
Accessway is straight and flat, rising slightly at its western end. Bollards at east end only.

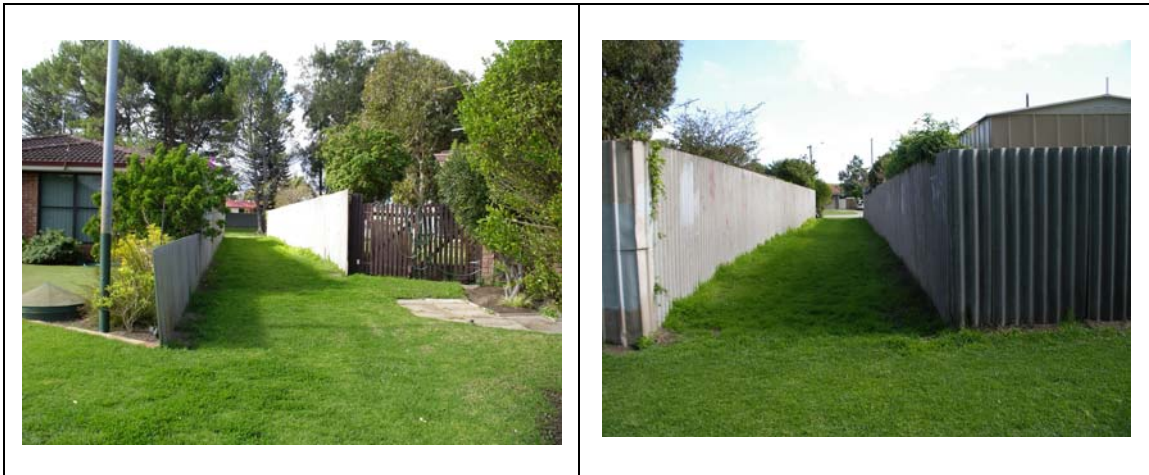
Accessway is straight & gently undulating. Approx. 3m wide and 33m long. No bollards.

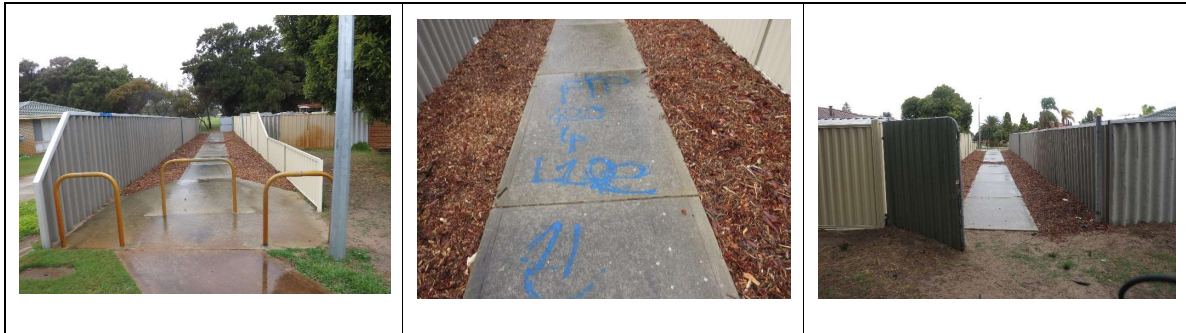
28m long and 4m wide. Short, straight and flat. Bollards located on the western entrance from Anchor Place. PAW is fenced on the eastern side on to the High School ovals.

Fair condition.
