SUBURB: Safety Bay

PAW Code No. SB 276

PAW location:

Connects Tobago Place to Kingston Way and Read Street.

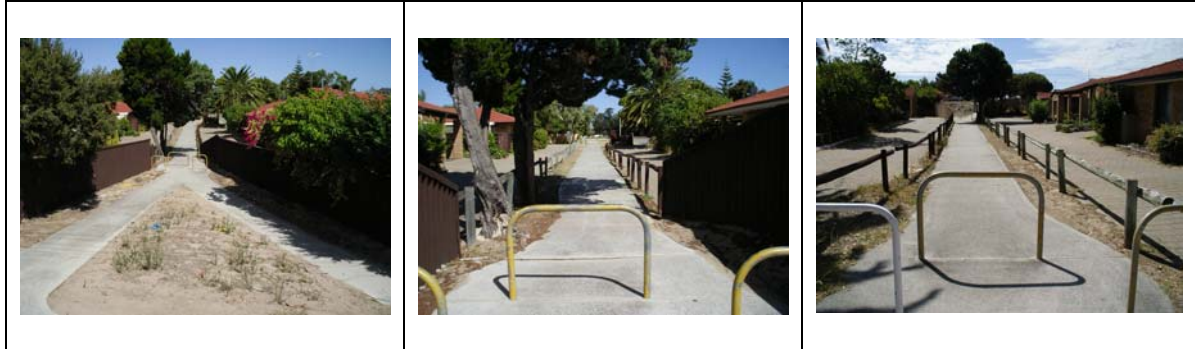
Connects Malibu Road to San Domingo Close.

PAW reserve approx. 4m wide, flaring to approx. 12m wide at northern end. Approx. 60 m long. Straight, long and flat. Bollards at each end. Connects to an underpass beneath Malibu Road.

Old low timber post and rail. Old damaged Super six.

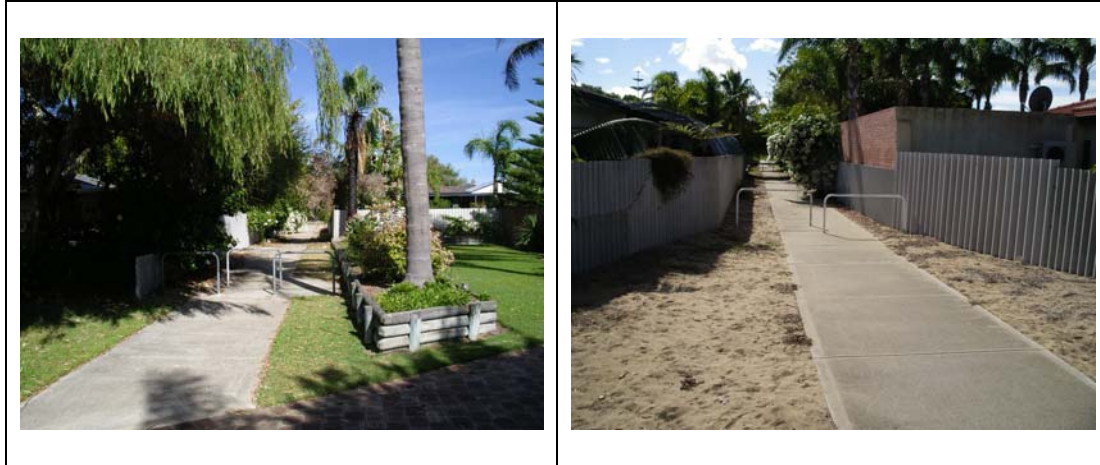
Connects Trade Winds Drive to Montego Close.

PAW reserve approx. 4m wide, flaring to approx. 12m wide at western end. Approx. 60 m long. Straight, long and flat. Steel bollards at both ends.

Super six, brick, low pine log retaining wall, all in fair condition.

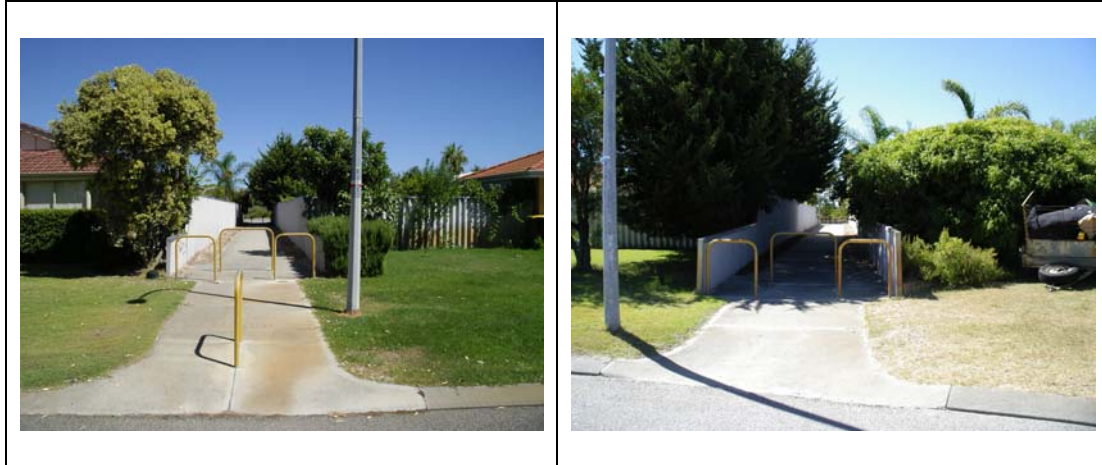
Connects Leeward Close cul-de-sac head to Port Royal Drive.

PAW reserve approx. 3m wide and 49m long. Straight and flat. Bollards at both ends.

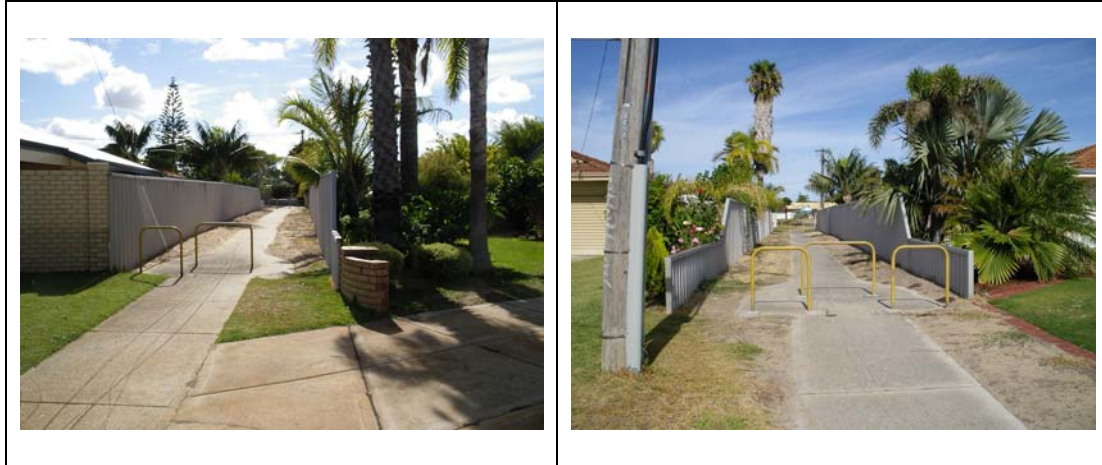
Connects Trade Winds Drive to Portland Place.

PAW reserve approx. 4m wide and 40 m long. Straight and flat. Steel bollards both ends.

High Super six in good condition. One side topped with a single strand of barbed wire.

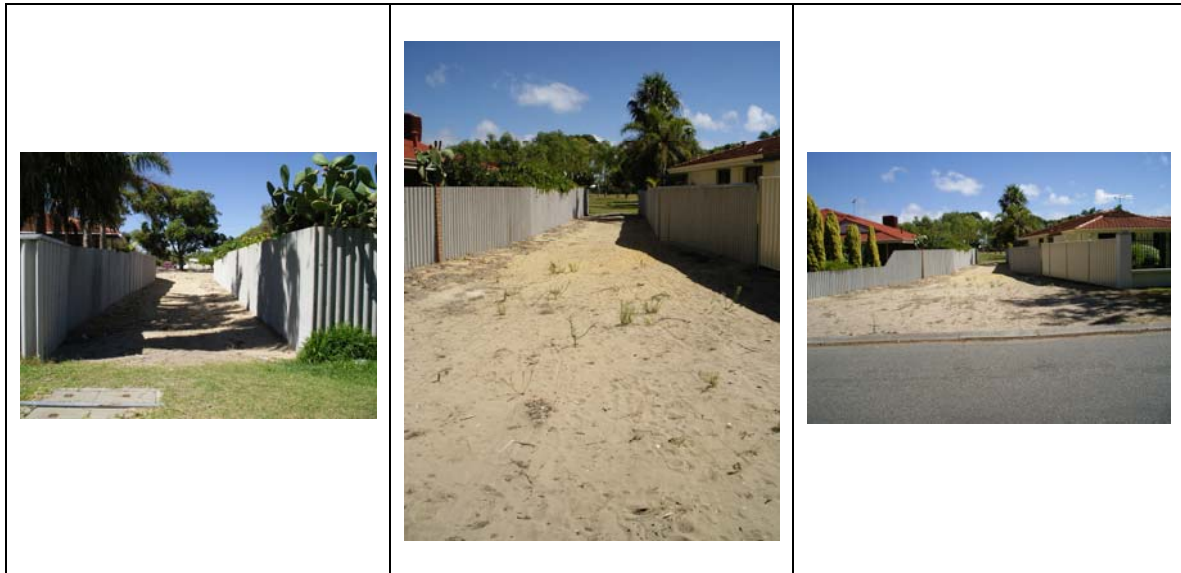
Connects Port Royal Drive to a small park.

PAW reserve approx. 4m wide flaring to 12m wide at its eastern end. Approx. 37m long. Straight, short and flat. Has no constructed pathway.

High Super six in fair to good condition.

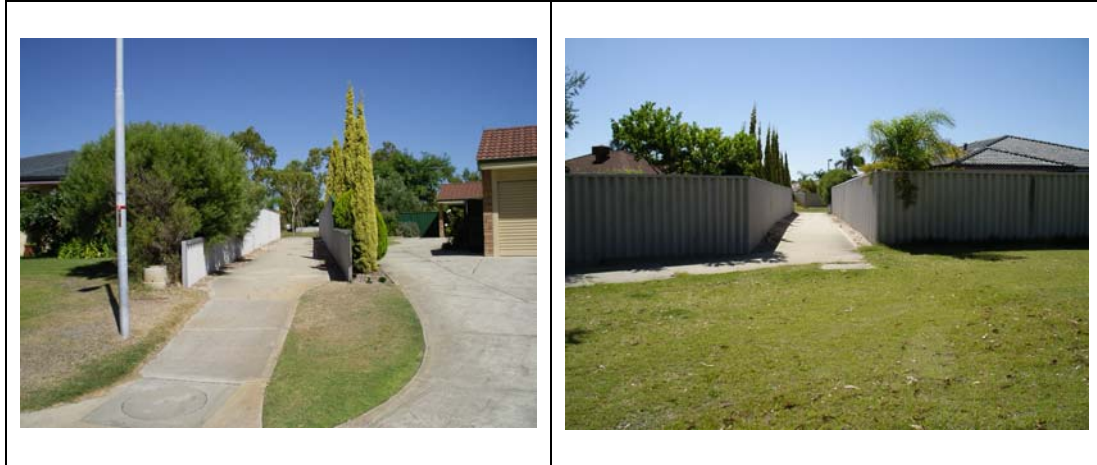
Connects San Jose Court to a park.

PAW reserve approx. 3m wide and 32m long. Straight, short and flat, but slopes down at cul-de-sac end. Bollards at this end have been removed. No bollards at park end.

High Super six in good condition.

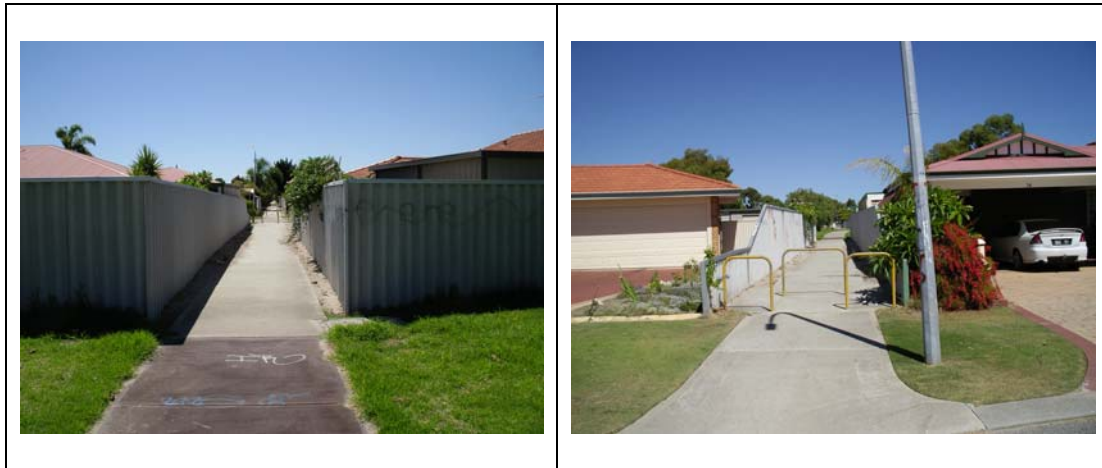
Connects Leeward Close to Panama Reserve.

PAW reserve approx. 3m wide and 34m long. Straight, short and flat. Bollards at north end only.

High Super six in good condition.

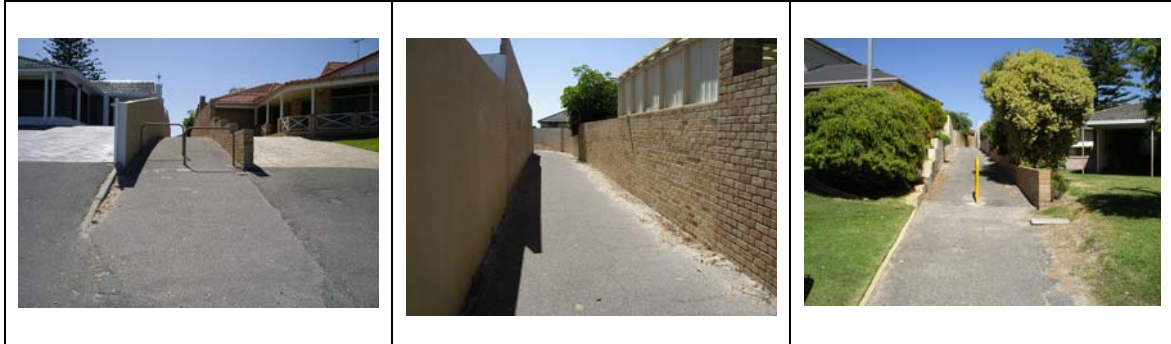
Connects Vista Place to Warnbro Beach Road.

PAW reserve approx. 2.4m wide (i.e., narrow), and approx. 85m long (i.e., long). Rises up from cul-de-sac end, and falls sharply at southern end. Bend in middle. Bollards at both ends.

Asphalt full width in fair condition.

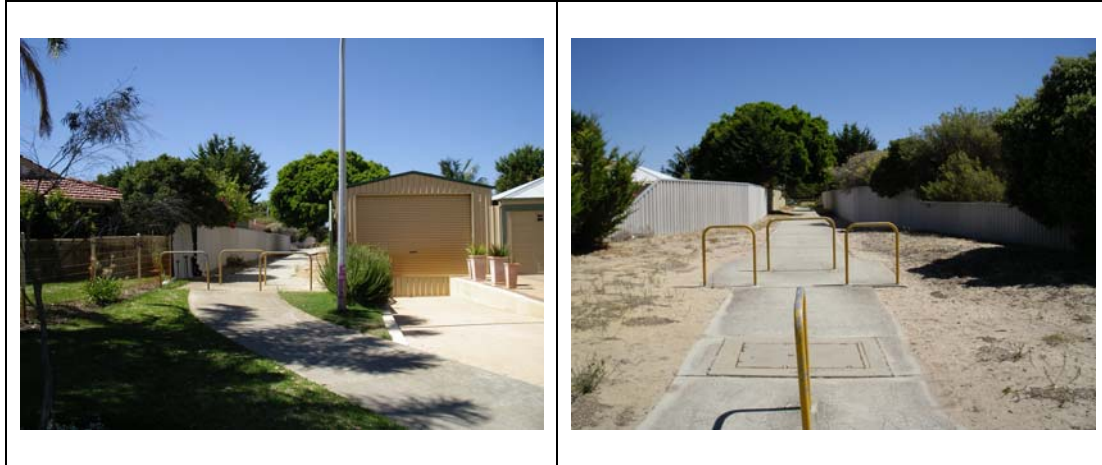
Connects Bolivar Court to Florida Road.

PAW reserve approx. 4.5m wide, flaring to 12.5m wide at the eastern end. Approx. 60m long. Straight, long and flat. Bollards at both ends.

High Super six and steel panels in generally good condition, although one panel broken.

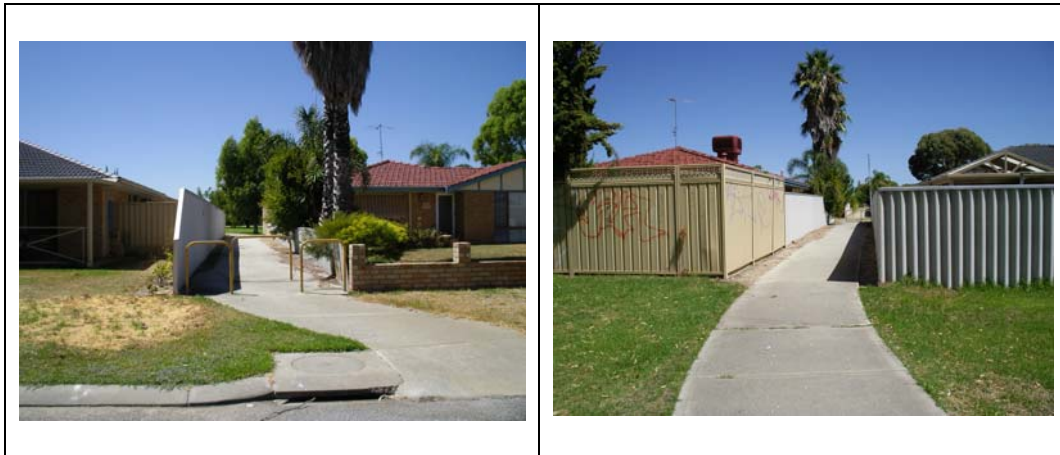
Connects Caballo Court to a small park.

PAW reserve approx. 3m wide and 32m long. Straight, short and flat. Bollards at west end only.

High Super Six in good condition. High steel panels covered in graffiti.

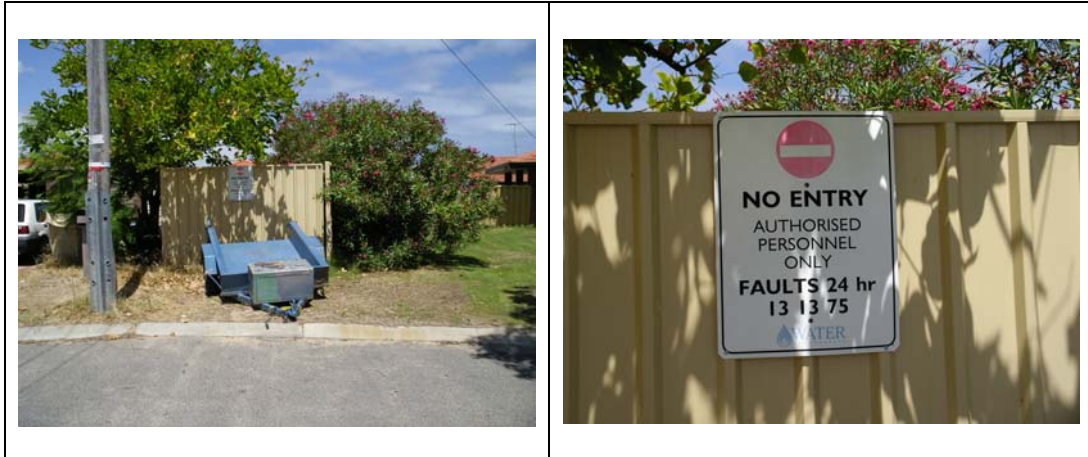
Connects Cederdale Way to a Water Corp accessway.

PAW reserve approx. 3m wide and 19m long. Straight and flat. Overgrown with weeds. High side fences and gated.

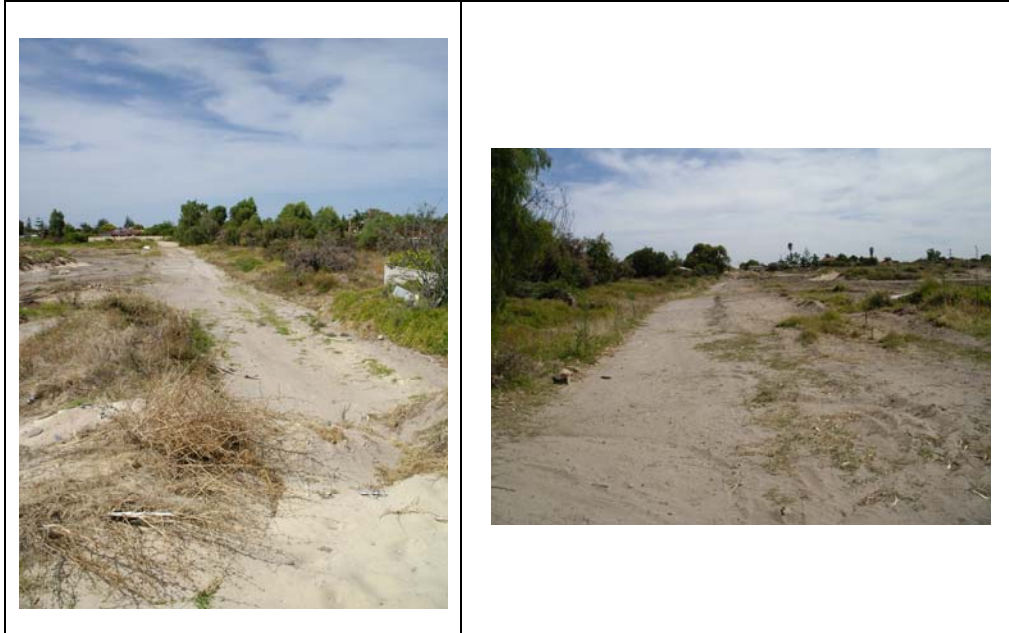
Connects ends of Shaw Street and Leeder Street.

PAW reserve approx. 3.2m wide and approx. 120m long. Currently occupied by a rough dirt track. Impassable by a vehicle at the northern end. Land on either side is vacant. Large lot on east side being used partly as an illegal rubbish dump.

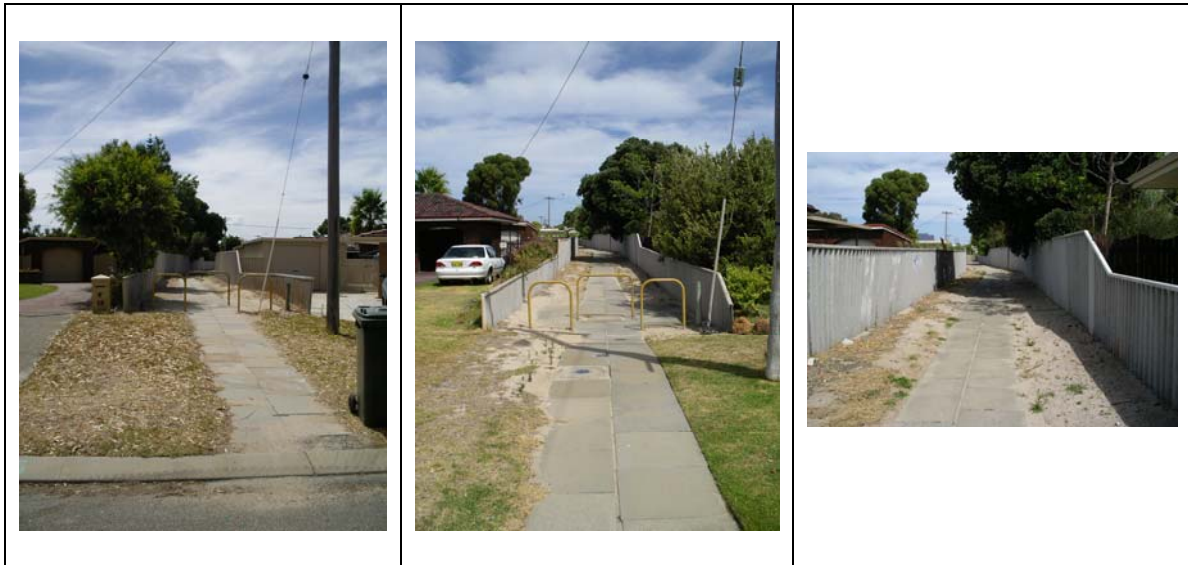
Connects Radford Place to Waimea Road.

PAW reserve approx. 4m wide and 65m long, with dog leg bend about 2/5^{ths} way along. Terrain is relatively flat. Bollards at each end.

Fair. Broken glass, some broken pavement & graffiti.

Super Six in fair to good condition.

Old concrete slabs 2 x wide. Some broken. Sand margins.

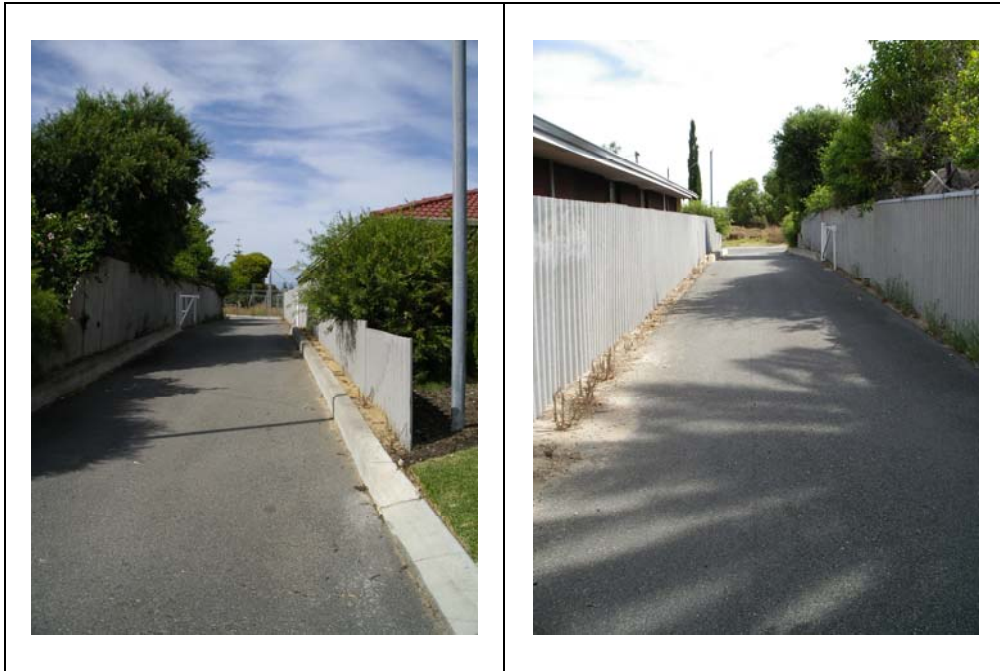
Connects Leeder Street to a fenced compound accommodating a Western Power utility facility.

PAW reserve approx. 4.3m wide and 36m long. Straight and flat with high locked gates at southern end, and lockable swing gate approx. half-way along its length.

High Super Six in good condition.

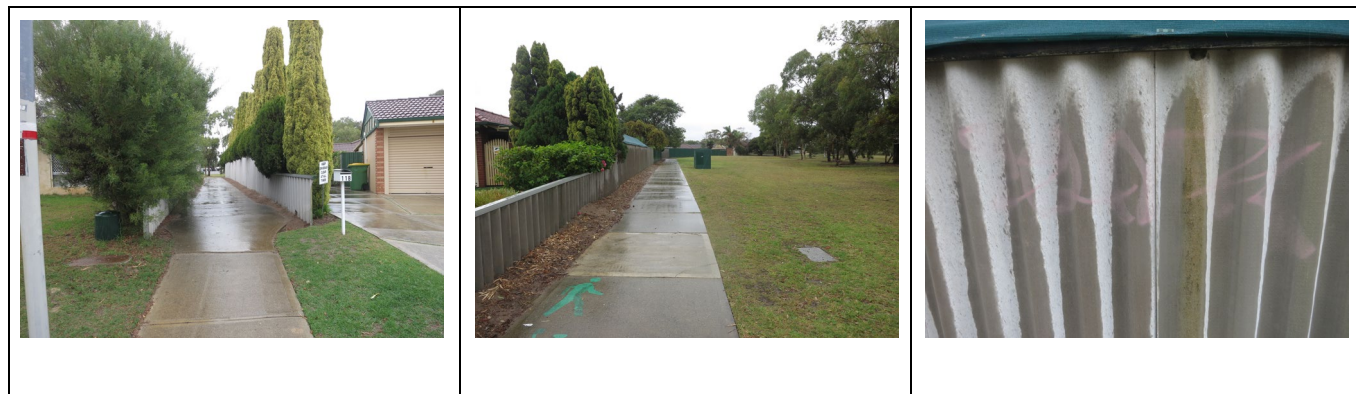
Connects Georgetown Drive in the south to PAW SB295 and San Jose Court beyond. PAW is adjacent to a neighbourhood park on the southern side.

PAW is 63m long and 3m wide. PAW is straight and flat.

Concrete pathway. Good condition, no cracks.

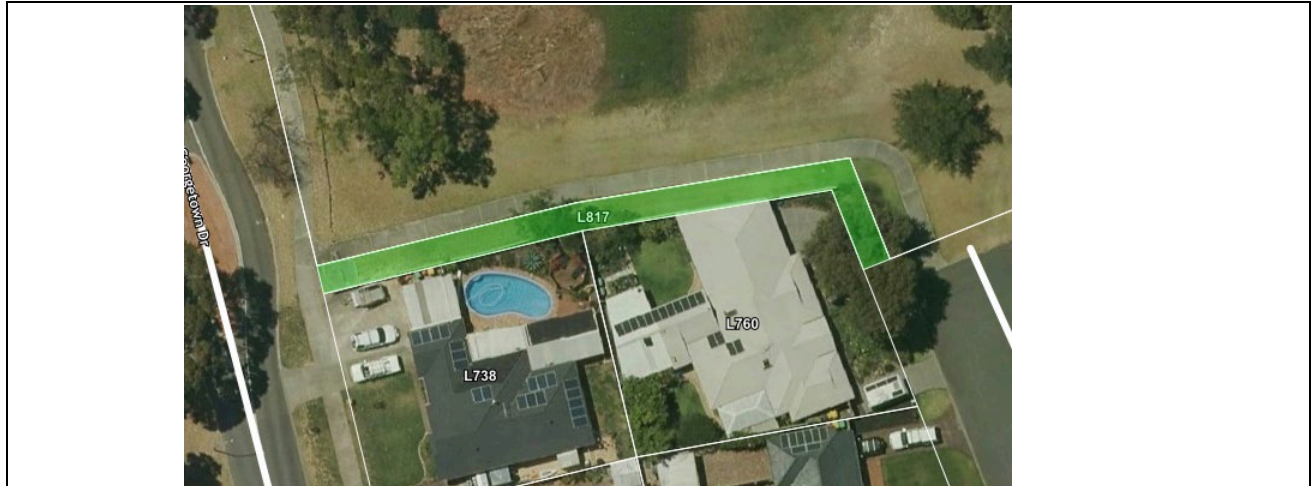
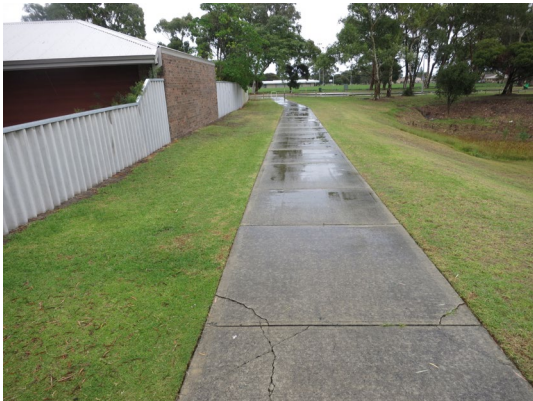
PAW is located on the left of the path pictured.

Good condition. No evidence of graffiti, sand, glass or rubbish. Grass path is well maintained.

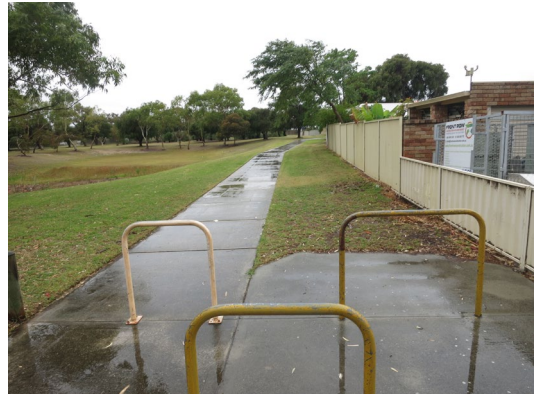
PAW is located on the right of the path pictured.
