# Day Cottage, East Rockingham

## Conservation Management Plan (2<sup>nd</sup> Ed)

June 2024 | 21-559

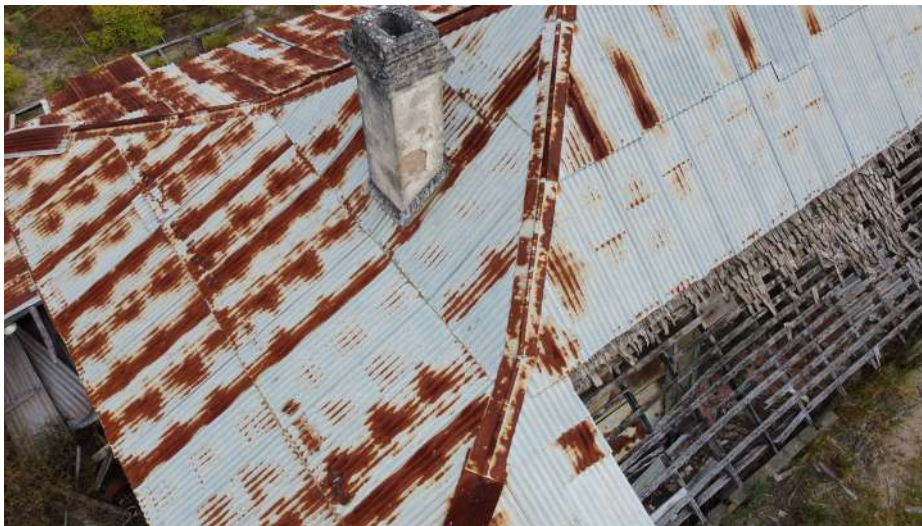
Figure 27. Aerial view from the south-east corner of *Day Cottage* noting corrugated sheet finish over timber shingles and stone chimney (element, 2021)

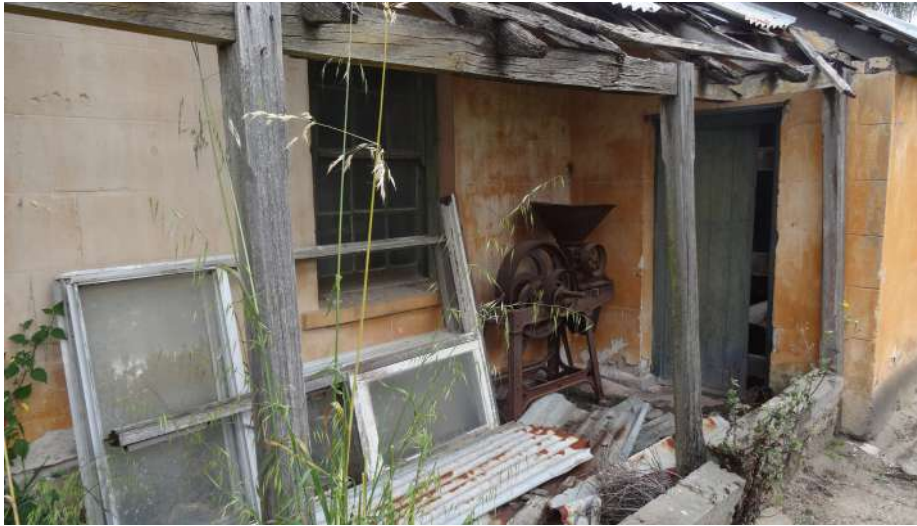
Figure 30. Front verandah noting low height stone wall, ashlar lining, double hung sash window to front facade and timber door to north eastern room (element, 2021)

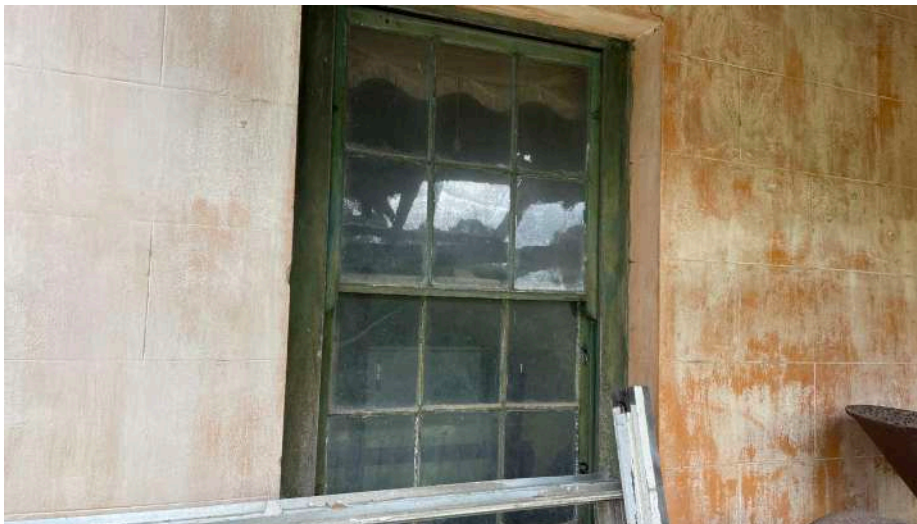
Figure 31. Detail of double hung sash window to front facade and ashlar lining finish with visible orange pigment (element, 2021)

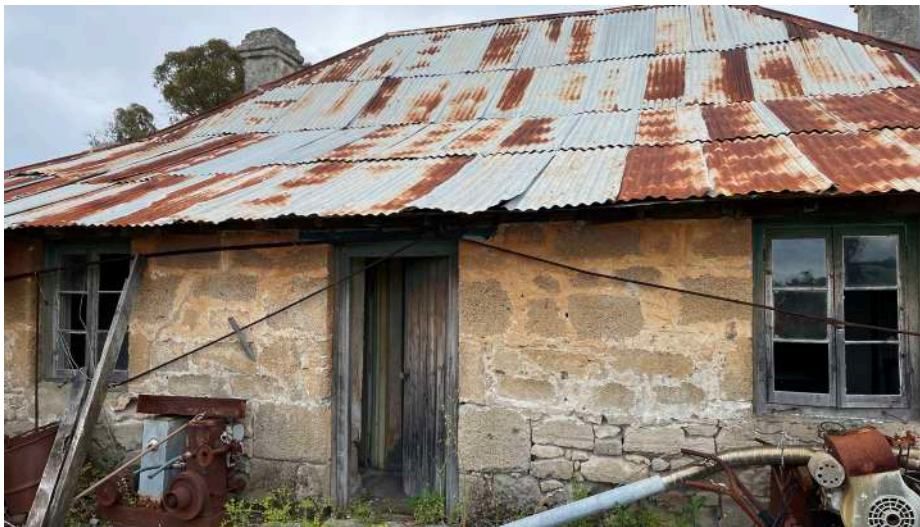
Figure 35. Rear facade (west facing) noting symmetry of window openings and chimneys in keeping with the front facade. External walls are uncoursed rubble stonework with no render or lining finish (element, 2021)

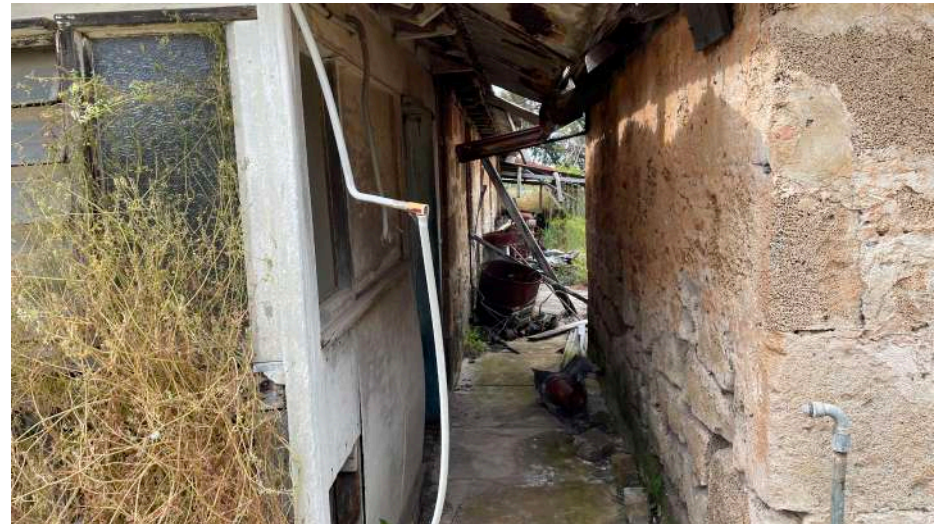
Figure 37. Access space between the rear of the cottage and detached kitchen building. A cement paved footpath has been added between the structures (element, 2021)

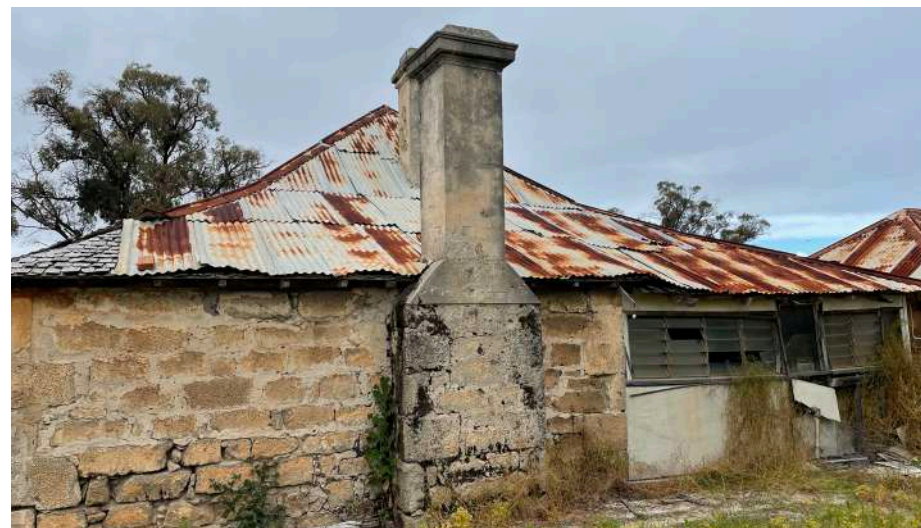
Figure 40. View to north facing facade noting external stone chimney structure and infill walls with glazed louvres to the north-west corner of the cottage (element, 2021)

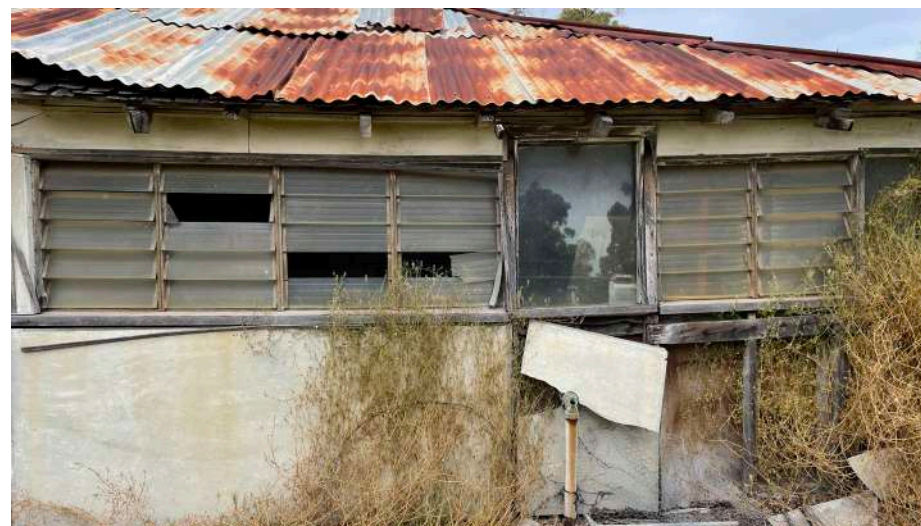
Figure 41. Infill walling to the north-west corner of the cottage noting extent of glazing to the upper half of the external walls (element, 2021)

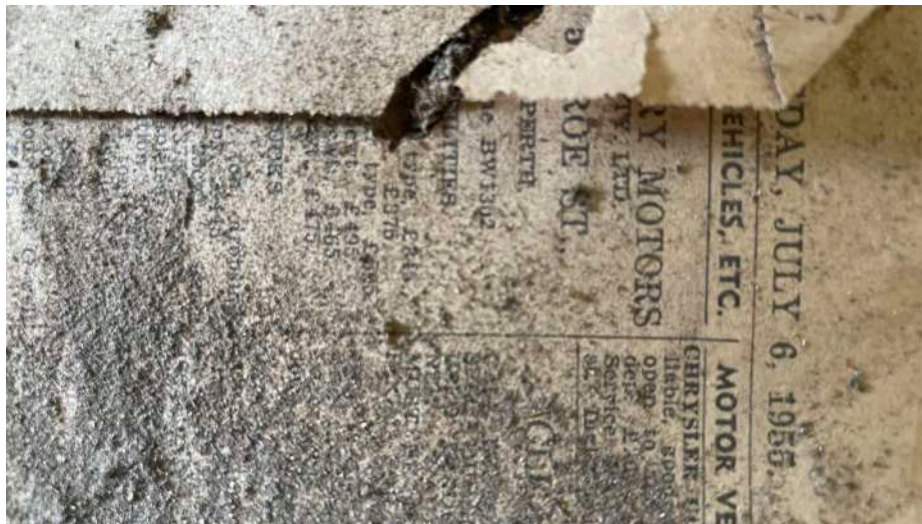
Figure 51. Newspaper lining below linoleum floor finish in Room 7 indicating rough date of installation (1955) (element, 2021)

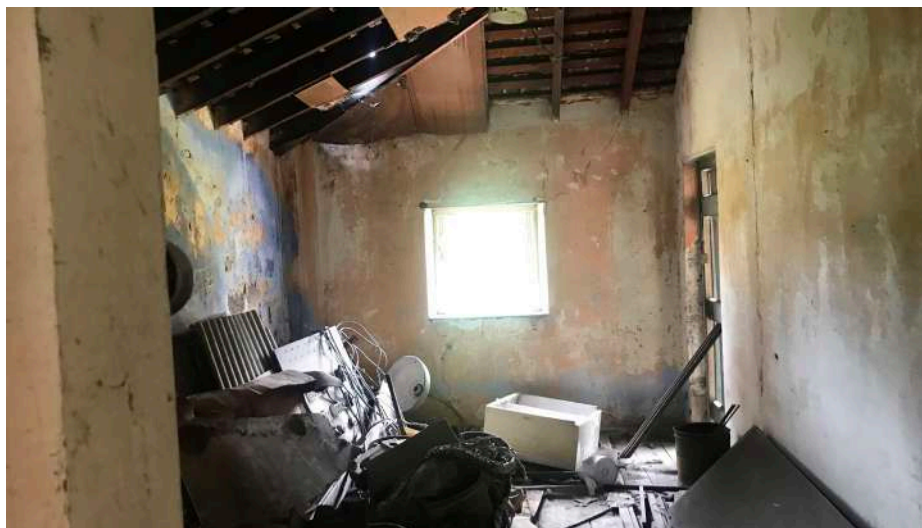
Figure 54. Room 3 looking east. Later ceiling linings have been nailed to the underside of rafters | (element, 2021)

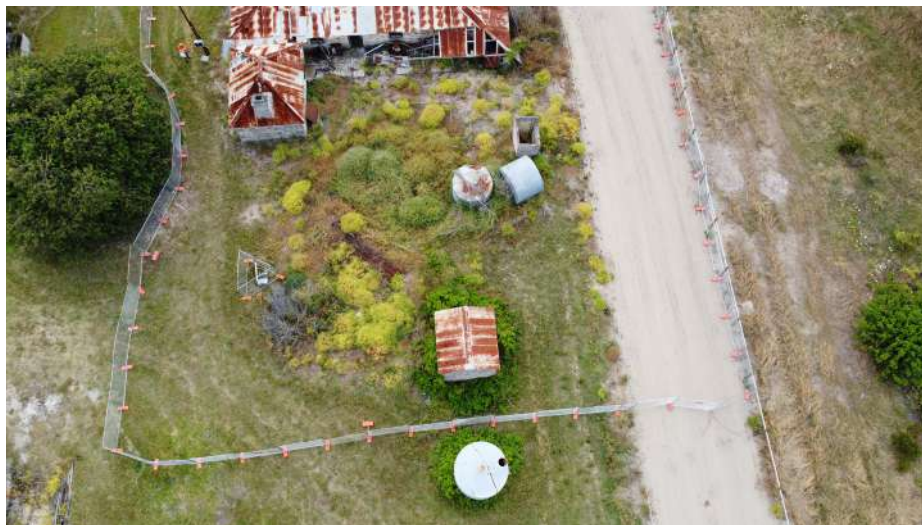
A short distance southwest of the cottage is a toilet outhouse, constructed of masonry. The walls are made of pressed shale blend bricks, rendered with a cement based mortar. The roof of this structure is no longer extant and the walls are open to the elements. Further back in the site is the laundry outhouse, of a more substantial size, and constructed of limestone with a pitched corrugated iron roof. Limestone employed for the walls of this building is the same as that used for the cottage but has not been painted or rendered. Significant vegetation growth surrounds this structure including a creeper vine which has grown up to the underside of the roof sheeting. An opening remains extant to the north wall, but it is unclear due to vegetation growth if the door itself remains. A small window can also be seen to the centre of the south wall, but this is again covered by significant growth making details difficult to ascertain. Internal access to this structure was not possible at the time of inspection.

Figure 66. Aerial view of outbuildings noting roofless toilet building closest to main cottage, water tanks behind, and larger outbuilding towards the rear of the lot (element, 2021)

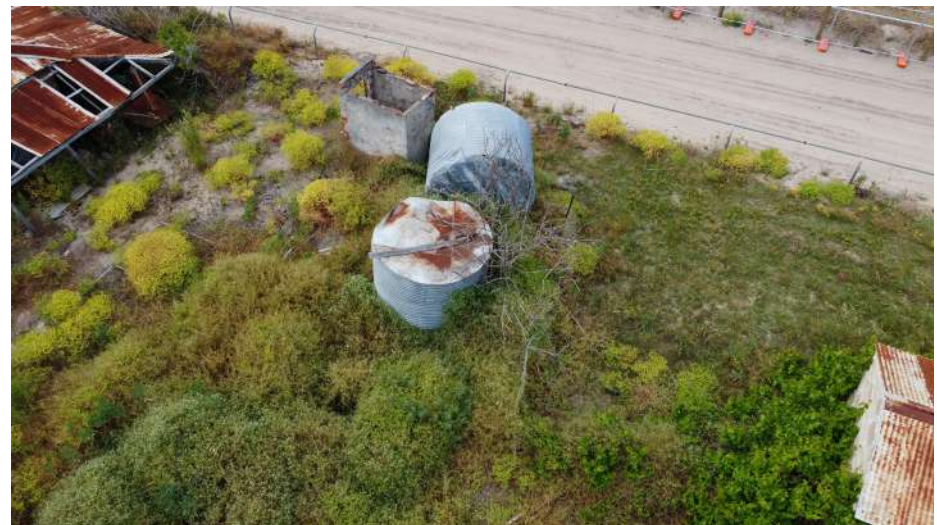
Previous assessment noted a tall timber tankstand, and a patent steel framed windmill also existing within the rear area of the lot. Remnants of these structures are present within the overgrown shrubs. They are believed to have collapsed at some point since the 1999 report was prepared. Two round corrugated water tanks remain, one of which is lying on its side likely due to the collapse of the tankstand.

Figure 68. Aerial view over toilet structure and water tanks (element, 2021)

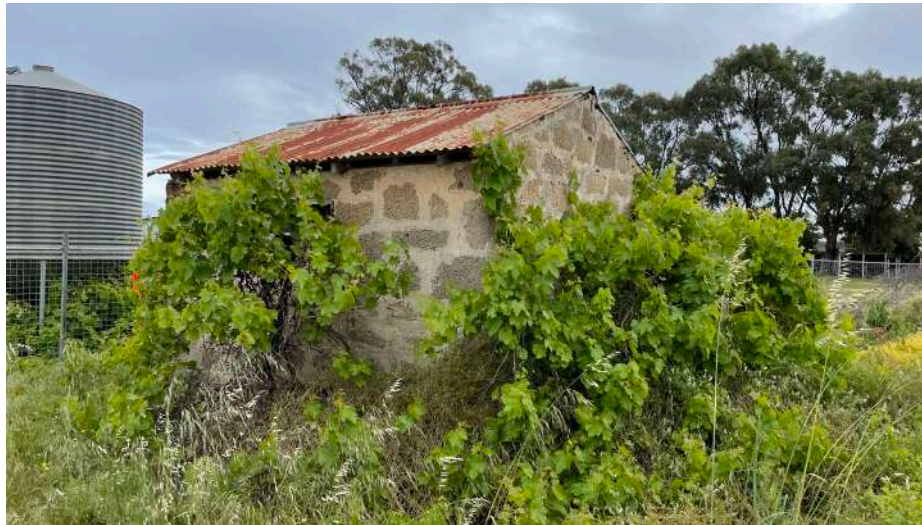
Figure 73. View of laundry looking north-west. Window opening to the southern face can just be seen through the creeper overgrowth (element, 2021)

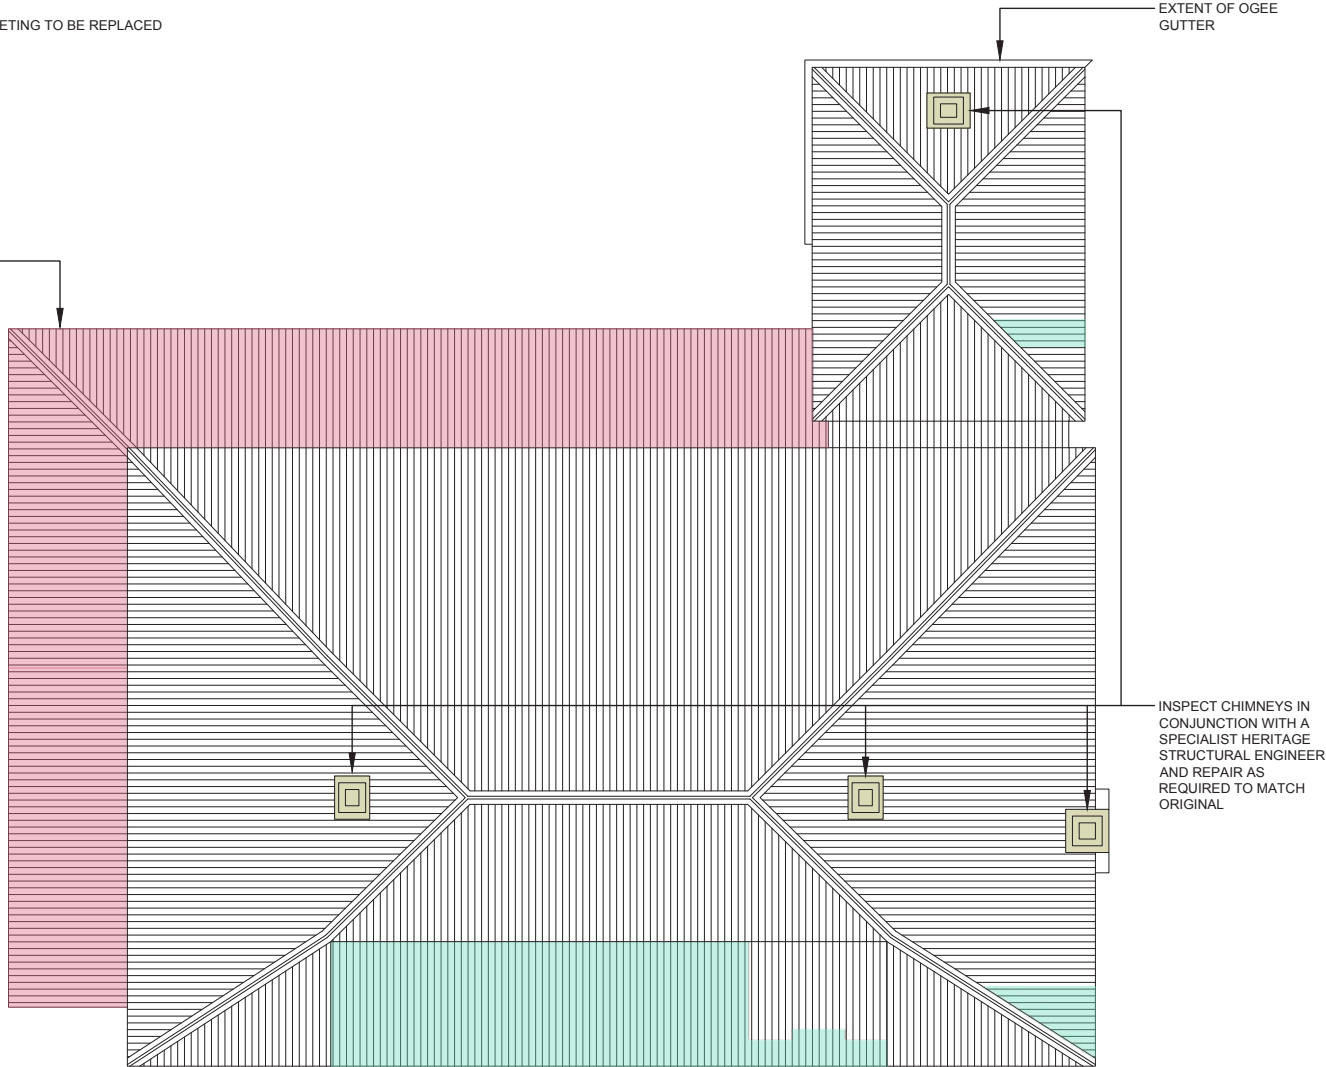
ROOF PLAN  
NOT TO SCALE

- LOCATIONS OF MISSING ROOF SHEETING  
(PRIORITY: 1)
- EXTENT OF DILAPIDATED / COLLAPSED VERANDAH DESIRABLE TO BE RECONSTRUCTED  
(PRIORITY: 5)
- CHIMNEYS TO BE REPAIRED (PRIORITY: 2)
- CORRODED ROOF SHEETING TO BE REPLACED  
(PRIORITY: 1)

LOOK TO RECONSTRUCT VERANDAH BASED ON ARCHIVAL EVIDENCE
