# Point Peron “K” Battery Conservation Management Plan

South West Corridor Development Foundation Inc.

**HOCKING**  
HERITAGE STUDIO

March 2016

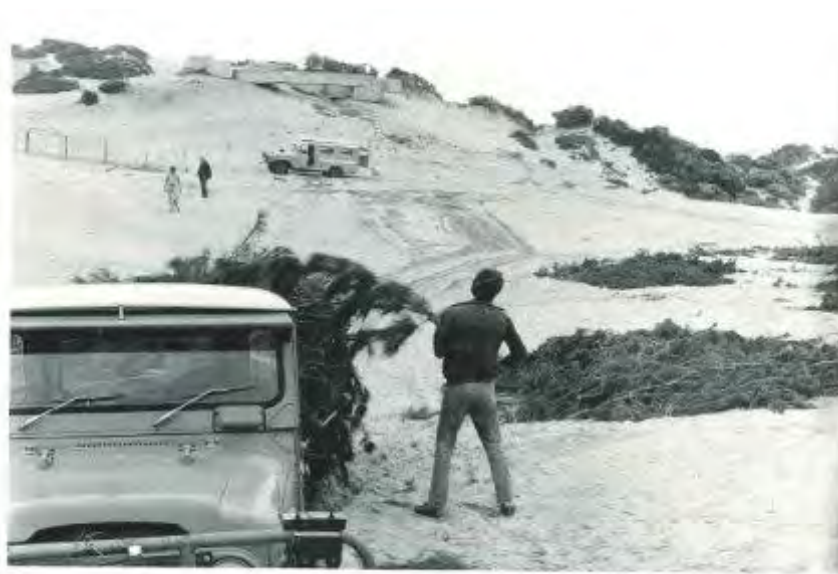
**Figure 42:** Conservation programs at Point Peron, c1980.  
Courtesy Tony Solin

The above image at Figure 42 shows how denuded the landscape was below the gun emplacement and is likely to have contributed to the destabilisation of the structure.

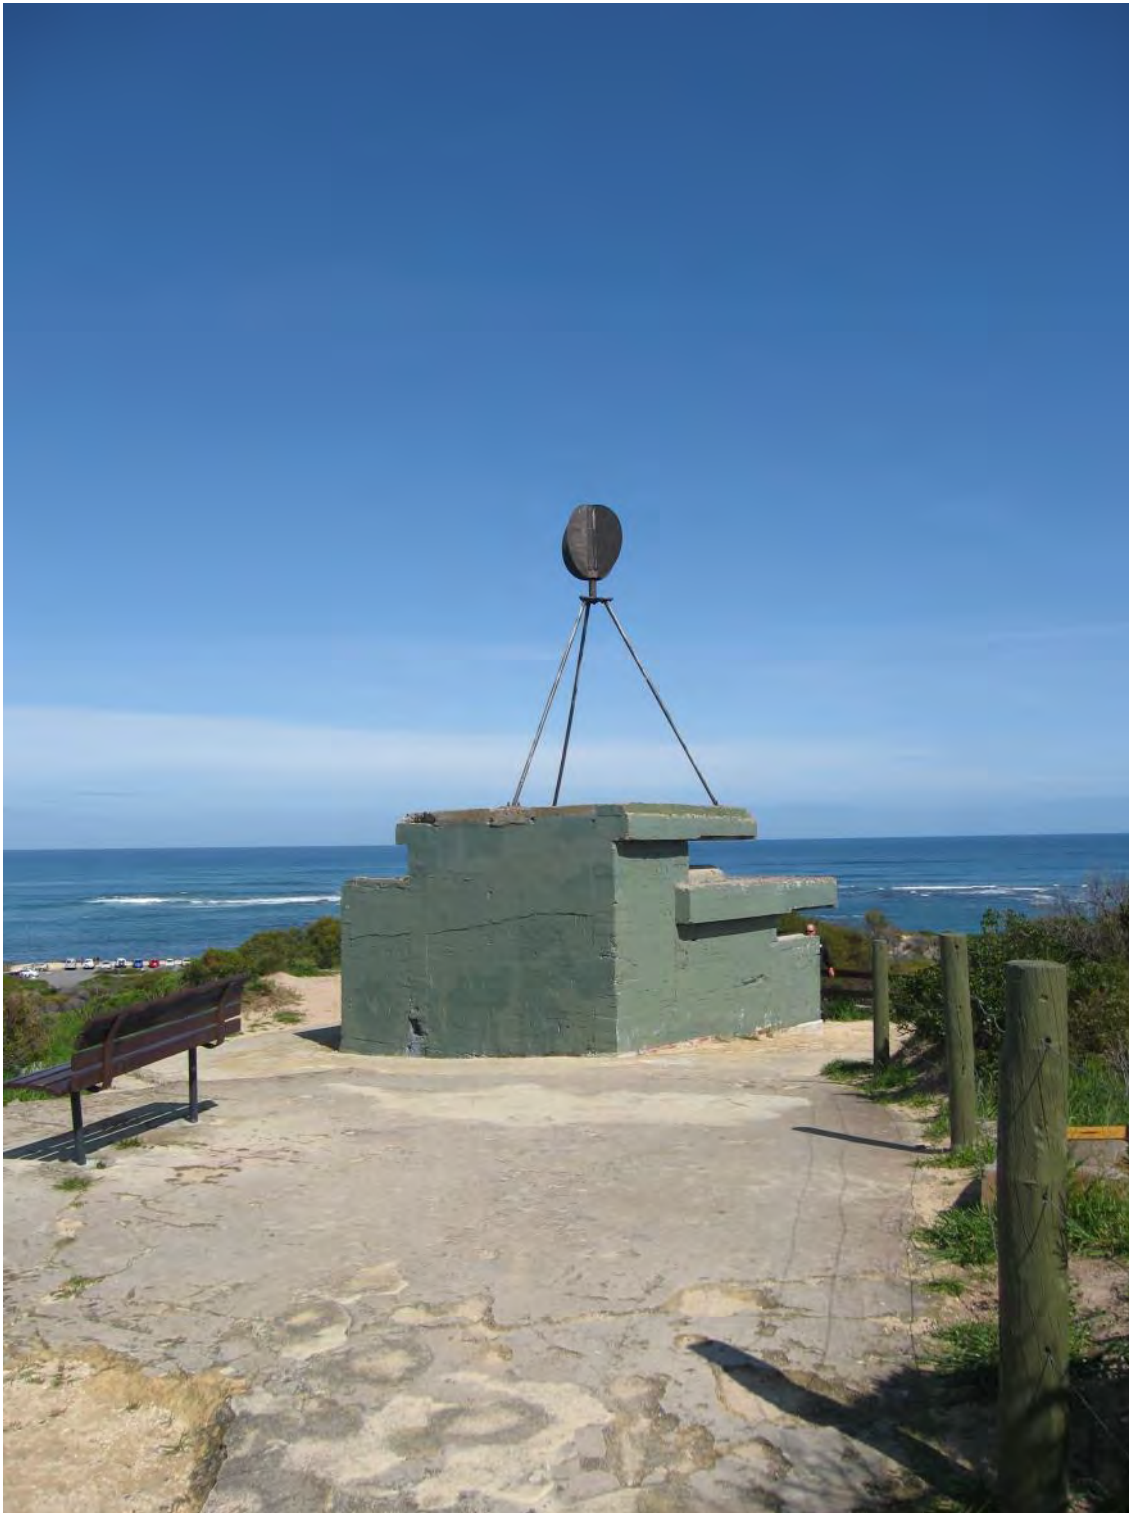
**Figure 53:** Observation Post - East and North Elevations

When approaching the observation tower from the steps you are faced with the blank wall of the east elevation. The elevation has been painted green in an attempt to reduce the impact of graffiti which has served to obscure the differentiation between the construction materials. The two concrete columns supporting the roof structure are visible on closer inspection but the clear distinction between the materials has been lost. The upper section of this wall also contains remnant render which is not visible on any of the other elevations. The brickwork laid in English Garden Bond is visible under the paint finish.

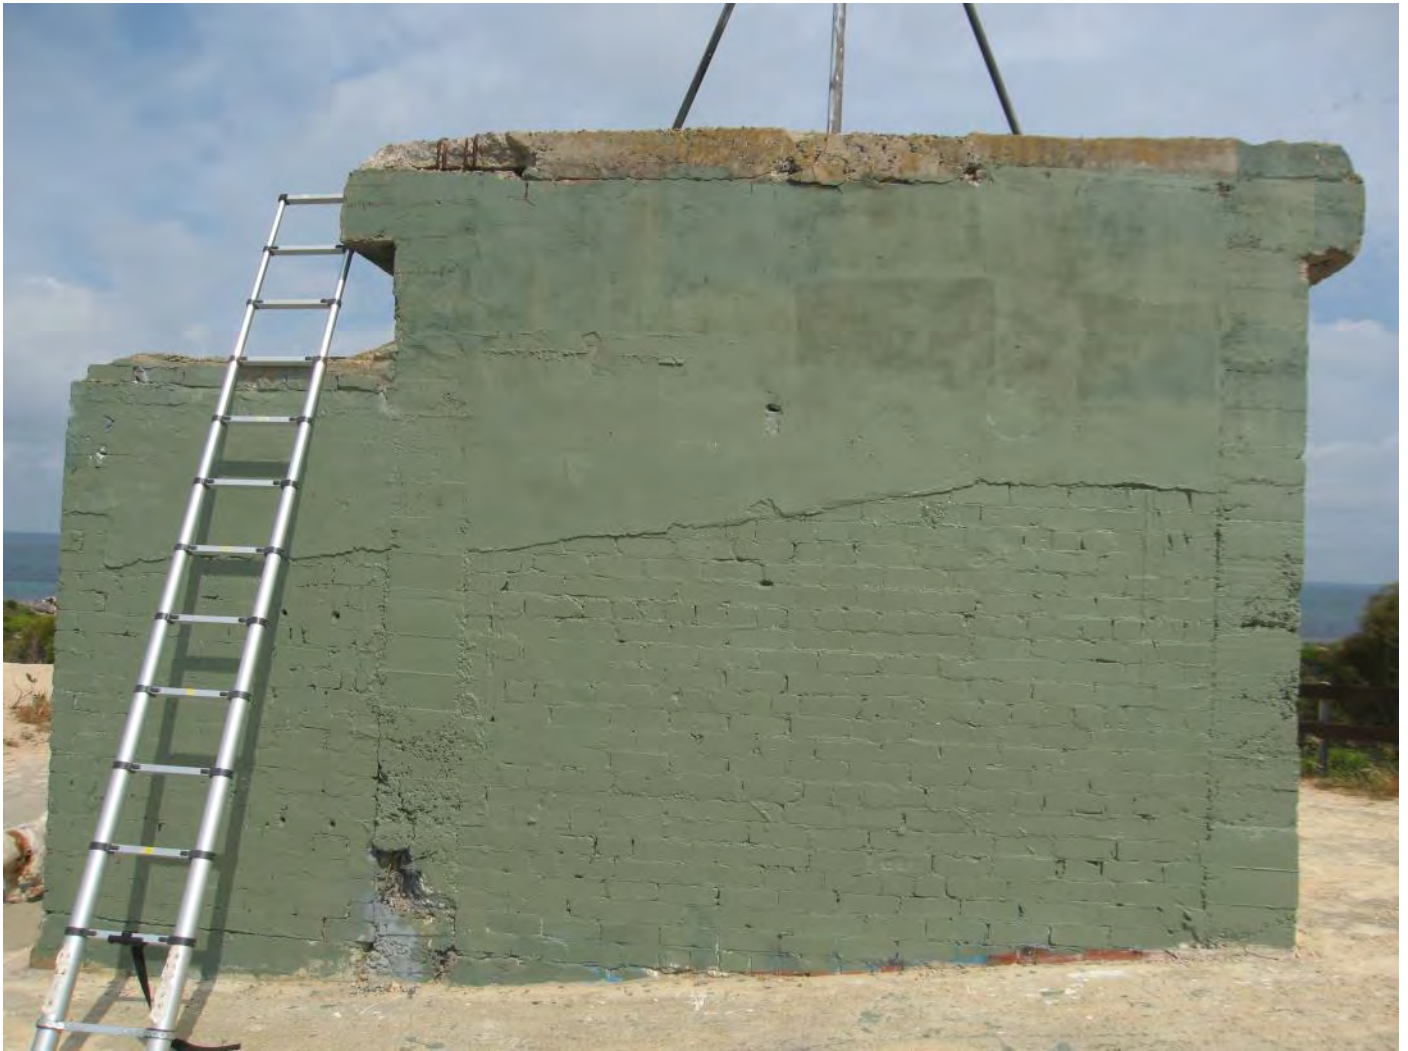
**Figure 54:**      **Observation Post - East Elevation**

The east elevation is the rear of the structure and presents with no activation. The elevation is stepped in terms of roof height with the lower section corresponding to the ground floor area of the structure and the higher level being the stairs to the upper section. The upper section of the east elevation has been rendered at an earlier stage, with the brick and mortar below this level being in variable condition. The reinforced concrete framework is also showing signs of deterioration.

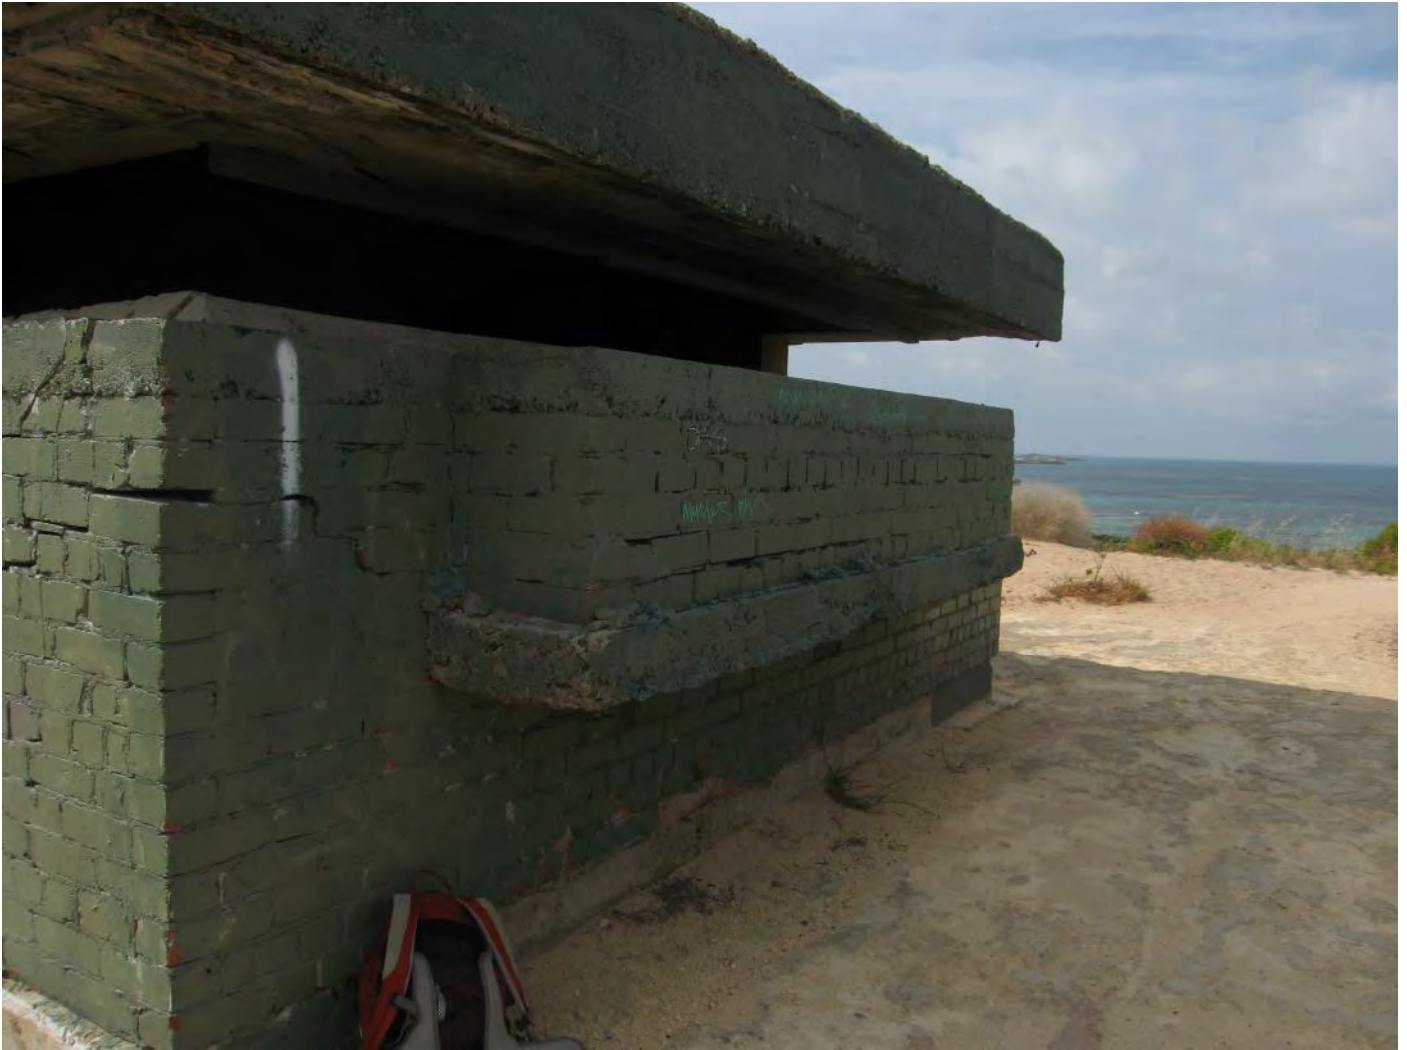
**Figure 60:**      **West Elevation - Observation Opening**

The west elevation is the principal façade of the structure with clear observations over the coast line. The observation opening, embrasure, extends across the full width of the elevation before returning along the north and south walls. Immediately below the opening on the west elevation is a projecting storage area of brick and concrete construction which is in poor condition.

Research has shown that in similar structures, the ground level often came up to the bottom of these projection or slightly above providing support. Over time the ground level has eroded or has been manually removed to provide a flat walking surface around the structure which has removed all support for the projecting element. As a consequence, the weight of the projecting storage area is pulling the wall away from the rest of the structure which is evident in the cracking seen along the brick joints.

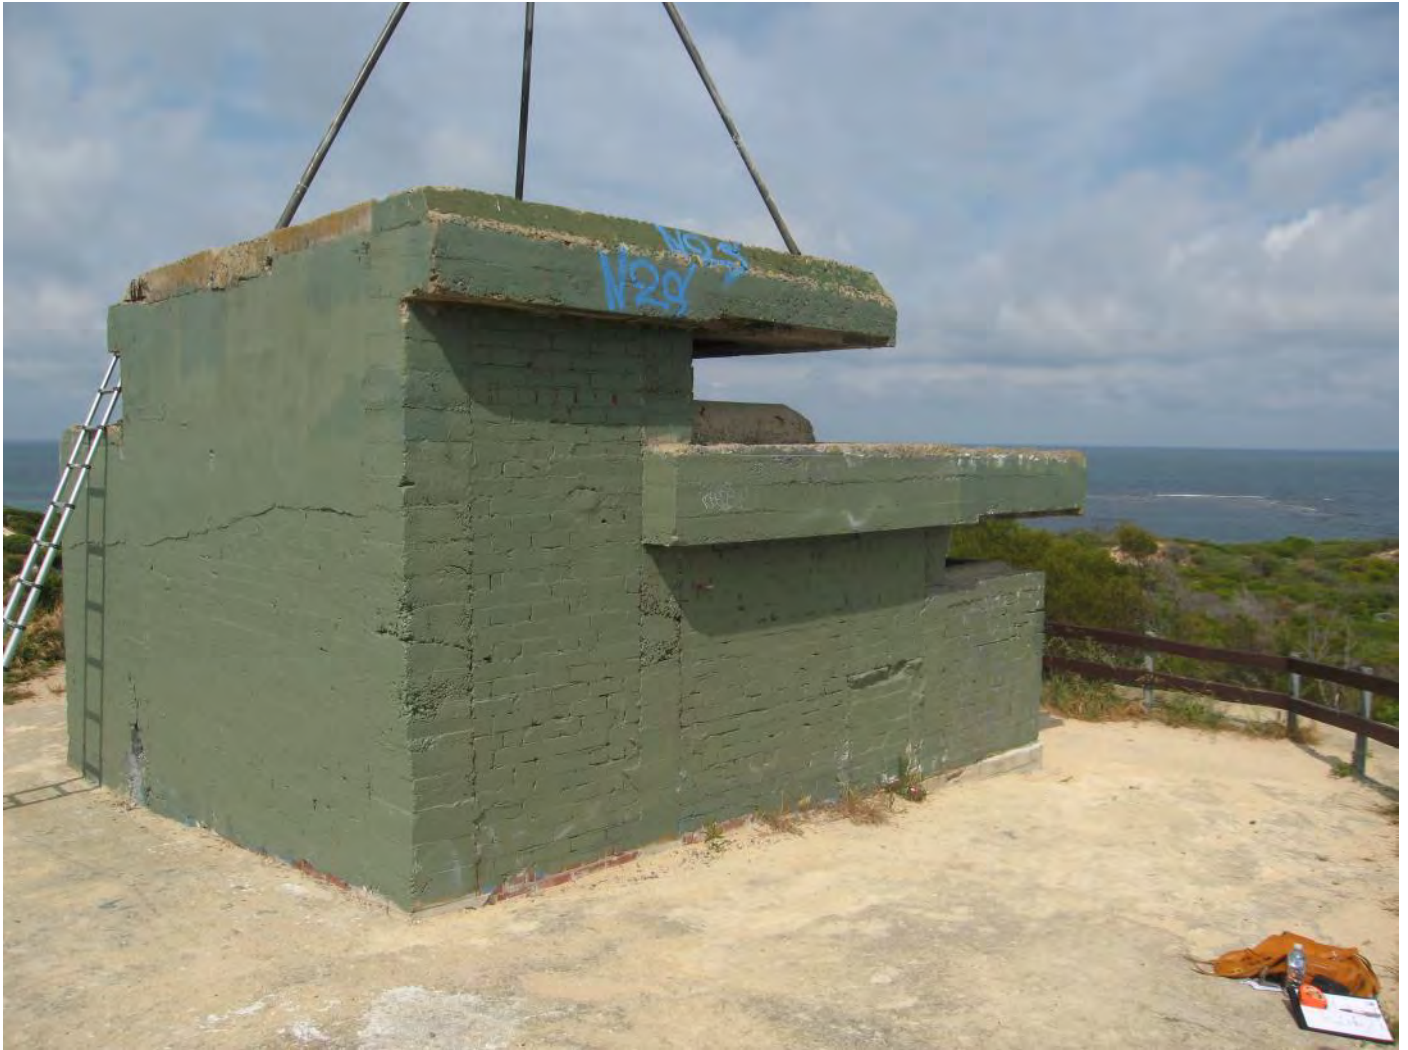
**Figure 62:**      **North Elevation**

The north elevation is similar to the south elevation in terms of construction and presentation albeit with no entrance door. Again the concrete framework is visible with brick infill panels. A low level section towards the western end of the elevation has also been in filled. As the structures were decommissioned all the military equipment and installations were removed resulting in brick infill.

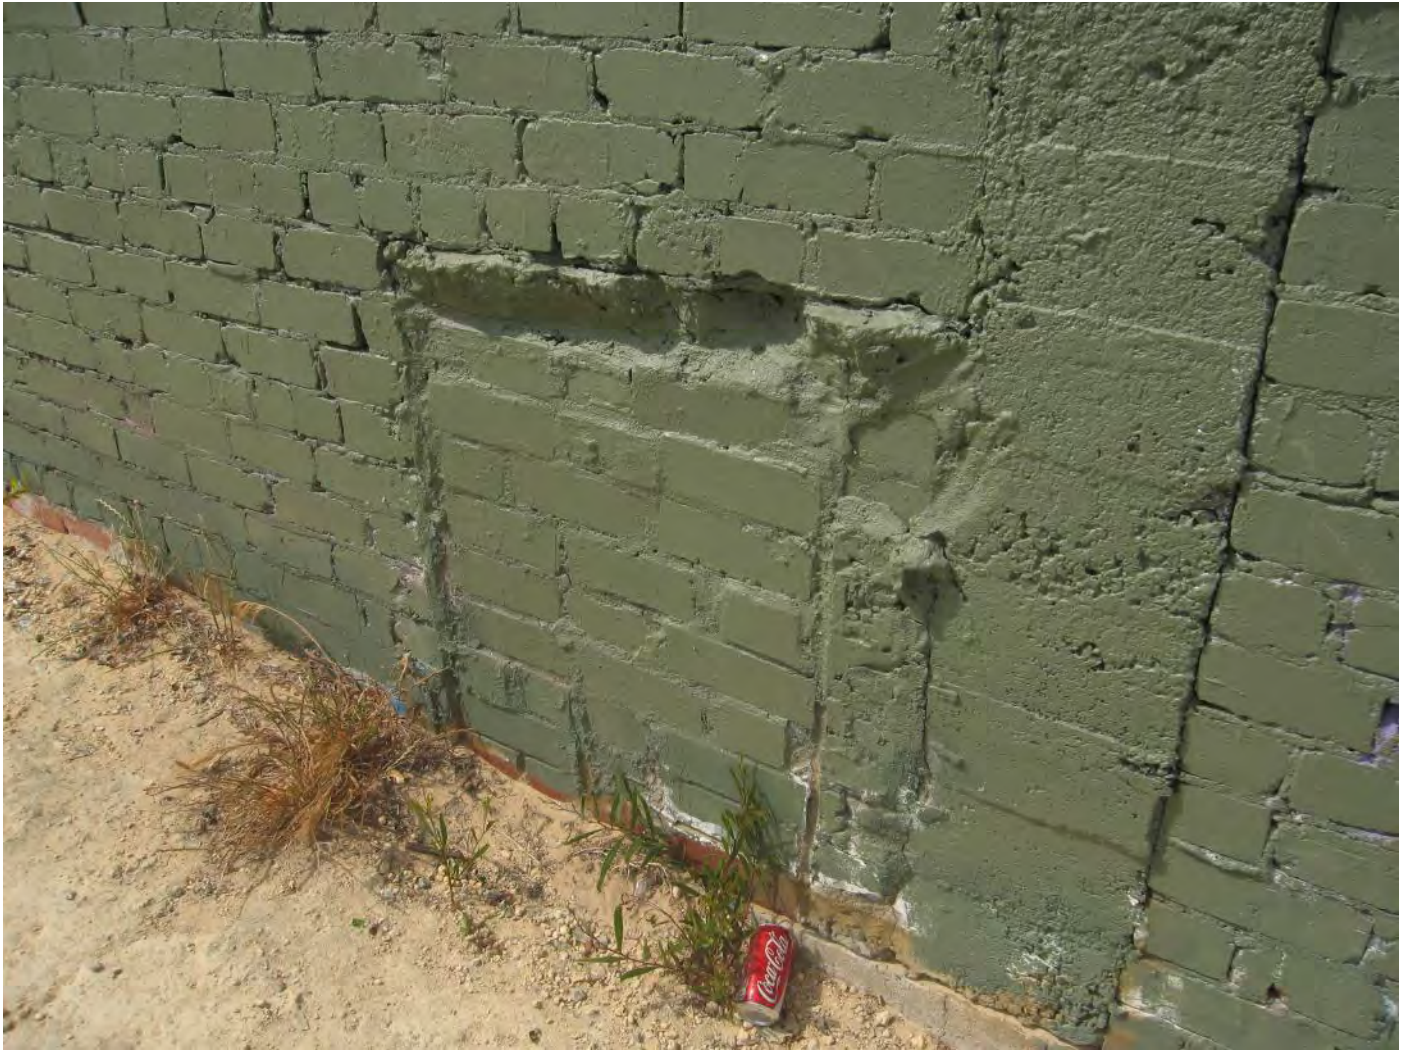
**Figure 64:** North Elevation – brick infill panel

The construction method of the structure is very basic, possibly reflective of the required haste in erecting these buildings. The basic form of the building comprises the reinforced concrete framework with the brick infill panels. The weakness being that the brick sections are not keyed into the concrete frame. Concrete slab top layers to the brick walls around the embrasure opening provide some structural strength but as the image above demonstrates, the weight of the projecting storage section to the west elevation is pulling the brickwork away and has caused cracking in the concrete top layer around the opening.

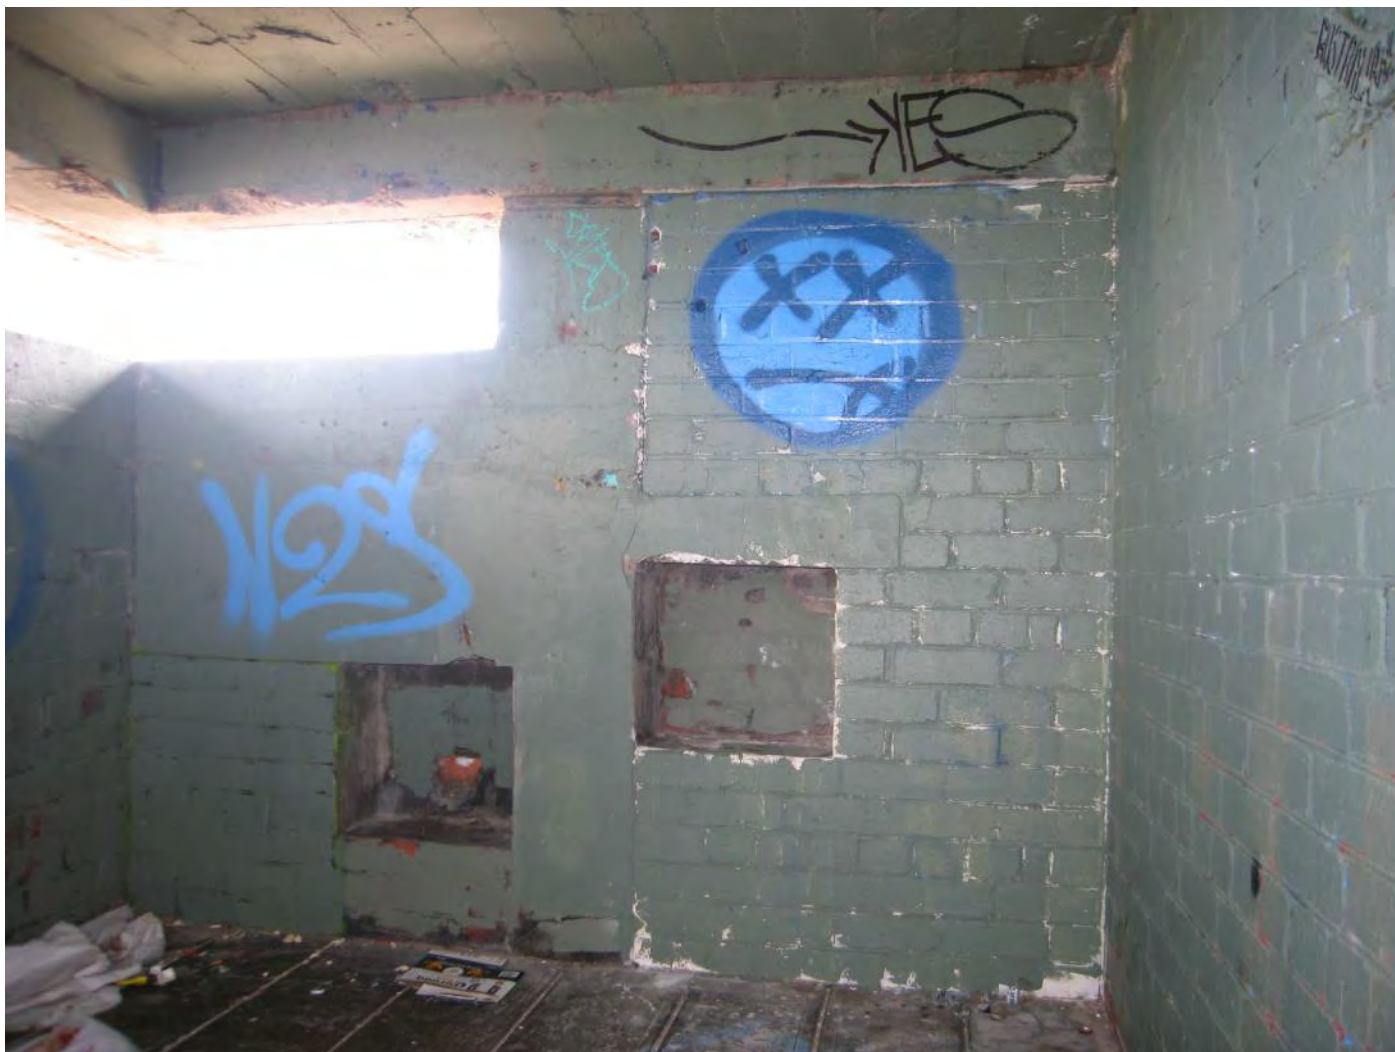
**Figure 73:** Storage areas incorporated into the north wall of the upper level

Small storage areas have been constructed into the north wall.

The entire space is full of debris and has been subjected to graffiti.

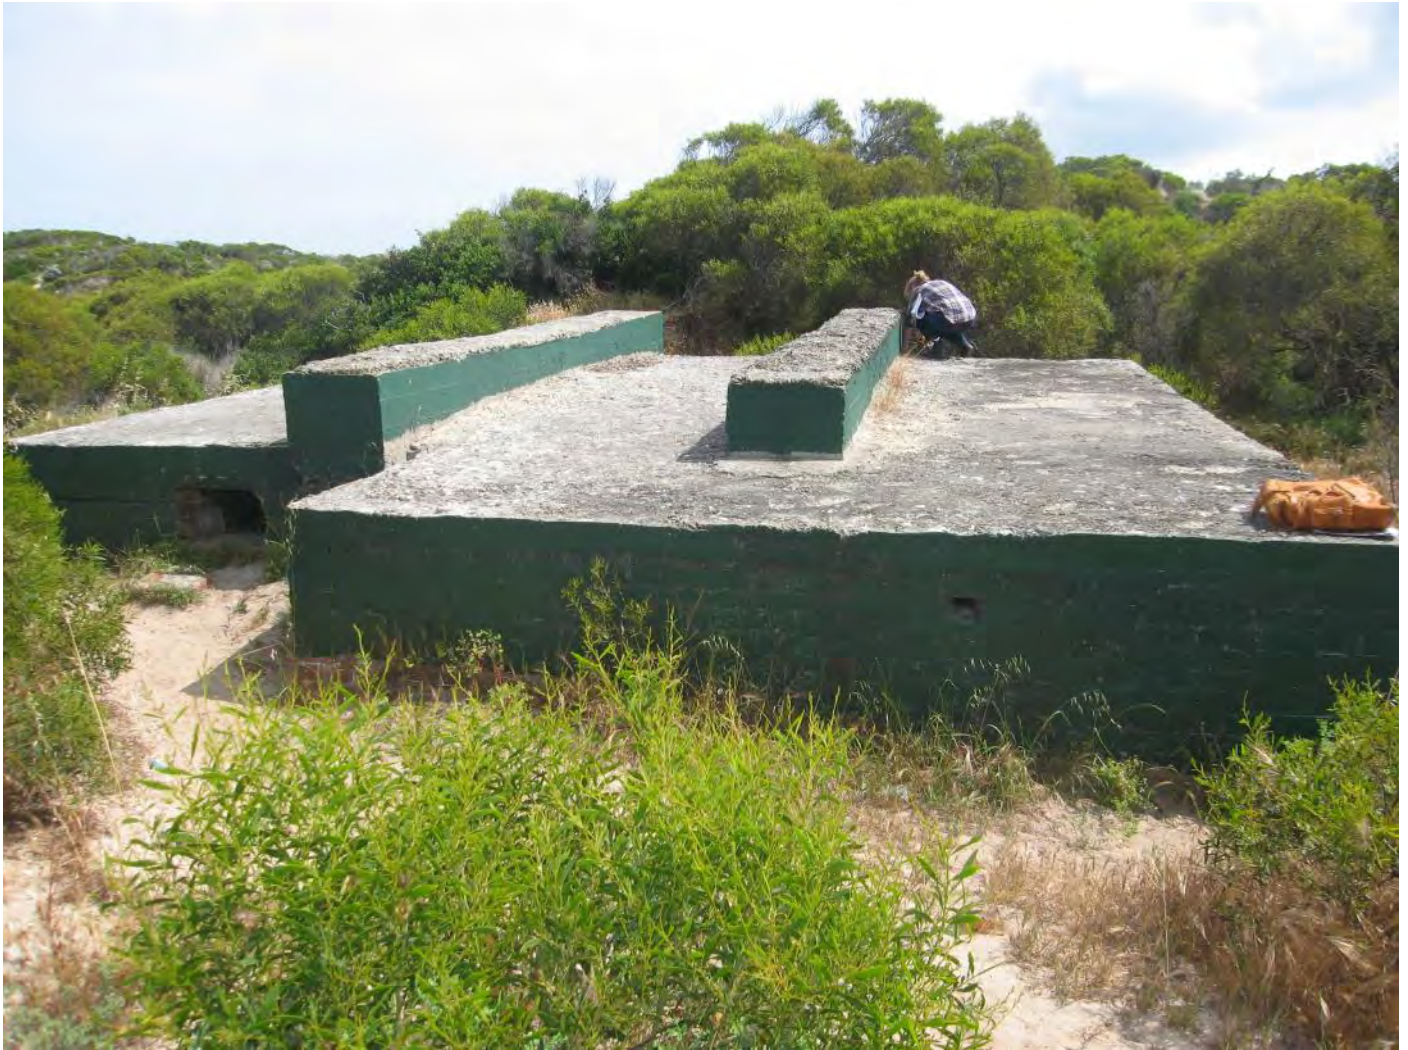
**Figure 79: Operations Bunker – Roof plan**

The layered blocks of the concrete are visible in the reinforced beams, each being three slabs high with a roughcast concrete top layer. Sand accumulation around the base of the beams is allowing for grass growth along the beams.

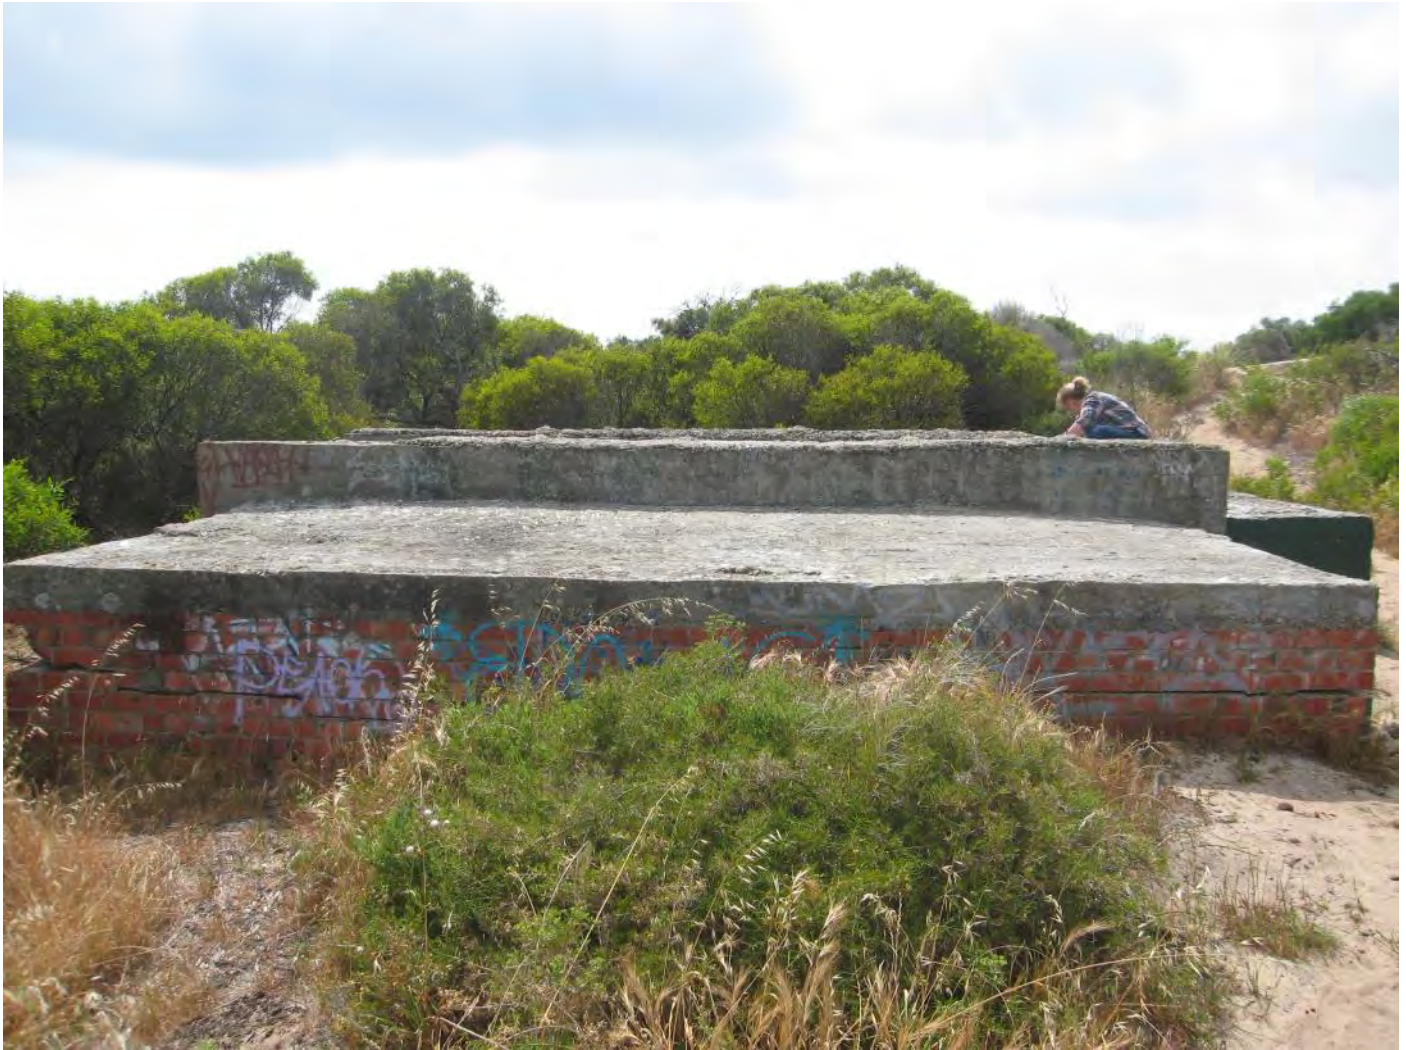
**Figure 84:**        **Operations Bunker – west elevation**

The majority of the walls have been painted in an attempt to hide existing graffiti and to try and reduce additional graffiti. The north and west elevations have not been painted and still present in the original brick and concrete form, again covered in graffiti.

The west elevation is largely submerged in the sand dune but the top ten brick courses are visible with an extensive crack extending along the full extent of the elevation, following the mortar joints. The crack is caused by the failure of the steel bar reinforcement in the brickwork which has rusted and expanded causing the brickwork to move and become loose. Brick from the north west corner are missing which will contribute to the continued deterioration of the brickwork and enlargement of the crack.

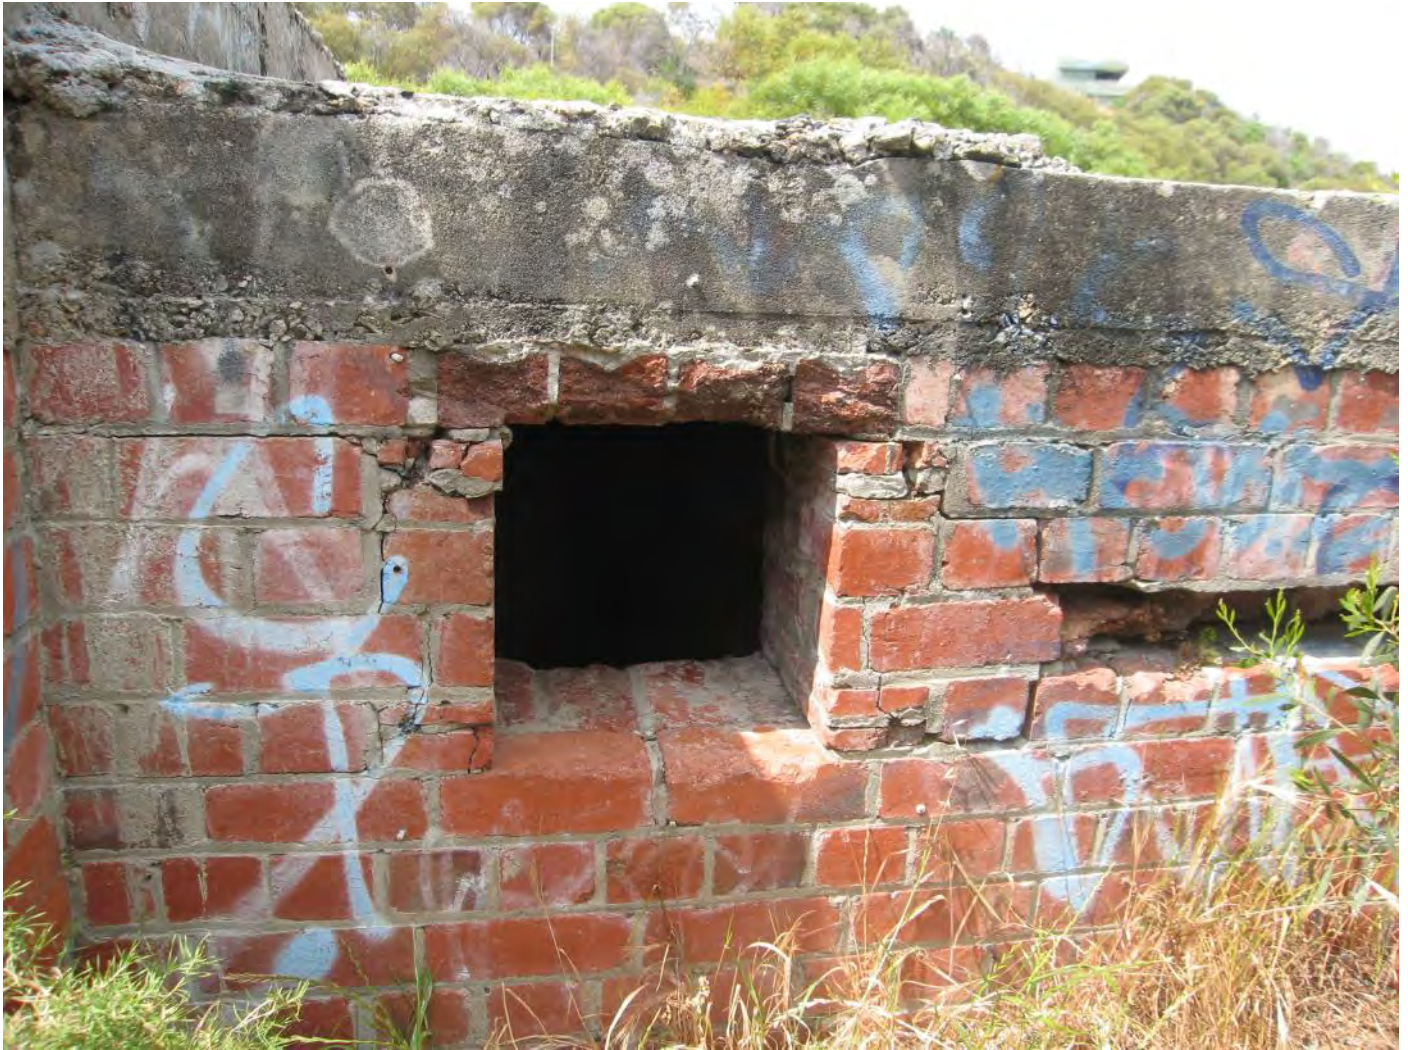
**Figure 85:** Operations Bunker – Openings in north wall

Small openings have been incorporated into the north wall, positioned one brick course below the concrete slab and are four bricks deep and approximately 1.5 bricks wide. Such holes often had a dual purpose of providing ventilation into the space but also to provide low level observations.

The brickwork immediately to the west of the opening, closest to the west elevation, is deteriorating. Bricks are missing with much of the damage being caused by the rusting and failing reinforcing steel. Previous repairs have been carried out with some evidence of localised repointing.

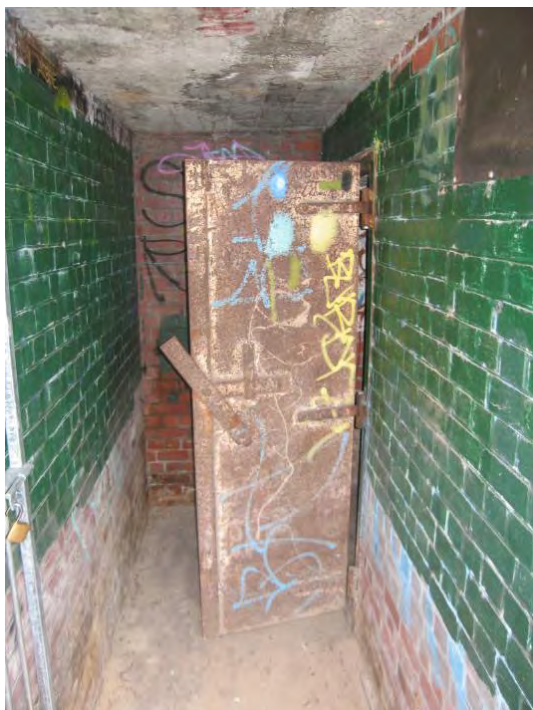
**Figure 89:** Operations Bunker – Extant steel entrance doors

The brick and concrete steps lead down into the entrance tunnel which is of brick construction with concrete floor and roof. The tunnel is about 3m long with the main entrance doors into the Operations Bunker being located at the far end on the south wall of the main building. The steel doors are the original heavy doors with each door being held in place with three hinges and locked by a pivot lock. The doors have been scratched and graffitied over time and are now presenting with surface rust.

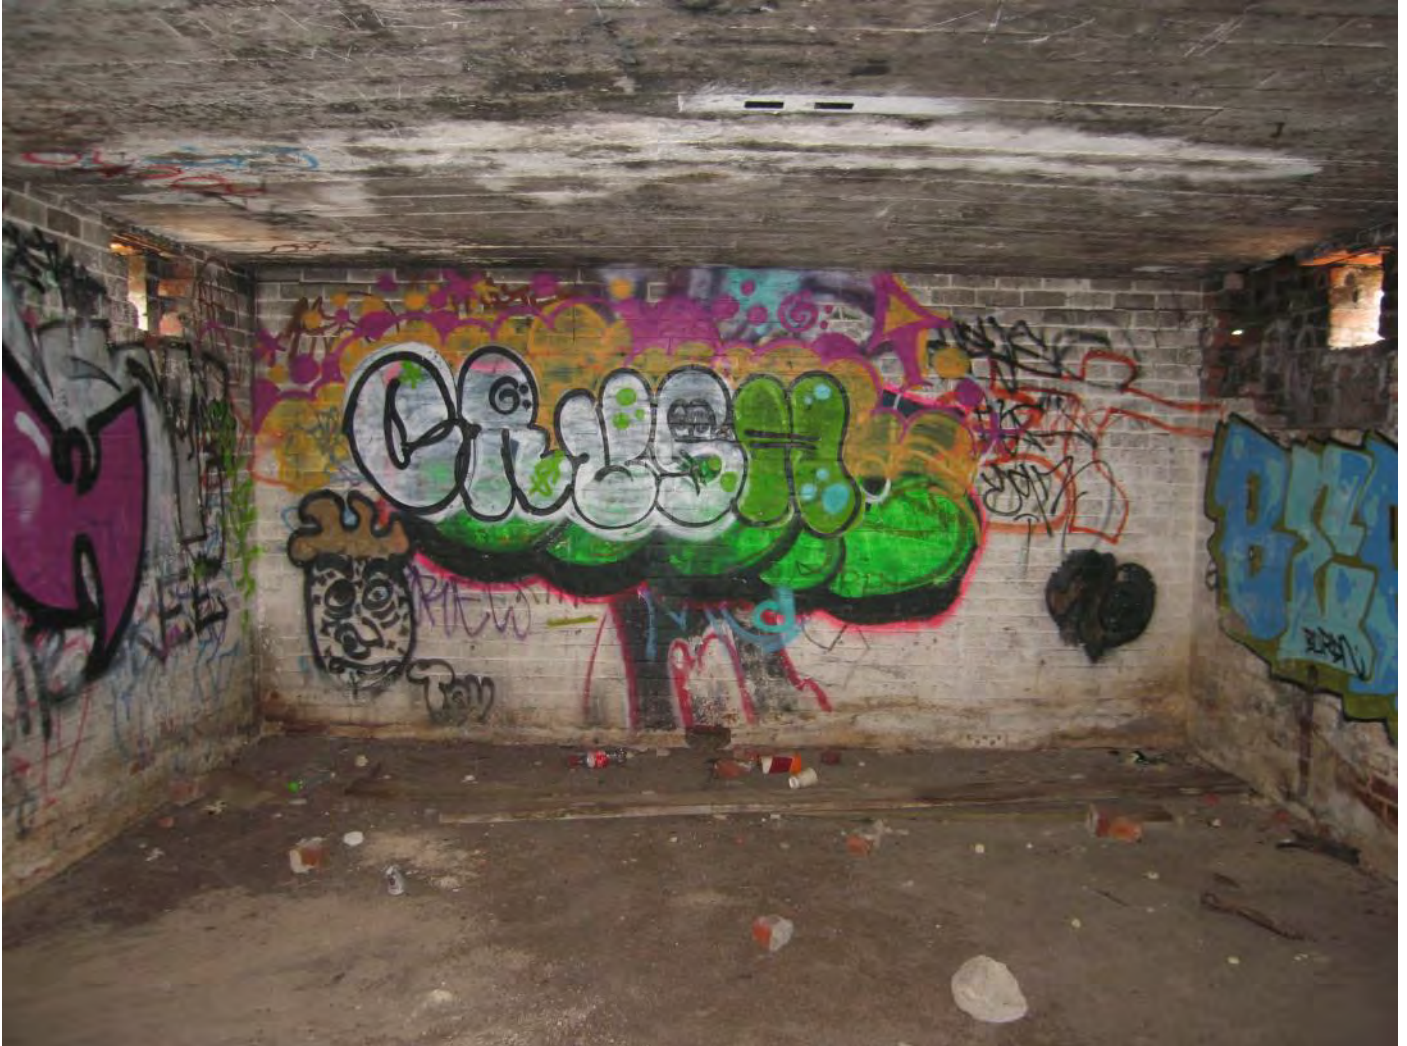
**Figure 90:** Operations Bunker – Interior (west wall)

The internal space consists of one rectangular shaped room of simple presentation. The brick walls are the internal leaf of the cavity wall which have been painted white at an earlier stage and are now covered in graffiti.

Loose bricks have collected on the concrete slab floor from the north west opening.

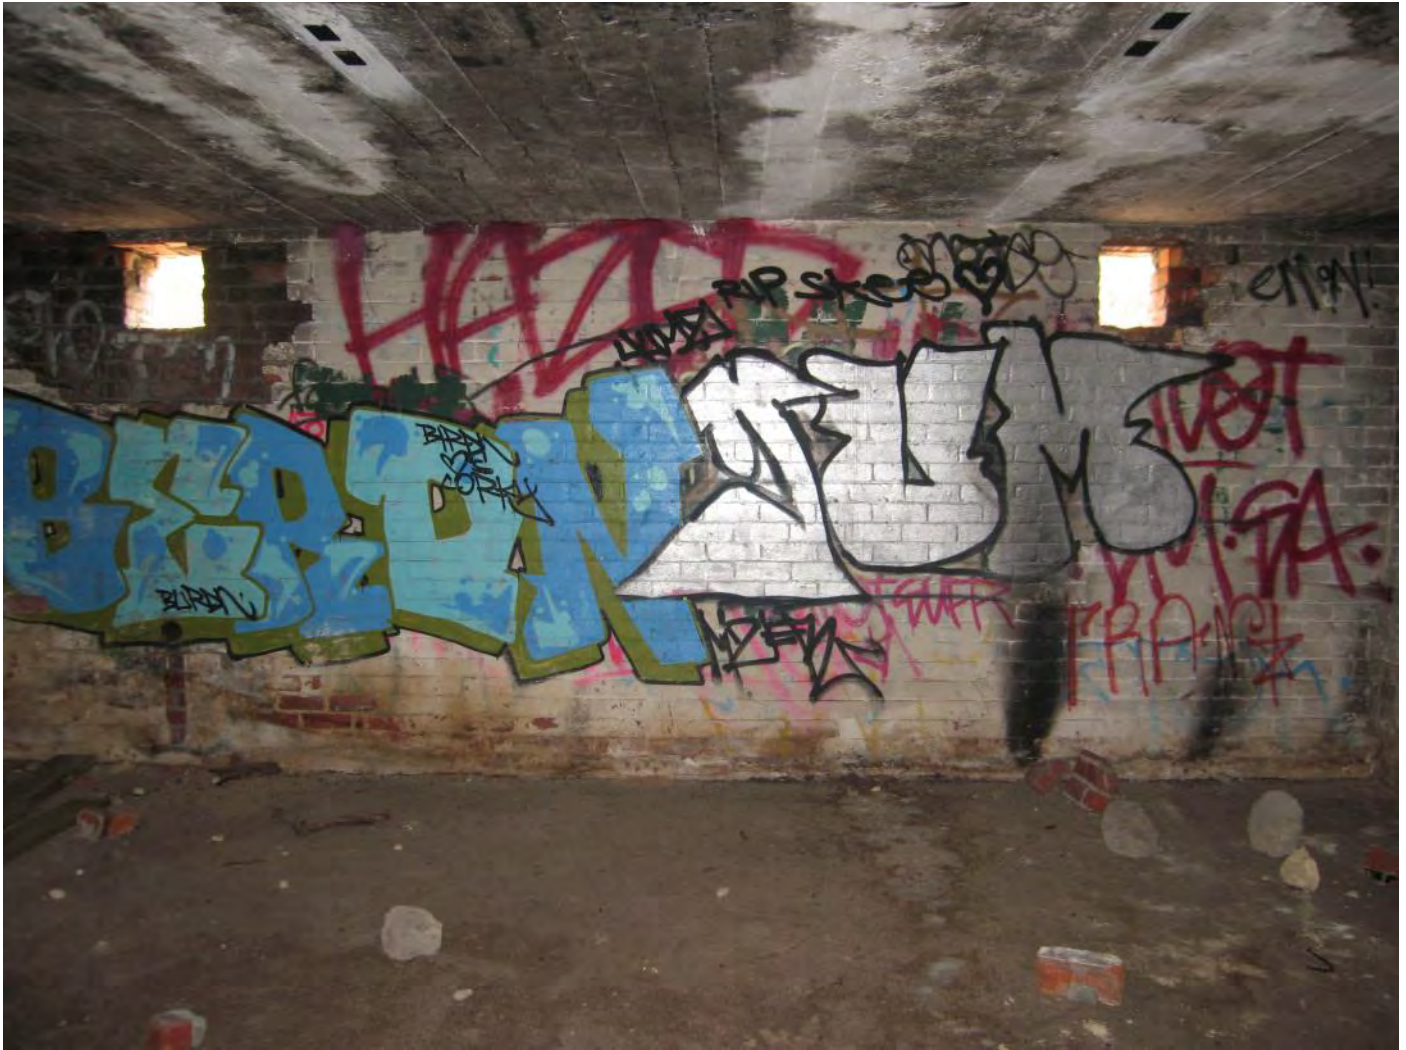
**Figure 92:**      **Operations Bunker – interior (north wall)**

The bricks around the north west opening have become loose and fallen from the wall. This in part is due to the failure of the steel reinforcement in the brick wall but part of the damage can also be attributed to vandalism. The remainder of the wall around the opening appears to be in a stable condition.

The lower levels of the walls are showing some signs of damp, most of which is attributable to the build up of sand over the years and the inability of the fabric to breathe.

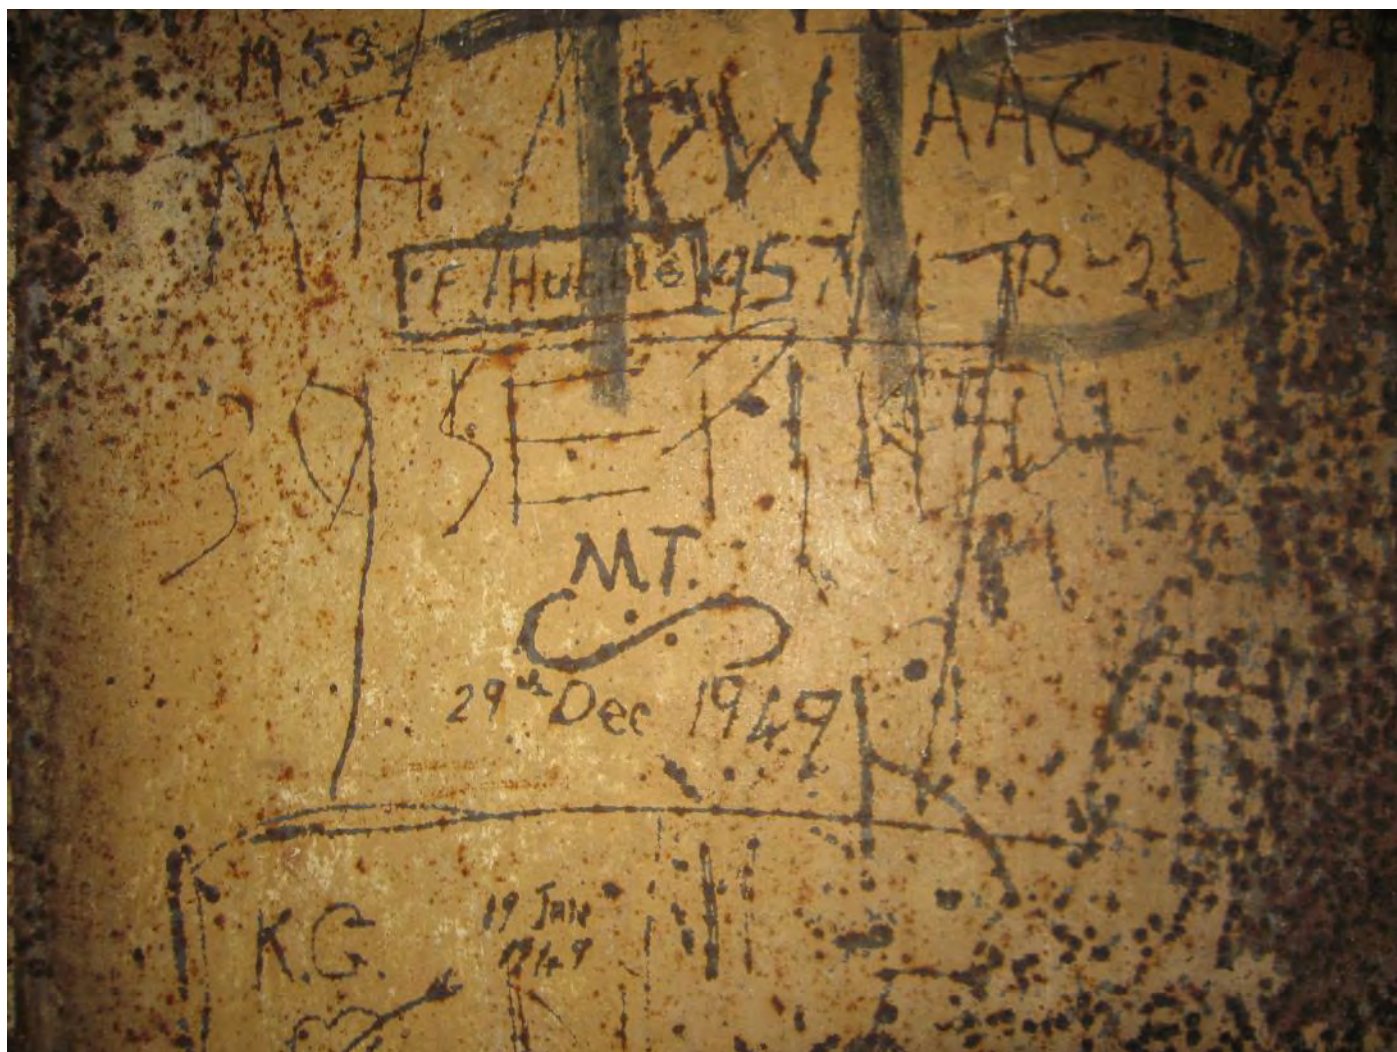
Figure 95: Operations Bunker – Graffiti scratched into entrance doors

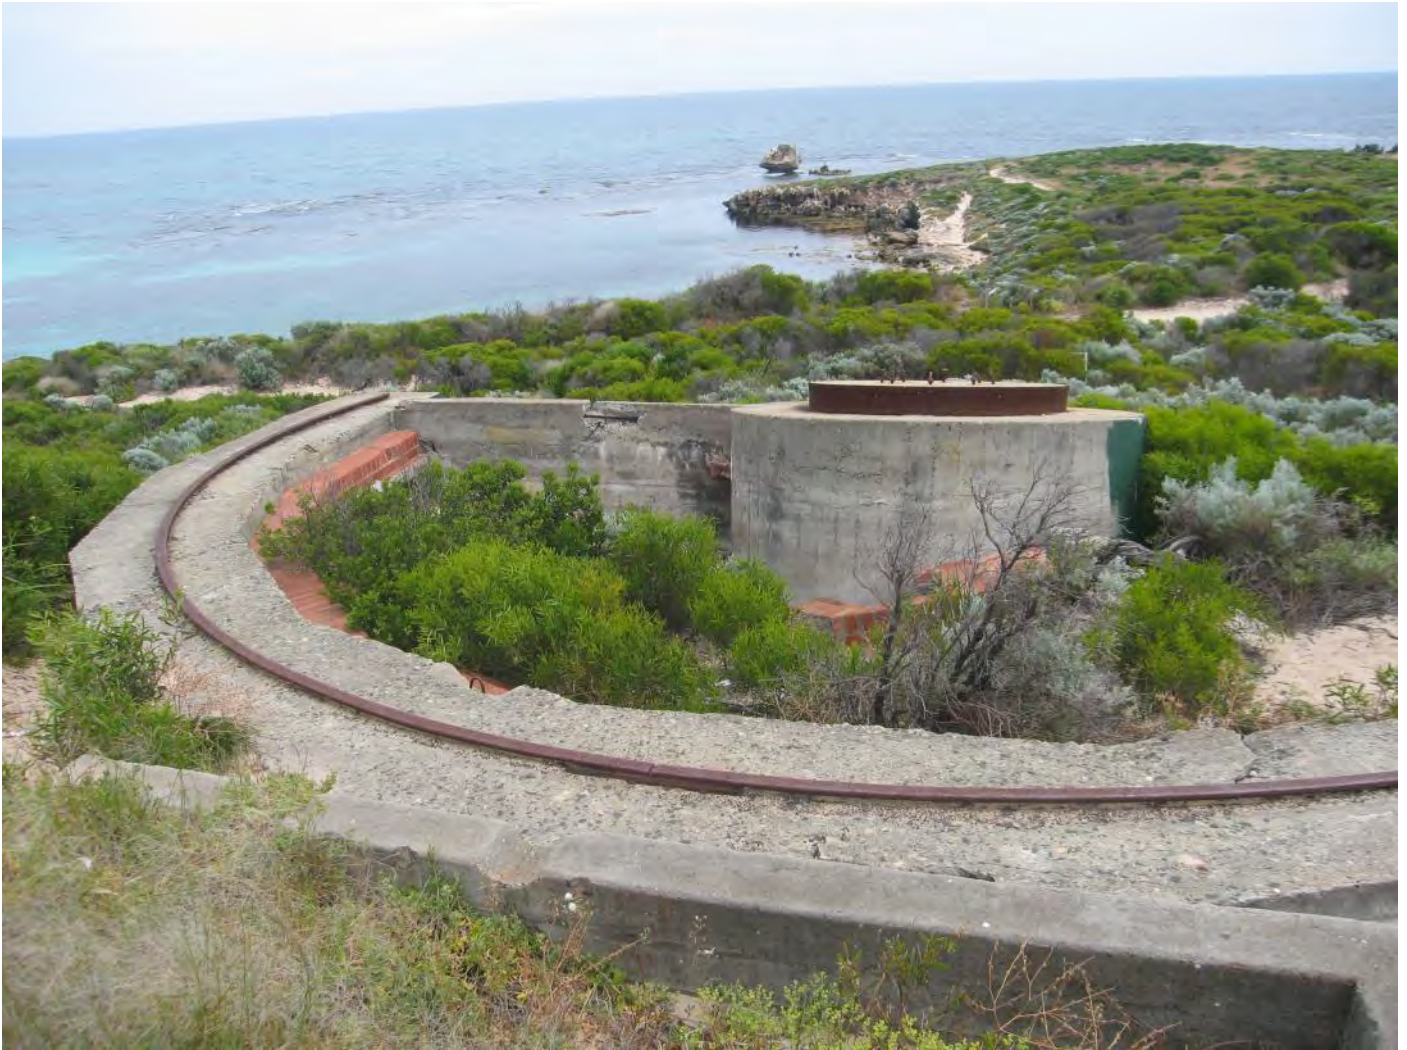
**Figure 99: Gun Emplacement**

Brick steps extend around the internal side of the concrete structure, leading to a brick paved floor and to the central gun mount. The brick elements have become displaced and no longer full extend around the internal space of the gun emplacement. Sand has accumulated and bushes grown in the internal area, further obscuring the planning of the gun emplacement.
