# Point Peron “K” Battery Conservation Management Plan

South West Corridor Development Foundation Inc.

**HOCKING**  
HERITAGE STUDIO

March 2016

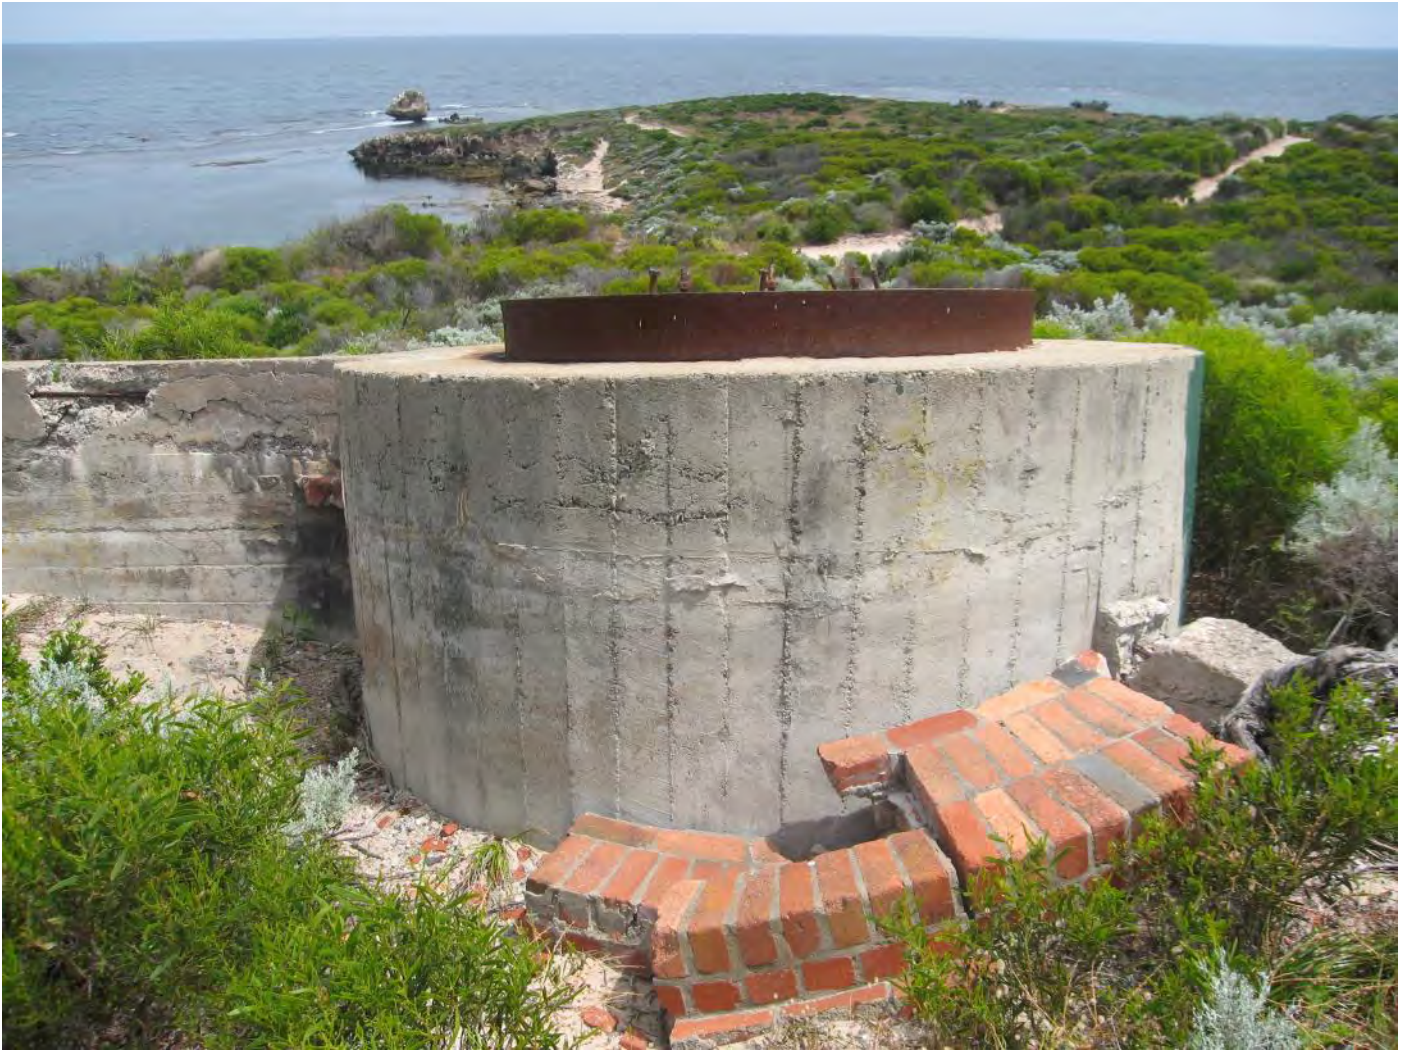
**Figure 100: Gun Emplacement**

The central gun mount and the concrete walls are all constructed from reinforced concrete. Sections of the concrete have blown due to the rusting of the reinforcements displacing chunks of concrete.

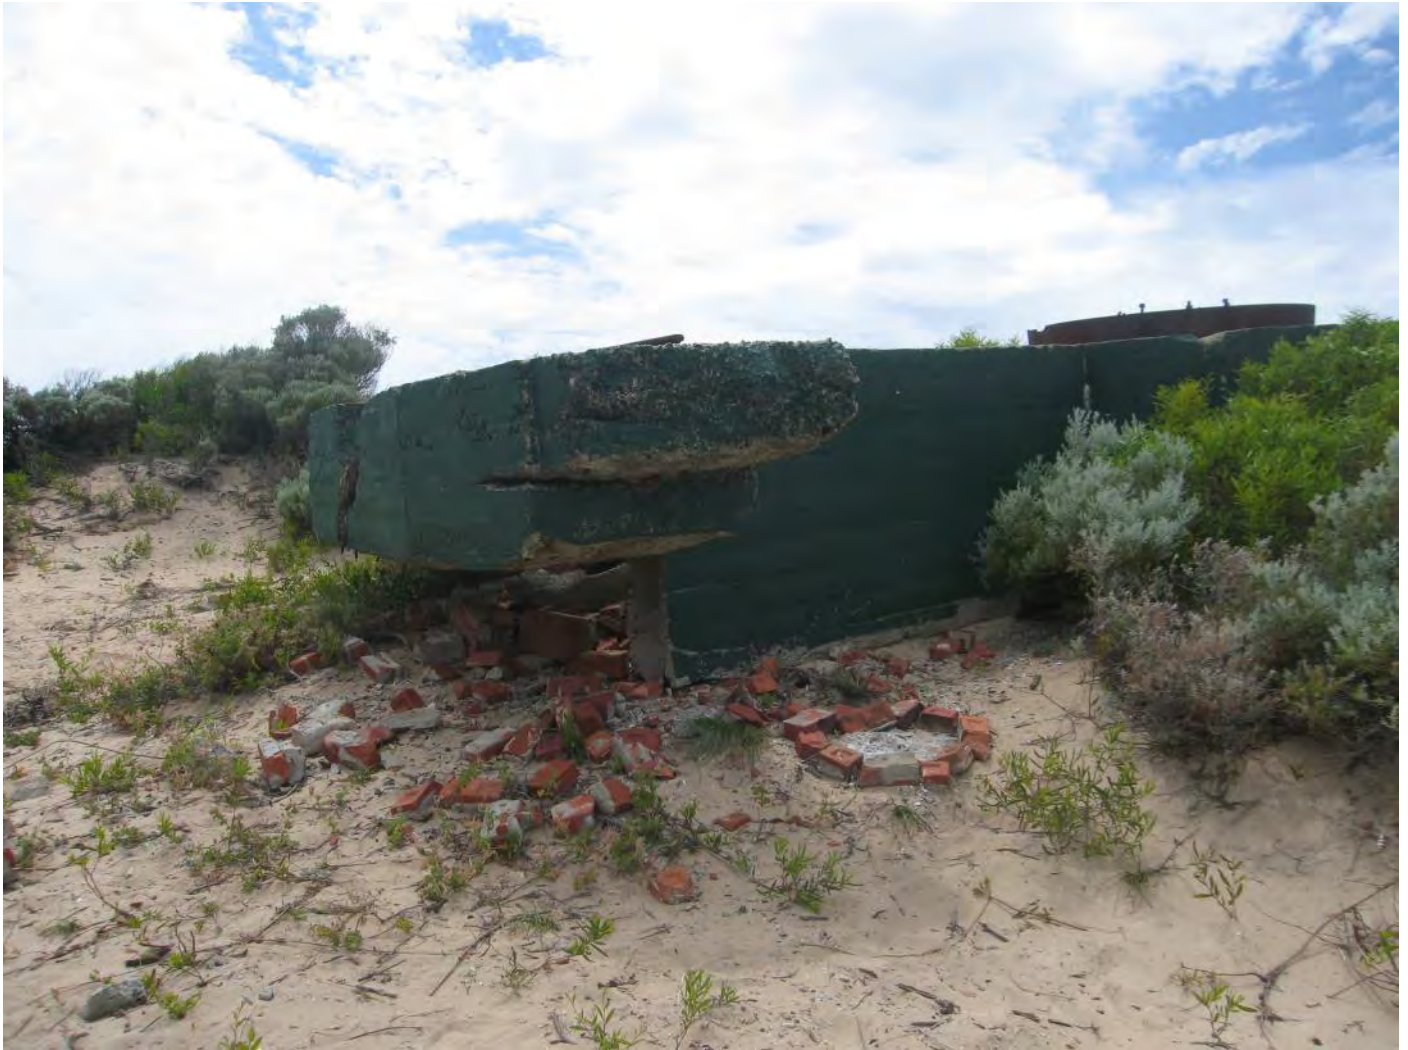
**Figure 103: Gun Emplacement**

As the underlying ground has moved, the fabric of the gun emplacement has become dislodged and loose. Much of the loose brick fabric appears to be collected on the ground and in the sand underneath the structure.

There is some evidence of concrete cancer in the main structure with elements of concrete breaking off and the reinforcing steel rusted and blown. The movement of the ground and the subsequent displacement of the gun emplacement has also resulted in severe cracking in the concrete structure. Whilst there is no practical reason for the gun emplacement to be reconstructed, the structure must be secured and stabilised as soon as possible.

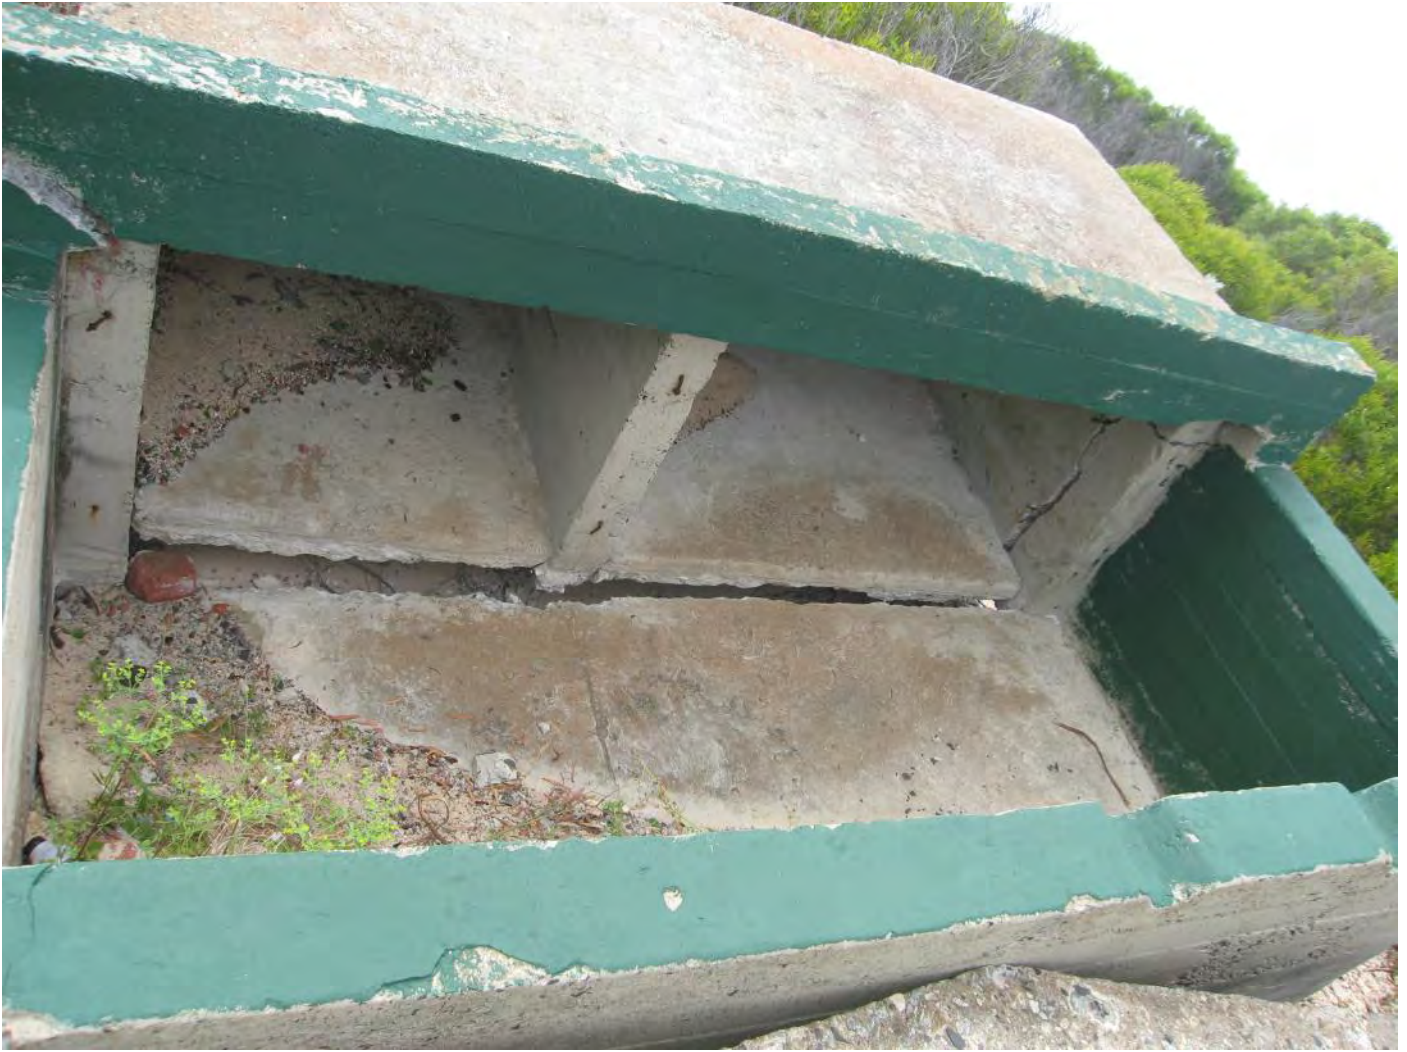
**Figure 107:**      **Gun Emplacement - Ammunition Store No. 1**

Whilst the structure has remained predominantly in one piece, cracks have occurred in the concrete and the floor of the two store rooms has become displaced. Despite the movement, the concrete walls have remained in tact.

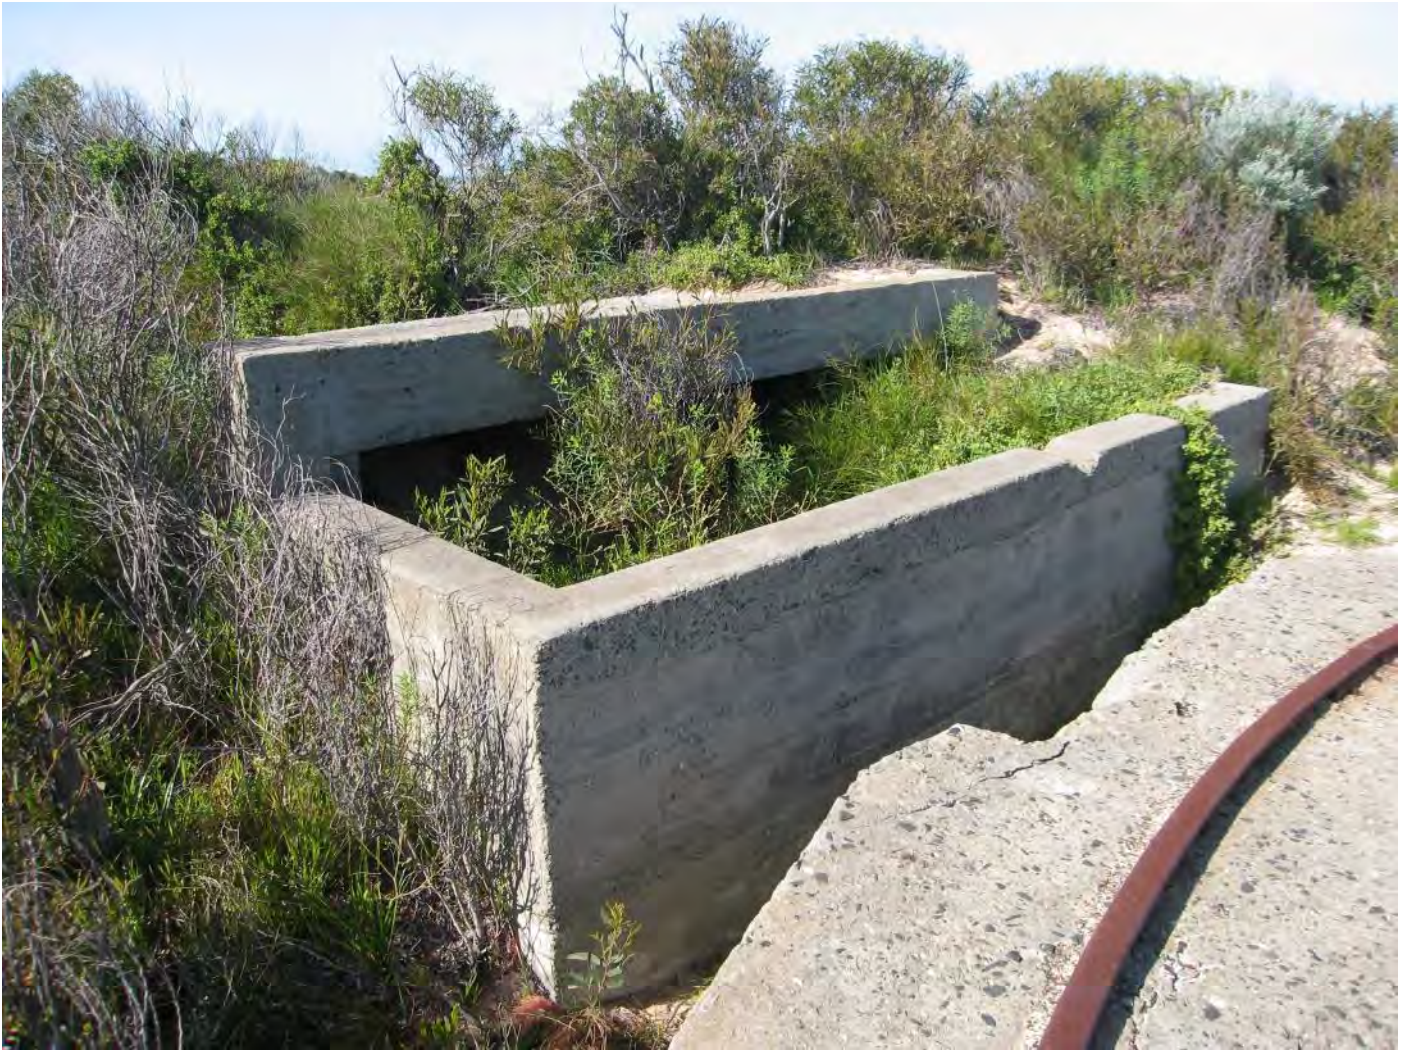
**Figure 111:** Gun Emplacement - Ammunition Store No. 2

Ammunition Store No. 2 is positioned to the south east of the gun emplacement and looks to be in, or close to, its original position. The structure has become largely submerged in the sand with the majority of the structure being obscured from view. Sand has accumulated on the roof and internally resulting in the growth of vegetation which will ultimately contribute to the deterioration of the concrete structure.

As far as can be determined, Ammunition Store No. 2 appears to have remained in tact with no obvious signs of cracking or displacement of the elements.

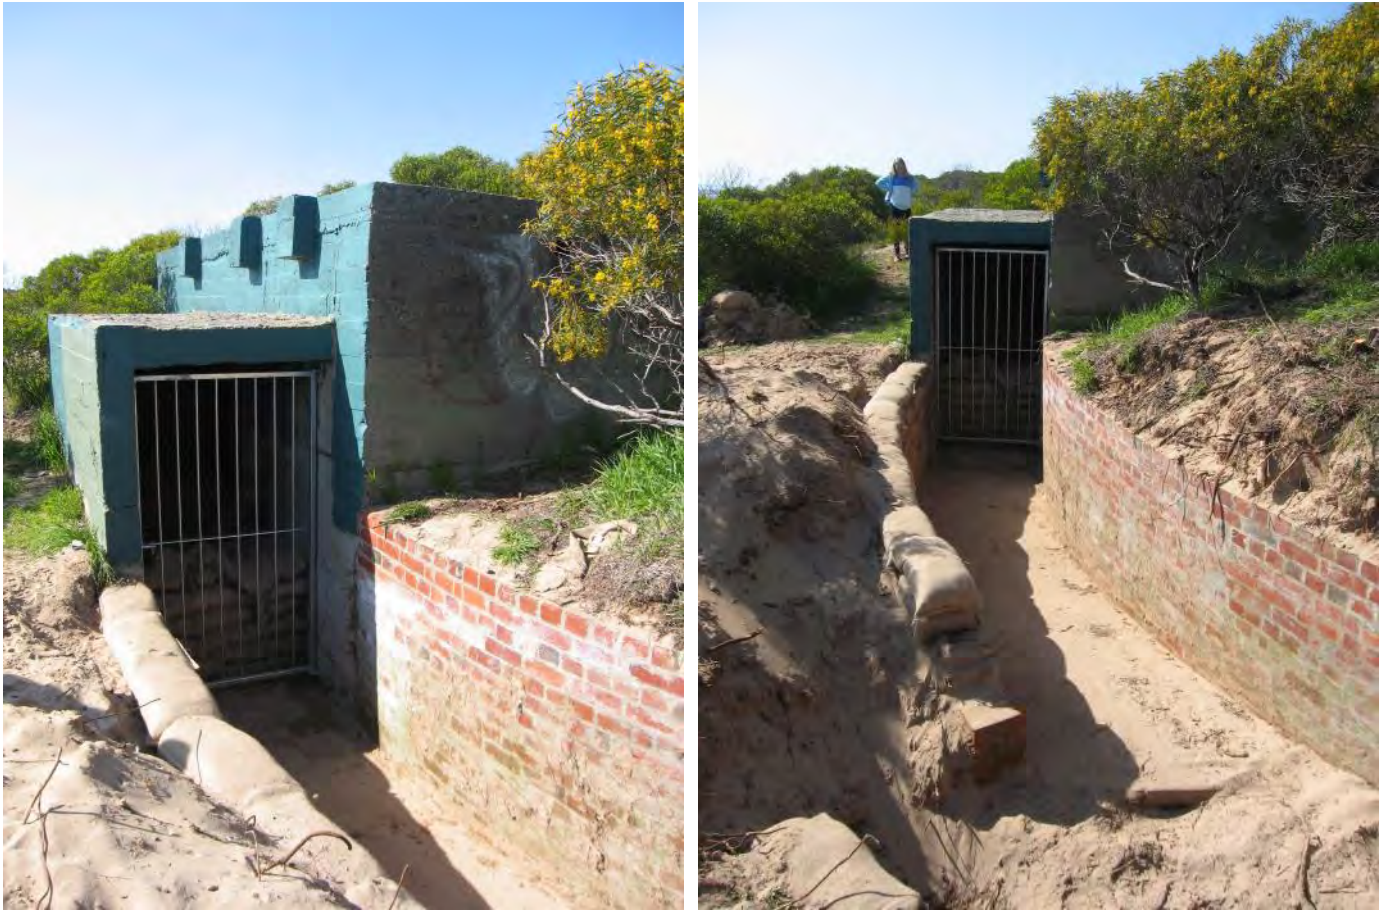
**Figure 116:** Ammunition Bunker - entrance

A metal grille gate has been installed across the entrance into the building, again to prevent general access into the Bunker. Sandbags have been placed directly behind the gate in an attempt to prevent further sand accumulation in the entry tunnel.

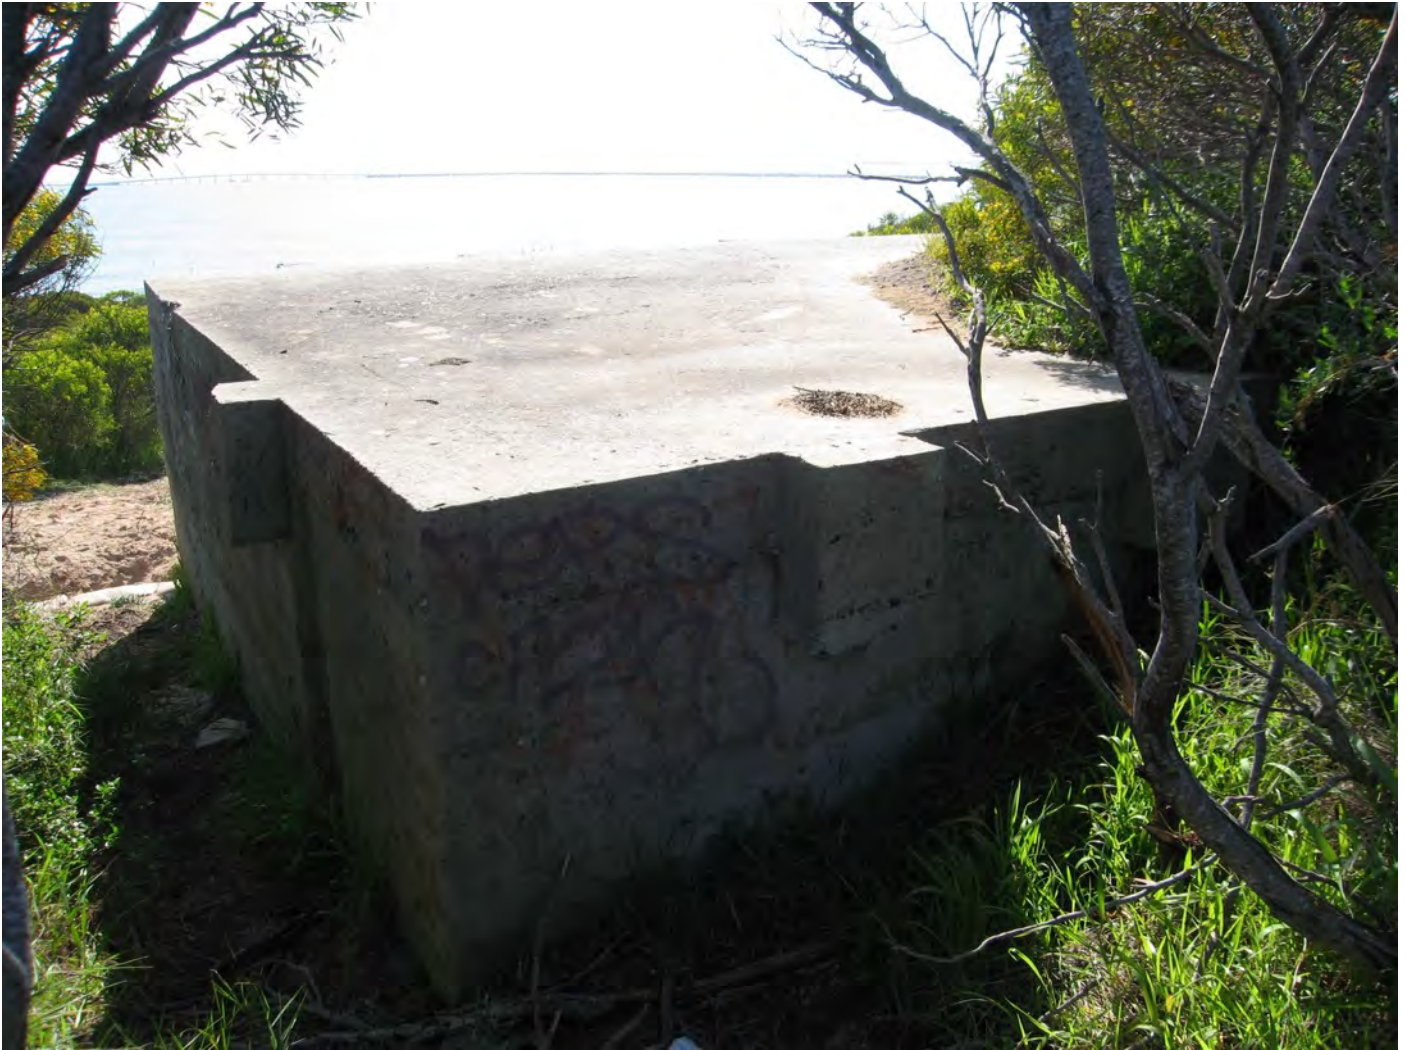
**Figure 118:** Ammunition Bunker – view across the roof

The Ammunition Bunker is a simple structure bearing similarities to the plan form and construction method of the other structures around the site. The external walls are of reinforced concrete construction with the roof being a reinforced concrete slab. Projecting vent shafts are placed at regular intervals around the building, level with the roof and extending down to approximately two concrete slab courses. One of the shafts on the north elevation has fallen off revealing a small opening in the wall.

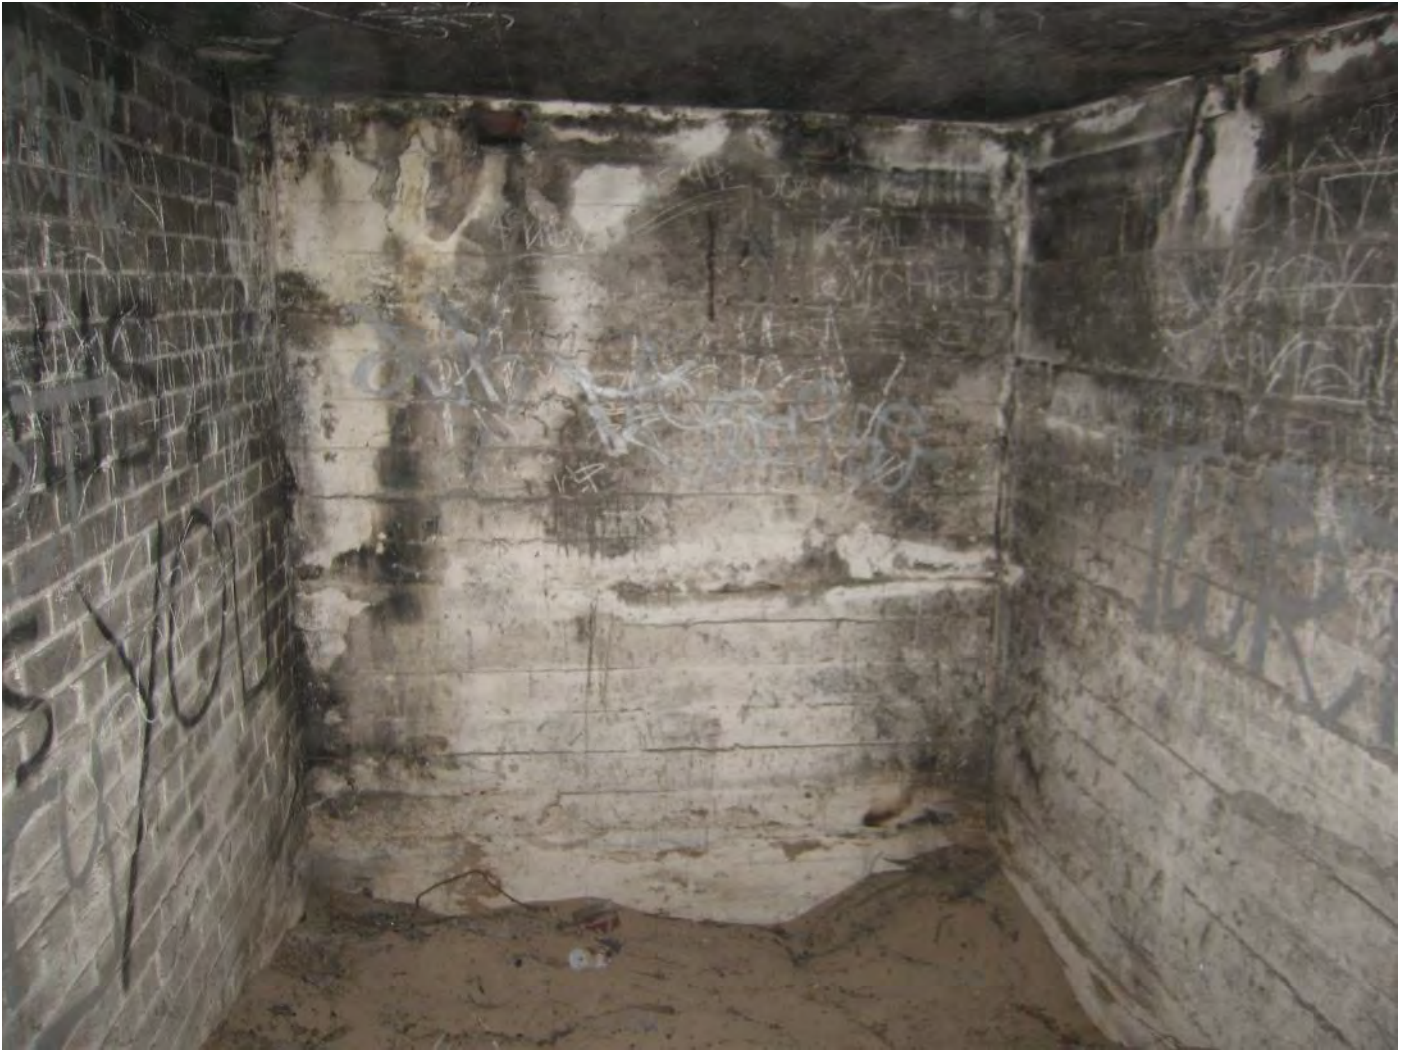
**Figure 122:** Ammunition Bunker – Room 1

The first room is a small rectangular space with no natural light flowing into the room. The three external walls are of concrete construction, the floor (under the cover of sand at the time of writing) is concrete and the roof is also reinforced concrete. The fourth wall, the west wall, is a double leaf brick load bearing wall.

The walls are a dusty white with graffiti with damp staining and possible fire scorch marks.

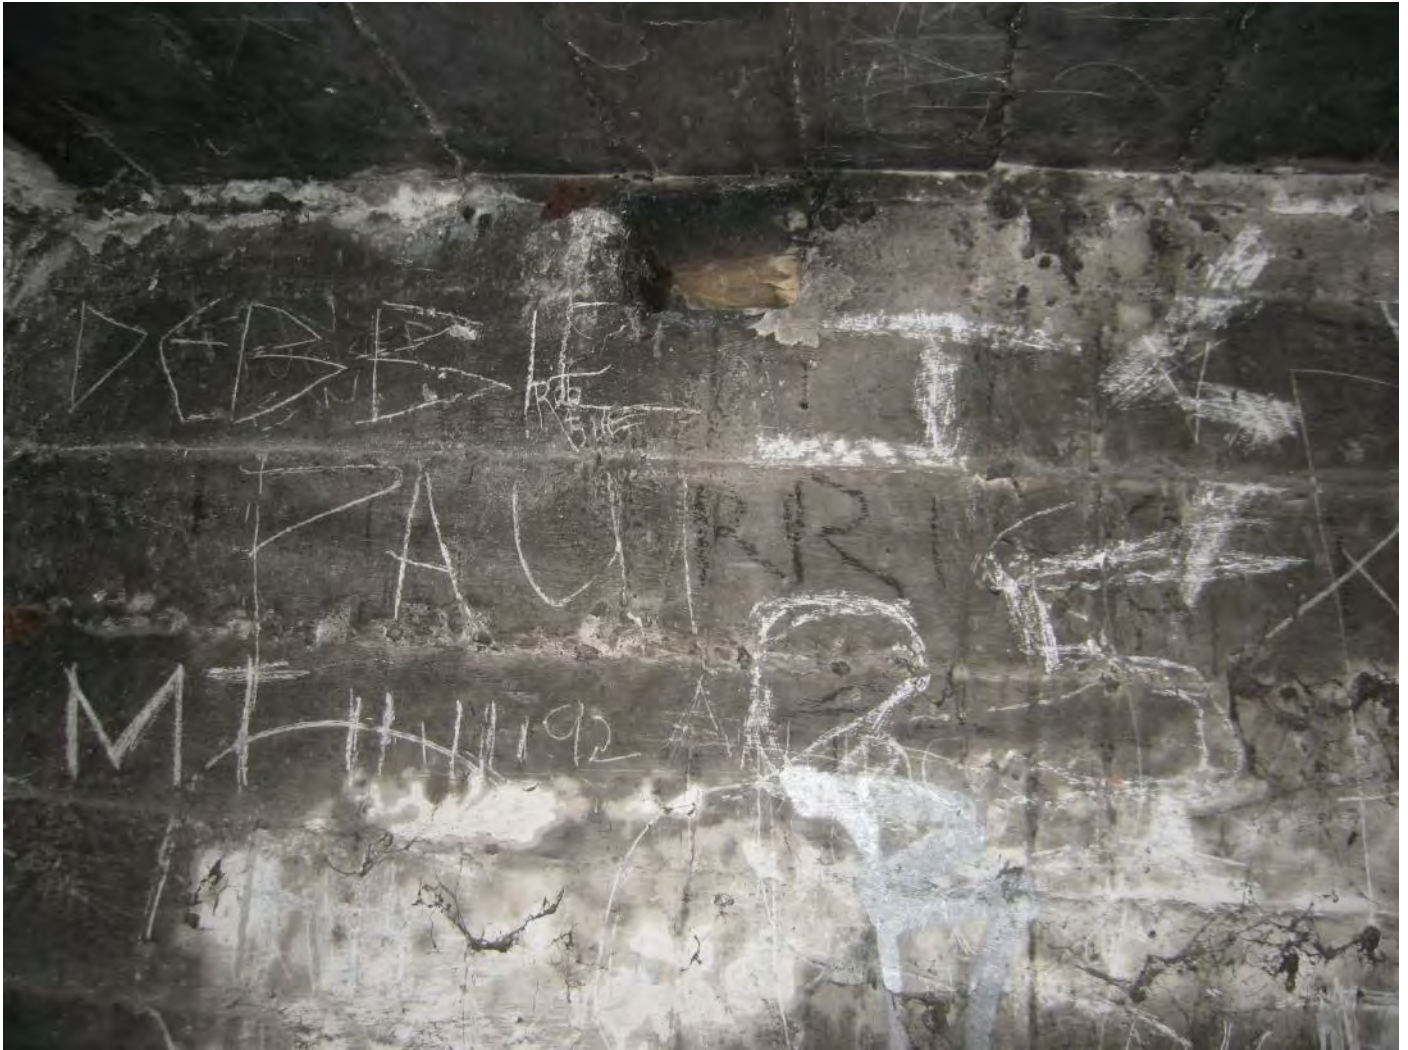
**Figure 123:**      **Ammunition Bunker – graffiti in Room 1**

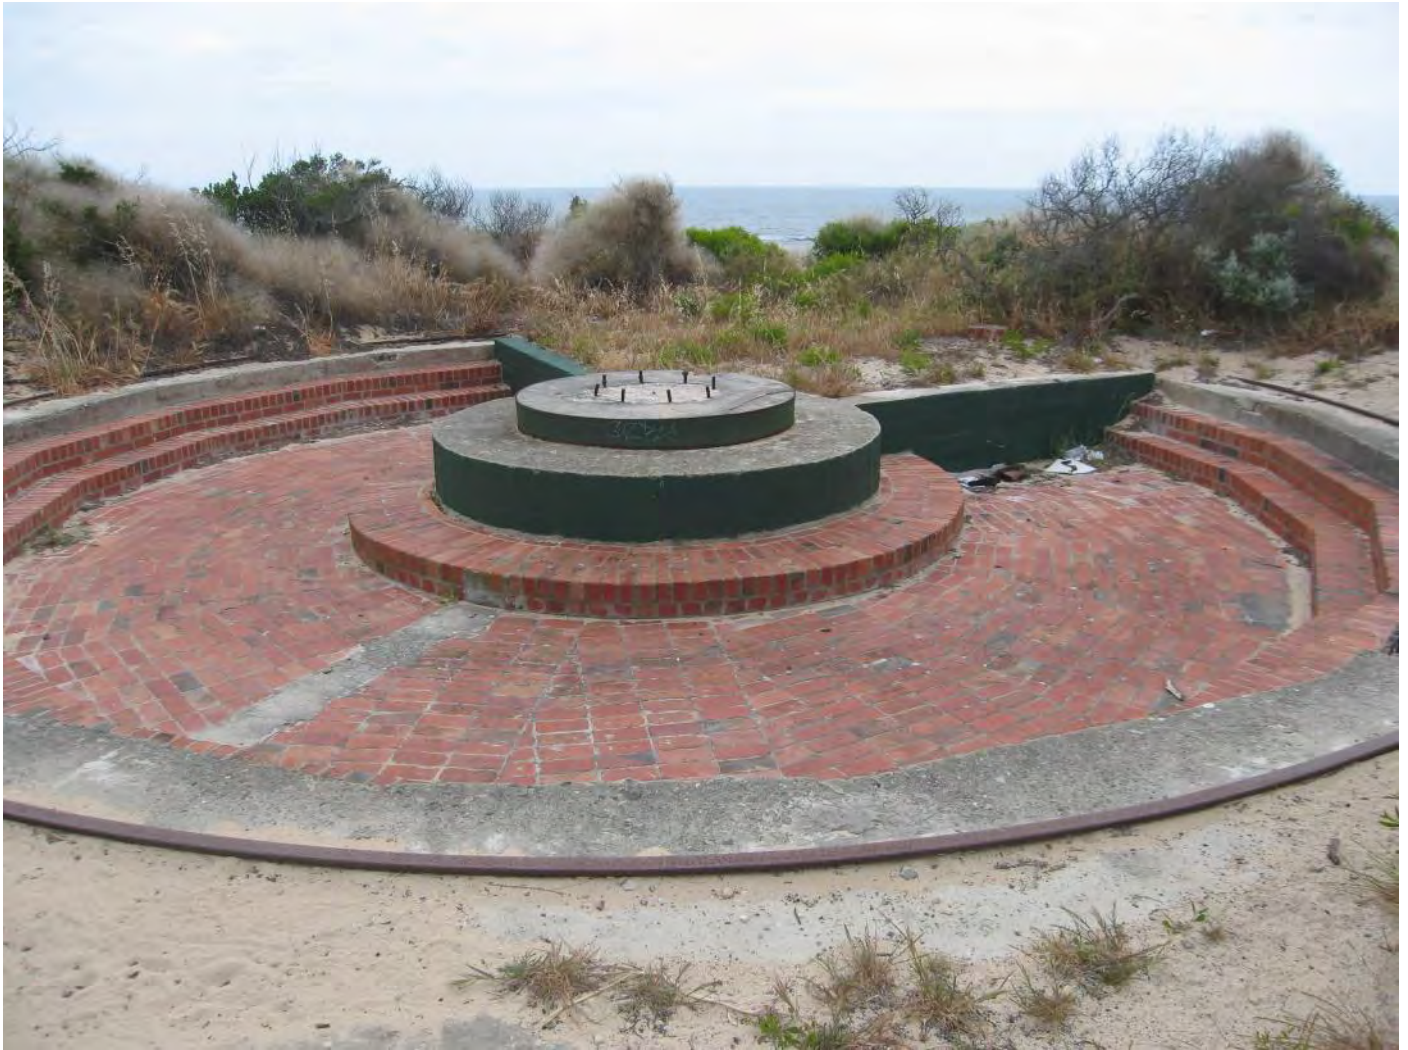
**Figure 129: Gun Emplacement No. 2**

Gun Emplacement No.2 is exactly the same as the Emplacement No. 1 apart from its condition. Gun Emplacement No. 2 is intact and presents as originally constructed which aids understanding of the form and function of the structure.

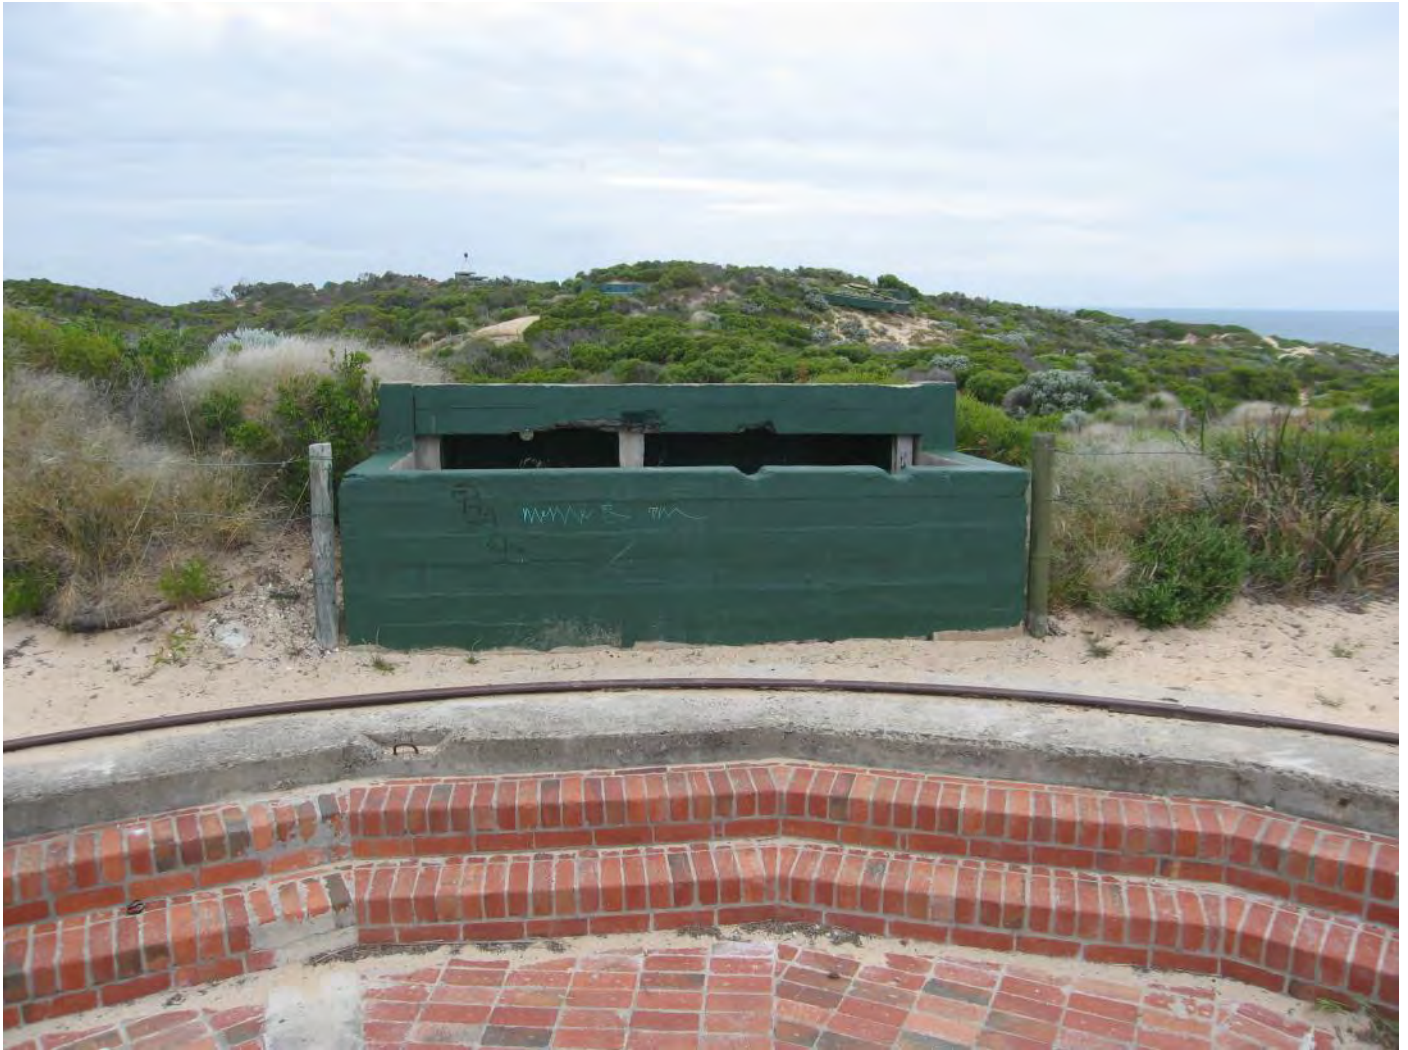
**Figure 134: Gun Emplacement No. 2 – Ammunition Store 1**

Both are in good condition and clearly demonstrate the plan form of the structures. Both are partially obscured by the sand around the sides and the rear of the structures but not to any great detrimental effect.

Though generally in good condition, the concrete is beginning to show early signs of concrete cancer in places, especially to the edge of the roof slab where chunks of concrete have broken away and the rusted reinforcing steel is visible.

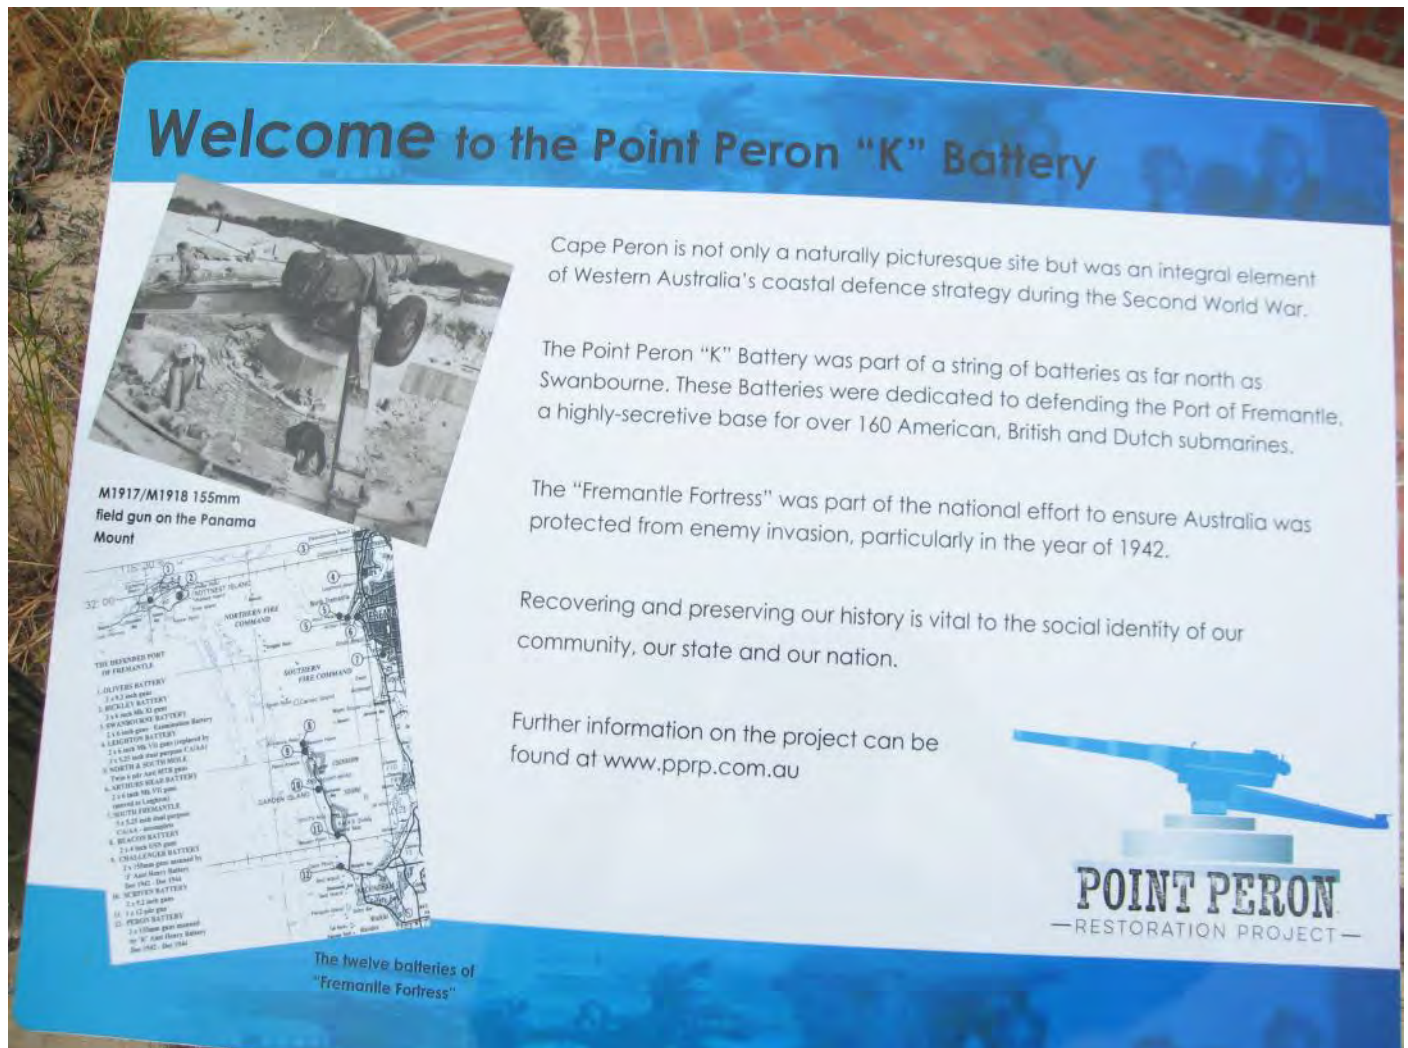
Figure 139: Gun Emplacement No. 2 – Recent Interpretation

The site generally is not explained to the visitor. For those who do not know the site, there is no mention of any WWII infrastructure in the car parks and once the various sites are happened upon, again there is no signage that explains what the buildings are and why they are there. The one and only interpretative signage was erected at Gun Emplacement No. 2 in November 2015, which provides a brief explanation of the Point Peron "K" Battery site and its relationship with the Fremantle Fortress.

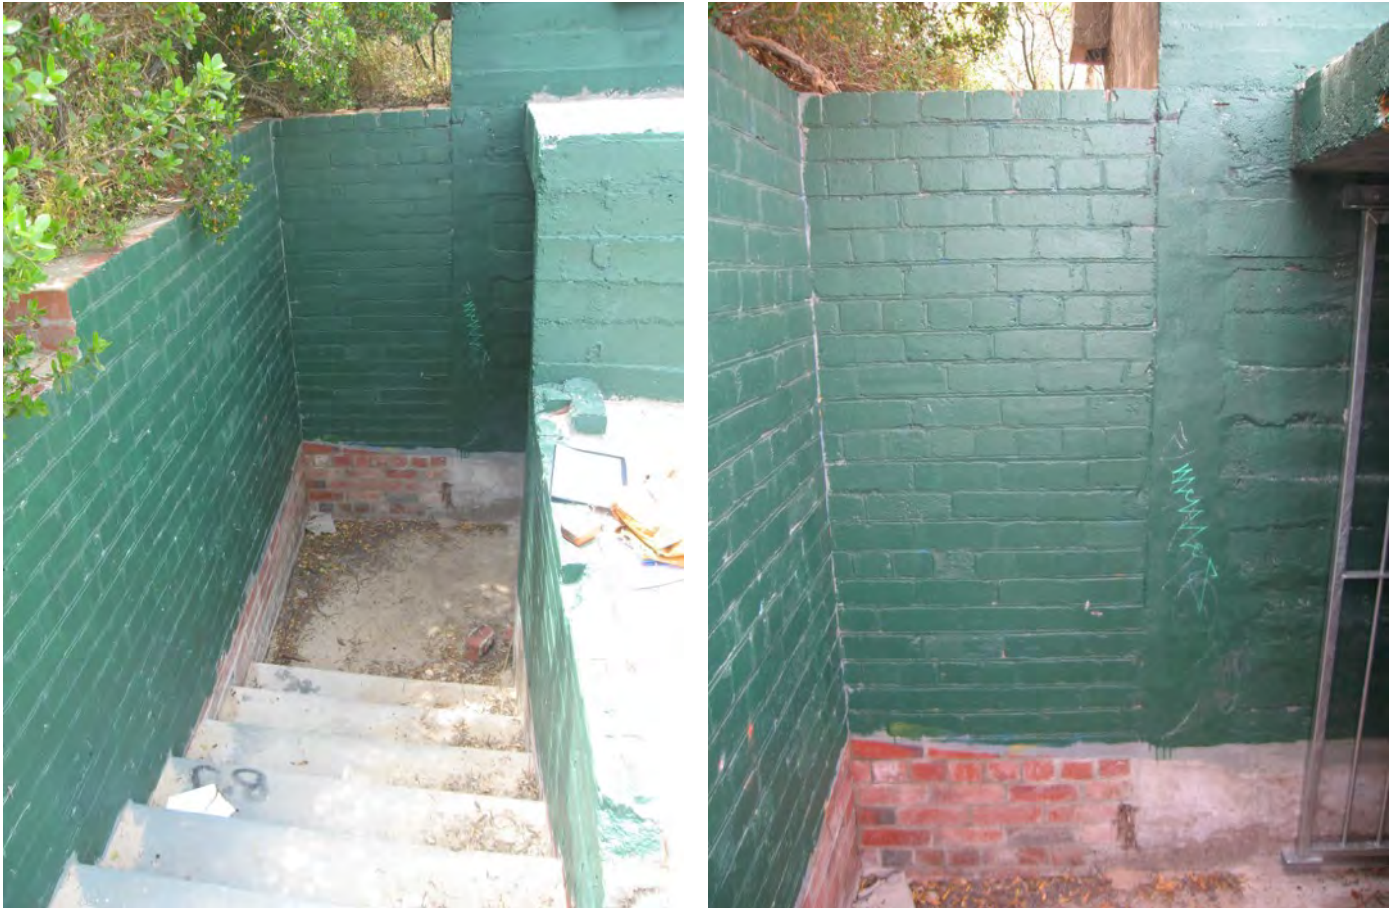
**Figure 143: Ammunition Bunker No. 2 – Entrance**

The entrance is located on the south-west elevation with the concrete steps projecting out from the main building line of the structure, before doglegging to the right and accessing the Bunker. The steps are protected by twin brick retaining walls, the majority of which have been painted with only the lower brick courses remaining in the natural state. Sand accumulation prevented the walls being painted fully to ground level. The brickwork is laid in English Garden bond consisting of three stretcher courses followed by a header course. The terminating brick wall at the foot of the steps abuts the concrete frame of the bunker structure and has not been keyed in.

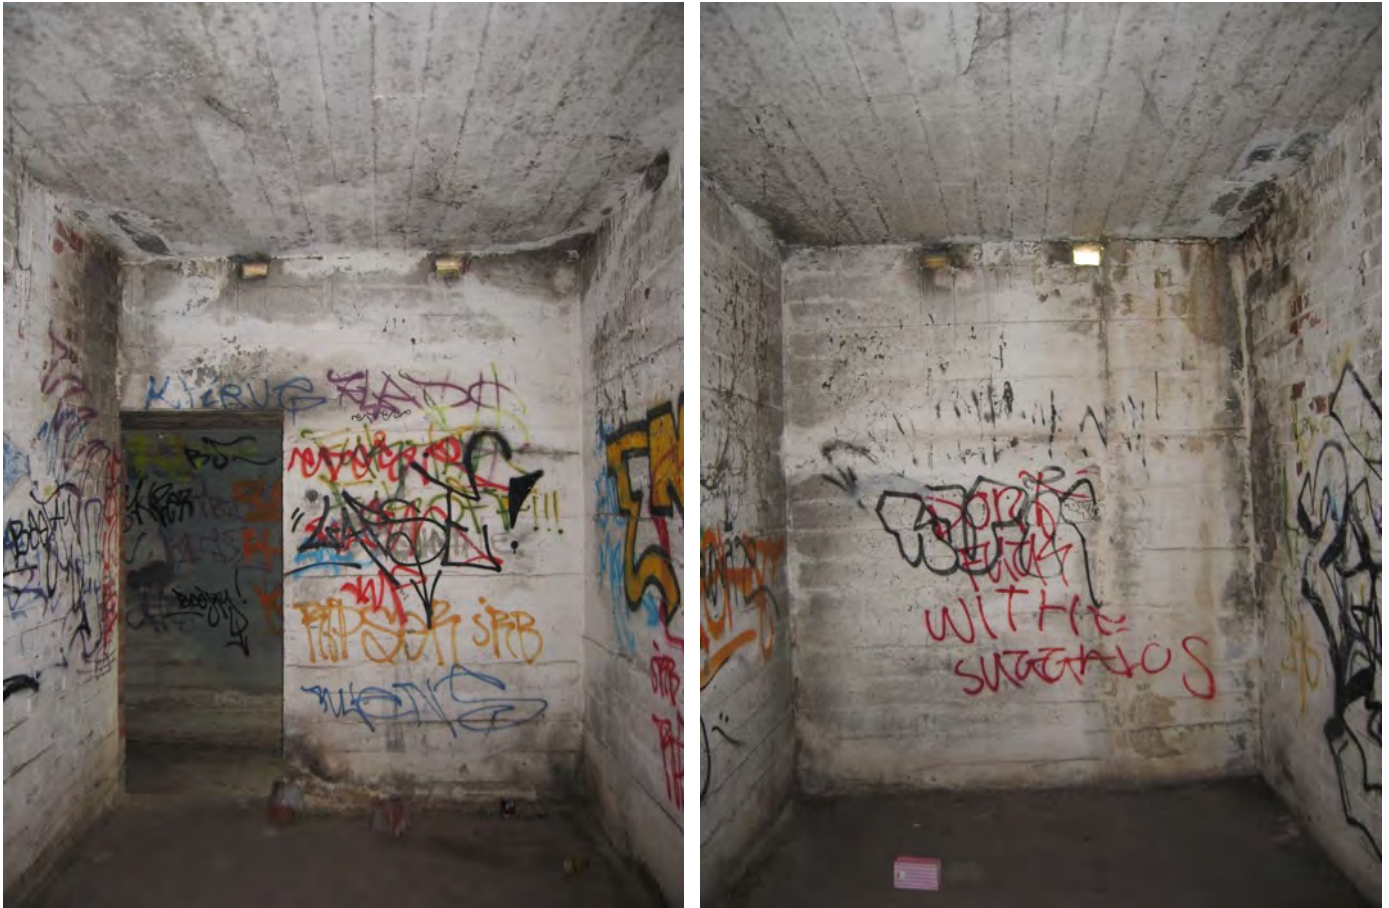
**Figure 146:** Ammunition Bunker - Room 1

Internally, the bunker has the same plan form as Bunker 1 with the main space divided into two rooms plus an entry tunnel. The smaller room, Room 1, has three external concrete walls with a fourth double leaf loading bearing brick wall dividing Room 1 from Room 2. The concrete to Room 1 has been painted white which is wearing off and has been covered in graffiti. Small ventilation holes are positioned directly below the ceiling. The sand has been removed but the walls are showing slight signs damp at lower level which may dry out now the sand has been cleared.

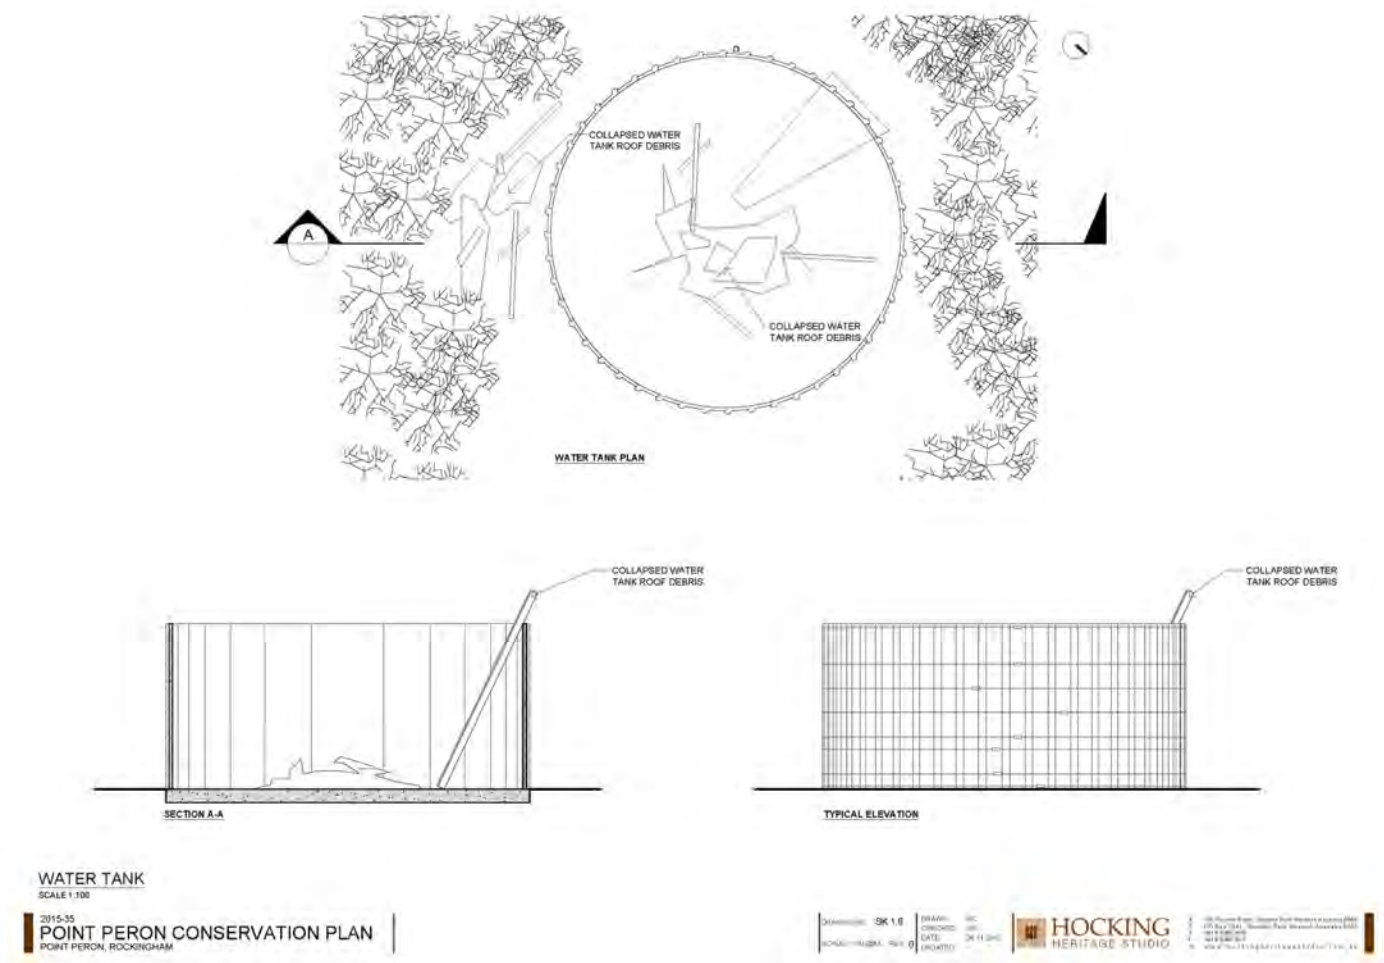
**Figure 151: Water Tank – Plan and Elevation**

The tank is circular, of reinforced concrete construction with steel bracing wrapping around the fluted sides at various positions up the height of the walls.

The roof is no longer extant with remnant corrugated iron and timber laying in the bottom of the tank and around the edges.

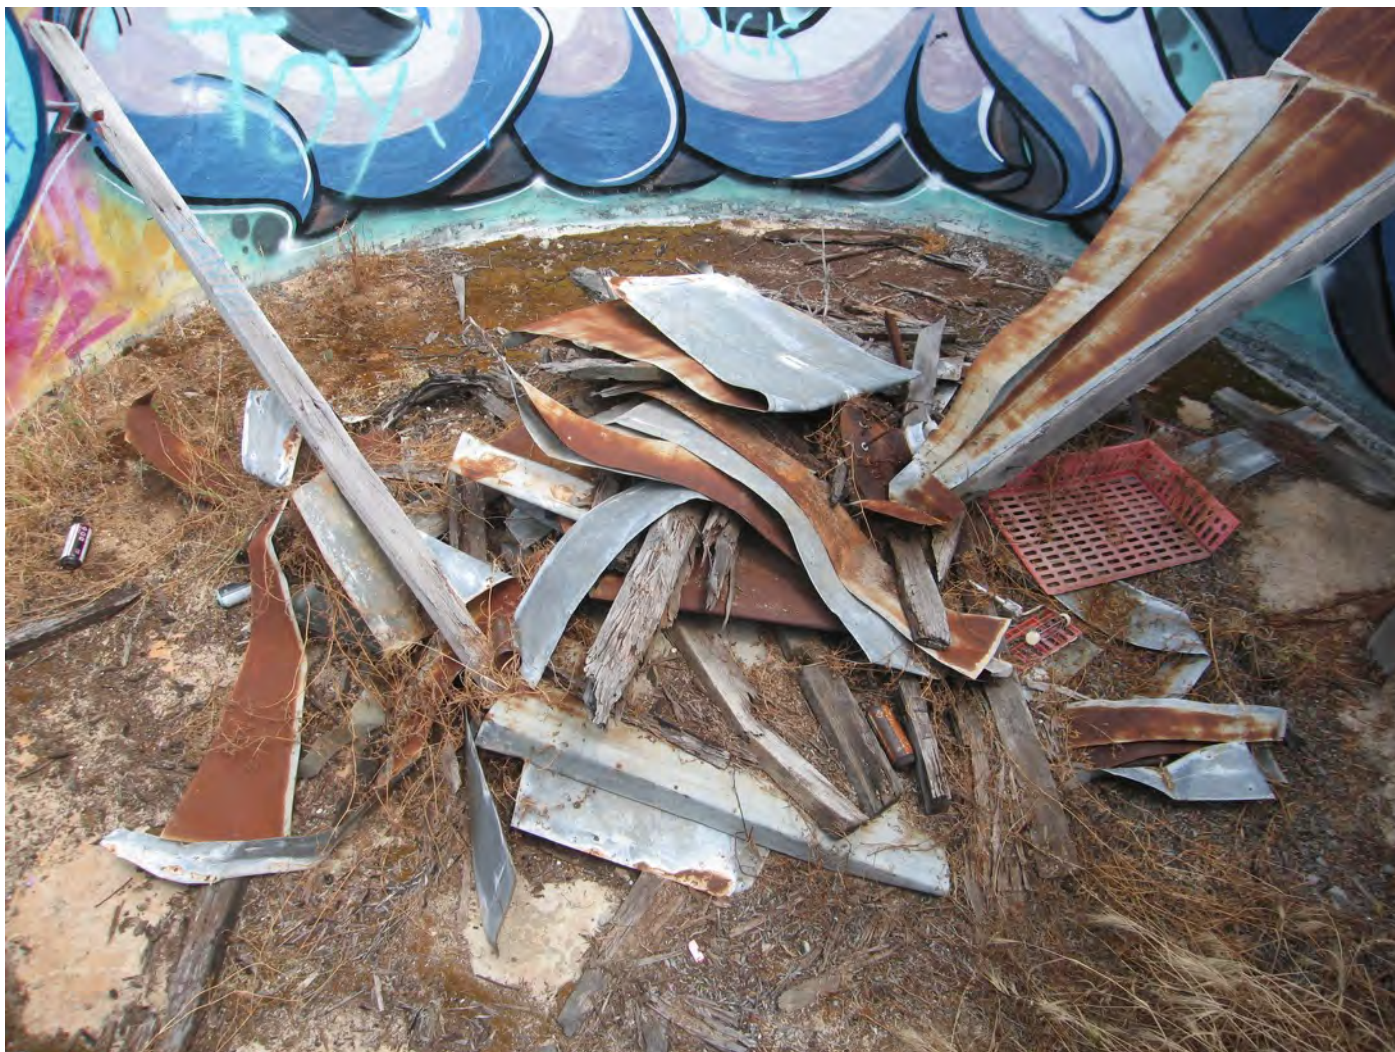
**Figure 154:**      **Water Tank – remnant roofing material**
