# Point Peron “K” Battery Conservation Management Plan

South West Corridor Development Foundation Inc.

**HOCKING**  
HERITAGE STUDIO

March 2016

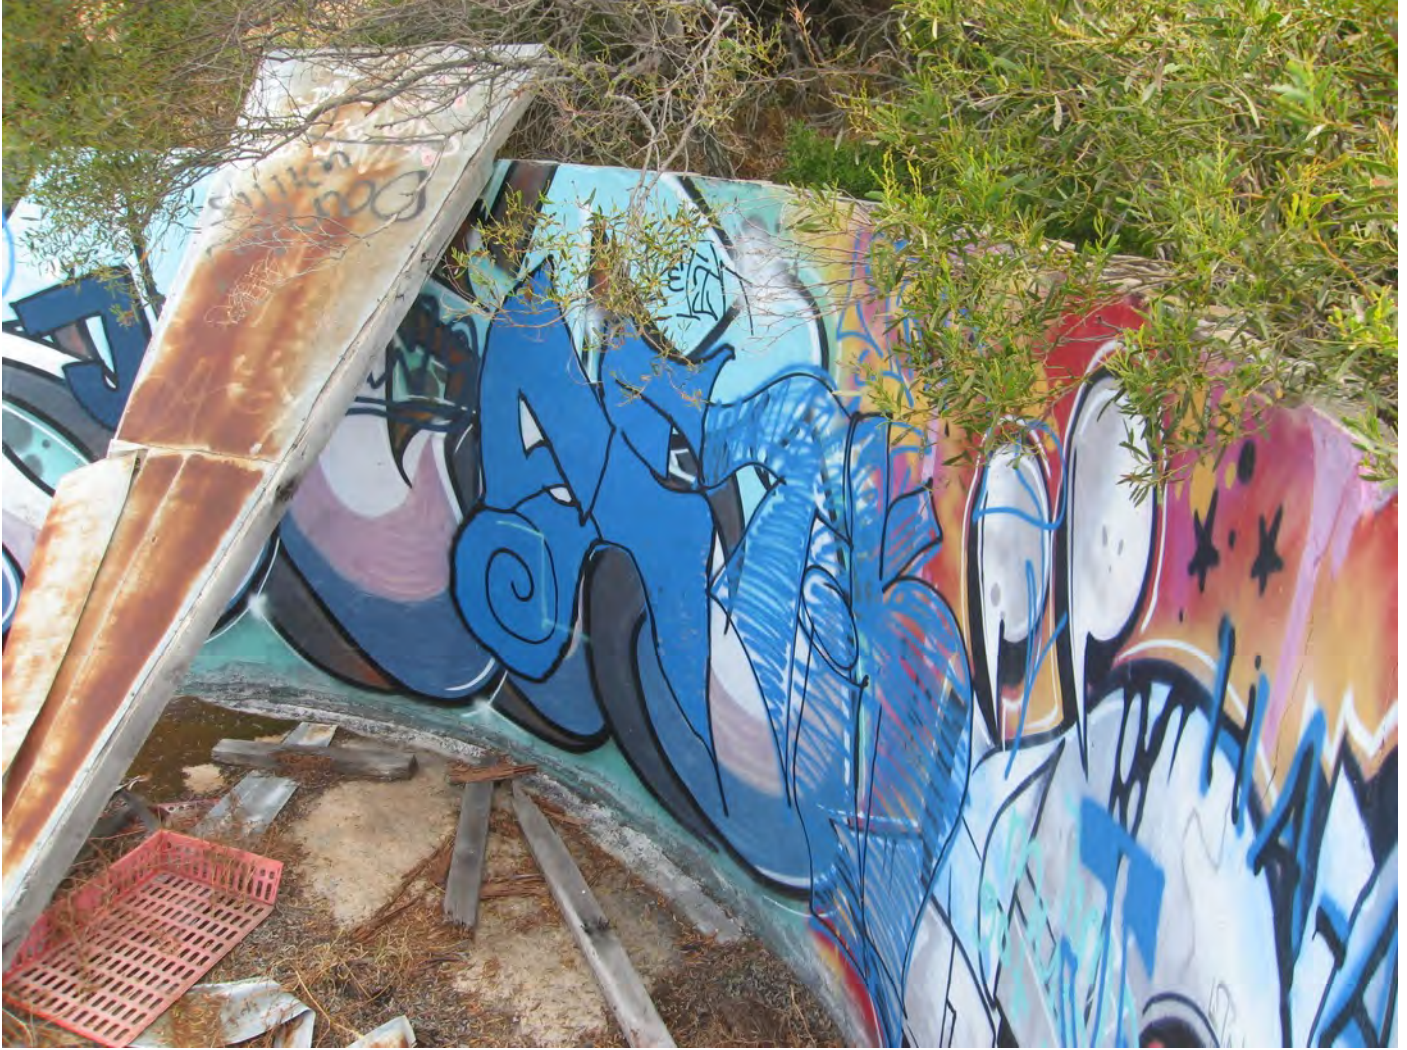
**Figure 155:** Water Tank – interior of water tank with remnant roofing fabric

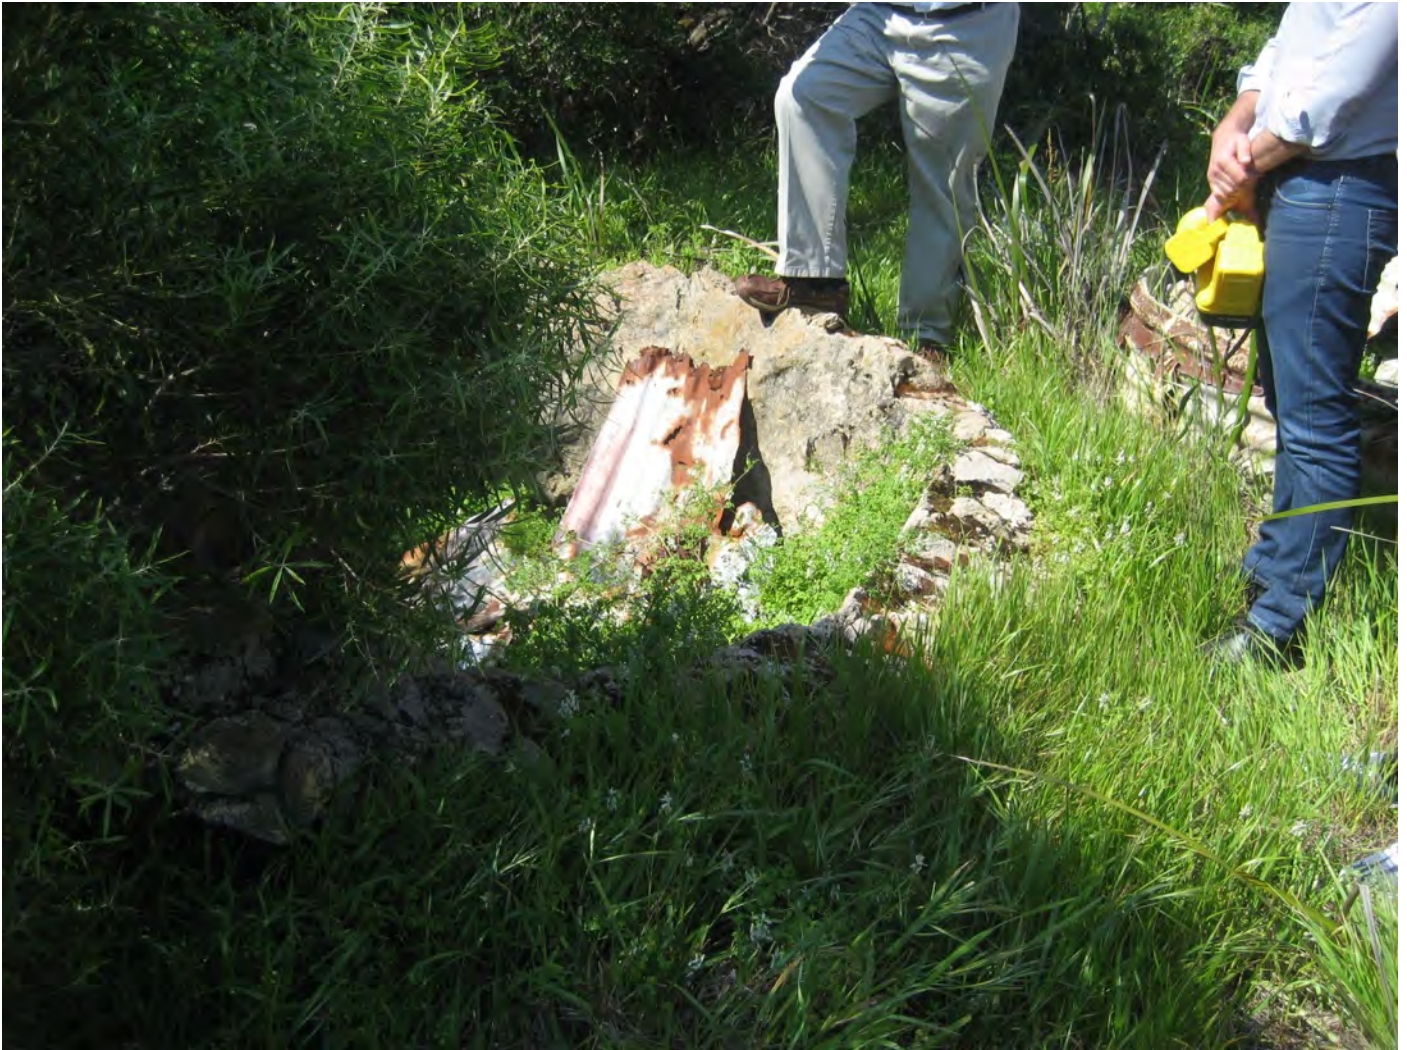
Figure 159: Well

The remnants of the well consist of a circular stone lined void of indeterminable depth. Remnant corrugated iron sheets are laying in the well which may have formed part of the well lid. The well is now full of building debris, sand and weeds.

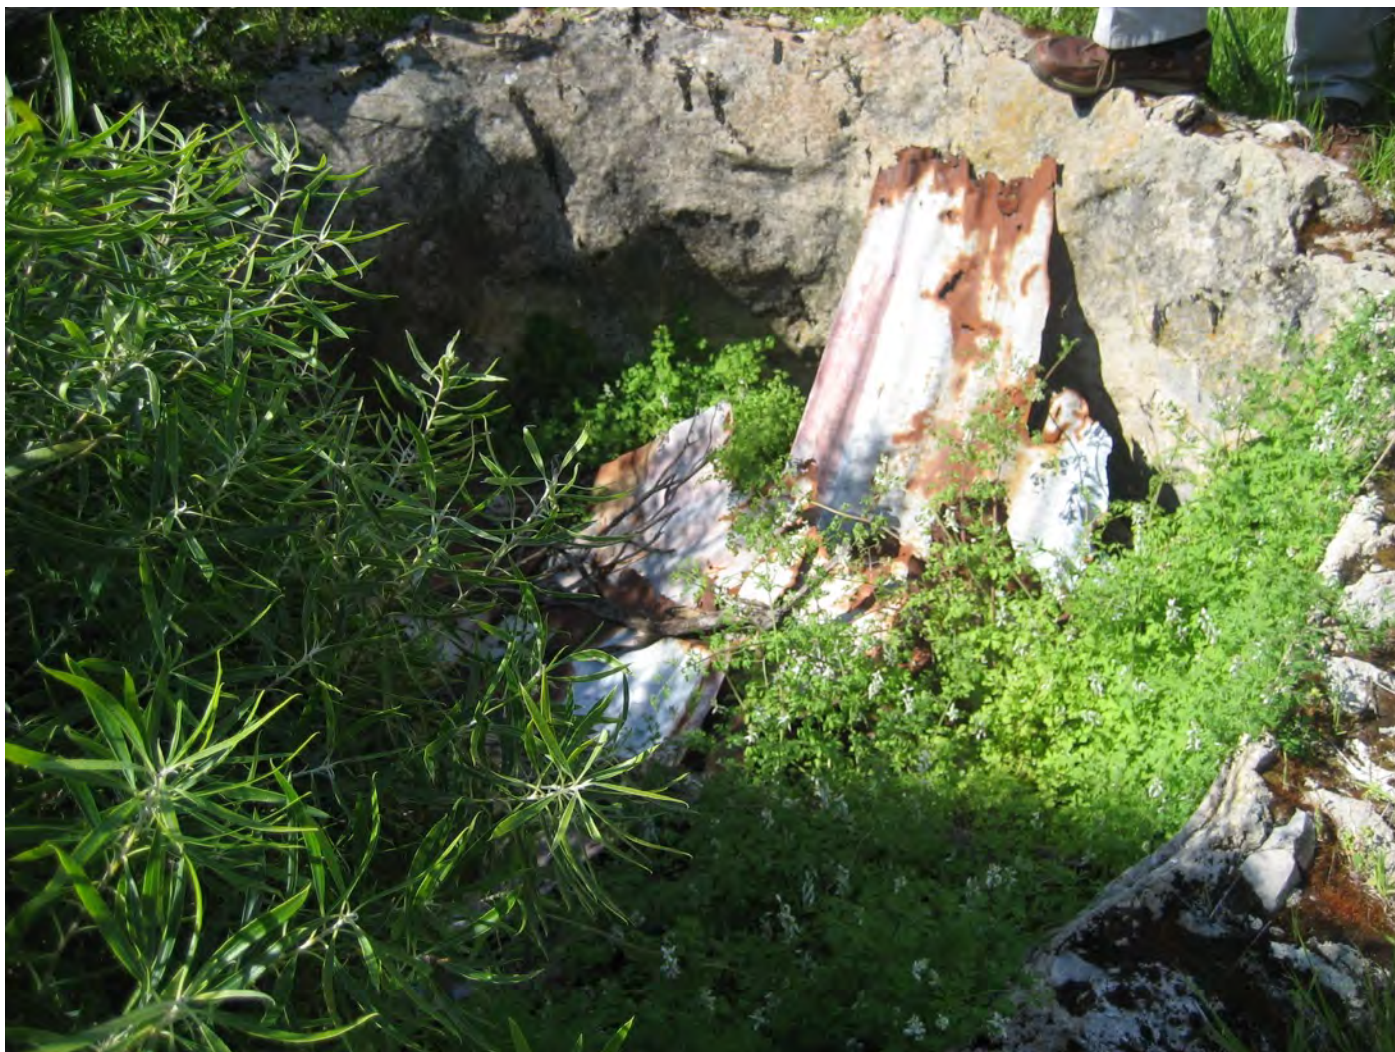
**Figure 160:** Well lining and remnant covering fabric

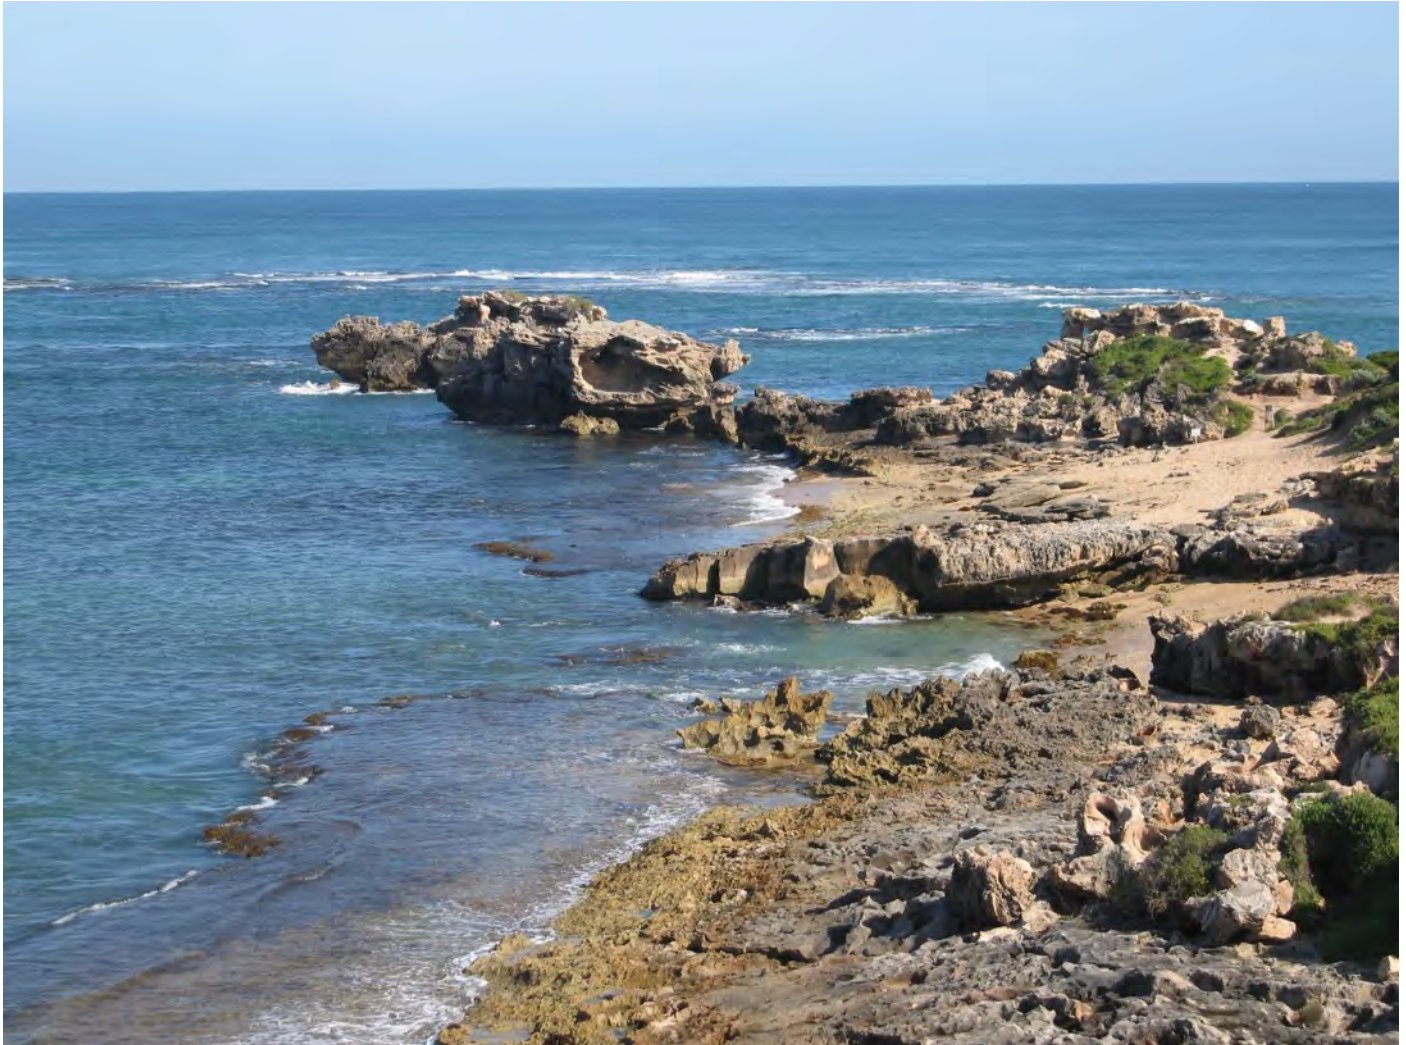
**Figure 162:** Mushroom Rock

Search lights were originally located at John Point and Mushroom Rock. Little evidence of the Sperry lights remains but the sites should be interpreted. John Point is fenced off due to the perilous condition of the cliff faces.

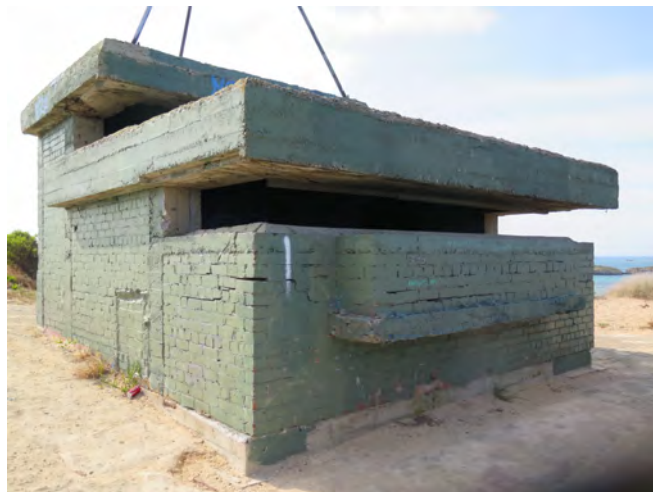
## 3.1 Observation Tower

The overall condition of the building is good given the original quality and speed of construction, its intended design life at outset, its atmospheric exposure and the levels of maintenance seen since decommissioning.

From the experience of similar sites it is most likely that the rapid acceleration of concrete cancer is not far away. With the cost and invasiveness of concrete repairs, the large scale concrete repair of such structures is likely to be both financially prohibitive and undesirable from a heritage viewpoint due to the scale of fabric loss. A more realistic approach to adopt is that of a managed ruin whereby efforts are focused on measures to slow down the onset of cancer as much as possible. Ultimately cancer will develop but with appropriate measures put in place, particularly those against water ingress and those promoting local and global drainage of surfaces, the timing of such can be slowed down significantly. The building's life is consequently extended significantly as a result.

- i) Re-screeding of concrete roof tops to good falls and with waterproof membrane or acrylic barrier.
- ii) Covers to look out openings at each levels.
- iii) Cover to entrance door opening.
- iv) Possible local concrete patch repairs and/or 'benching' of local surface to improve drainage.
- v) Corrosion inhibitor and epoxy/acrylic barrier coatings to exposed external concrete surfaces.
- vi) Carbonation barrier and corrosion inhibitor coatings to all internal concrete surfaces.

A permanent solution for the issue outlined in 3.1.3 above is required, whether this is to return backfill against the wall or some other means of providing support to the underside of the storage boxes. Crack damage to the return walls needs to be stitched.

The significance of the tripod to the place must be determined in the normal way via the Conservation Plan. Direction can then be given to its future. If to be retained there are works needed to all fastenings used both in the structure and for fixity to the roof slab. These are suffering corrosion. Corrosion expansion of the holding down bolts are causing damage to the roof slab. Renewal of all fixings with durable replacements required.

Paintwork to all steelwork is due for renewal. It has been lost fully at base plates and corrosion expansion has ensued applying further stress on bolts and the concrete roof slab in turn.

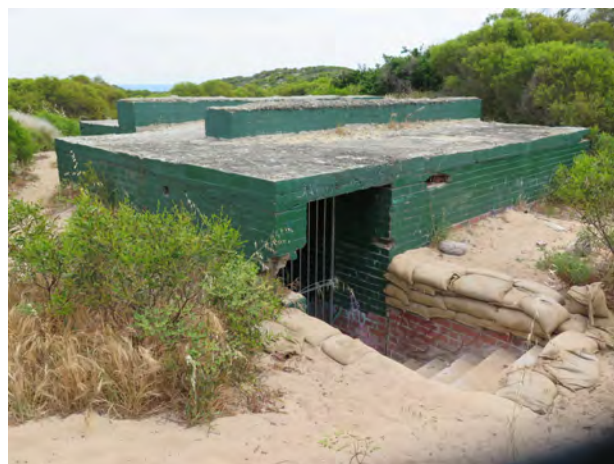
As for the Observation Tower, the structure has fared well given its history. The most vulnerable element on the face of it, the concrete roof slab, is in good condition without widespread cancer damage. Consistent damage has occurred however in the high level courses of the perimeter brickwork onto which the slab immediately drains. Horizontal steel bar bed reinforcement has been used at one course down in the two leafs of brickwork. These have corroded and expanded significantly in locations, particularly at the building corners. Here corrosion forces have been high, sufficient to jack up slab corners and push local brickwork off the building both externally and internally. This is both the most important condition issue and most important safety issue facing the building.

Shifting external ground levels has clearly occurred over time with erosion appearing to dominate the West side and deposition the East. This has not affected the structure much except to increase exposure to lateral moisture penetration on the East side and block the entry (now cleared). Additional lateral pressure is exerted on the brick retaining walls of the entry approach but to no effect as yet since entry clearing work. There has been undermining of the small brick vent shafts on the north side, these have consequently fallen away.

The subject steel causing the high level problems in the brick walls was and remains in fact of little use structurally and is best removed from the structure for the long term good. A systematic approach to raking out joints and removing bars can be used in conjunction with brick and crack repairs.

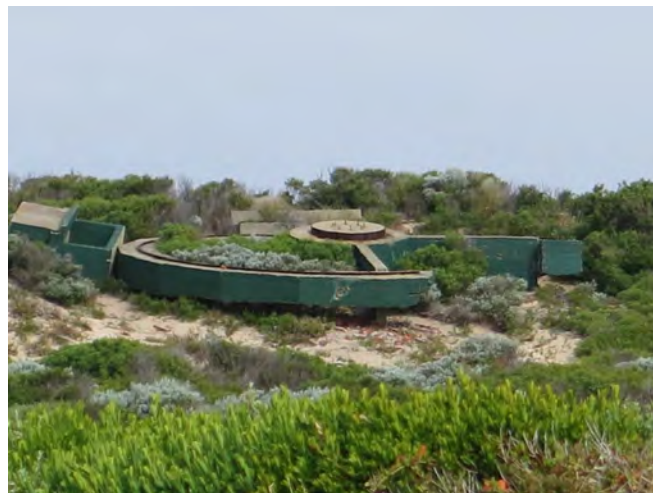
The structure exists in precarious dramatic equilibrium between shifting ground supports and its own structural ability to cope with these shifts. It has variously settled, twisted, snapped, slid, dragged, slumped and rotated in all planes with the natural erosion of the supporting dune.

The concrete strip footing of the stay track has been severely undermined and now spans in beam action to where support can be gained from either the dune or radial walls. It has failed in torsion on the North side trying to do this. Steel reinforcement has yielded and a new temporary equilibrium found until further dune erosion brings about a worsening of support conditions. A good deal of the South wing of the footing is suspended and with similar problems. The central concrete pedestal has been partially undermining but has tipped to the North with the weight of the stay footing imposed on it via its wing wall. The brick paving has all but fallen away and the northern munitions store has tipped and slid as a unit in the direction of sand shift, its base breaking up under the movement. The Southern munitions store remains the most stable of the site's features although this too has developed a lean towards downhill.

Some additional concrete repairs beyond those for concrete cancer would also possibly be necessary due to the structural damage incurred under dune movement. The scale of these will depend on the scheme selected for re-supporting the structure.

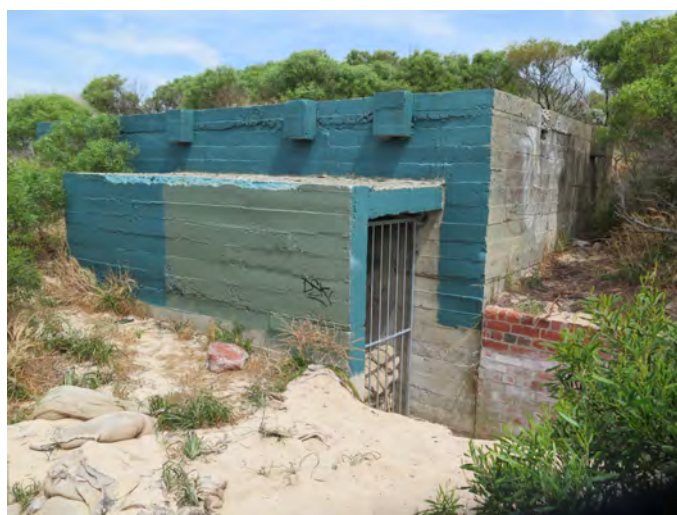
The concrete components have performed remarkably well. Clear concrete cancer is very limited in it's occurrence – at the base of external vent hoods only. The building's location on high ground with good falls away from structure and good drying conditions have benefited the

structure well. There is water ingress occurring through fine cracks in the roof slab and lateral ingress is taking place in the rear wall against which external sand build up has occurred, but this has not developed into visible concrete cancer to date.

Internally, brickwork is in good condition. The floor slab are obscured by sand build up but are expected also to be in good condition.

The principals and actions outlined in 3.1.3 for the Observation Tower apply here. Whilst concrete is in much better condition here, the advances made by carbonation and chloride fronts still need to be known in order plan for the structure's future management. No issues are anticipated for the concrete ground slabs, covers to openings serve to protect against moisture ingress into the fabric generally.

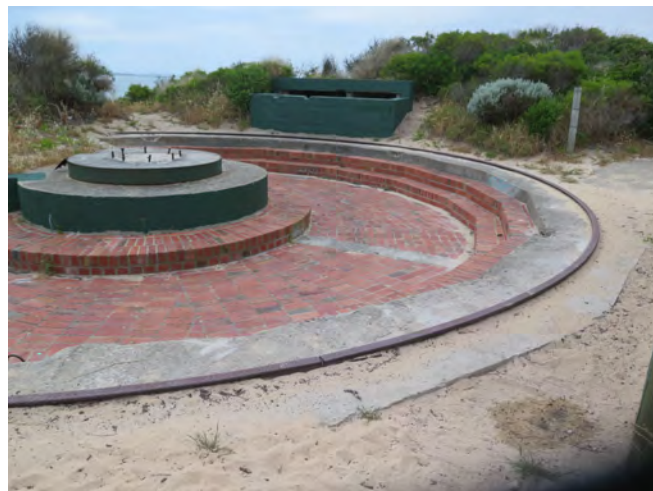
The emplacement remains are in good general structural condition. Shifting soil issues do not appear to have adversely affected stability of this site unlike the Emplacement 1 site. Concrete cancer is evident on the soffits of the munitions stores' roof slabs but the gun mount is relatively unaffected.

The steel perimeter belt around the upstand of the central gun hold down has corroded through on the far side of the upstand and presents a hazard to users. Potentially loose cover concrete to the munitions stores' roof soffits is another hazard is users who may enter the store space.

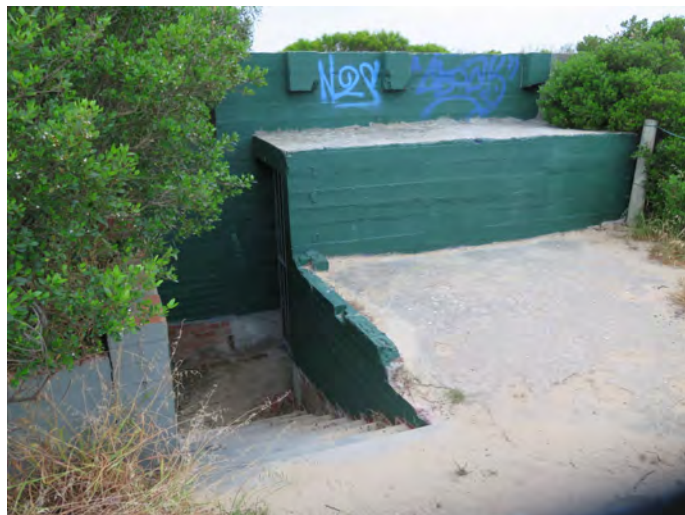
The building is similar in construction and condition to the bunker at Gun Emplacement 1.

The concrete components have performed well. Clear concrete cancer is limited in it's occurrence – the base of external vent hoods are affected only. The water ingress occurring through cracks in the roof slab is heavier than at the Gun Emplacement 1 bunker but this has not developed into visible concrete cancer to date.

Internally, brickwork is in good condition. The floor slabs are obscured by sand build up but are expected also to be in good condition

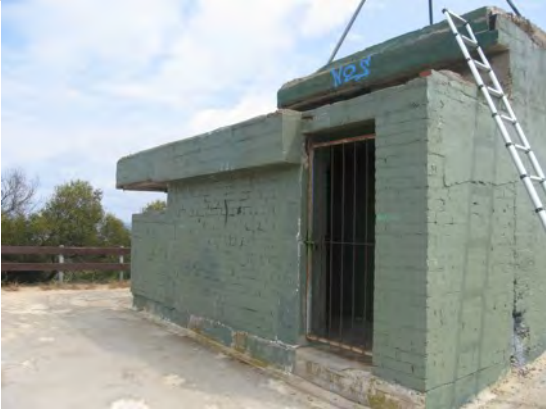
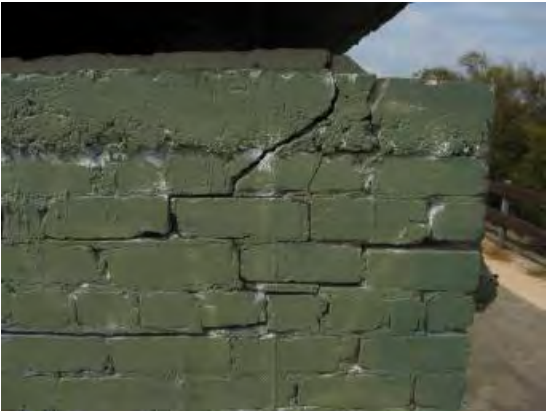
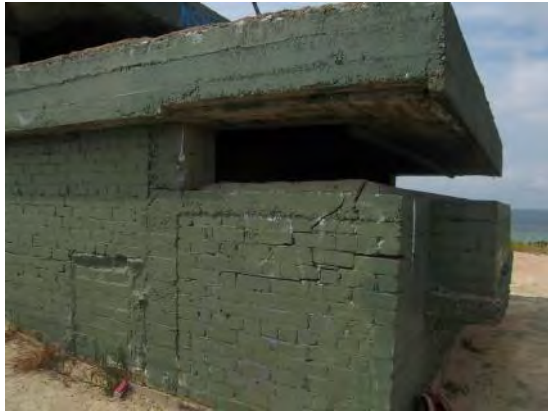
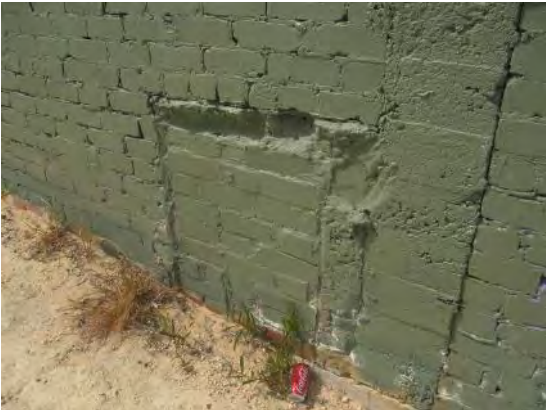
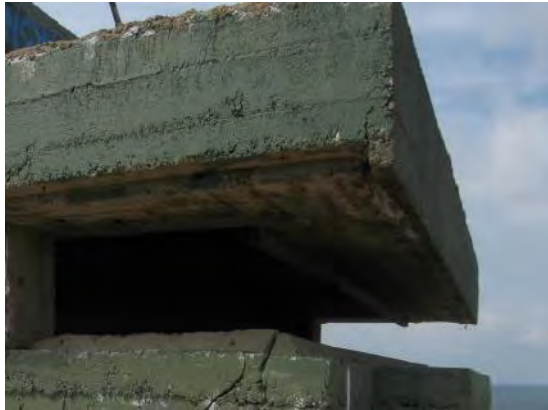
| Building Name | Condition Rating | Defect and Location | Work to Rectify Defect | Priority Ranking |
|---|---|---|---|---|
| North elevation | C | Cracking occurring to the north west corner where the weight of the projecting storage spaces is pulling the west wall away from the north and south elevations. Spalling of concrete caused by water ingress into the concrete and subsequent rusting of the steel reinforcement. Loose and missing mortar to the brickwork. Non-original paint finish. | A solution to supporting the projecting section of the west wall needs to be determined either by way of reintroducing the ground level under the projection which will provide support in the original manner or some form of bracket/brace will need to be designed by the engineer to provide adequate load bearing support. | 1 |

| Building Name | Condition Rating | Defect and Location | Work to Rectify Defect | Priority Ranking |
|---|---|---|---|---|
| | | | Once the projecting element to the west wall has been remediated the cracking in the north wall can be remediated by crack stitching using Helifix Helibars to engineer's specification. The crack stitching will tie the wall back together reintroducing the desired level of structural stability and redistribute the load of the wall in its desired manner. | 1 |
| | | | Remove paint from entire elevation as this can contribute to the deterioration of the fabric. Paint removal should not unduly damage the substrate and mortar and test panels in discrete locations should be established prior to embarking on the full removal. Non-caustic solvent based methods or low pressure steam removal can be tried. Peelaway paint removal system can be used or Westox's DeLam which applies a poultice to the paint and will be ready to be removed within a few days. Not all paint traces will be removed due to the texture of the bricks and concrete. | 1 |
| | | | Repoint all joints showing sign of deterioration by raking out loose mortar to a depth that will ensure new mortar will hold. Mortar is to match existing ensuring that the mortar is a softer mix than the brick. | 1 |
| | | | Concrete elements are to be remediated. Rusting to the structural elements encased by the concrete is becoming visible causing the concrete to spall and break off. The high salt content in the air contributes to the accelerated rate of deterioration as does inadequate protection from water ingress.<br><br>It is not recommended that the damaged concrete be removed in its entirety, utilising patch repairs to try and retain the original fabric. Where the steel reinforcement has rusted causing the concrete to spall, the concrete needs to be cutback and the steel cleaned, treated with an anticorrosive treatment such as Sika Ferro Guard and new concrete patched in to match existing. Due to the harsh environmental conditions at Point Peron, it is recommended that a corrosion barrier coating is applied to all concrete surfaces to reduce/delay further deterioration.<br><br>As graffiti appears to be an on-going issue, an anti-graffiti coating may be considered but this should not interfere with the performance of the corrosion | 1 |

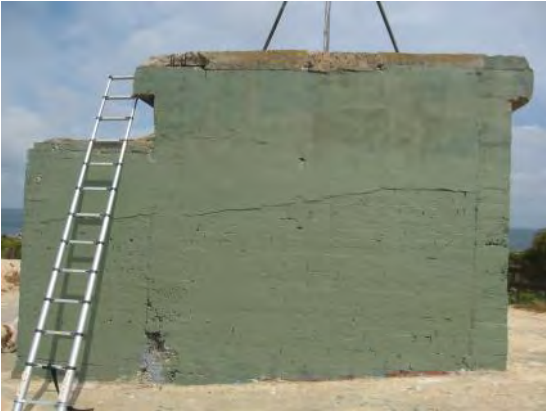
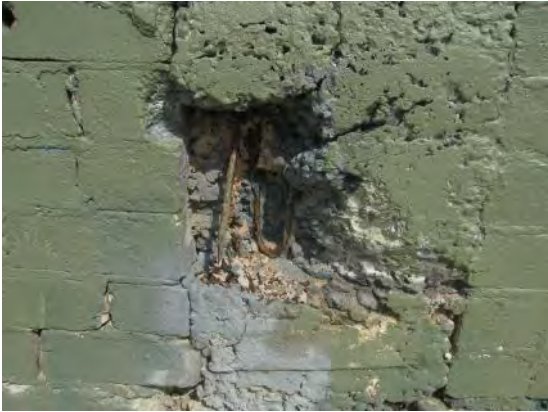
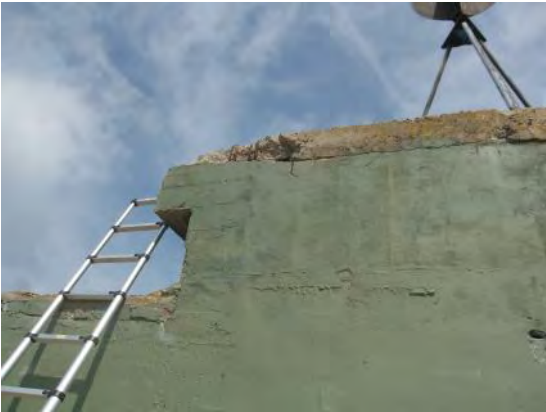
| Building Name | Condition Rating | Defect and Location | Work to Rectify Defect | Priority Ranking |
|---|---|---|---|---|
| East Elevation | C | <p>Spalling of concrete caused by water ingress into the concrete and subsequent rusting of the steel reinforcement.<br/>Loose and missing mortar to the brickwork.<br/>Non-original paint finish.</p> <div></div> | <p>Damage to the reinforced concrete framework, particularly at low level is to be remediated utilising the cut out, application of corrosive inhibitor and patch repair of the concrete method outlined above for the north elevation.</p> <p>The cause of the low level damage is unknown as it is a localised area of failure and may have been exacerbated through human intervention. Land levels have been altered around the building which</p> | 2 |

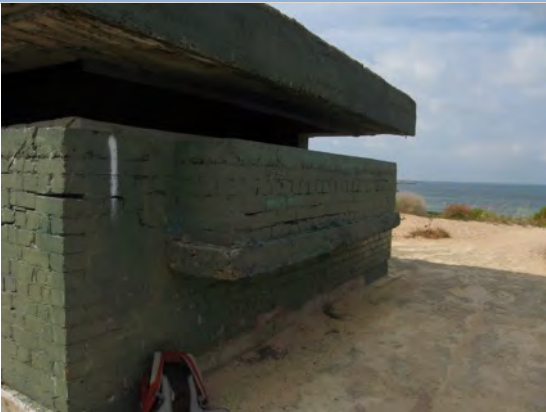
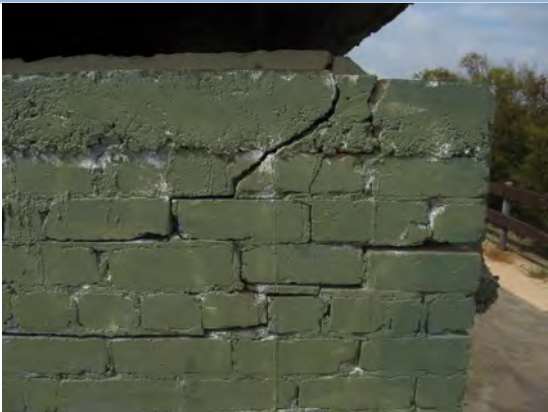
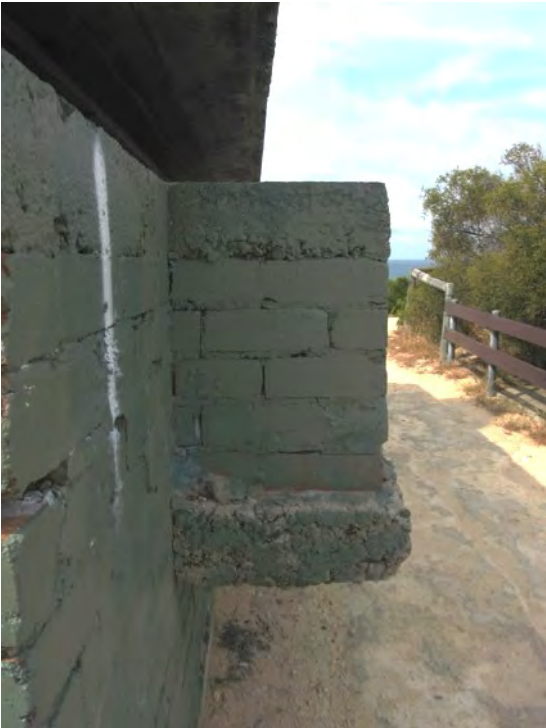
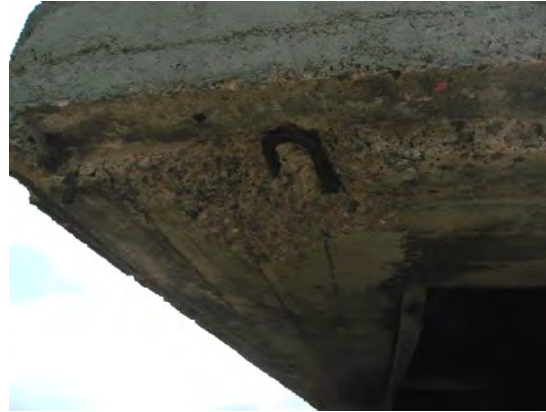
| Building Name | Condition Rating | Defect and Location | Work to Rectify Defect | Priority Ranking |
|---|---|---|---|---|
| | | <p>Loose mortar in brick joints</p> <p>Non-original paint finish</p> <p>Rusted reinforcements in the concrete causing sections of concrete to spall and fall off</p> | <p>Peelaway paint removal system can be used or Westox's DeLam which applies a poultice to the paint and will be ready to be removed within a few days. Not all paint traces will be removed due to the texture of the bricks and concrete.</p> <p>Repoint all joints showing sign of deterioration by raking out loose mortar to a depth that will ensure new mortar will hold. Mortar is to match existing ensuring that the mortar is a softer mix than the brick.</p> <p>Concrete elements are to be remediated. Rusting to the structural elements encased by the concrete is becoming visible causing the concrete to spall and break off. The high salt content in the air contributes to the accelerated rate of deterioration as does inadequate protection from water ingress.</p> <p>It is not recommended that the damaged concrete be removed in its entirety, utilising patch repairs to try and retain the original fabric. Where the steel reinforcement has rusted causing the concrete to spall, the concrete needs to be cutback and the steel cleaned, treated with an anticorrosive treatment such as Sika Ferro Guard and new concrete patched in to match existing. Due to the harsh environmental conditions at Point Peron, it is recommended that a corrosion barrier coating is applied to all concrete surfaces to reduce/delay further deterioration.</p> | <p>1</p> <p>1</p> |

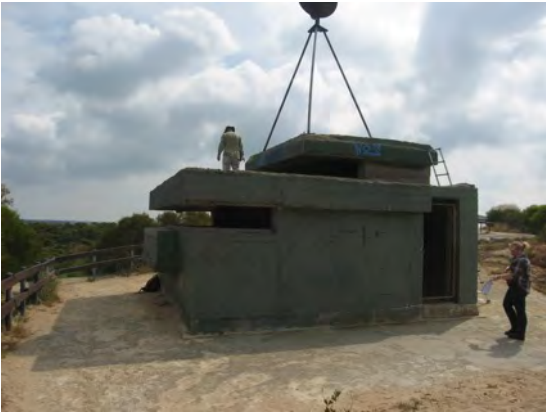
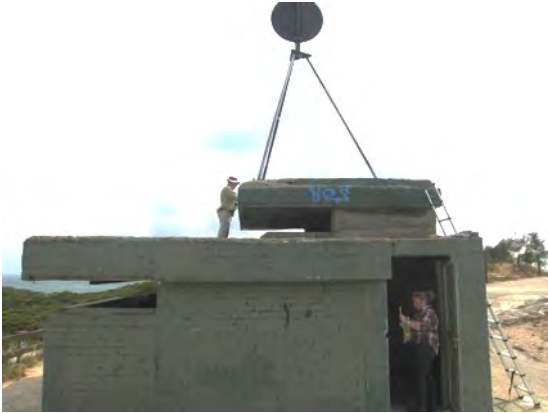
| Building Name | Condition Rating | Defect and Location | Work to Rectify Defect | Priority Ranking |
|---|---|---|---|---|
| South Elevation | B | <p>The south elevation is in good condition apart from sections of missing or loose mortar around the bricks.</p> | <p>Remove paint from entire elevation as this can contribute to the deterioration of the fabric. Paint removal should not unduly damage the substrate and mortar and test panels in discrete locations should be established prior to embarking on the full removal. Non-caustic solvent based methods or low pressure steam removal can be tried. Peelaway paint removal system can be used or Westox's DeLam which applies a poultice to the paint and will be ready to be removed within a few days. Not all paint traces will be removed due to the texture of the bricks and concrete.</p> | 2 |

| Building Name | Condition Rating | Defect and Location | Work to Rectify Defect | Priority Ranking |
|---|---|---|---|---|
| | | | <p>Repoint all joints showing sign of deterioration by raking out loose mortar to a depth that will ensure new mortar will hold. Mortar is to match existing ensuring that the mortar is a softer mix than the brick.</p> | 2 |

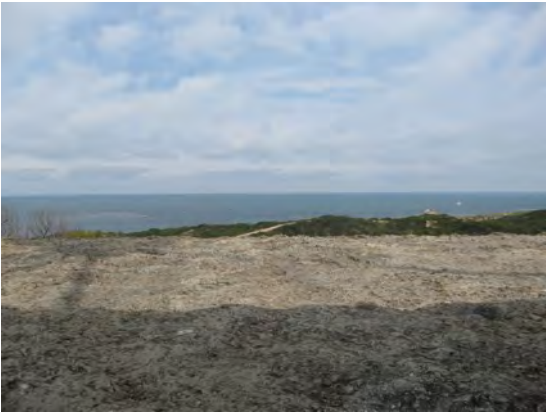
| Building Name | Condition Rating | Defect and Location | Work to Rectify Defect | Priority Ranking |
|---|---|---|---|---|
| Roof | B | Concrete roof slabs supported on load bearing reinforced concrete framework and brick infill panels.<br> | Monitor condition as currently appears to be in sound condition. Bitumen covering has eroded and consideration may be given to reapplying the finish if water ingress becomes an issue. | 2 |

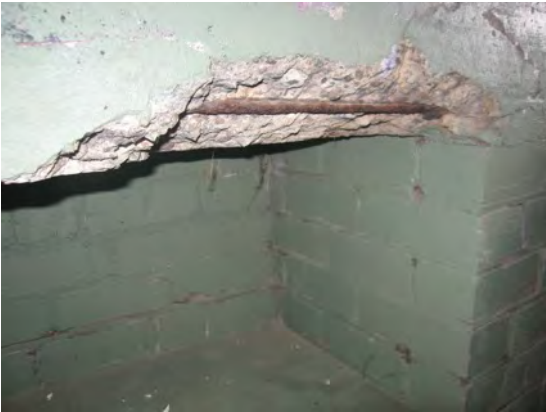
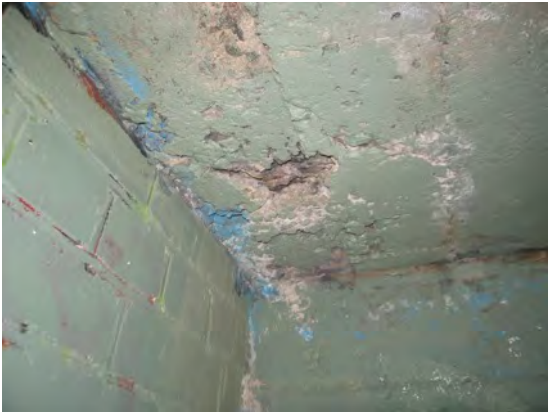
| Building Name | Condition Rating | Defect and Location | Work to Rectify Defect | Priority Ranking |
|---|---|---|---|---|
| Ground floor – interior | C | Spalling of concrete in projecting storage areas with clearly visible rusted steel reinforcement rods.<br> | Patch repairs to reinforced concrete as outlined above. Monitor condition of ceiling for further deterioration. | 2 |

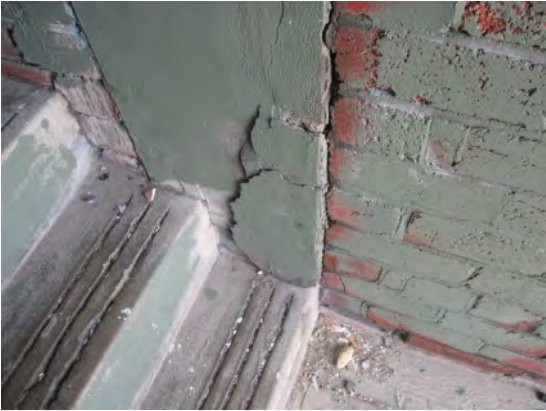
| Building Name | Condition Rating | Defect and Location | Work to Rectify Defect | Priority Ranking |
|---|---|---|---|---|
| | | Render to concrete column at foot of stairs is drummy, cracking and falling off.<br><br>Painted finish with graffiti | Remove drummy render from the concrete column at the foot of the stairs, ensuring that all retained render is in a sound condition. Patch repair in a render mix to match existing.<br><br>If the structure is to be secured by the metal grille gate graffiti should not be an ongoing issue for the internal space and once all paint and graffiti has been removed, there should not be a requirement to coat the internal fabric with an anti-graffiti coating. | 2 |

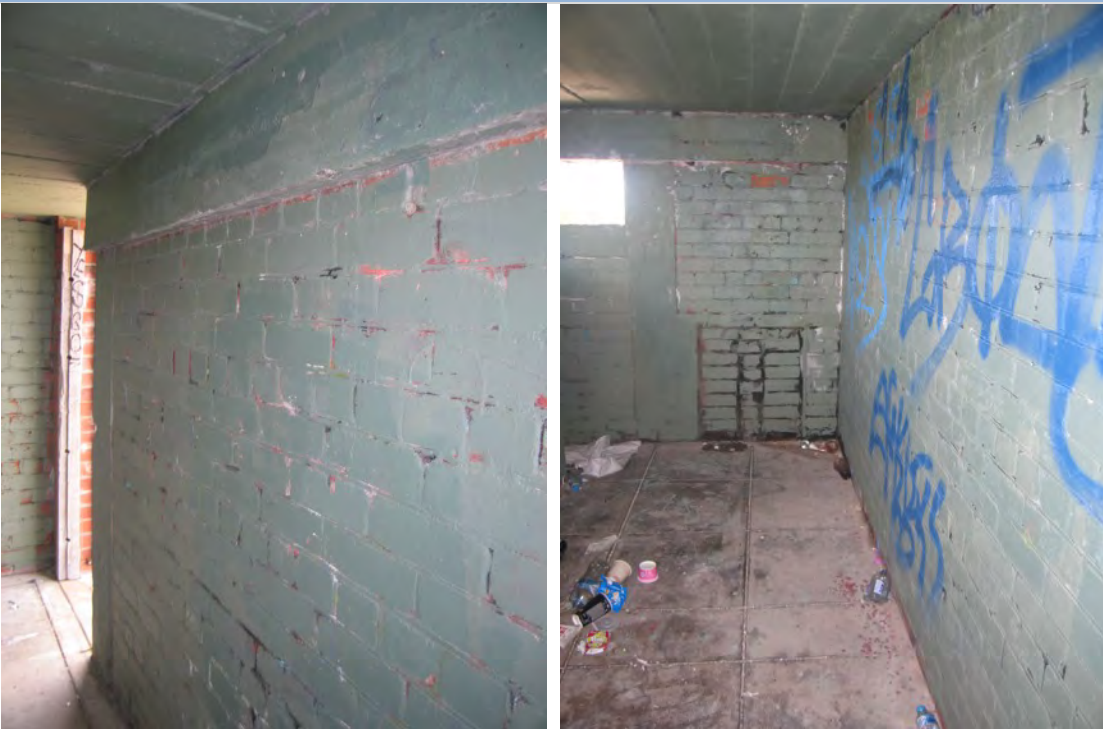
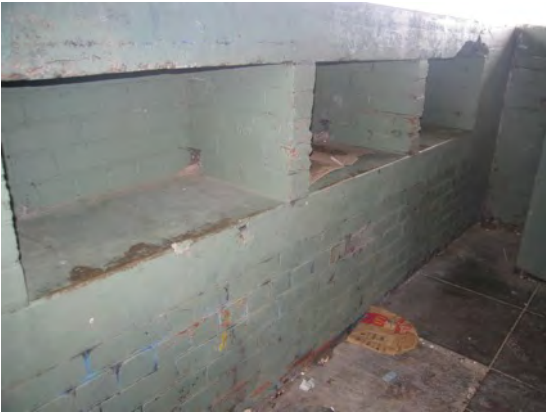
| Building Name | Condition Rating | Defect and Location | Work to Rectify Defect | Priority Ranking |
|---|---|---|---|---|
| | | <div></div> <p>Missing flagstones</p> <div></div> | | |

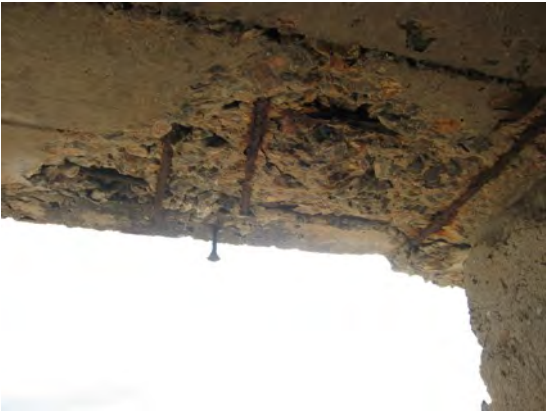
| Building Name | Condition Rating | Defect and Location | Work to Rectify Defect | Priority Ranking |
|---|---|---|---|---|
| Upper floor interior | C | <p>Concrete cancer around embrasure opening with prominent rusted steels projecting through concrete with the reinforced steel framework clearly visible demonstrating a substantial loss of concrete.</p> <div></div> | <p>Concrete elements are to be remediated. Rusting to the structural elements encased by the concrete is becoming visible causing the concrete to spall and break off. The high salt content in the air contributes to the accelerated rate of deterioration as does inadequate protection from water ingress.</p> <p>It is not recommended that the damaged concrete be removed in its entirety, utilising patch repairs to try and retain the original fabric. Where the steel reinforcement has rusted causing the concrete to spall, the concrete needs to be cutback and the steel cleaned, treated with an anticorrosive treatment such as Sika Ferro Guard and new concrete patched in to match existing. Due to the harsh environmental conditions at Point Peron, it is recommended that a corrosion barrier coating is applied to all concrete surfaces to reduce/delay further deterioration.</p> <p>Remove paint from all elevations as this can contribute to the deterioration of the fabric. Paint removal should not unduly damage the substrate and mortar and test panels in discrete locations should be established prior to embarking</p> | <p>2</p> <p>2</p> |

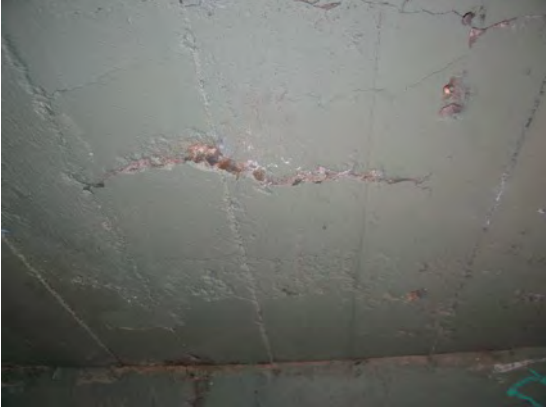
| Building Name | Condition Rating | Defect and Location | Work to Rectify Defect | Priority Ranking |
|---|---|---|---|---|
| | | <p>hairline cracking in the concrete slab ceiling</p> | <p>on the full removal. Non-caustic solvent based methods or low pressure steam removal can be tried.</p> <p>Peelaway paint removal system can be used or Westox's DeLam which applies a poultice to the paint and will be ready to be removed within a few days. Not all paint traces will be removed due to the texture of the bricks and concrete.</p> | |

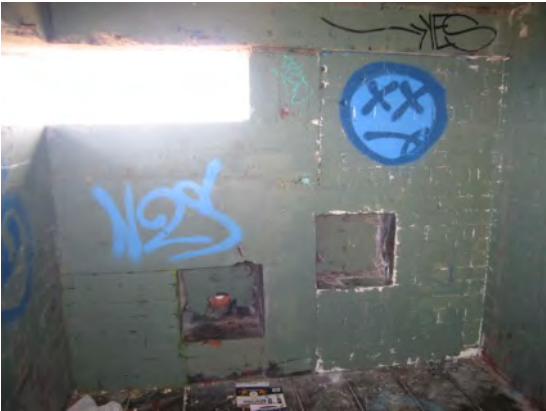
| Building Name | Condition Rating | Defect and Location | Work to Rectify Defect | Priority Ranking |
|---|---|---|---|---|
| | | <p>Painted finish with graffiti and rubbish accumulation</p> | | |

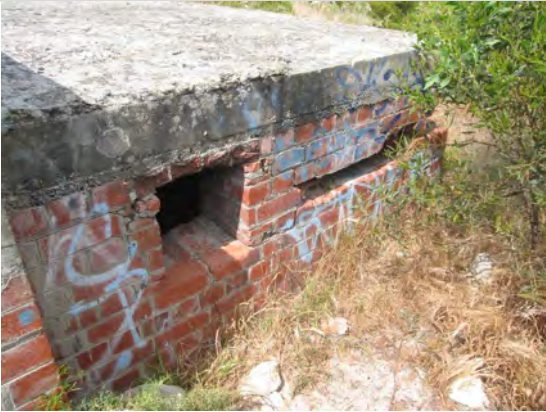
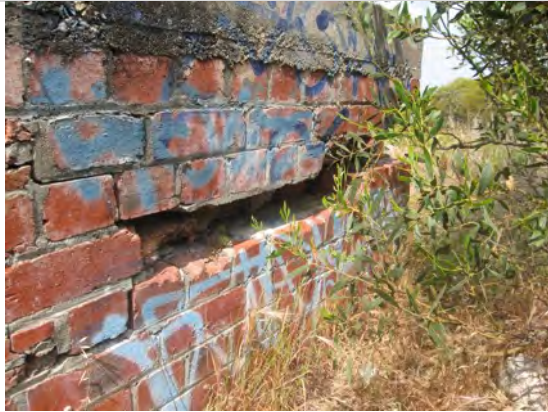
| Building Name | Condition Rating | Defect and Location | Work to Rectify Defect | Priority Ranking |
|---|---|---|---|---|
| | | <p>The concrete roof slab in the north east corner has been pushed up from the brickwork with the corner of the slab breaking off.</p> | <p>given to using a hydraulic lime to give increased strength. The original style of pointing should be replicated in all new work.</p> <p>Where bricks need to be replaced, these should be salvaged bricks to match the existing. Bricks from around the site may be used. All introduced bricks should be the same dimensions as the originals.</p> <p>Concrete elements are to be remediated. Rusting to the structural elements encased by the concrete is becoming visible causing the concrete to spall and break off. The high salt content in the air contributes to the accelerated rate of deterioration as does inadequate protection from water ingress.</p> <p>It is not recommended that the damaged concrete be removed in its entirety, utilising patch repairs to try and retain the original fabric. Where the steel reinforcement has rusted causing the concrete to spall, the concrete needs to be cutback and the steel cleaned, treated with an anticorrosive treatment such as Sika Ferro Guard and new concrete patched in to match existing. Due to the harsh environmental conditions at Point Peron, it is recommended that a corrosion barrier coating is applied to all concrete surfaces to reduce/delay further deterioration.</p> <p>Graffiti is an issue across the site. Santi graffiti coatings can be applied but these should not be to the detriment of the original underlying fabric. Any coating should allow the underlying fabric to breathe and function as designed. Any coating should not impact on the aesthetic of the underlying fabric.</p> | 1 |

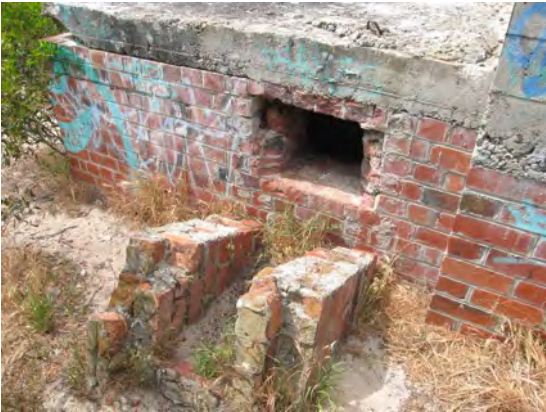
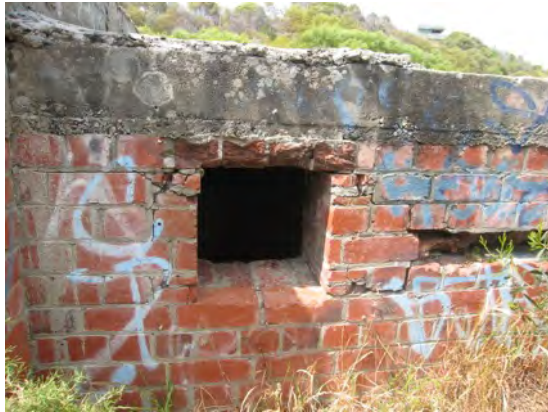
| Building Name | Condition Rating | Defect and Location | Work to Rectify Defect | Priority Ranking |
|---|---|---|---|---|
| | | <p>Brickwork is covered in graffiti</p> | | |
