# Point Peron “K” Battery Conservation Management Plan

South West Corridor Development Foundation Inc.

**HOCKING**  
HERITAGE STUDIO

March 2016

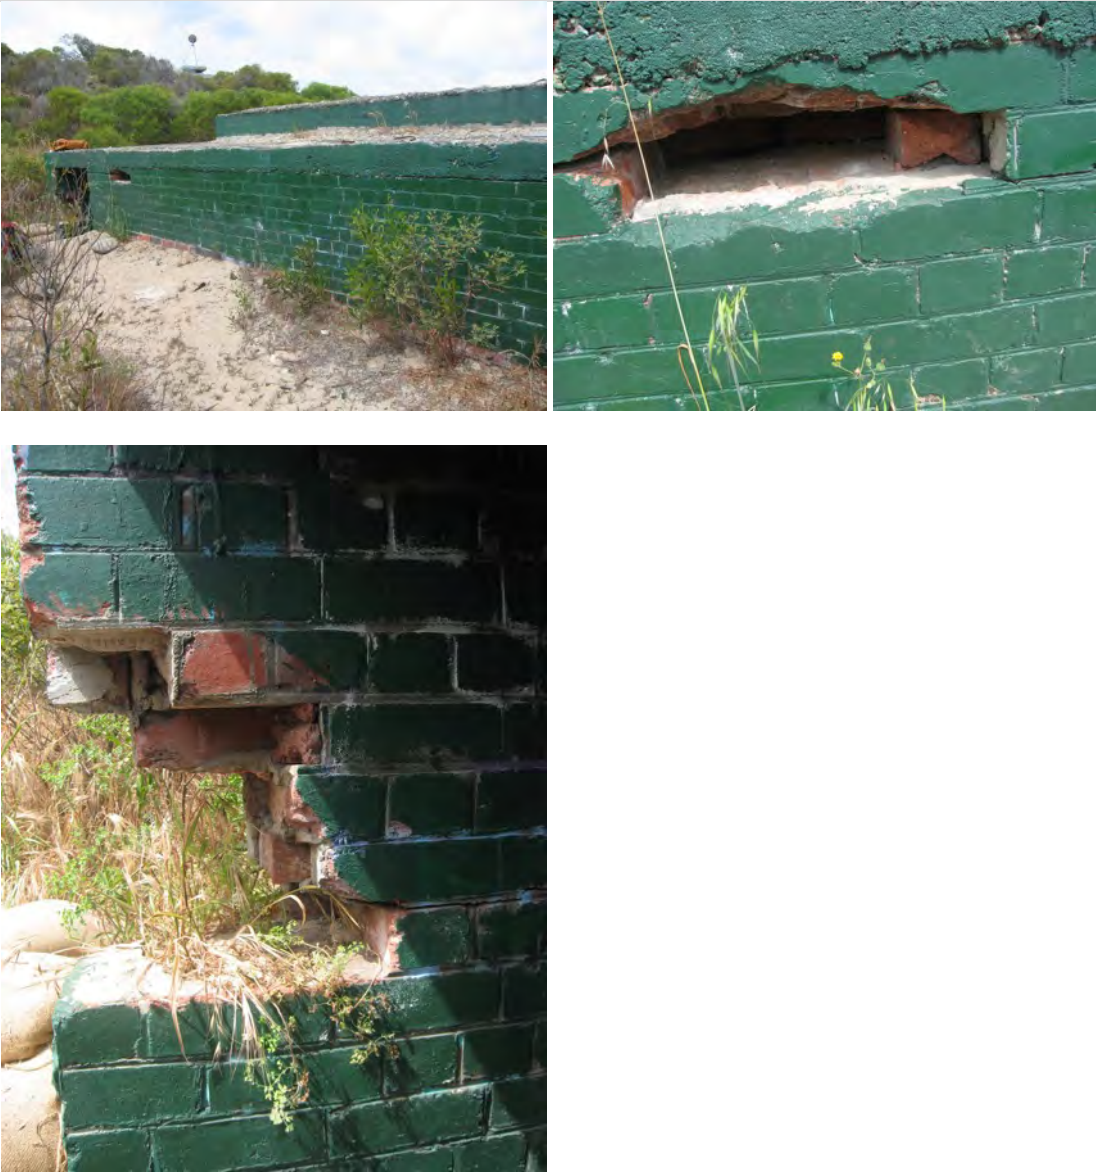
| Building Name | Condition Rating | Defect and Location | Work to Rectify Defect | Priority Ranking |
|---|---|---|---|---|
| East Elevation | B | The east elevation incorporates the entrance and is generally in good condition. Bricks are missing to the south east corner by the entrance and along the main elevation. | Remove paint from entire elevation as this can contribute to the deterioration of the fabric. Paint removal should not unduly damage the substrate and mortar and test panels in discrete locations should be established prior to embarking on the full removal. Non-caustic solvent based methods or low pressure steam removal can be tried.<br>Peelaway paint removal system can be used or Westox's DeLam which | 2 |

| Building Name | Condition Rating | Defect and Location | Work to Rectify Defect | Priority Ranking |
|---|---|---|---|---|
| | | | <p>applies a poultice to the paint and will be ready to be removed within a few days. Not all paint traces will be removed due to the texture of the bricks and concrete. Specifier's instructions are to be followed in the application.</p> <p>The missing brickwork around the entrance should be reinstated. Check around the structure to look for bricks. If salvaged bricks are to be used, ensure they are clean of mortar debris prior to reinstatement. Rake the mortar joints out to a good depth to ensure the new mortar will hold and relay the bricks using the same bond and pointing style as the original.</p> | 1 |

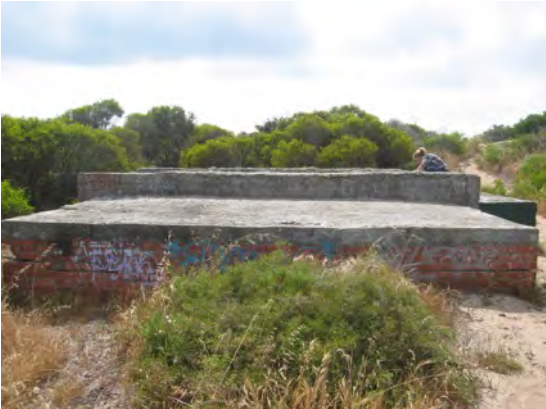
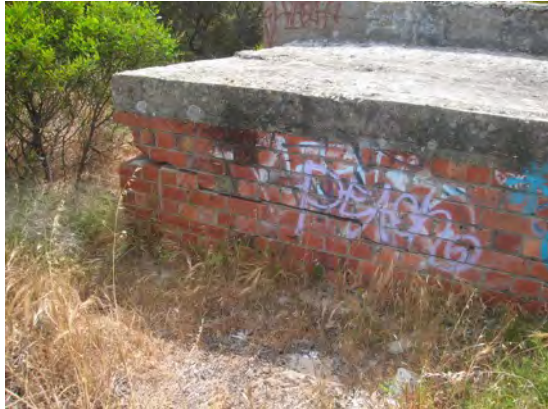
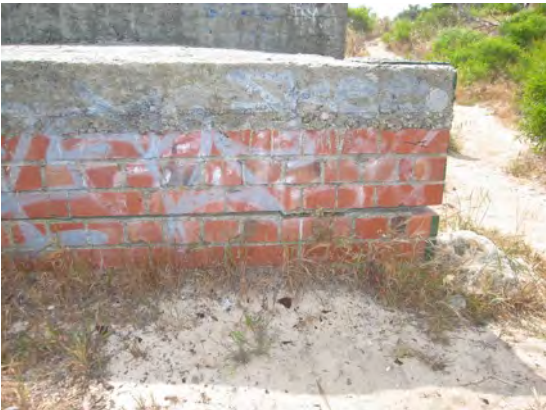
| Building Name | Condition Rating | Defect and Location | Work to Rectify Defect | Priority Ranking |
|---|---|---|---|---|
| West Elevation | D | Upper sections of brick walls are showing signs of failure due to water damage from the flat roof causing the steel reinforcement bars to rust and expand causing failure to the brickwork. | The reinforcing bars should be removed to prevent further damage. Each should be cut out by raking out the joints, removing the corroded steel, replace with Helibars to crack stitch the walls to engineer specifications. | 1 |

| Building Name | Condition Rating | Defect and Location | Work to Rectify Defect | Priority Ranking |
|---|---|---|---|---|
| | | | Areas of damaged mortar to be raked out to an appropriate depth to allow the new mortar to hold. New mortar is to match the existing and is advisable to have the mortar analysed to ensure a match is made. The mortar is likely to be a lime mortar which is softer than the brick allowing for moisture to escape through the joints rather than destroy the brick. Due to the harsh environmental conditions the structures are located in, consideration may be given to using a hydraulic lime to give increased strength. The original style of pointing should be replicated in all new work. | 1 |
| | | | Where bricks need to be replaced, these should be salvaged bricks to match the existing. Bricks from around the site may be used. All introduced bricks should be the same dimensions as the originals. | 1 |
| | | | Concrete elements are to be remediated. Rusting to the structural elements encased by the concrete is becoming visible causing the concrete to spall and break off. The high salt content in the air contributes to the accelerated rate of deterioration as does inadequate protection from water ingress.<br><br>It is not recommended that the damaged concrete be removed in its entirety, utilising patch repairs to try and retain the original fabric. Where the steel reinforcement has rusted causing the concrete to spall, the concrete needs to be cutback and the steel cleaned, treated with an anticorrosive treatment such as Sika Ferro Guard and new concrete patched in to match existing. Due to the harsh environmental conditions at Point Peron, it is recommended that a corrosion barrier coating is applied to all concrete surfaces to reduce/delay further deterioration.<br><br>Graffiti is an issue across the site. Santi graffiti coatings can be applied but these should not be to the detriment of the original underlying fabric. Any coating should allow the underlying fabric to breathe and function as designed. Any coating should not impact on the aesthetic of the underlying fabric. | 1 |

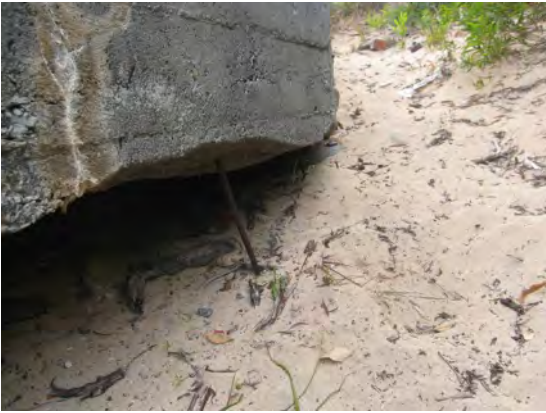
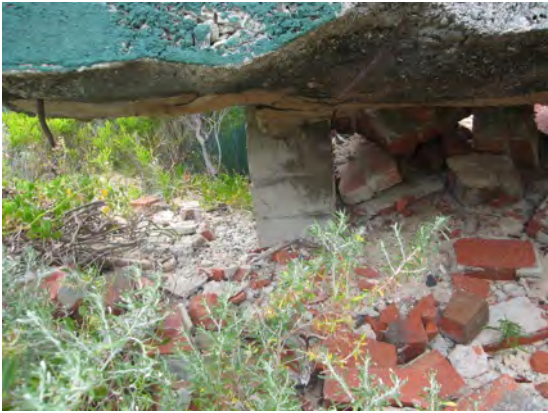
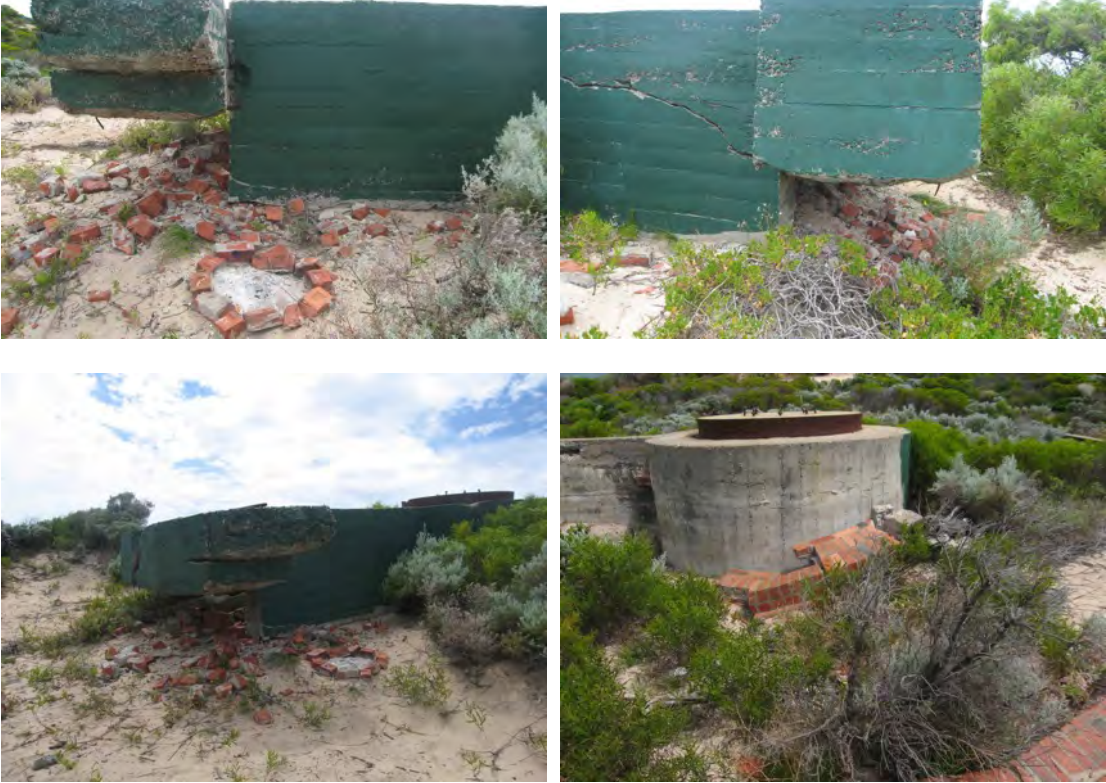
| Building Name | Condition Rating | Defect and Location | Work to Rectify Defect | Priority Ranking |
|---|---|---|---|---|
| <b>Gun Emplacement No. 1</b><br><br>Reinforced concrete construction with remnant brick paving, central reinforced concrete gun mount | E | <p>Gun Emplacement No. 1 is in poor condition but it is not recommended that the structure be reconstructed. The current state of the gun emplacement reflects the way in which the unstable land conditions can impact on any built structure. However, Gun Emplacement No. 1 is in a potentially dangerous condition for visitors and works are required to stabilise the structure. Reinforcement steel bars are sticking out beneath the structure. The loads have shifted due to the changing land conditions which has removed the structural support from aspects of the structure causing cracking and potential splitting of elements, especially the concrete retaining wall. The structure has been partially painted.</p> | <p>Any repairs are to be undertaken in conjunction with the structural engineer's advice.</p> <p>The key issue is to try and create ground stability prior to implementing any repairs to the Gun Emplacement structure. The type of investigative works required to determine a solution is outside the scope of this report and will require the input of a specialist geotechnical engineer. The works required to create any level of stabilisation will be substantial but should prevent the structure from slipping and twisting further. Once stabilisation has been achieved, the structure will remain in its current condition and will not be reconstructed.</p> <p>Once the structure is stabilised, certain conservation works will be required to address the onset of concrete cancer. Repairs are to be carried out in line with the methodology outlined above.</p> <p>Substantial cracks have occurred in the concrete retaining wall due to a shifting of loading conditions and loss of support. Depending upon the method of stabilisation implemented, some form of crack stitching or introduction of ties may be required to tie the elements back together.</p> <p>Ideally the paint should be removed.</p> <p>The amount of public access to the structure needs to be carefully considered. At present, the structure provides a tempting invitation to climb all over it. Whilst it is not the best form of conservation to have this occur due to the ongoing damage it can cause to the fabric, preventing access would be require some form of fencing which may impact on the natural aesthetics of the place. The heritage significance of the place must be weighed up</p> | 1<br><br>1<br><br><br>2<br><br>2<br><br>2<br><br>2 |

| Building Name | Condition Rating | Defect and Location | Work to Rectify Defect | Priority Ranking |
|---|---|---|---|---|
| | | | against public safety. At present there are a large number of reinforcement rods that project out of the concrete retaining walls which can cause serious injury. | |

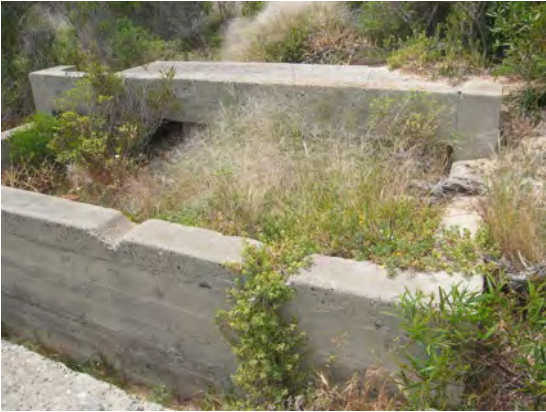
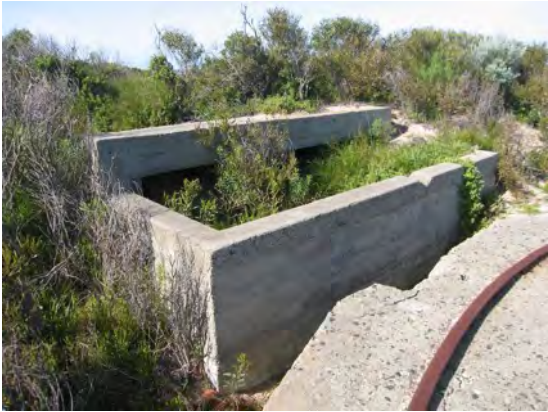
| Building Name | Condition Rating | Defect and Location | Work to Rectify Defect | Priority Ranking |
|---|---|---|---|---|
| <b>Ammunition Store 2</b><br><br>Reinforced concrete | C | <p>The second ammunition store has fared much better with only slight movement from its original position and has not been subjected to the same degree of twist and torsion and has therefore remained virtually in tact. The structure is largely submerged in the sand dune which may have contributed to its protection.<br/>The Ammunition Store is full of sand and vegetation.</p> | <p>Remove the sand and vegetation growth from within the structure, address any signs of concrete cancer utilising the methodology outlined above.</p> | 1 |

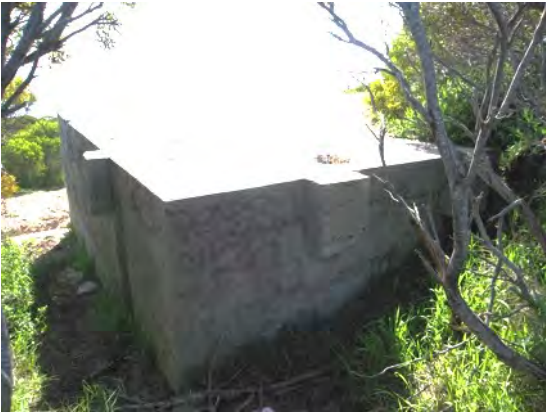
| Building Name | Condition Rating | Defect and Location | Work to Rectify Defect | Priority Ranking |
|---|---|---|---|---|
| South Elevation | B | Partially submerged into sand dune and partially obscured by vegetation. Full inspection not possible.<br>Concrete deterioration to base of air vent shaft.<br> | Full inspection of the elevation is required to determine condition.<br><br>Concrete patch repairs required to base of air vent shaft. | 1<br><br>2 |

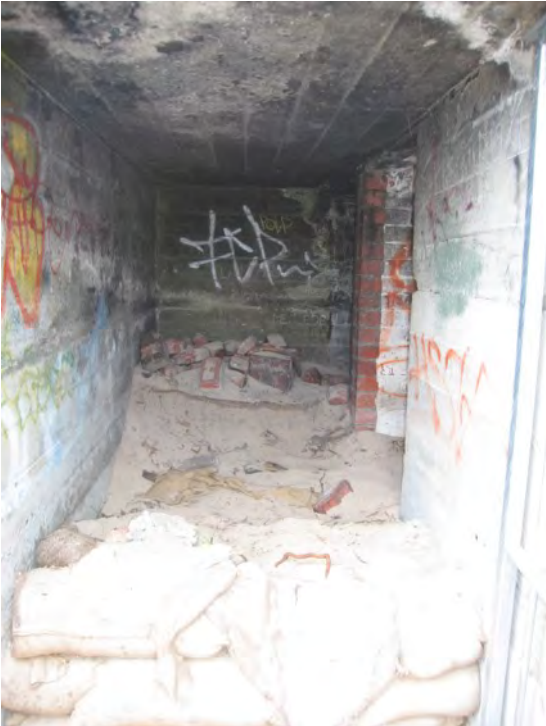
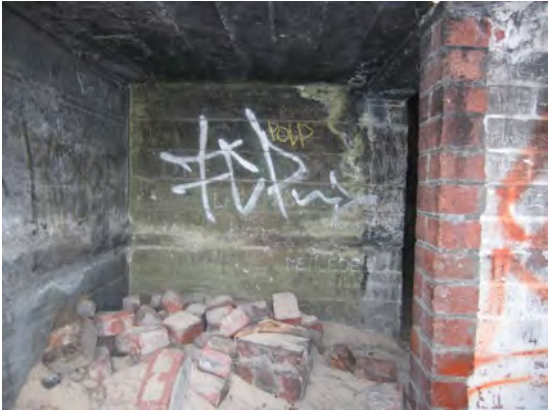
| Building Name | Condition Rating | Defect and Location | Work to Rectify Defect | Priority Ranking |
|---|---|---|---|---|
| Entry passageway | C | <div>Concrete walls, ceiling and floor.<br/>Graffiti to most surfaces.<br/>Deep sand build-up.<br/>Partial painted treatment to walls.</div> <div></div> | <div>Remove paint from entire elevation as this can contribute to the deterioration of the fabric. Paint removal should not unduly damage the substrate and mortar and test panels in discrete locations should be established prior to embarking on the full removal. Non-caustic solvent based methods or low pressure steam removal can be tried.<br/>Peelaway paint removal system can be used or Westox's DeLam which applies a poultice to the paint and will be ready to be removed within a few days. Not all paint traces will be removed due to the texture of the bricks and concrete.</div> <div>Remove sand and inspect walls and floor for damage.</div> <div>Retain all loose bricks for repairs to the structure or other buildings on site.</div> | <div>2</div> <div>1</div> |

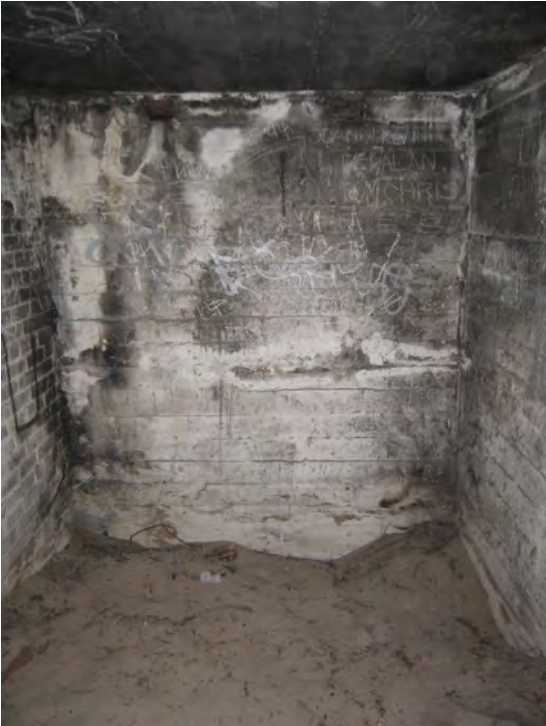
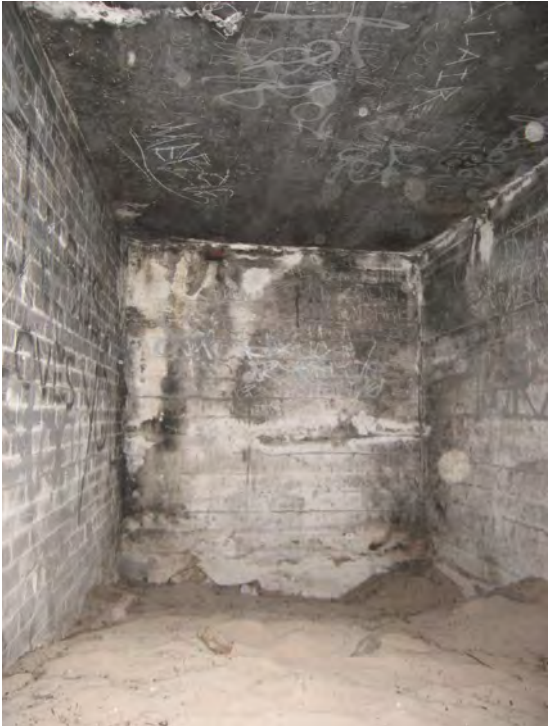
| Building Name | Condition Rating | Defect and Location | Work to Rectify Defect | Priority Ranking |
|---|---|---|---|---|
| Room 1 | C | <div>Concrete outer walls and a brick partition wall.<br/>Clouded white paint finish wearing off. Walls with graffiti.<br/>Sand accumulation.</div> <div></div> | <div>Remove sand accumulation and monitor further collections to prevent damage to floor and lower levels of the walls.<br/>Remove painted finish and graffiti.</div> | <div>2</div> |

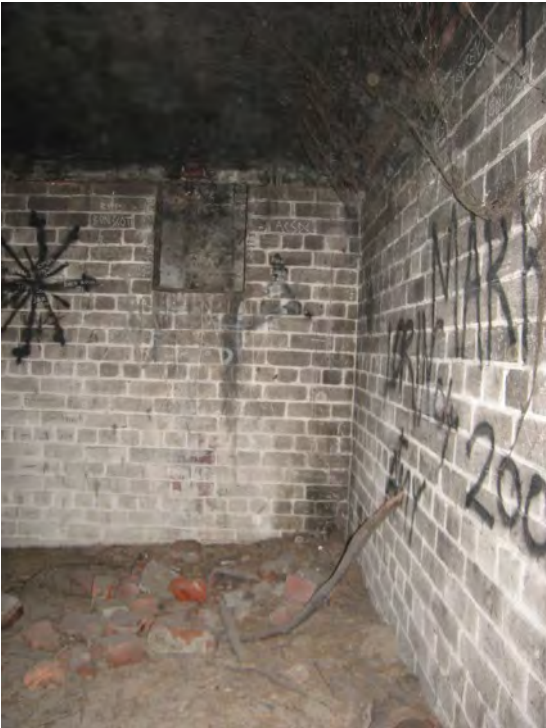
| Building Name | Condition Rating | Defect and Location | Work to Rectify Defect | Priority Ranking |
|---|---|---|---|---|
| Room 2 plus blast corridor | C | <p>Brick internal walls with concrete outer walls. Clouded paint finish to walls with graffiti. Sand accumulation.</p> <div></div> | <p>Remove graffiti. There is no requirement for an anti-graffiti coating to be applied if public access is going to be controlled. Removal of graffiti should not damage the underlying brick and concrete.</p> <p>Remove painted finish to the walls as per specifications above or other suitable alternative conservation method.</p> <p>Slight signs of concrete deterioration to the ceiling. Further deterioration to be monitored.</p> <p>Sand accumulation to be monitored and removed prior to substantial build-up.</p> | <p>2</p> <p>2</p> |

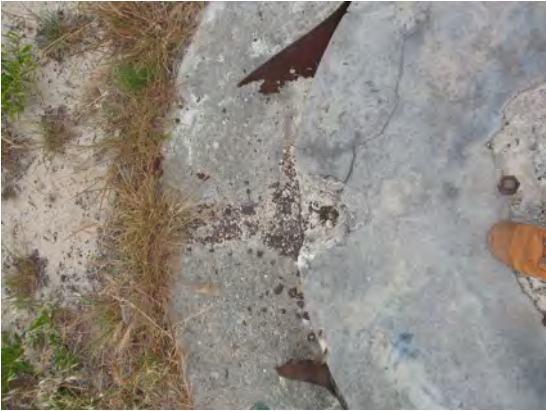
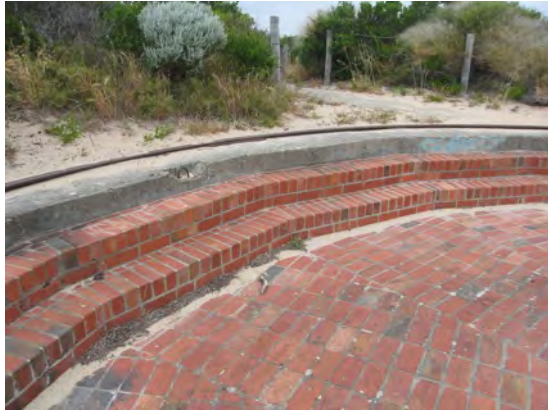
| Building Name | Condition Rating | Defect and Location | Work to Rectify Defect | Priority Ranking |
|---|---|---|---|---|
| <p><b>Gun Emplacement No. 2</b></p> <p>Reinforced concrete retaining wall, brick steps and paving, central reinforced concrete gun mount</p> | B | <p>Gun Emplacement No. 2 is in good condition and has not suffered from the same fate as its counterpart Gun Emplacement No. 1. Shifting sand and ground conditions do not appear to be impacting on the structural condition of this structure.</p> <p>There is some concrete damage to the top of the gun mount and the steel perimeter edging around the top of the mount has rusted in places, springing loose from the concrete it is encasing.</p> <p>Sand accumulation in places.</p> <p>Non-original painted surfaces.</p> <div></div> | <p>Conservation works are limited to replacing the steel edge to the gun mount and regularly removing the sand. The paint should be removed from the gun mount as per the methodology specified elsewhere in this report.</p> <p>The concrete elements should be regularly monitored as they will be susceptible to the harsh coastal environmental conditions.</p> <p>As this element is to be the main focus of the site and potentially the site for a memorial, the visitor numbers will be higher. The paving and brick steps should be regularly inspected to ensure they are not loose and creating trip hazards.</p> | 2 |

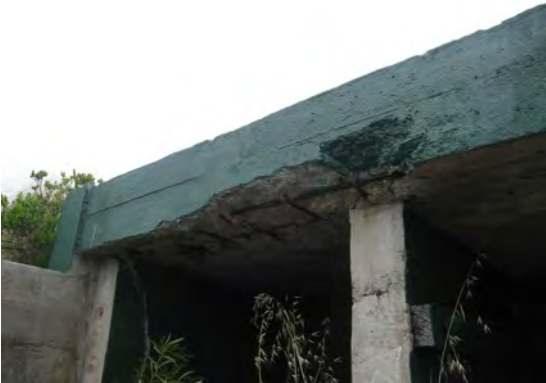
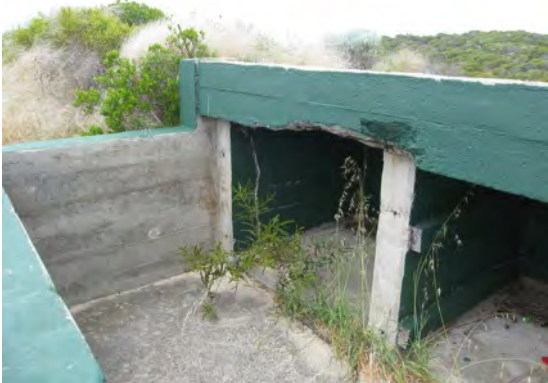
| Building Name | Condition Rating | Defect and Location | Work to Rectify Defect | Priority Ranking |
|---|---|---|---|---|
| <b>Ammunition Store 1</b><br><br>Reinforced concrete | B | The ammunition store is in good condition with only slight signs of concrete cancer occurring to the roof.<br><br>Non-original painted elements.<br><br>Sand accumulation and vegetation growth. | Remove paint from entire elevation as this can contribute to the deterioration of the fabric. Paint removal should not unduly damage the substrate and mortar and test panels in discrete locations should be established prior to embarking on the full removal. Non-caustic solvent based methods or low pressure steam removal can be tried.<br>Peelaway paint removal system can be used or Westox's DeLam which applies a poultice to the paint and will be ready to be removed within a few days. Not all paint traces will be removed due to the texture of the bricks and concrete. | 3 |
| | | | Concrete elements are to be remediated. Rusting to the structural elements encased by the concrete is becoming visible causing the concrete to spall and break off. The high salt content in the air contributes to the accelerated rate of deterioration as does inadequate protection from water ingress. | 3 |

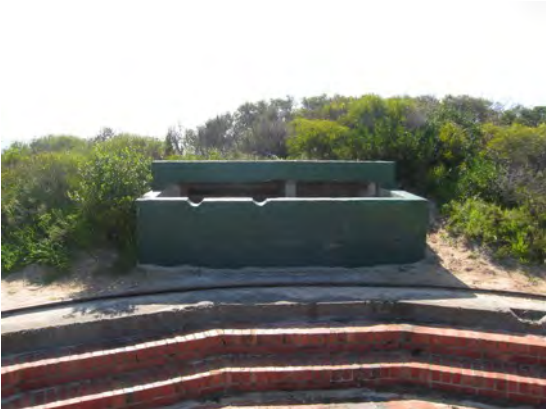
| Building Name | Condition Rating | Defect and Location | Work to Rectify Defect | Priority Ranking |
|---|---|---|---|---|
| <b>Ammunition Store 2</b><br><br>Reinforced concrete | B | Generally in good condition. Slight signs of concrete deterioration. Painted finish and sand accumulation. | Remove paint from entire elevation as this can contribute to the deterioration of the fabric. Paint removal should not unduly damage the substrate and mortar and test panels in discrete locations should be established prior to embarking on the full removal. Non-caustic solvent based methods or low pressure steam removal can be tried.<br>Peelaway paint removal system can be used or Westox's DeLam which applies a poultice to the paint and will be ready to be removed within a few days. Not all paint traces will be removed due to the texture of the bricks and concrete. | 3 |
| | | | Concrete elements are to be remediated. Rusting to the structural elements encased by the concrete is becoming visible causing the concrete to spall and break off. The high salt content in the air contributes to the accelerated rate of deterioration as does inadequate protection from water ingress.<br><br>It is not recommended that the damaged concrete be removed in its entirety, utilising patch repairs to try and retain the original fabric. Where the steel reinforcement has rusted causing the concrete to spall, the concrete needs to be cutback and the steel cleaned, treated with an anticorrosive treatment such as Sika Ferro Guard and new concrete patched in to match | 3 |

| Building Name | Condition Rating | Defect and Location | Work to Rectify Defect | Priority Ranking |
|---|---|---|---|---|
| | | | existing. Due to the harsh environmental conditions at Point Peron, it is recommended that a corrosion barrier coating is applied to all concrete surfaces to reduce/delay further deterioration.<br><br>Remove sand and vegetation from within the structure. | 2 |

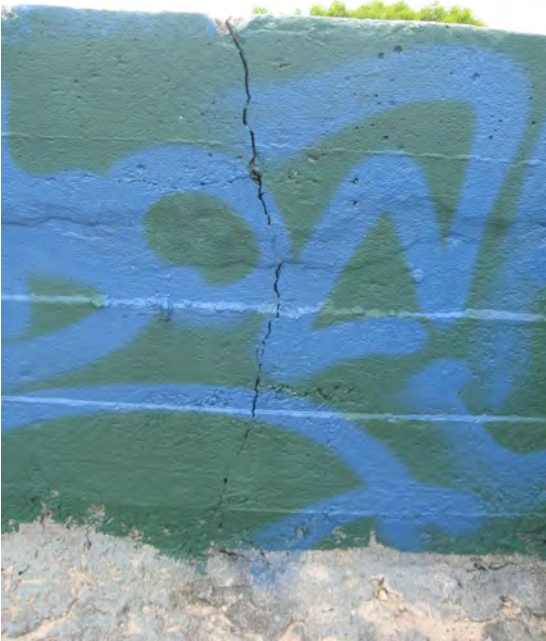
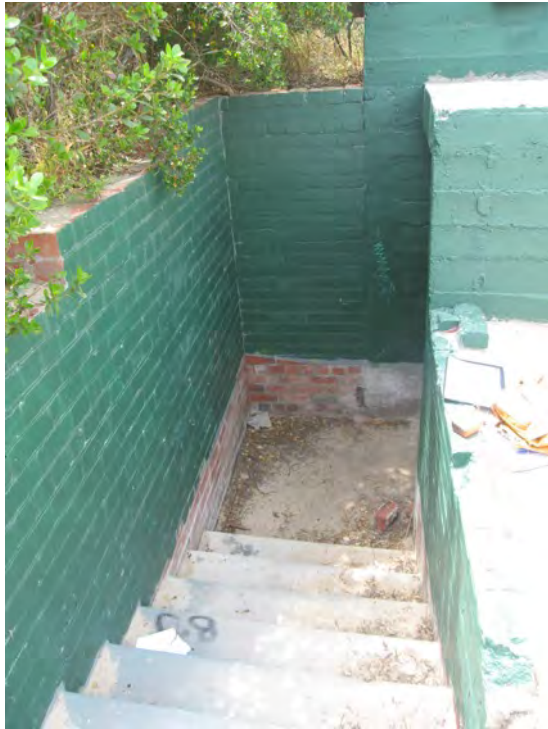
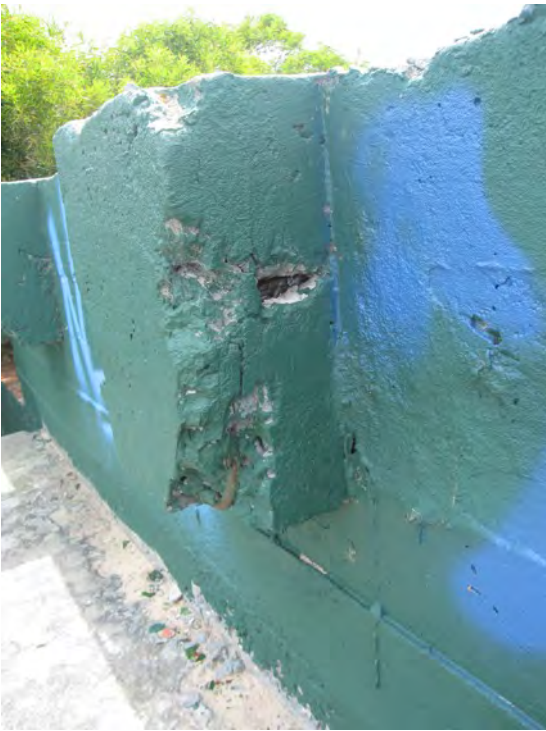
| Building Name | Condition Rating | Defect and Location | Work to Rectify Defect | Priority Ranking |
|---|---|---|---|---|
| South Elevation | C | The south elevation is the principal elevation incorporating the entrance steps and the lower level entry passageway. Generally, the south elevation is in fair to good | The cracks in the wall and roof need addressing. Investigation into the full extent of the cracking is required prior to a remedial solution being specified. | 1 |

| Building Name | Condition Rating | Defect and Location | Work to Rectify Defect | Priority Ranking |
|---|---|---|---|---|
| | | <p>condition but signs of cracking at the upper level which extends through the roof and the first few concrete block courses resulting in water ingress into the structure. If left unchecked this will result in failure of the concrete through rusted reinforcement rods and blown concrete.</p> <p>Deteriorated undersides to the projecting air shafts where water drip is causing the fabric to decay. Concrete has blown and fallen off in chunks.</p> <p>Painted finish with graffiti. Sand collection in the footwell of the steps.</p> <div></div> | <p>The concrete around the cracking sound be checked for its soundness. If it is likely that the reinforcement steels are rusted and blown appropriate action should be taken to clean and protect the steels prior to remediating the concrete.</p> <p>Remove paint from entire elevation as this can contribute to the deterioration of the fabric. Paint removal should not unduly damage the substrate and mortar and test panels in discrete locations should be established prior to embarking on the full removal. Non-caustic solvent based methods or low pressure steam removal can be tried.</p> <p>Peelaway paint removal system can be used or Westox's DeLam which applies a poultice to the paint and will be ready to be removed within a few days. Not all paint traces will be removed due to the texture of the bricks and concrete.</p> | 2 |

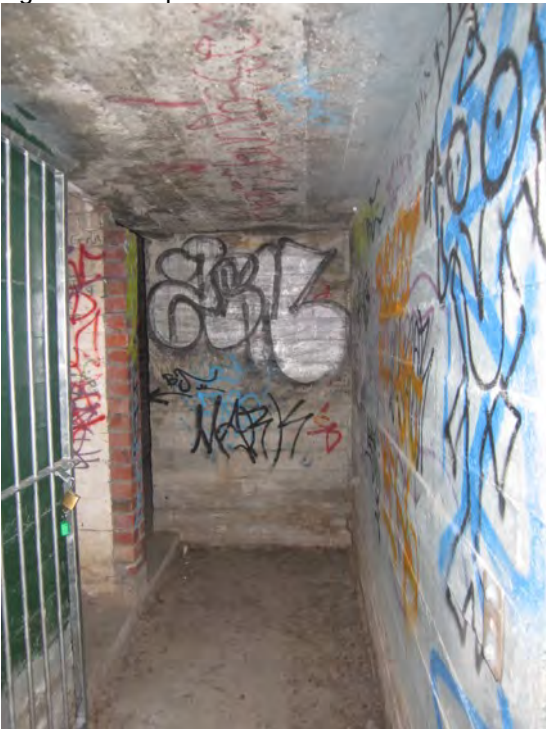
| Building Name | Condition Rating | Defect and Location | Work to Rectify Defect | Priority Ranking |
|---|---|---|---|---|
| Entry Passage | C | <p>Concrete walls and ceiling painted in a white paint finish which is beginning to show signs of wear. Walls and ceiling subjected to graffiti. Sand accumulation causing early signs of damp at low level.</p> | <p>Remove paint from entire elevation as this can contribute to the deterioration of the fabric. Paint removal should not unduly damage the substrate and mortar and test panels in discrete locations should be established prior to embarking on the full removal. Non-caustic solvent based methods or low pressure steam removal can be tried.</p> <p>Peelaway paint removal system can be used or Westox's DeLam which applies a poultice to the paint and will be ready to be removed within a few days. Not all paint traces will be removed due to the texture of the bricks and concrete.</p> <p>Graffiti to be removed. An anti-graffiti coating is not required.</p> <p>Ensure sand levels are maintained implementing regular removal.</p> | 3 |

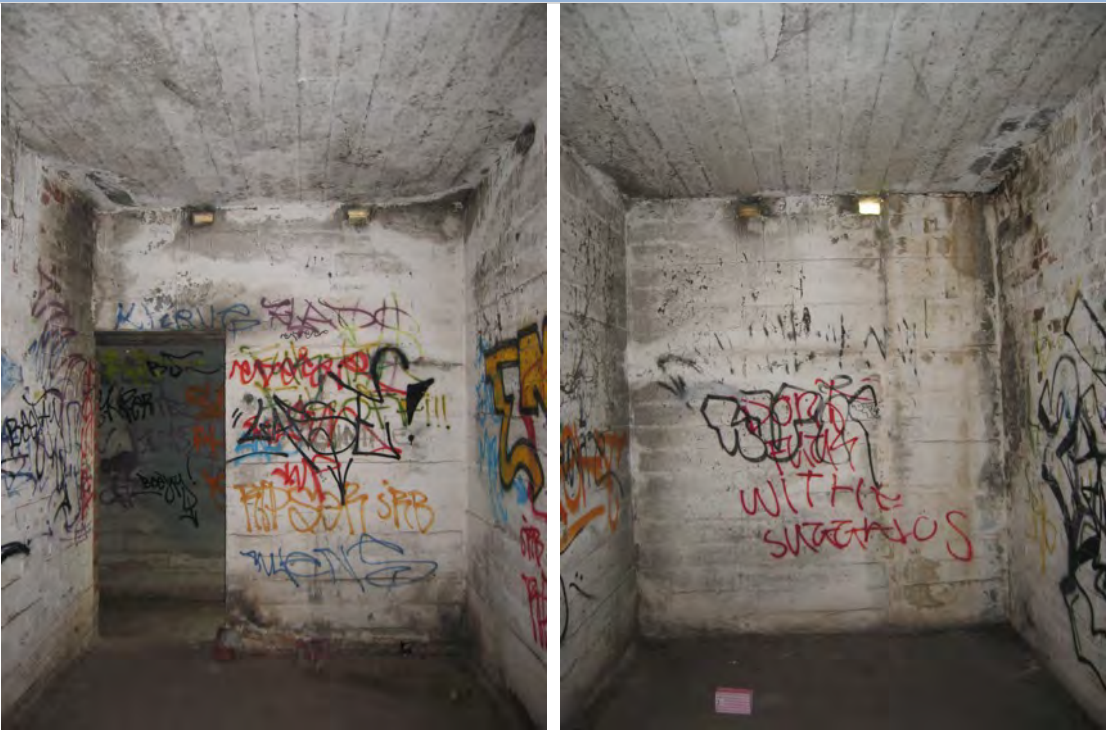
| Building Name | Condition Rating | Defect and Location | Work to Rectify Defect | Priority Ranking |
|---|---|---|---|---|
| Room 1 | C | <p>Concrete and brick walls and concrete ceiling all been painted white which is beginning to cloud and wear off. Walls covered with graffiti. High level signs of damp at junction of wall and ceiling and around the open air vents.</p> <p>Previous sand accumulation has caused slight signs of low level damp.</p> <p>Concrete floor appears in sound condition.</p> | <p>Remove paint from entire elevation as this can contribute to the deterioration of the fabric. Paint removal should not unduly damage the substrate and mortar and test panels in discrete locations should be established prior to embarking on the full removal. Non-caustic solvent based methods or low pressure steam removal can be tried.</p> <p>Peelaway paint removal system can be used or Westox's DeLam which applies a poultice to the paint and will be ready to be removed within a few days. Not all paint traces will be removed due to the texture of the bricks and concrete.</p> <p>Remove graffiti. An anti-graffiti coating is not required.</p> <p>Ensure sand levels are monitored, removing any sand build up on a regular basis.</p> <p>Monitor the areas of damp. Allow to dry and assess condition of concrete prior to undertaking any remedial action. Once the air vent shaft has been reconstructed, water ingress will be substantially reduced and the surrounding fabric will dry out. However the water damage may have caused deterioration to the concrete and its condition is to be monitored.</p> | <p>2</p> <p>2</p> <p>1</p> <p>1</p> |

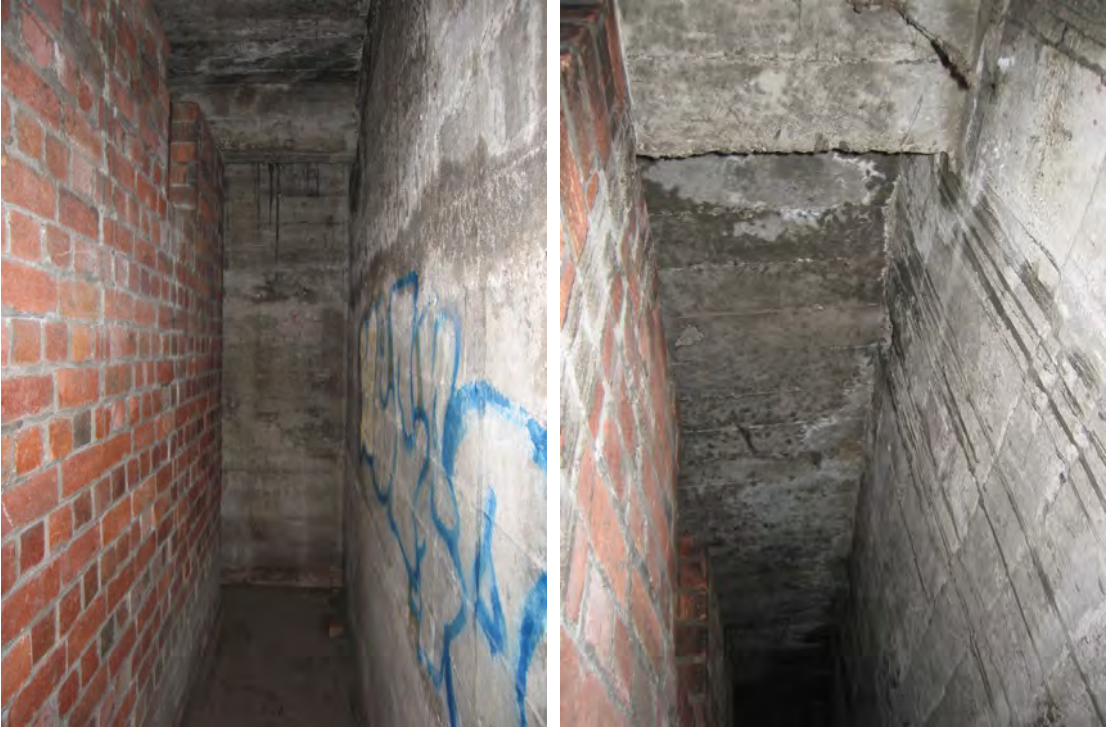
| Building Name | Condition Rating | Defect and Location | Work to Rectify Defect | Priority Ranking |
|---|---|---|---|---|
| Room 2 plus blast corridor | C | <p>Brick work to the internal walls is generally in sound condition, with some graffiti. Dusted white painted finish wearing off from the walls. Some slight signs of damp at the junction between the wall and ceiling, likely to be in line with the roof cracks. Evidence of recent sand removal from both the main room and the blast corridor.</p> <p>Signs of early concrete cancer to the roof with some of the enforcement bars rusting and breaking through the concrete.</p> | <p>Remove paint from entire elevation as this can contribute to the deterioration of the fabric. Paint removal should not unduly damage the substrate and mortar and test panels in discrete locations should be established prior to embarking on the full removal. Non-caustic solvent based methods or low pressure steam removal can be tried. Peelaway paint removal system can be used or Westox's DeLam which applies a poultice to the paint and will be ready to be removed within a few days. Not all paint traces will be removed due to the texture of the bricks and concrete.</p> <p>Remove graffiti. An anti-graffiti coating is not required.</p> <p>Ensure sand levels are monitored, removing any sand build up on a regular basis.</p> | <p>2</p> <p>2</p> <p>1</p> |
