SUBURB: Hillman**PAW Code No.****F36H****PAW location:**

SUBURB: Hillman

PAW Code No. H55

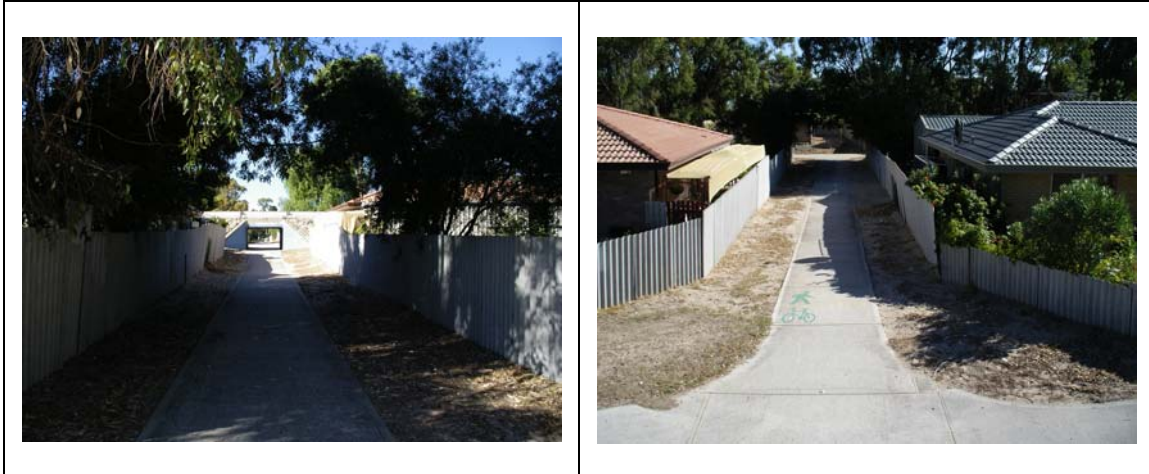
PAW location:

Connects Unnaro Street to a park, and to PAW H61.

PAW reserve is approx. 5.5m wide, flaring to 11.5m wide at its southern end. Approx. 37m long. The reserve is straight and the path is slightly undulating. It connects to an underpass beneath Unnaro Street. There are no bollards.

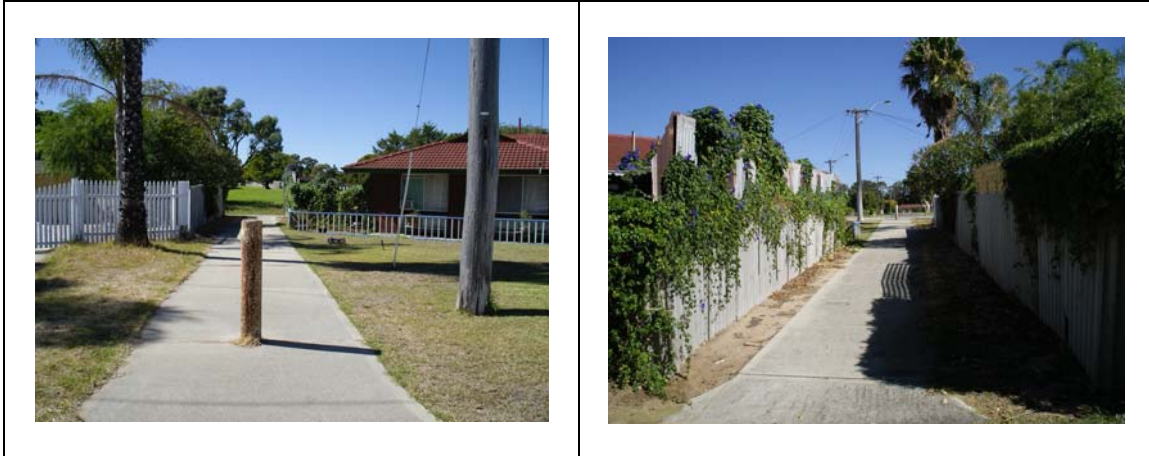
PAW location:

Connects Mimbalup Close to a park.

PAW reserve is approx. 3.7m wide and 22m long. Straight with a gentle slope down west to east. There is a single central bollard on the verge at the cul-de-sac end.

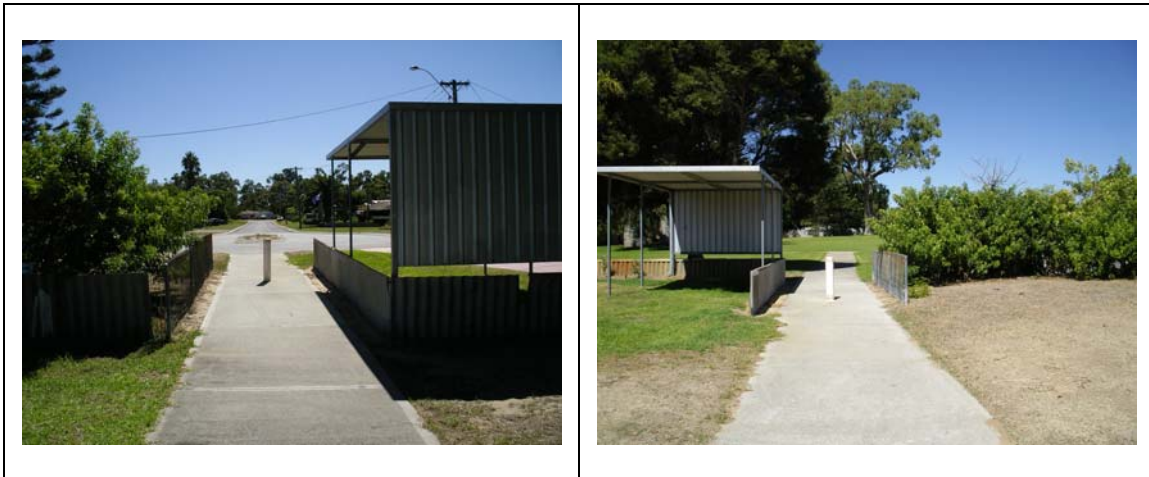
PAW location:

Connects Goline Court to a park.

PAW reserve is very short – just 7m long. Approx. 4m wide. Straight, flat, with one central bollard.

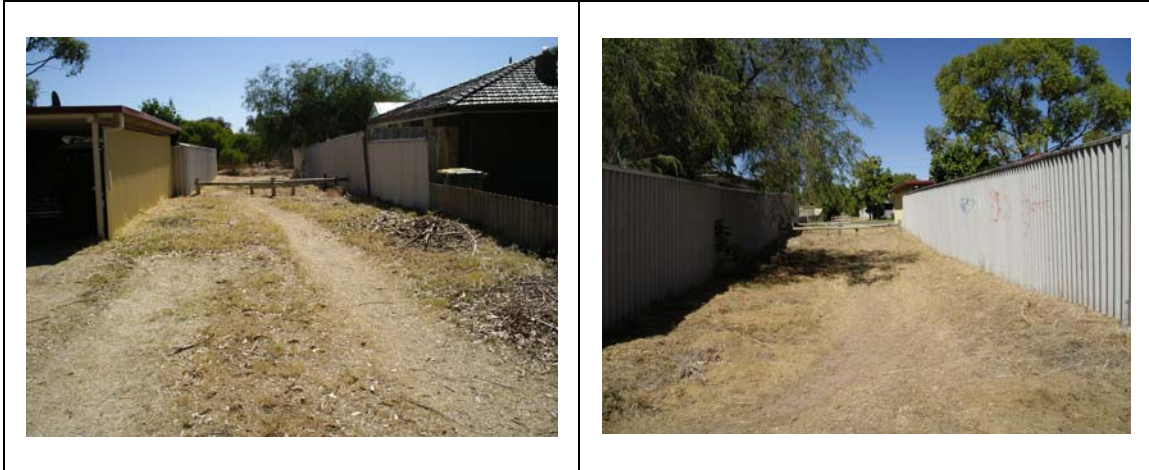
PAW location:

Connects Calume Street to a Reserve behind.

PAW reserve is approx. 5.5m wide, flaring to approx. 11m wide at its southern end. Approx. 37m long. The reserve is straight, with a slight slope downwards at the northern end. There are some low pine post-and-rail bollards midway in the PAW. There is no constructed path.

High Super six in good condition.

There is no constructed path, just a worn track in the sand.

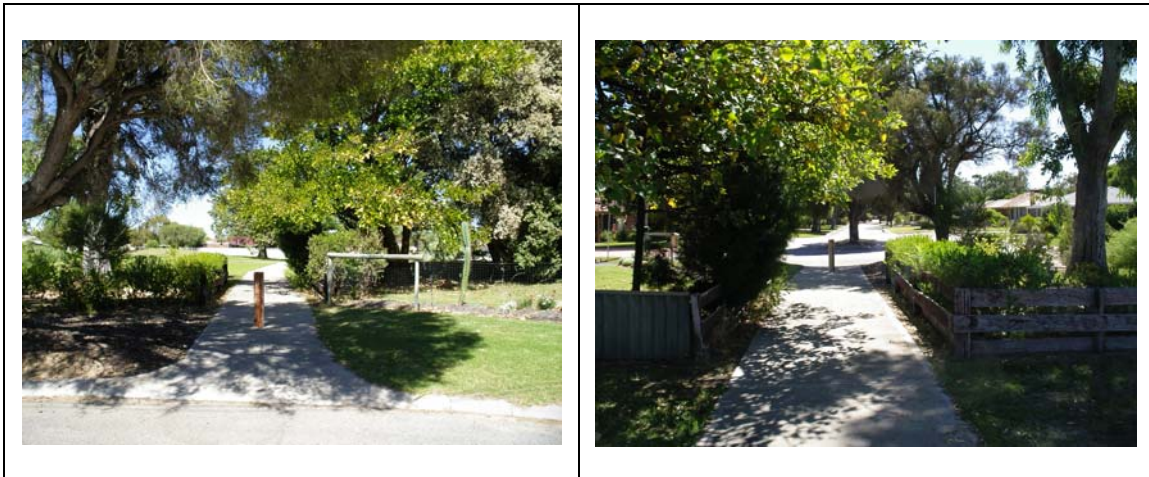
PAW location:

Connects Tarup Place to a park.

PAW reserve is very short – just 7m long. Approx. 4m wide. Straight, flat, with one central bollard.

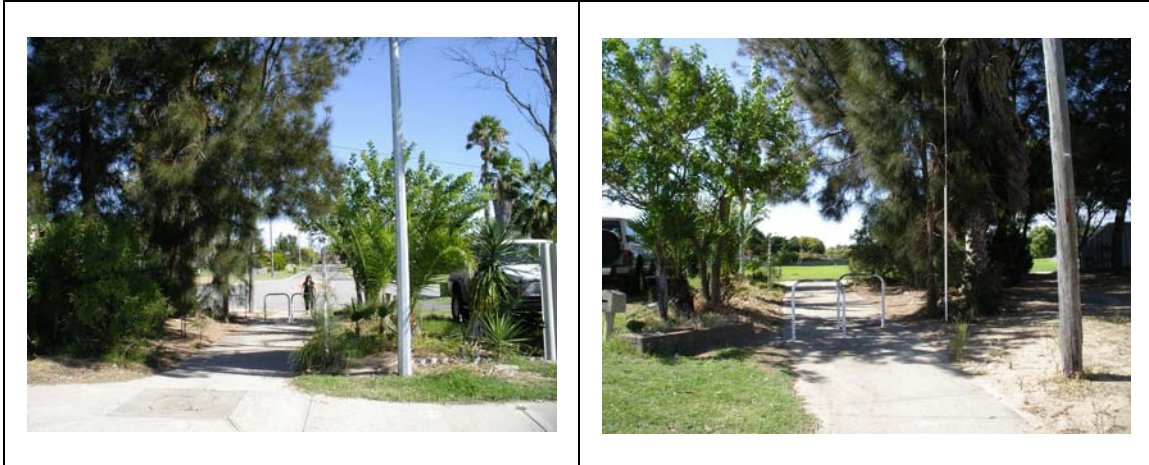
PAW location:

Connects Gilba Close to a large park and a lighted dual use east-west path.

PAW reserve is approx. 3.7m wide and 10m long. Short and straight. Slight rise from south to north. Bollards at each end.

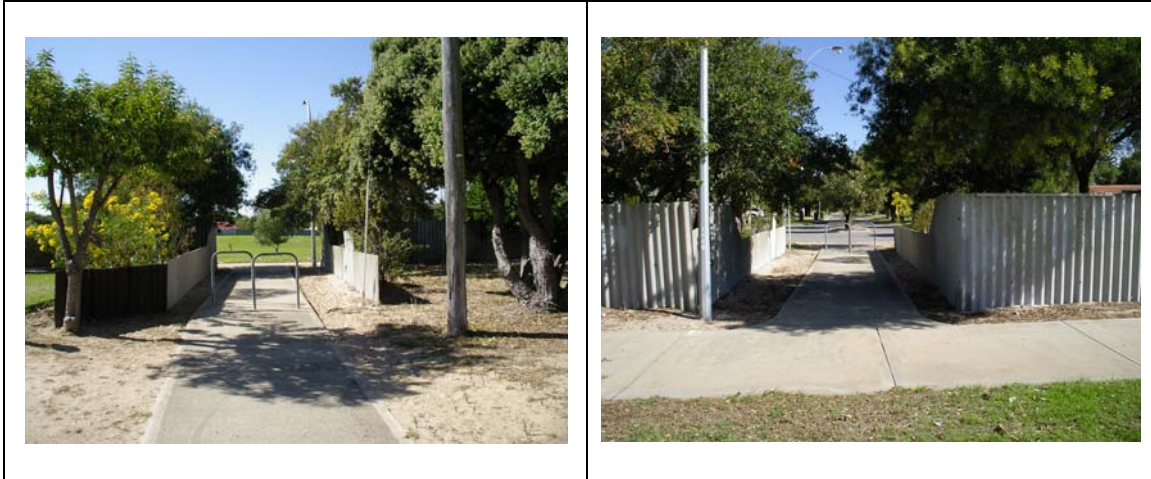
PAW location:

Connects Bibanup Court to a large park and a lighted dual use east-west path.

PAW reserve is approx. 3.7m wide and 10m long. Short, flat and straight. Bollards at cul-de-sac end.
