**SUBURB:** Rockingham

**PAW Code No.** R1R (Previous PAW R262)

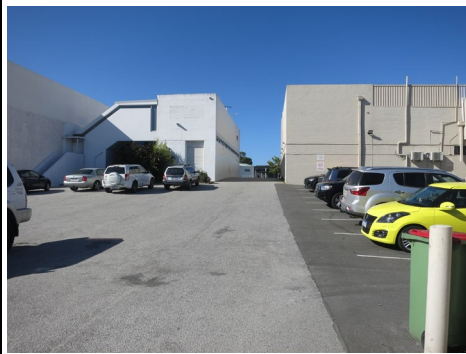
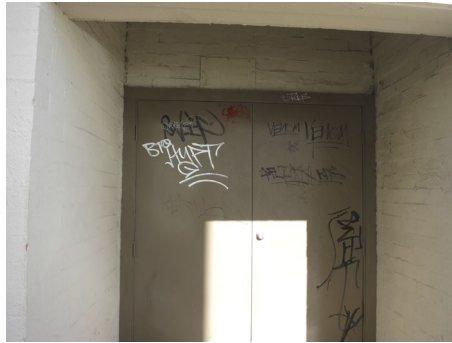
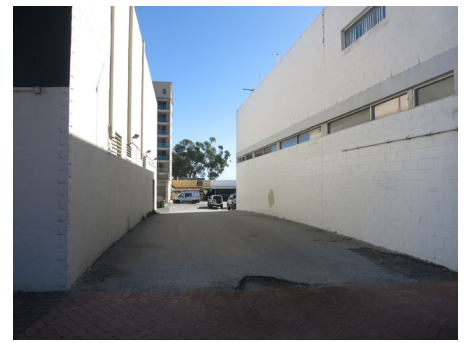
Fair. Bitumen is in relatively good condition. Some graffiti.

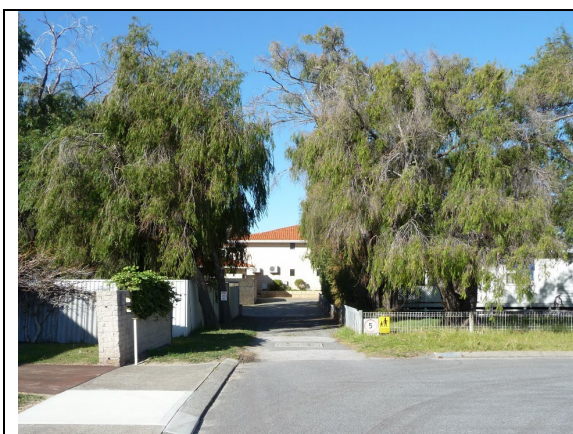
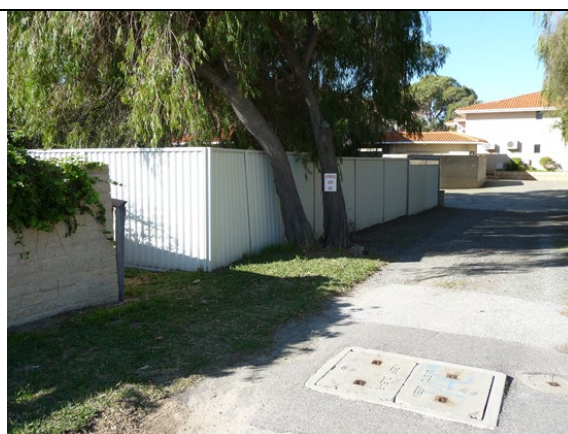
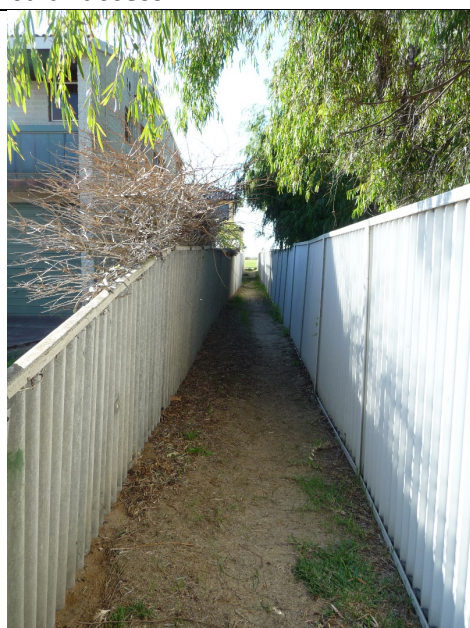
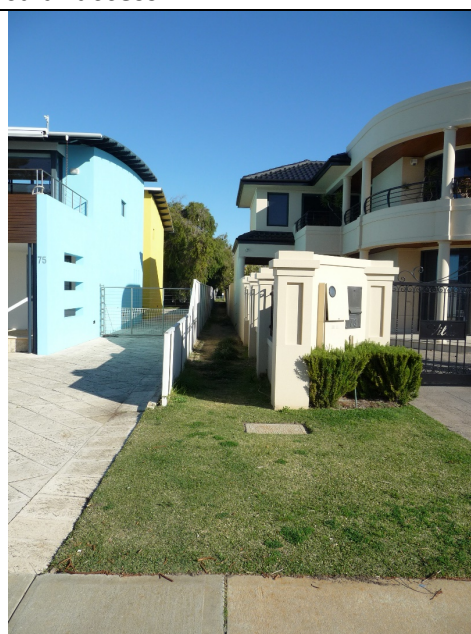
The ROW is in fair to good condition.

The pedestrian leg appears to be reasonably used based on worn sand tracks. The vehicular access leg is also used frequently by residents of 81 Esplanade to gain access to residential properties.

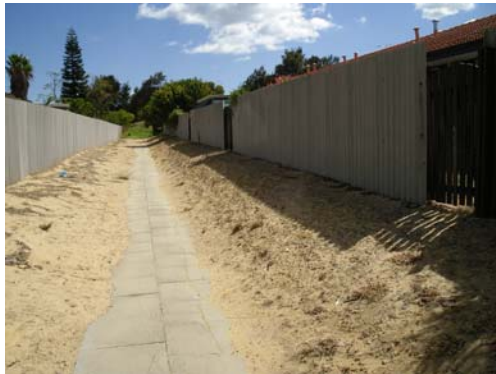
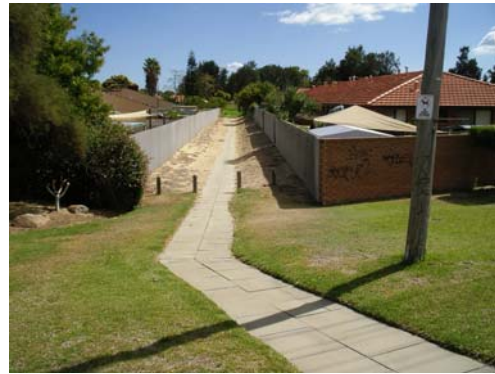
Very poor. Sand across path which is in poor condition. Leaves, rubbish and some graffiti.

High super six in fair to good condition. There are a half dozen gates along the fence on the north side of the PAW.

Concrete slabs 2 x wide. Approx 1.2m. Narrow, many missing, sand covering many slabs.

This PAW provides a pedestrian connection from Simpson Avenue to the Ashford Avenue Reserve. The park is very rough in condition, and has no paths or lights. Because of its configuration, Ashford Avenue provides an adequate alternative access to this PAW. It is in very poor condition, little used and could be closed if requested.

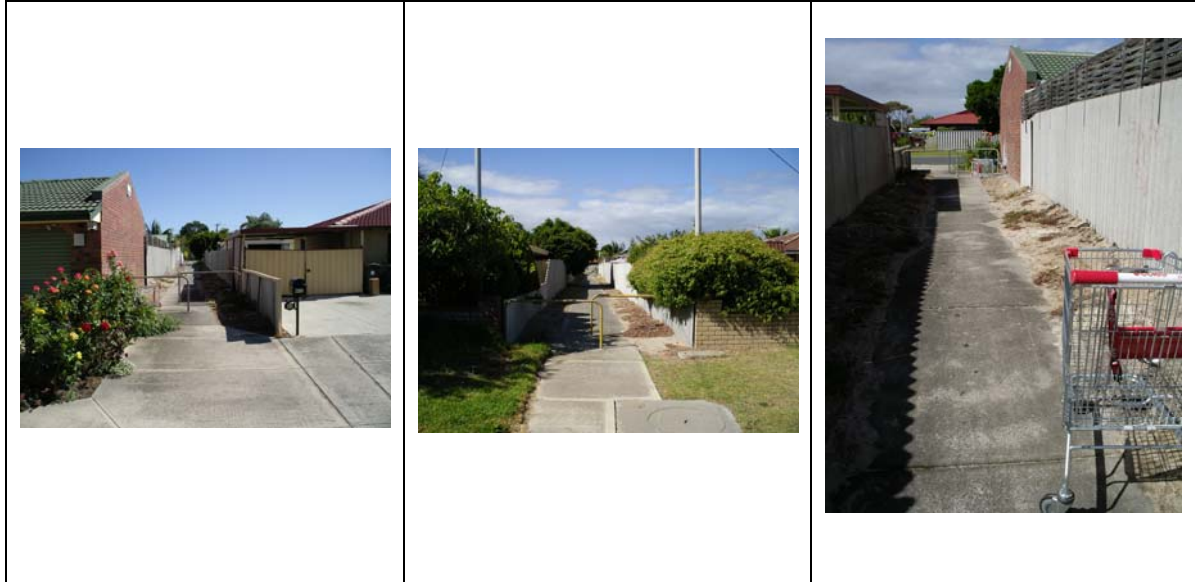
Connects Boon Court to Arkwell Avenue.

Poor to fair. Rubbish, weeds, leaves, broken glass, dog excreta. Two abandoned shopping trolleys (which is apparently a regular occurrence.) Some graffiti on fences.

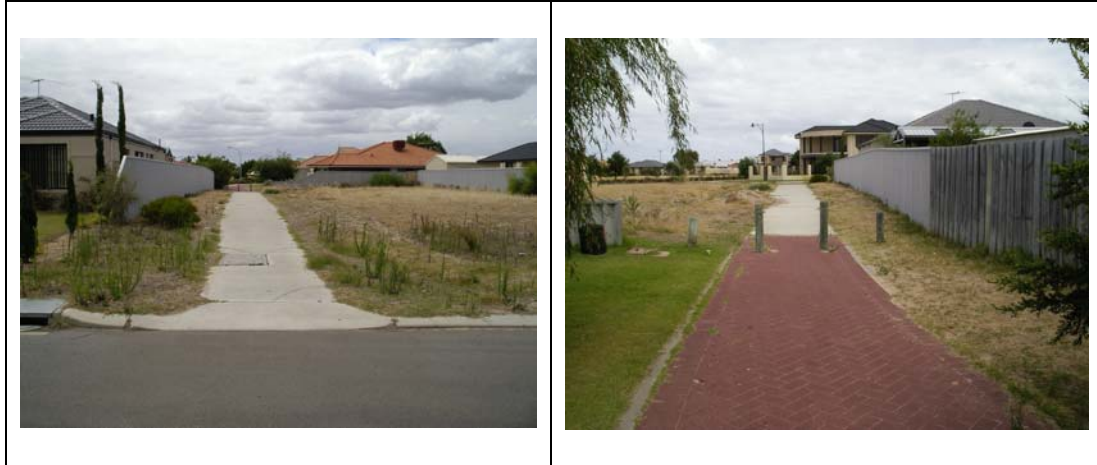
Connects Liechardt Loop to Morritt Close.

New Super Six in good condition on northern side. Unfenced on southern side.

Concrete path approx. 1.65m wide. Some cracking apparent.

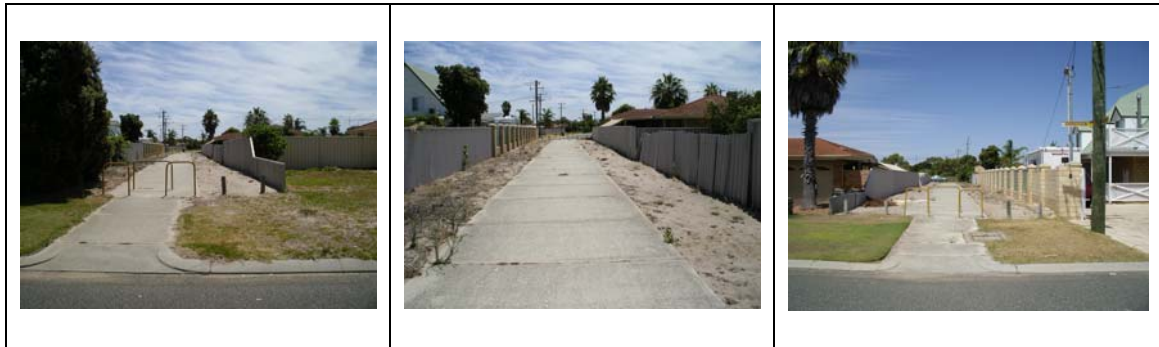
Connects two parts of Christison Way.

Fair. Some broken glass, weeds and small amount of graffiti.

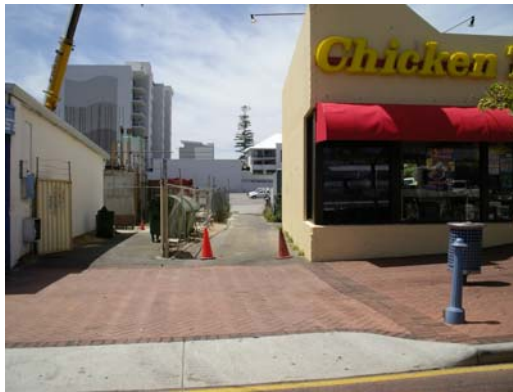
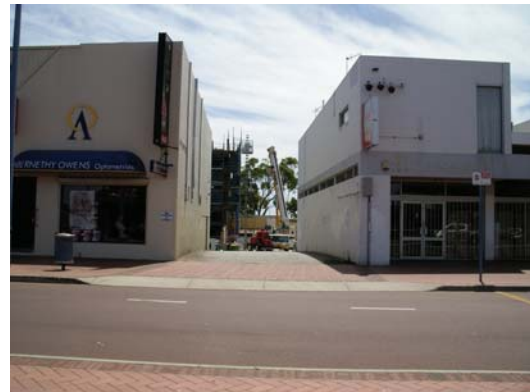
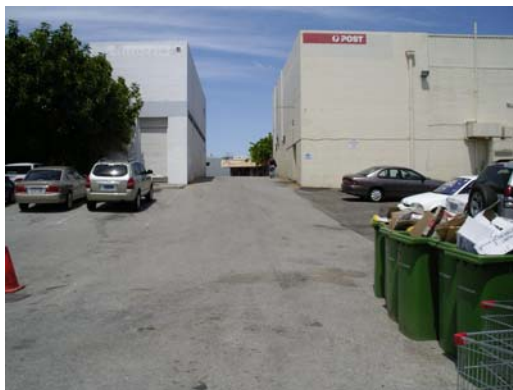
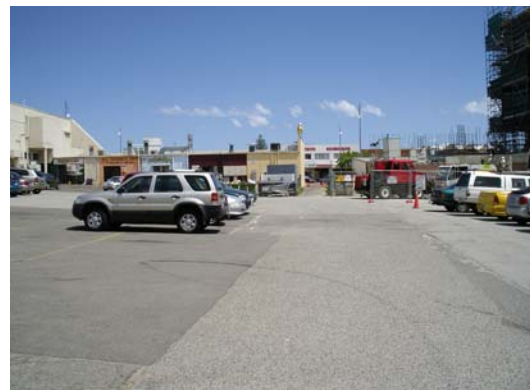
Behind private commercial buildings and having access points off Railway Terrace and Kent Street.

PAW R266 is good, while PAW R264 is very poor, being narrow and with broken pavement. (The adjoining lots on the north side are currently construction sites.)

Good in daytime, due to the open nature of the PAWs and their adjacent car parks. Night time far less so due to inadequate lighting.

Asphalt, ranging in condition from poor to good.

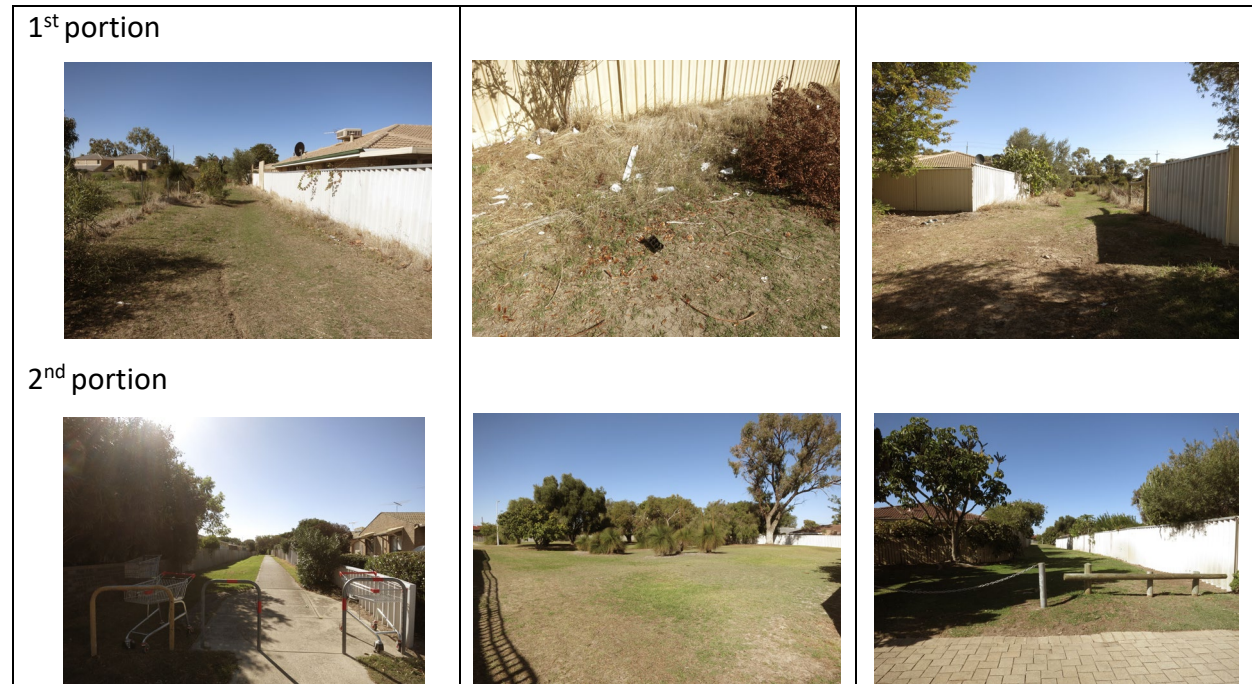
PAW split in two. First portion connects Sepia Court to Read Street. Second portion connects Sepia Court to Merope Close, adjacent to Sepia Reserve.

First portion of PAW is approximately 73m long and 7m wide. Straight and flat. No bollards. PAW is uneven with dips and pot holes.

First portion: Low. Connects residential cluster to Read Street, however no pathway and bad condition.
