**SUBURB:** Waikiki

**PAW Code No.** WK 389

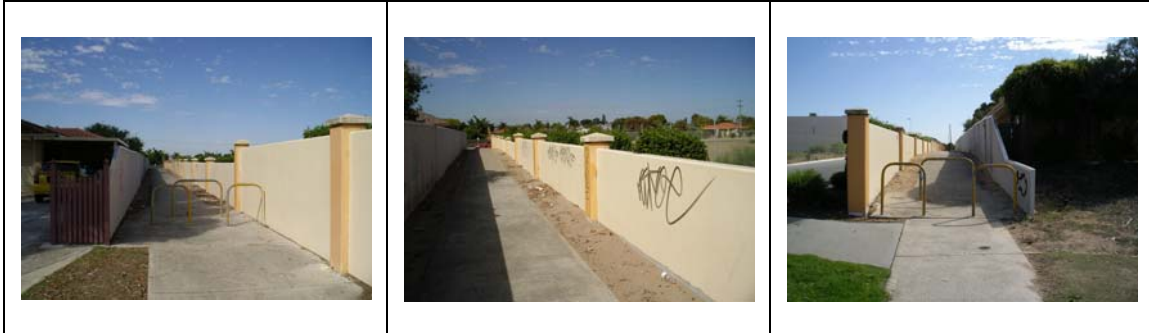
Connects Conway Loop to Ghangara Drive.

PAW reserve approx. 3m wide and 70m long. Straight and long, flat but with a pronounced slope down at the southern end. Bollards at both ends.

This PAW provides convenient north-south access principally for Conway Loop residents. It provides direct access to the bus stop on Gngara Drive at the PAW's southern end. Gngara Drive is also a designated cycle route, as is Castlerock Avenue which is aligned with the southern end of PAW WK397. The PAW also provides access to the Stargate Waikiki shopping centre located immediately to the west of the PAW. Retention of this PAW is recommended.

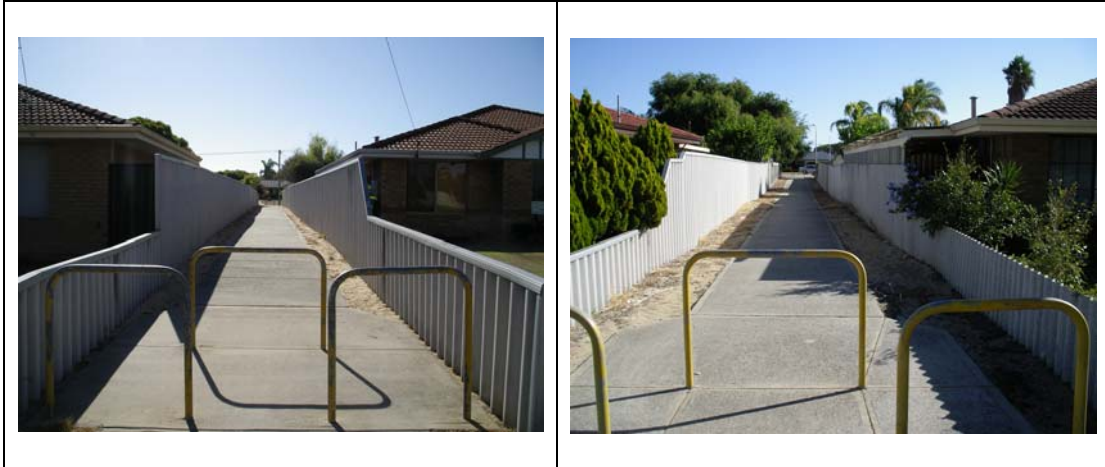
Connects Hope Place to Jubilee Drive.

PAW reserve approx. 3m wide and 70m long. Straight, almost flat and long with bollards at both ends.

High Super six in good condition.

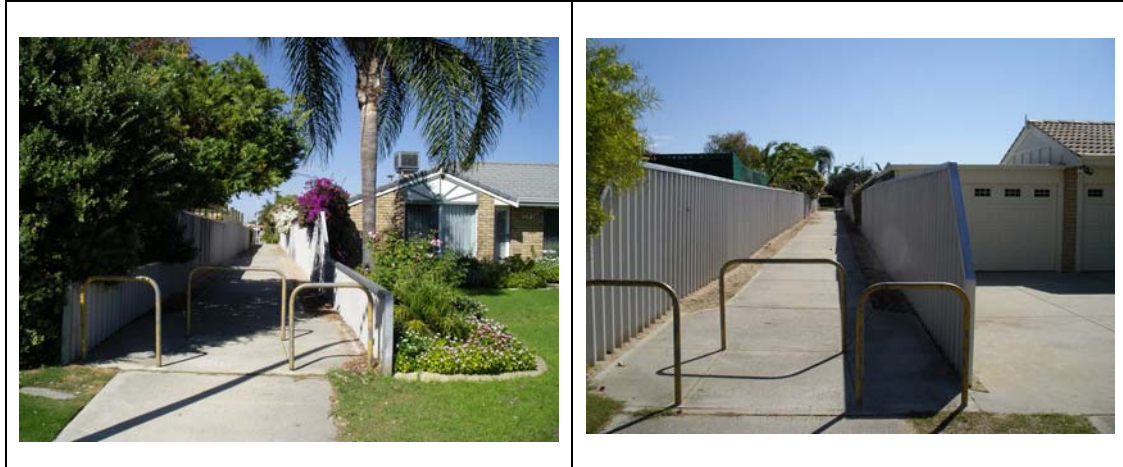
Connects Hazlett Place to Eyre Street.

PAW reserve approx. 3m wide and 68m long. Straight, flat and long with bollards at both ends.

High Super six in good condition.

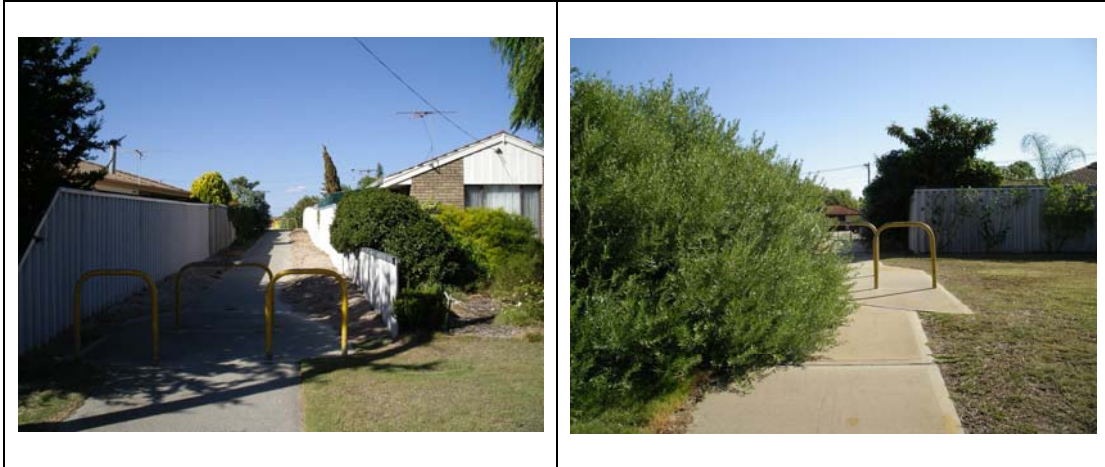
Connects Nandi Court to Noumea Place.

PAW reserve approx. 4m wide and 44m long. Straight, sloping down from east to west with bollards at both ends.

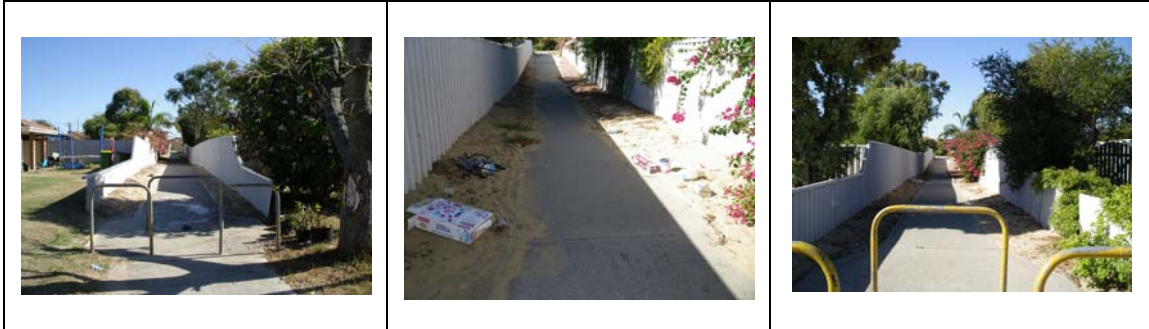
Connects Tana Court to Lakemba Way.

PAW reserve approx. 4m wide and 70m long. Straight with pronounced dip half-way. Bollards at both ends.

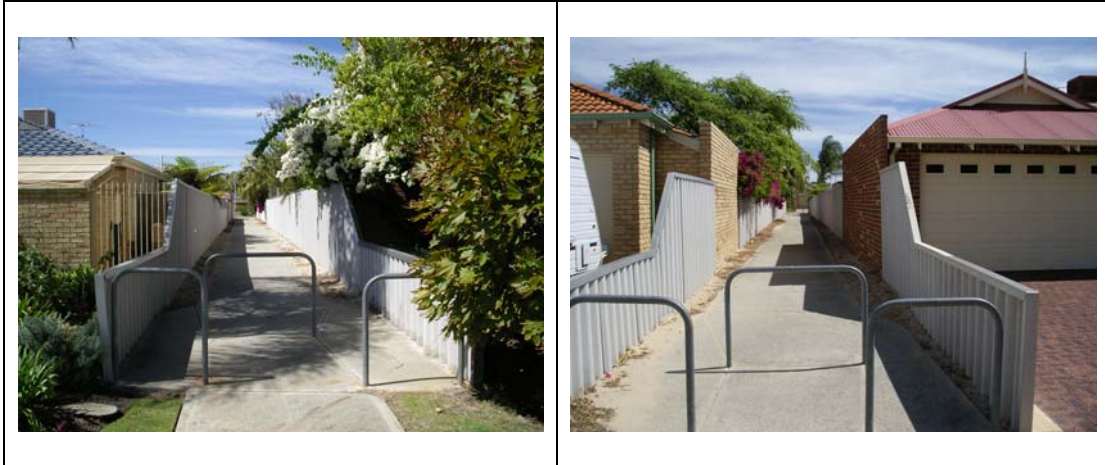
Connects Schooner Place to Keel Cove.

PAW reserve approx. 3m wide and 68m long. Straight, flat and long with bollards at both ends.

High Super six and brick in good condition. One section of super six is topped with two strands of barbed wire.

This PAW connects the heads of two culs-de-sac, and would provide most benefit to Keel Cove residents, who can use the PAW to directly access Rand Avenue Reserve and the Waikiki Community Family Centre. The PAW therefore has very localised usefulness. It is not part of any comprehensive network. It is in a good state of repair and there seems no reason to close it.

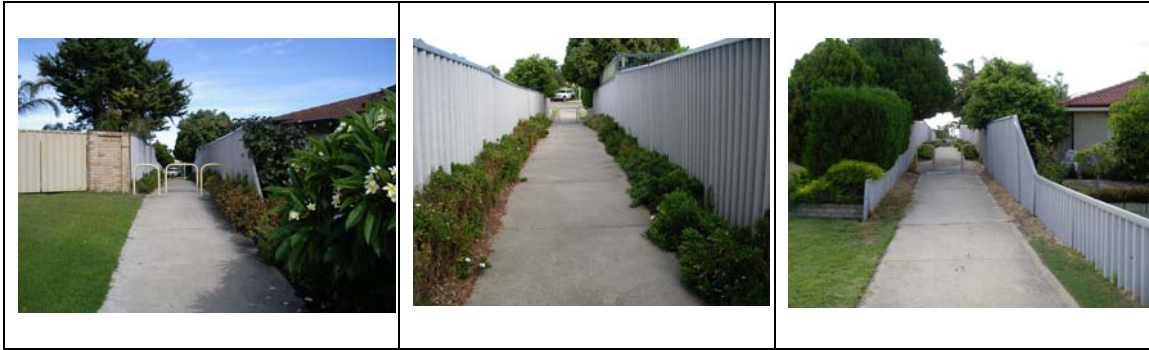
Connects Tasman Place to Portsmouth Place.

PAW reserve approx. 3m wide and 33m long. Straight, hump in end-to-end profile, with bollards at both ends.

High Super six in fair to good condition.

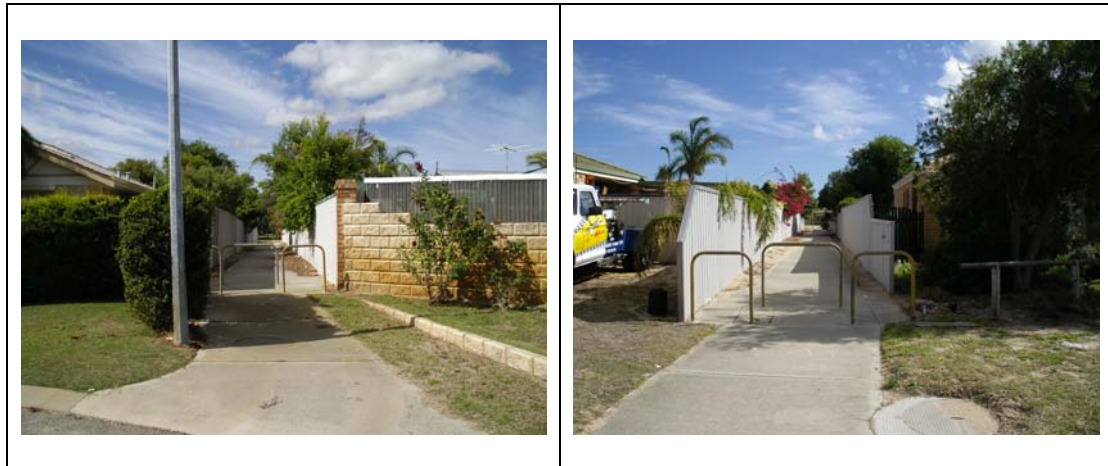
Connects Varuna Way to Stern Close.

PAW reserve approx. 3m wide and 58m long. Straight, flat, with bollards at both ends.

High Super six in good condition.

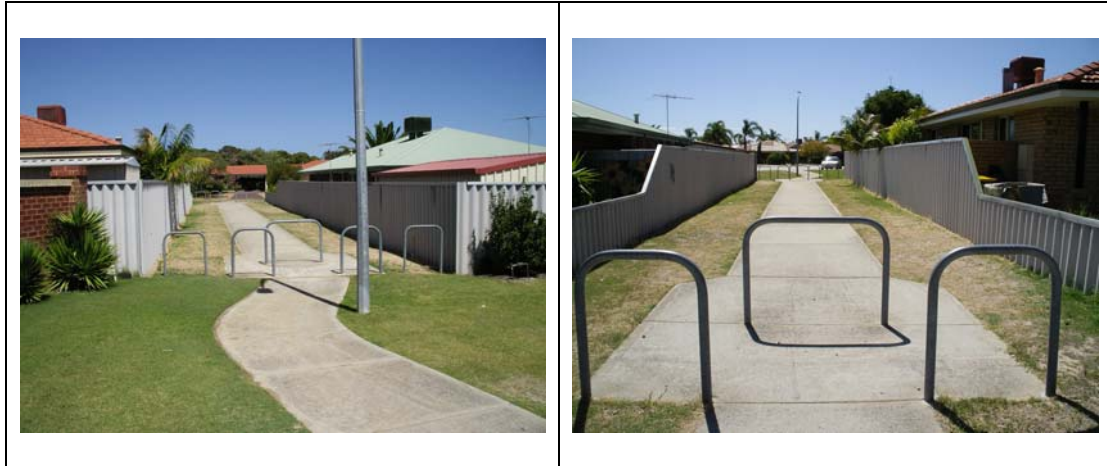
Connects Bridgewater Court to Charthouse Road.

PAW reserve approx. 6m wide and 34m long. Straight, short, flat and wide with bollards at both ends.

High Super six in very good condition.

This PAW provides a convenient connection for Bridgewater Court residents to Charthouse Road with its shops and bus route, as well as Seahaven Rserve. The PAW is in very good condition and has a high level of casual surveillance. While not essential to the pedestrian network in the locality, there seems no reason to close it.

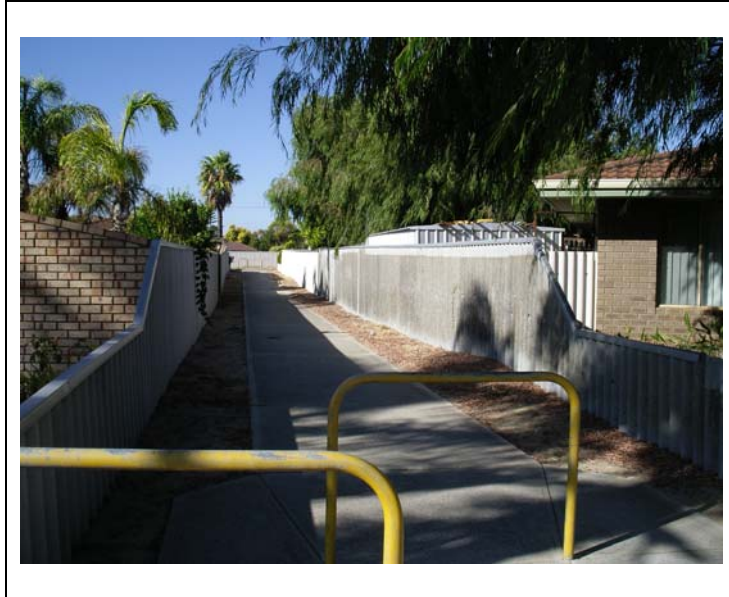
Connects Pinjar Court to Erindoon Way.

PAW reserve approx. 4m wide and 60m long. Straight, slightly undulating with bollards at both ends.

High Super six in fair to good condition.

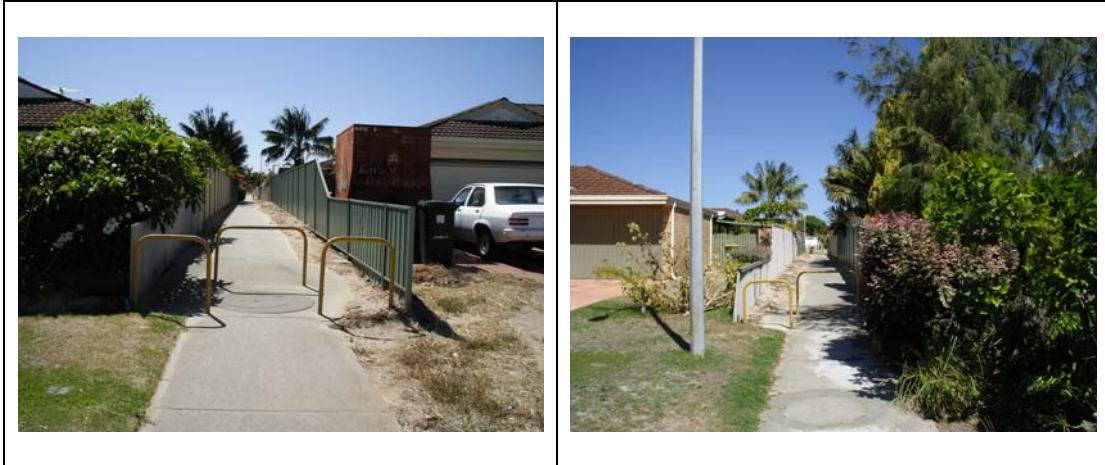
Connects Kite Place to Spinnaker Close.

PAW reserve approx. 3m wide and 64m long. Straight, slight hump in end-to-end profile, with bollards at both ends.

High Super six and steel panels in fair to good condition.

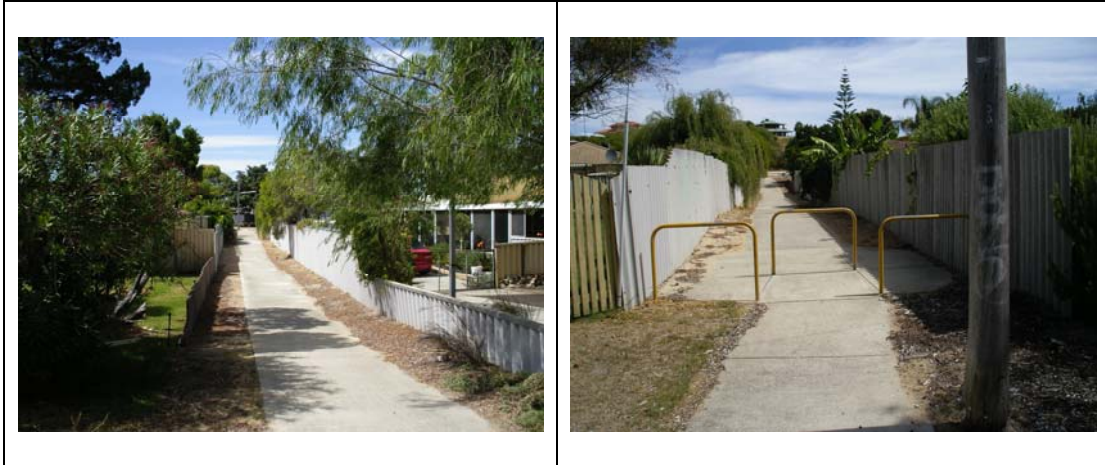
Connects Jones Place to Fendam Street.

PAW reserve approx. 4m wide and 60m long. Straight, undulating with bollards at Jones Place end only.

High Super six and new steel panel sliding gate in fair to good condition. One low section of super six.

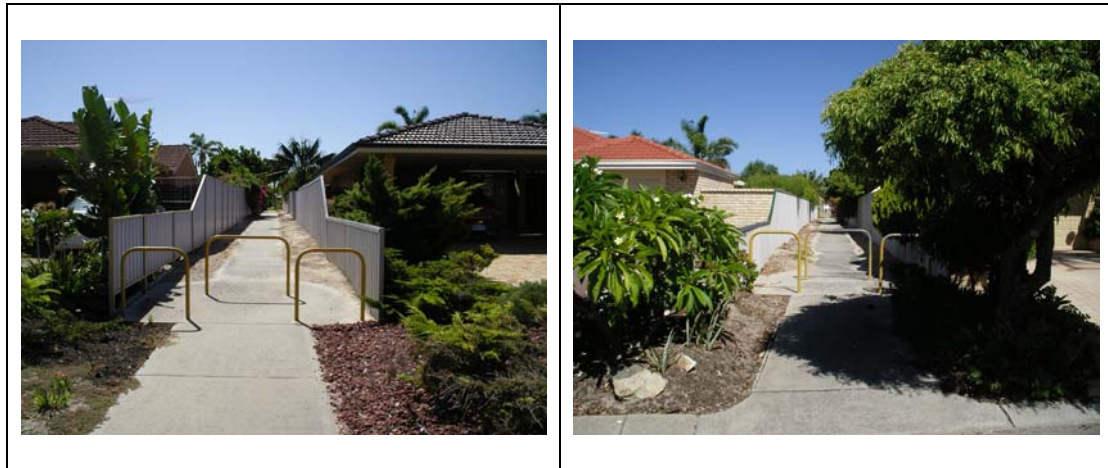
Connects Spinnaker Close to Mizzen Court.

PAW reserve approx. 3m wide and 73m long. Straight, flat and long with bollards at both ends.

High Super six and steel panels in good condition.

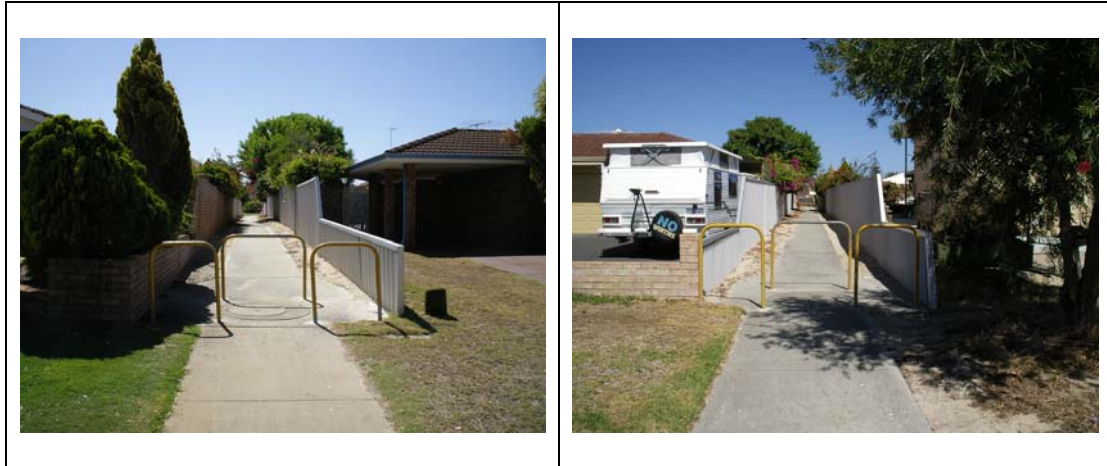
Connects Jib Close to Kite Place.

PAW reserve approx. 3m wide and 71m long. Straight, flat and long with bollards at both ends.

High Super six and masonry in fair to good condition.

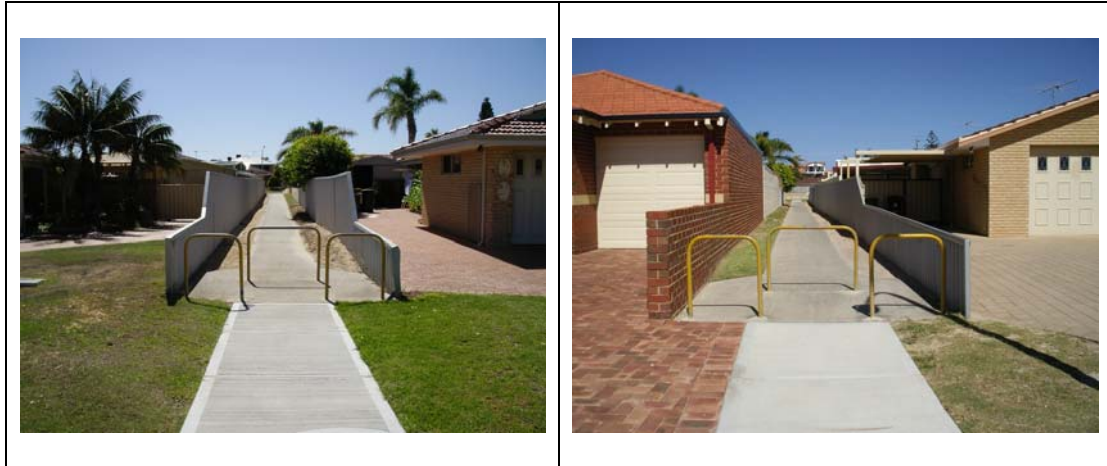
Connects Safety Bay Road to Jib Close.

PAW reserve approx. 3m wide and 63m long. Straight, flat with bollards at both ends.

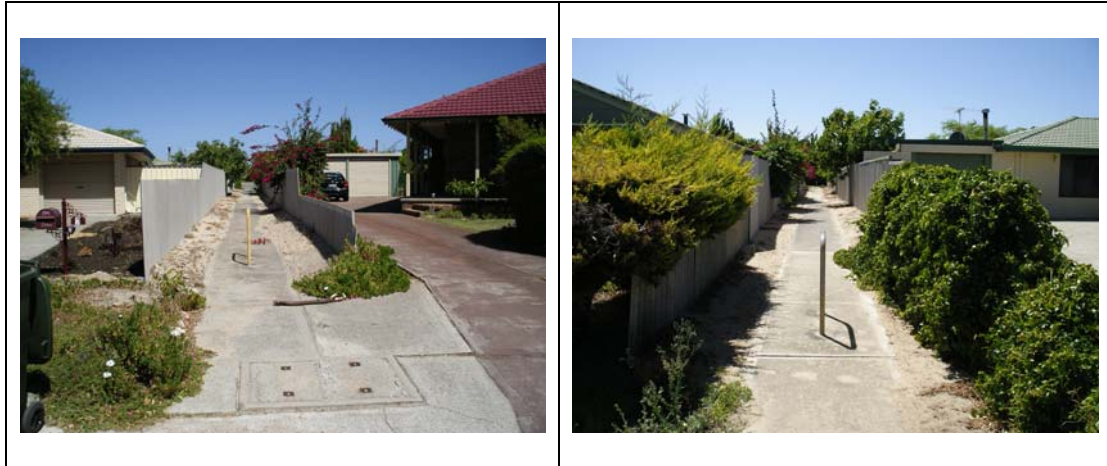
Connects Mainsail Crescent to Compass Place.

PAW reserve approx. 3m wide and 67m long. Straight, flat and long with bollards at both ends.

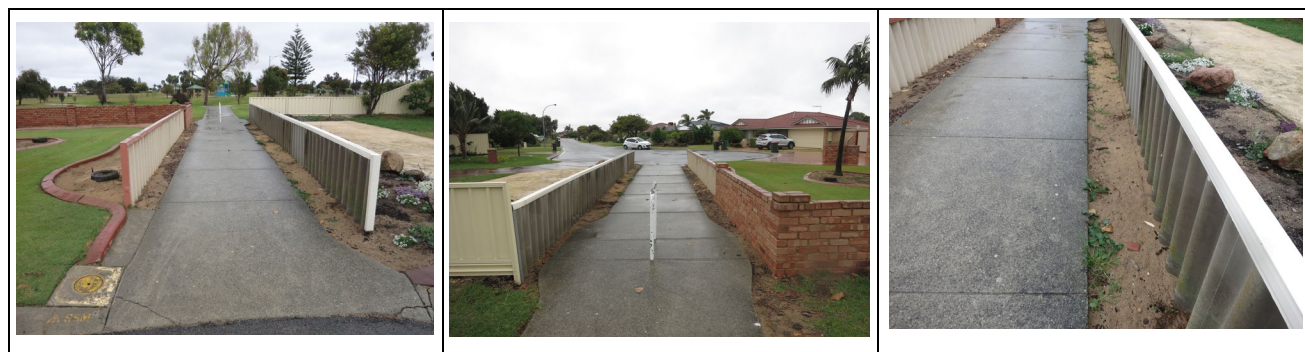
Connects the Swallow Grove road reserve through a pathway system to Centenary Park reserve.

Approximately 3m wide and 3.5m long. Short, straight and flat. Bollard at the northern entrance from Centenary Park.

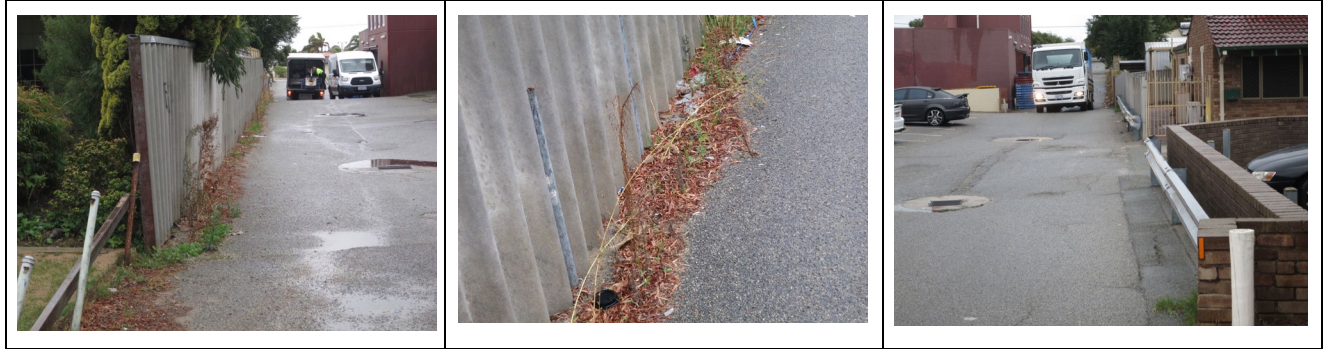
Connects Currie Street from the south through a laneway to Safety Bay Road to the north. South Waikiki Shopping Centre is located immediately adjacent to the ROW to the east and residential and commercial development is to the west.

ROW is approximately 95m long and 6m wide. ROW is straight and not flat, quite bumpy. There are no bollards at either end.
