## Environmental Assessment Report

Lots 1512 and 5000 Lake Street, Rockingham

Revision 3, July 2018

Defence Housing Australia (DHA)  
Level 1, 27-35 William St  
Fremantle WA 6160

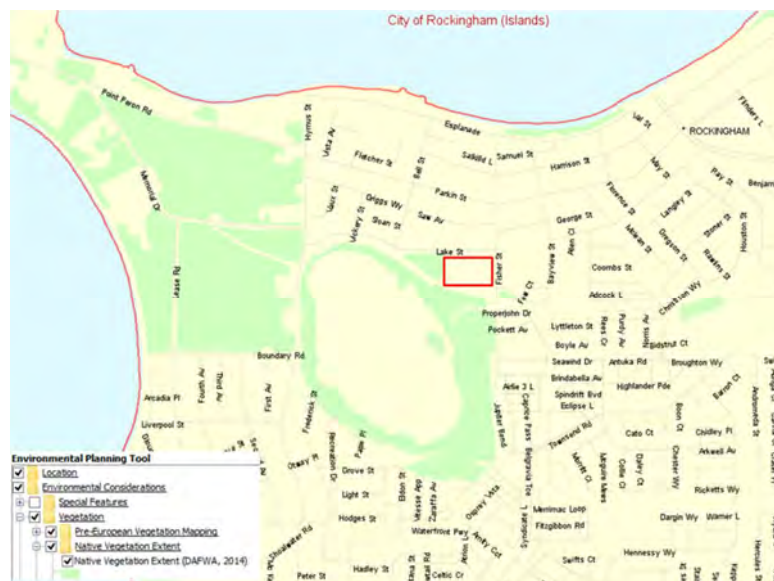
**Plate 1: Native Vegetation Extent Mapping (LBP)**

The Local Biodiversity Program (LBP) Regional Framework for local biodiversity conservation priorities have identified Local Natural Areas (LNA) which are defined as all nature areas outside of Bush Forever, DBCA managed land and regional parks. (WALGA LBP, 2013). Based on LBP (2015) database there is currently no mapped remnant vegetation (or LNAs) within the site.

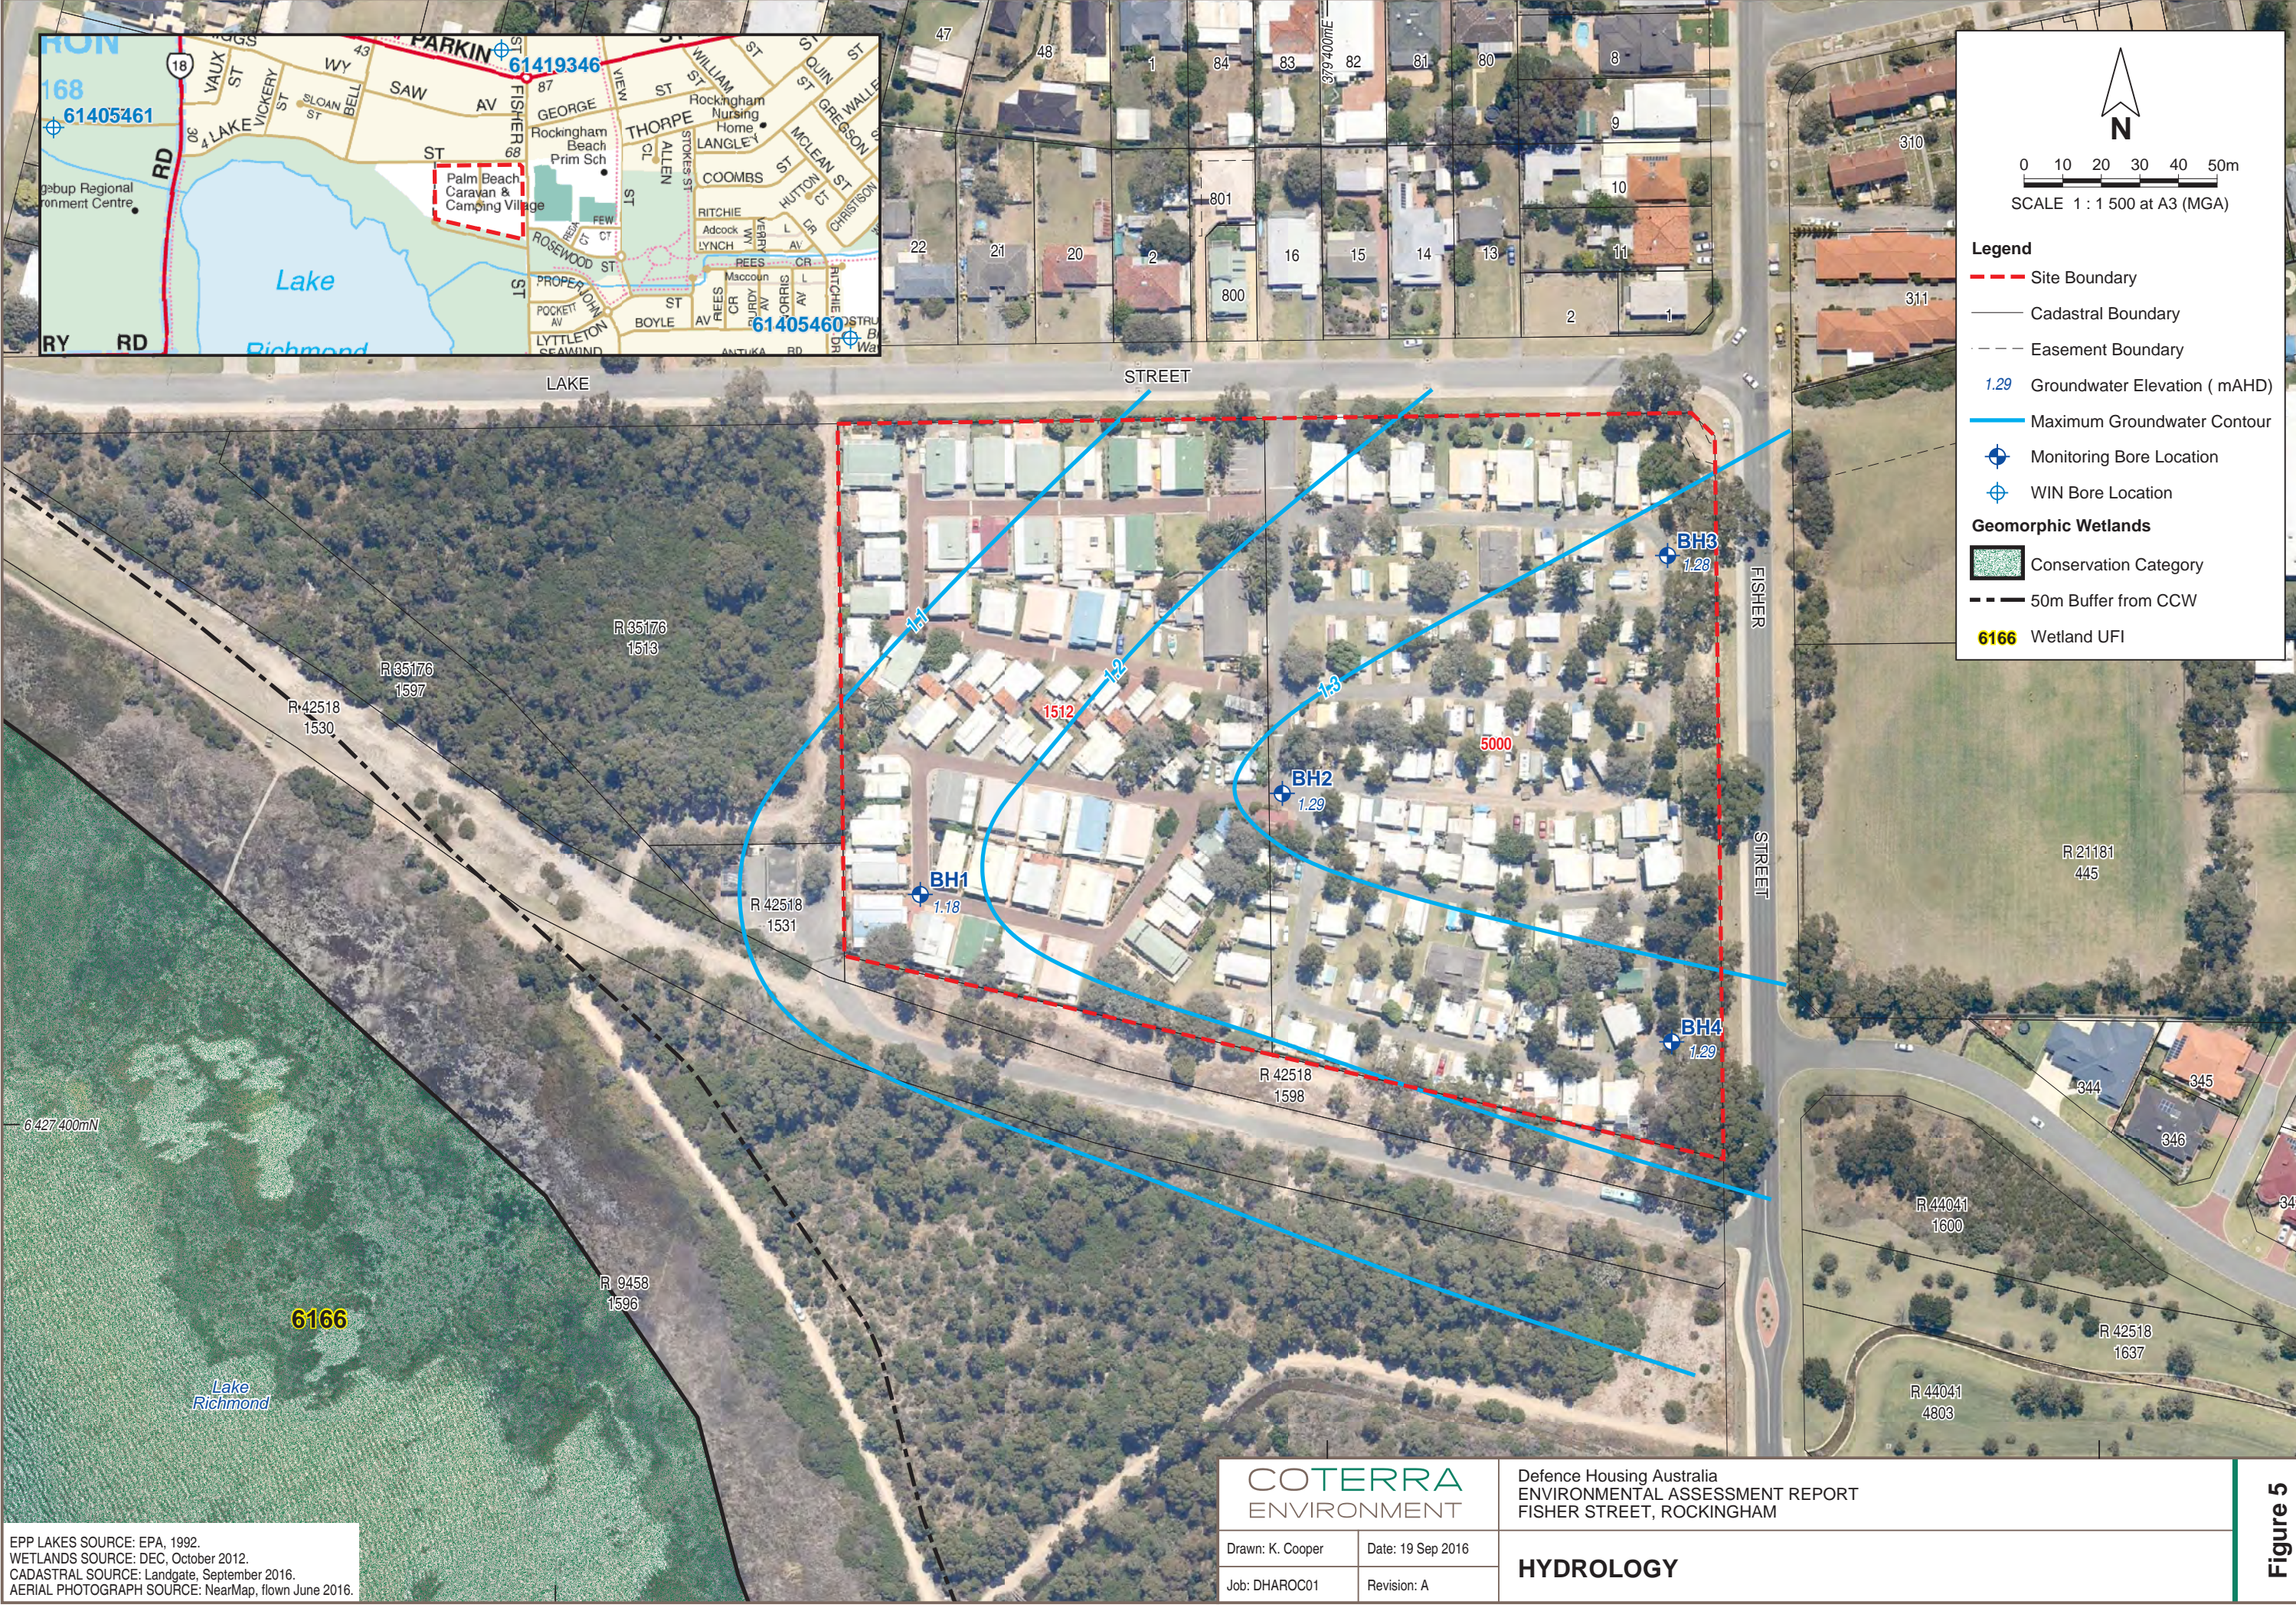
Figure 5

HYDROLOGY

Four groundwater monitoring bores were installed at the site during the geotechnical investigation in January 2013 (Figure 5). Prior to the commencement of groundwater monitoring at the site the (then) Department of Water was consulted to confirm the groundwater monitoring requirements. It was agreed that monitoring of one groundwater peak period would be sufficient, based on the following:

The maximum groundwater level recorded over the monitoring period ranged from 1.18 mAHD in the south-western corner of the site to 1.29 mAHD in the centre to east of the site. This equates to a separation of approximately 0.85 to 1.62 m from existing ground levels. Maximum groundwater contours based on the onsite monitoring data are included on Figure 5.

There are no mapped wetlands within the site as identified in the DBCA geomorphic wetlands database (Figures 5 and 6).

The south western corner of the site is approximately 100m to Lake Richmond and therefore does not intrude to the generic 50m buffer associated with the CCW (refer to Figure 5).
